**Flood Control Project Maintenance  
Levee Inspections**  
**LMA District Cover Sheet**  
**Spring 2017 Levee Inspection Results**

**Reclamation District No. 1602 Del Puerto**

Waterway			Bank	Unit Miles
Unit No. 01 San Joaquin River			Left	6.24
	Spring (March - May)	Summer (June - August)	(September - November) Fall	Winter (December - February)
Unit Maintenance Rating (Fall Only)				
Date of Inspection	4/6/2017 - 4/6/2017			
DWR Inspector	Pavel Kazi			
Accompanied By	Tony Martinez RD 1602

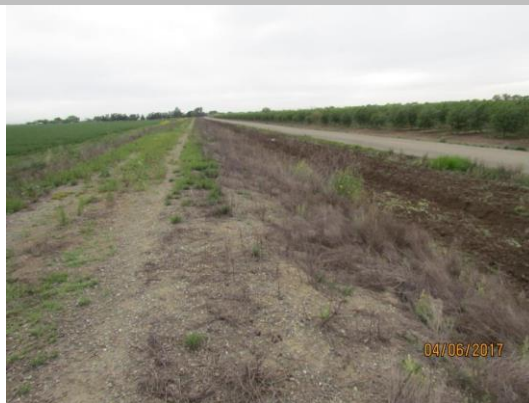
Photo 1 of 1 : SP\_2017\_RD1602\_110\_17\_20170410\_00092.jpg

LM Start	0.13	Rating **	M	Issue No.	17
LM End	0.60	Issue Type +	Ma	Location *	LS
Category	Earthen Levee			GPS Latitude/Longitude	
				Start	End
Item	Vegetation			37.477228 °	37.479964 °
				-121.081733 °	-121.074593 °
DWR ID	DWR_RD1602_01_f_2016_17				
Comment Code					
V1 : Control annual grass and weeds on the levee slopes and easements.					
Inspector Comment

View of the vegetation on the landside of the levee. Spring 2017

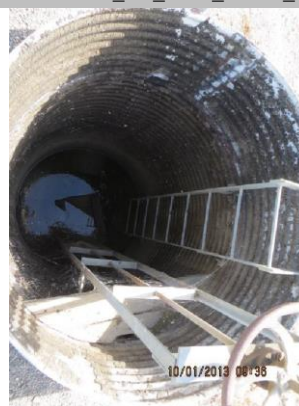
Photo 2 of 3 : UCIP\_SP\_2017\_51325\_36701.jpg

FS\_ID:51325  
DS\_ID:20215  
EP\_NO: N/A  
Repair Type: No Action Needed  
Crossing Status: Found  
UCIP Comments: 11/18/2016 Crossing has been downgraded from Urgent to No Action Needed a cover has been added to the CMP riser. (O. Magana - DWR UCIP)10/01/2013 Open 60-inch CMP riser on WS needs lid as it's depth may be a hazard to the public. (W. Wylie - DWR UCIP)  
FIELD\_STRUCT\_DESC: 16-inch steel drainage pipe through levee, 11.3 feet below crown. Slide gate in 60-inch corrugated metal pipe (CMP) riser located on the waterside (WS). Concrete inlet is approximately 110 feet west of the levee crown or 110 feet off landside (LS) toe next to roadway. [Additional Reference(s): DWR Levee Log, 1992. USACE San Joaquin River O&M Manual Unit 13, April 1964, (HLM 0.58), Drawing No. 7-4-1784].  
FS Date: 11/18/2016

LM Start	<b>0.58</b>	Rating **	A/W	Issue No.	<b>200 (cont)</b>
LM End	<b>0.58</b>	Issue Type +	Ma	Location *	WS

CMP riser with slide gate on WS shoulder.

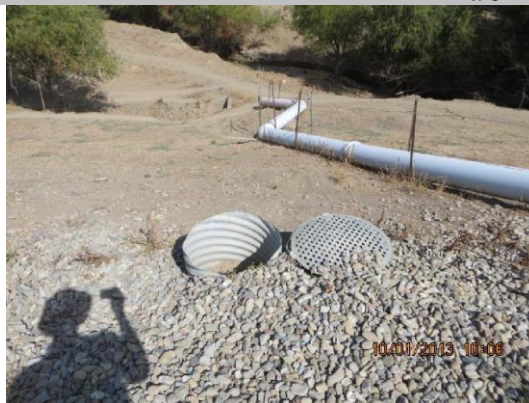
Photo 2 of 3 : UCIP\_SP\_2017\_51636\_36757.jpg

FS\_ID:51636  
DS\_ID:20217  
EP\_NO: N/A  
Repair Type: Non-Urgent  
Crossing Status: Found  
UCIP Comments: 11/18/2016 Crossing has been downgraded from Urgent to Non-Urgent a flap gate has been added to the WS but pipe is currently not connected to pump. According to Tony Martinez, LMA representative, this crossing is currently not in use. Owner will need to coordinate with CVFPB to obtain permit. (O. Magana - DWR UCIP)10/01/2013 Appears abandoned and if so should be done so properly. Flapgate missing. (W. Wylie - DWR UCIP)  
FIELD\_STRUCT\_DESC: \*ABANDONED\* 1 of 2: 16-inch steel drainage pipe through levee, 17 feet below crown. Pumps on the pump platform are located on the landside (LS). Siphon breaker in 24-inch corrugated metal pipe (CMP) riser is located on the waterside (WS) shoulder. Concrete "U" headwall and flap gate are located on the WS end.  
[Additional Reference(s): DWR Levee Log, 1992. USACE San Joaquin River O&M Manual Unit 13, April 1964, (HLM 1.01), Drawing No. 7-4-1784].

LM Start	<b>1.00</b>	Rating **	M	Issue No.	<b>203 (cont)</b>
LM End	<b>1.00</b>	Issue Type +	Ma	Location *	WS

Siphon breaker in 24-inch CMP riser on WS shoulder.

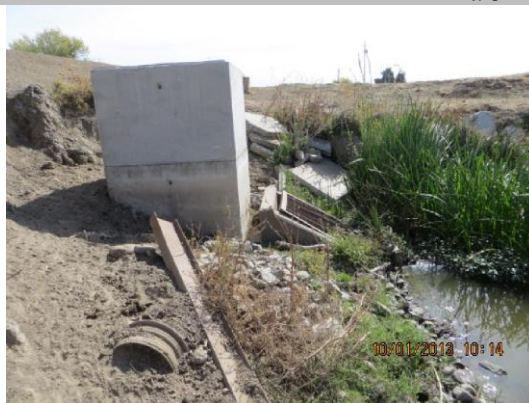
Photo 1 of 3 : UCIP\_SP\_2017\_51329\_36786.jpg

FS\_ID:51329  
DS\_ID:20218  
EP\_NO: N/A  
Repair Type: Urgent  
Crossing Status: Found  
UCIP Comments: 11/18/2016 Same as previous inspection headwall on the WS toe has separated from pipe and flap gate is still missing. Erosion around concrete headwall and undermined WS slope are visible from WS. The slope undermined appears to have progressed but no photos were taken due to the dense vegetation covering area. According to Tony Martinez, LMA representative, the WS concrete headwall has been detached since 2008/2009. LMA has been in contact with CVFPB, DWR, and USACE regarding this site. (O. Magana - DWR UCIP)10/01/2013 Headwall on WS toe separated from pipe. Erosion around concrete headwall and undermined at WS toe. Flap gate missing from WS toe headwall. (W. Wylie - DWR UCIP) FIELD\_STRUCT\_DESC: 30-inch square reinforced concrete box culvert through levee, 25.4 feet below crown. Concrete "U" headwalls on both waterside (WS) and landside (LS) ends. Slide gate in concrete surge box located on the WS slope. A 5-foot by 5-foot concrete box is located on LS toe. Flap gate is located on the WS end. [Additional Reference(s): DWR Levee Log, 1992. USACE San Joaquin River O&M Manual Unit 13, April 1964, (HLM 1.02), Drawing No. 7-4-1784]. FS Date: 11/18/2016

LM Start	<b>1.02</b>	Rating **	U	Issue No.	<b>205 (cont)</b>
LM End	<b>1.02</b>	Issue Type +	Ma	Location *	WS

Grated inlet and 5'X5' concrete box on LS toe.

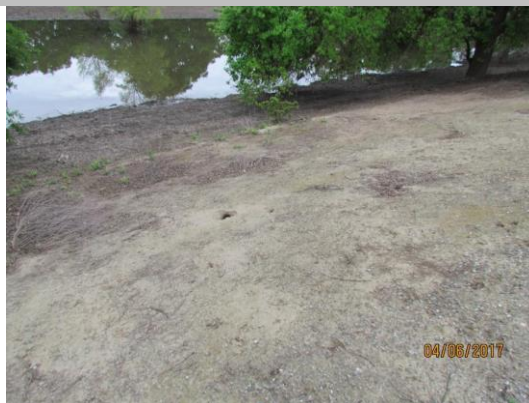
Photo 1 of 1 : SP\_2017\_RD1602\_110\_55\_20170410\_00093.jpg

LM Start	1.70	Rating **	M	Issue No.	55
LM End	1.70	Issue Type +	Ma	Location *	WS
Category	Earthen Levee			GPS Latitude/Longitude	
				Start	End
Item	Animal Control			37.476482 °	37.476482 °
				-121.058136 °	-121.058136 °
DWR ID	DWR_RD1602_01_s_2017_55				
Comment Code					
A3 : No rodents visible, but rodent burrows visible; need to backfill and compact or grout burrows.					
Inspector Comment

View of a rodent hole on the waterside slope of the levee.

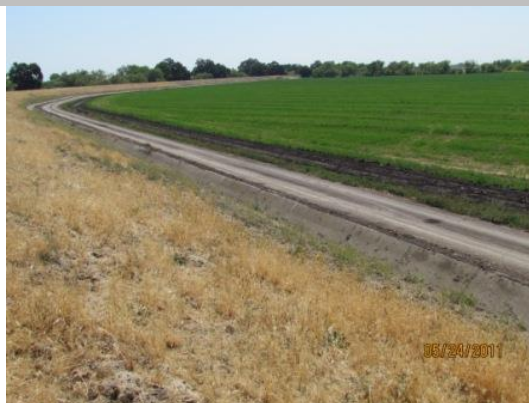
Photo 1 of 1 : SP\_2017\_RD1602\_110\_59\_20170327\_00032.jpg

LM Start	2.23	Rating **	M	Issue No.	59
LM End	3.30	Issue Type +	En	Location *	LS
Category	Earthen Levee			GPS Latitude/Longitude	
				Start	End
Item	Encroachments			37.470119 °	37.461147 °
				-121.055117 °	-121.041785 °
DWR ID	DWR_RD1602_01_s_2012_59				
Comment Code					
DT : Ditch					
Inspector Comment					
Concrete ditch was constructed before the levee was built.

Concrete drain was built at the toe of the levee. The picture was taken from the crown looking upstream.

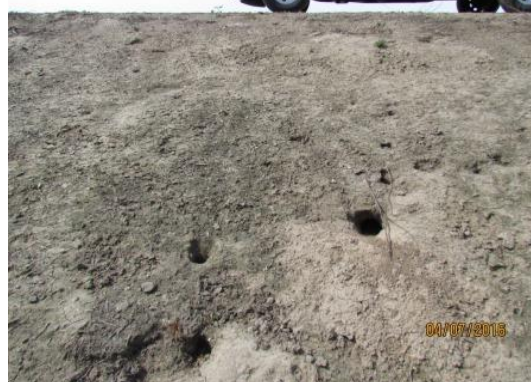
Photo 1 of 1 : SP\_2017\_RD1602\_110\_19\_20170327\_00006.jpg

LM Start	2.67	Rating **	M	Issue No.	19
LM End	2.67	Issue Type +	Ma	Location *	WS
Category	Earthen Levee			GPS Latitude/Longitude	
				Start	End
Item	Animal Control			37.468212 °	37.468212 °
				-121.048096 °	-121.048096 °
DWR ID	DWR_RD1602_01_s_2016_19				
Comment Code					
A3 : No rodents visible, but rodent burrows visible; need to backfill and compact or grout burrows.					
Inspector Comment

View of rodent holes on the waterside of the levee.

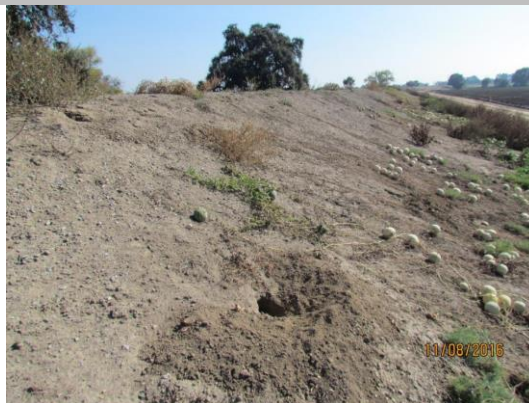
Photo 2 of 2 : SP\_2017\_RD1602\_110\_40\_20170327\_00021.jpg

LM Start	2.73	Rating **	M	Issue No.	40 (cont)	
LM End	2.73	Issue Type +	Ma	Location *	LS	
Category	Earthen Levee			GPS Latitude/Longitude		
				Start		End
Item	Animal Control			37.467507 °		37.467507 °
				-121.047245 °		-121.047245 °
DWR ID	DWR_RD1602_01_f_2016_40					
Comment Code						
A3 : No rodents visible, but rodent burrows visible; need to backfill and compact or grout burrows.						
Inspector Comment

View of rodent hole on the landside of the levee. Fall 2016

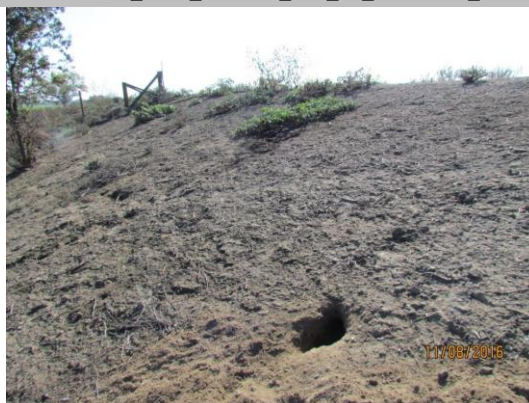
Photo 1 of 1 : SP\_2017\_RD1602\_110\_41\_20170327\_00022.jpg

LM Start	2.79	Rating **	M	Issue No.	41
LM End	2.79	Issue Type +	Ma	Location *	WS
Category	Earthen Levee			GPS Latitude/Longitude	
				Start	End
Item	Animal Control			37.466887 °	37.466887 °
				-121.046460 °	-121.046460 °
DWR ID	DWR_RD1602_01_f_2016_41				
Comment Code					
A3 : No rodents visible, but rodent burrows visible; need to backfill and compact or grout burrows.					
Inspector Comment

View of rodent holes on the waterside slope of the levee. Fall 2016

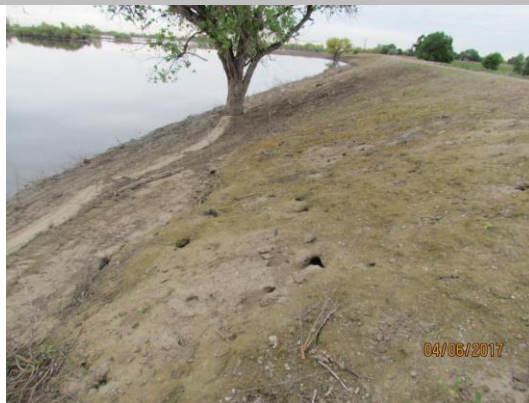
Photo 1 of 1 : SP\_2017\_RD1602\_110\_49\_20170410\_00099.jpg

LM Start	2.89	Rating **	M	Issue No.	49
LM End	2.89	Issue Type +	Ma	Location *	WS
Category	Earthen Levee			GPS Latitude/Longitude	
				Start	End
Item	Animal Control			37.465898 °	37.465898 °
				-121.045209 °	-121.045209 °
DWR ID	DWR_RD1602_01_f_2016_49				
Comment Code					
A3 : No rodents visible, but rodent burrows visible; need to backfill and compact or grout burrows.					
Inspector Comment

View of rodent holes on the waterside slope of the levee. Spring 2017

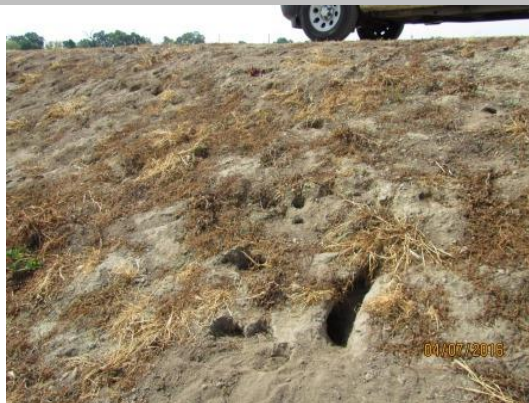
Photo 1 of 1 : SP\_2017\_RD1602\_110\_24\_20170327\_00010.jpg

LM Start	3.10	Rating **	M	Issue No.	24
LM End	3.10	Issue Type +	Ma	Location *	WS
Category	Earthen Levee			GPS Latitude/Longitude	
				Start	End
Item	Animal Control			37.463563 °	37.463563 °
				-121.042784 °	-121.042784 °
DWR ID	DWR_RD1602_01_s_2016_24				
Comment Code					
A3 : No rodents visible, but rodent burrows visible; need to backfill and compact or grout burrows.					
Inspector Comment

View of rodent holes on the waterside of the levee looking upstream.

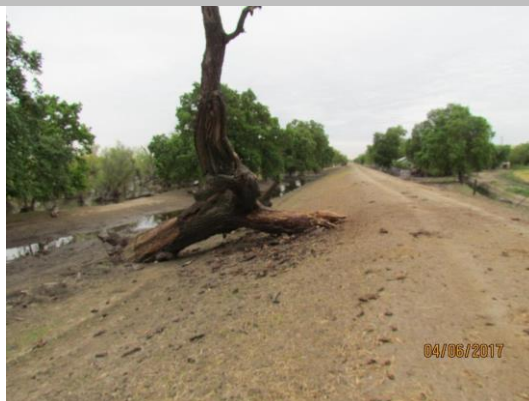
Photo 1 of 1 : SP\_2017\_RD1602\_110\_83\_20170410\_00100.jpg

LM Start	3.76	Rating **	M	Issue No.	83
LM End	3.76	Issue Type +	Ma	Location *	WS
Category	Earthen Levee			GPS Latitude/Longitude	
				Start	End
Item	Encroachments			37.455414 °	37.455414 °
				-121.043765 °	-121.043765 °
DWR ID	DWR_RD1602_01_s_2017_83				
Comment Code					
TR : Tree or limb					
Inspector Comment

View of a tree trunk on the waterside slope of the levee.

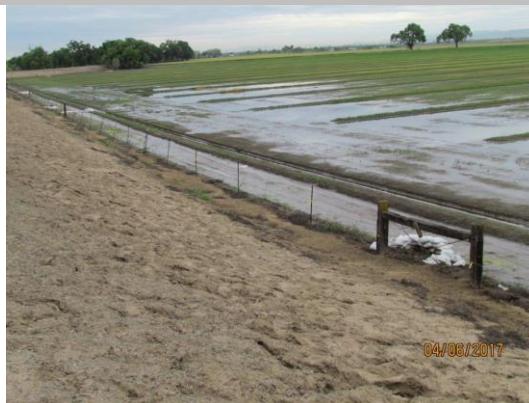
Photo 1 of 1 : SP\_2017\_RD1602\_110\_87\_20170410\_00102.jpg

LM Start	4.21	Rating **	A	Issue No.	87
LM End	4.21	Issue Type +	Ob	Location *	LS
Category	Earthen Levee			GPS Latitude/Longitude	
				Start	End
Item	Seepage / Sandboils			37.449953 °	37.449953 °
				-121.039167 °	-121.039167 °
DWR ID	DWR_RD1602_01_s_2017_87				
Comment Code					
Inspector Comment					
LMA placed sack rings on the toe of the levee.

View of a sack ring on the landside toe of the levee looking upstream.  
Spring 2017

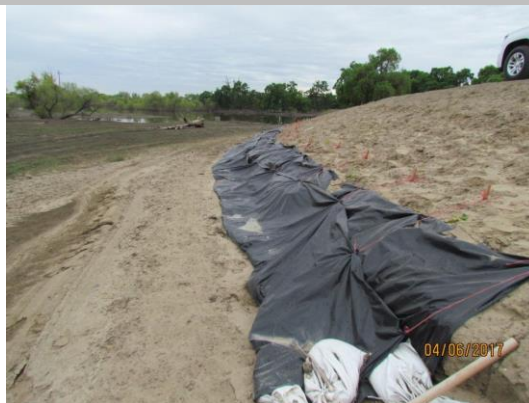
Photo 1 of 2 : SP\_2017\_RD1602\_110\_89\_20170410\_00104.jpg

LM Start	4.40	Rating **	A/W	Issue No.	89
LM End	4.40	Issue Type +	Ma	Location *	WS
Category	Earthen Levee			GPS Latitude/Longitude	
				Start	End
Item	Erosion / Bank Caving			37.447433 °	37.447433 °
				-121.037639 °	-121.037639 °
DWR ID	DWR_RD1602_01_s_2017_89				
Comment Code					
E1 : Note and monitor erosion site.					
Inspector Comment					
LMA placed wavewash (400 ft) on the waterside slope of the levee.

View of wave wash installed by the LMA on the waterside toe of the levee. Spring 2017

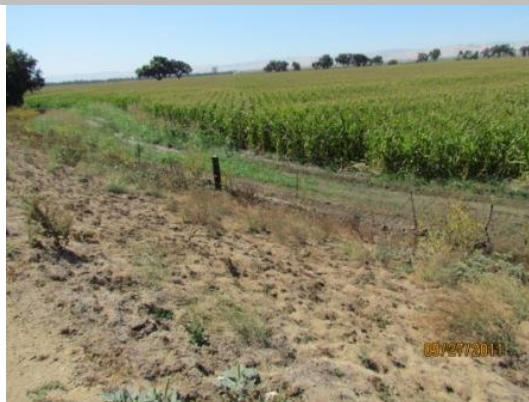
Photo 1 of 1 : SP\_2017\_RD1602\_110\_67\_20170327\_00041.jpg

LM Start	4.42	Rating **	M	Issue No.	67
LM End	4.88	Issue Type +	En	Location *	LS
Category	Earthen Levee			GPS Latitude/Longitude	
				Start	End
Item	Encroachments			37.447213 °	37.441014 °
				-121.037665 °	-121.036932 °
DWR ID	DWR_RD1602_01_s_2012_67				
Comment Code					
FE : Fence					
Inspector Comment

View of the fence on the landside toe of the levee. The picture was taken from the crown looking upstream.

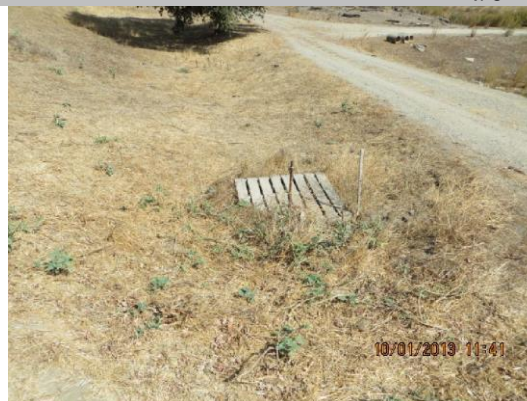
Photo 1 of 3 : UCIP\_SP\_2017\_51332\_36819.jpg

LM Start	<b>4.47</b>	Rating **	M	Issue No.	<b>208 (cont)</b>
LM End	<b>4.47</b>	Issue Type +	En	Location *	LS

Slide gate in CMP riser on WS slope.

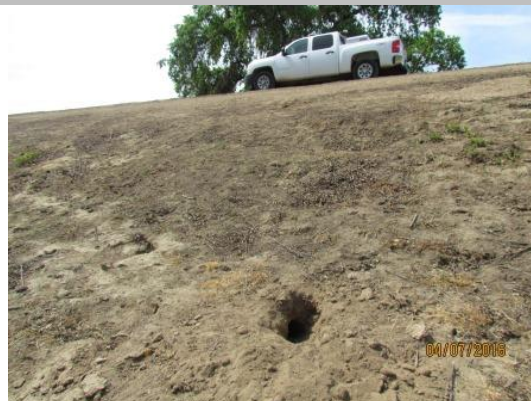
Photo 1 of 1 : SP\_2017\_RD1602\_110\_74\_20170327\_00044.jpg

LM Start	4.77	Rating **	M	Issue No.	74
LM End	4.77	Issue Type +	Ma	Location *	WS
Category	Earthen Levee			GPS Latitude/Longitude	
				Start	End
Item	Animal Control			37.442465 °	37.442465 °
				-121.036947 °	-121.036947 °
DWR ID	DWR_RD1602_01_s_2015_74				
Comment Code					
A3 : No rodents visible, but rodent burrows visible; need to backfill and compact or grout burrows.					
Inspector Comment

View of a rodent hole on the waterside toe of the levee.
