**Flood Control Project Maintenance
Levee Inspections**
LMA District Cover Sheet
Spring 2018 Levee Inspection Results

Reclamation District No. 1602 Del Puerto

Spring 2018 Levee Inspection Results

Waterway			Bank	Unit Miles
Unit No. 01 San Joaquin River			Left	6.24
	Spring (March - May)	Summer (June - August)	(September - November) Fall	Winter (December - February)
Unit Maintenance Rating (Fall Only)				
Date of Inspection	3/13/2018 - 3/13/2018			
DWR Inspector	Richard Willoughby			
Accompanied By	Tony Martinez RD 1602

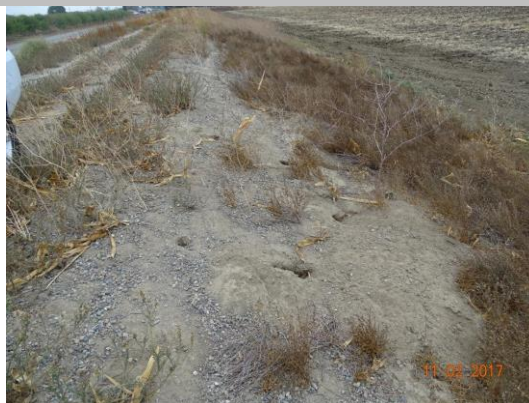
Photo 1 of 2 : SP_2018_RD1602_110_29_20180307_00013.jpg

LM Start	0.26	Rating **	M	Issue No.	29
LM End	0.26	Issue Type +	Ma	Location *	WS
Category	Earthen Levee			GPS Latitude/Longitude	
				Start	End
Item	Animal Control			37.478138 °	37.478138 °
				-121.079810 °	-121.079810 °
DWR ID	DWR_RD1602_01_f_2017_29				
Comment Code					
A3 : No rodents visible, but rodent burrows visible; need to backfill and compact or grout burrows.					
Inspector Comment

View of a rodent hole on the waterside of the levee. Fall 2017

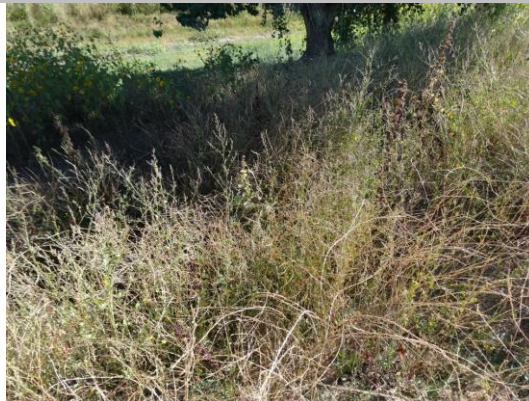
Photo 2 of 4 : SP_2018_RD1602_110_2_20180307_00003.jpg

LM Start	1.05	Rating **	M	Issue No.	2 (cont)
LM End	1.05	Issue Type +	Ma	Location *	WS

Close view of the erosion.

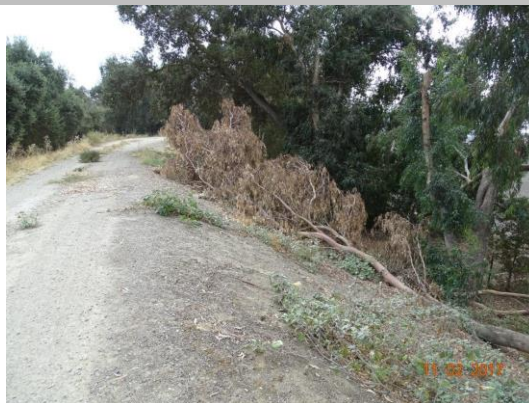
Photo 1 of 1 : SP_2018_RD1602_110_33_20180307_00015.jpg

LM Start	1.57	Rating **	M	Issue No.	33
LM End	1.57	Issue Type +	Ma	Location *	LS
Category	Earthen Levee			GPS Latitude/Longitude	
				Start	End
Item	Encroachments			37.478113 °	37.478113 °
				-121.059287 °	-121.059287 °
DWR ID	DWR_RD1602_01_f_2017_33				
Comment Code					
PR : Prunings					
Inspector Comment

View of prunings on the landside of the levee.

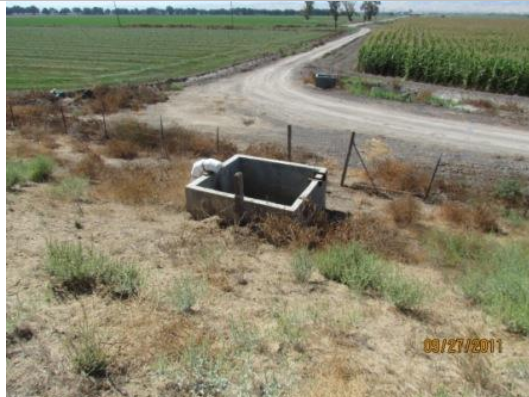
Photo 1 of 1 : SP_2018_RD1602_110_45_20180307_00026.jpg

LM Start	2.03	Rating **	M	Issue No.	45
LM End	2.03	Issue Type +	En	Location *	LS
Category	Earthen Levee			GPS Latitude/Longitude	
				Start	End
Item	Encroachments			37.471734 °	37.471734 °
				-121.057670 °	-121.057670 °
DWR ID	DWR_RD1602_01_s_2012_45				
Comment Code					
EQ : Equipment					
Inspector Comment					
A well is present at the toe of the landside of the slope.

A well is located at the landside toe of the levee. The picture was taken from the crown looking toward the landside of the levee.

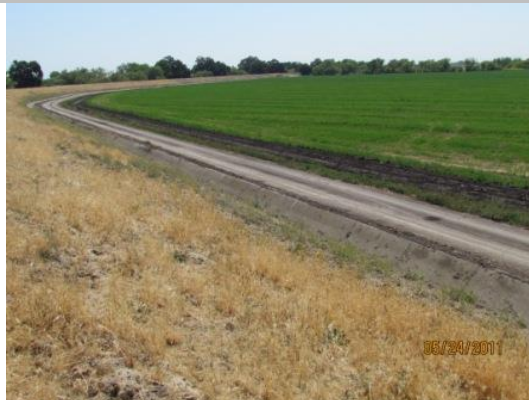
Photo 1 of 1 : SP_2018_RD1602_110_59_20180307_00036.jpg

LM Start	2.23	Rating **	M	Issue No.	59
LM End	3.30	Issue Type +	En	Location *	LS
Category	Earthen Levee			GPS Latitude/Longitude	
				Start	End
Item	Encroachments			37.470119 °	37.461147 °
				-121.055117 °	-121.041785 °
DWR ID	DWR_RD1602_01_s_2012_59				
Comment Code					
DT : Ditch					
Inspector Comment					
Concrete ditch was constructed before the levee was built.

Concrete drain was built at the toe of the levee. The picture was taken from the crown looking upstream.

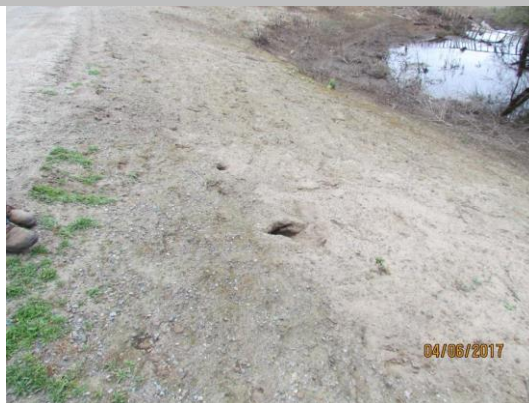
Photo 1 of 1 : SP_2018_RD1602_110_81_20180307_00047.jpg

LM Start	2.56	Rating **	M	Issue No.	81
LM End	2.56	Issue Type +	Ma	Location *	WS
Category	Earthen Levee			GPS Latitude/Longitude	
				Start	End
Item	Animal Control			37.469268 °	37.469268 °
				-121.049413 °	-121.049413 °
DWR ID	DWR_RD1602_01_s_2017_81				
Comment Code					
A3 : No rodents visible, but rodent burrows visible; need to backfill and compact or grout burrows.					
Inspector Comment

View of a rodent hole on the waterside slope of the levee.

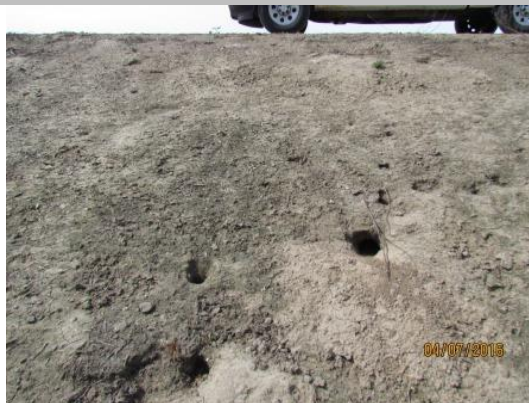
Photo 1 of 1 : SP_2018_RD1602_110_19_20180307_00006.jpg

LM Start	2.67	Rating **	M	Issue No.	19
LM End	2.67	Issue Type +	Ma	Location *	WS
Category	Earthen Levee			GPS Latitude/Longitude	
				Start	End
Item	Animal Control			37.468212 °	37.468212 °
				-121.048096 °	-121.048096 °
DWR ID	DWR_RD1602_01_s_2016_19				
Comment Code					
A3 : No rodents visible, but rodent burrows visible; need to backfill and compact or grout burrows.					
Inspector Comment

View of rodent holes on the waterside of the levee.

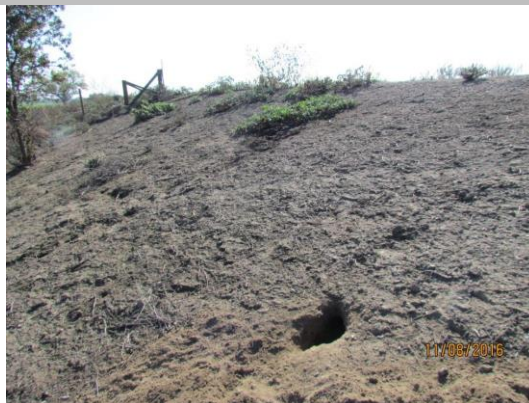
Photo 1 of 1 : SP_2018_RD1602_110_41_20180307_00022.jpg

LM Start	2.79	Rating **	M	Issue No.	41
LM End	2.79	Issue Type +	Ma	Location *	WS
Category	Earthen Levee			GPS Latitude/Longitude	
				Start	End
Item	Animal Control			37.466887 °	37.466887 °
				-121.046460 °	-121.046460 °
DWR ID	DWR_RD1602_01_f_2016_41				
Comment Code					
A3 : No rodents visible, but rodent burrows visible; need to backfill and compact or grout burrows.					
Inspector Comment

View of rodent holes on the waterside slope of the levee. Fall 2016

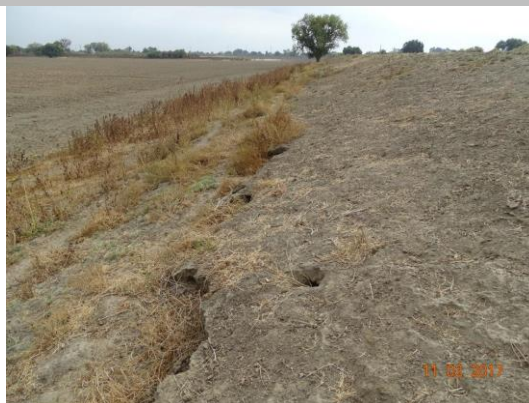
Photo 1 of 1 : SP_2018_RD1602_110_44_20180307_00025.jpg

LM Start	2.82	Rating **	M	Issue No.	44
LM End	2.82	Issue Type +	Ma	Location *	LS
Category	Earthen Levee			GPS Latitude/Longitude	
				Start	End
Item	Animal Control			37.466645 °	37.466645 °
				-121.046148 °	-121.046148 °
DWR ID	DWR_RD1602_01_f_2016_44				
Comment Code					
A3 : No rodents visible, but rodent burrows visible; need to backfill and compact or grout burrows.					
Inspector Comment

View of rodent holes on the landside of the levee.

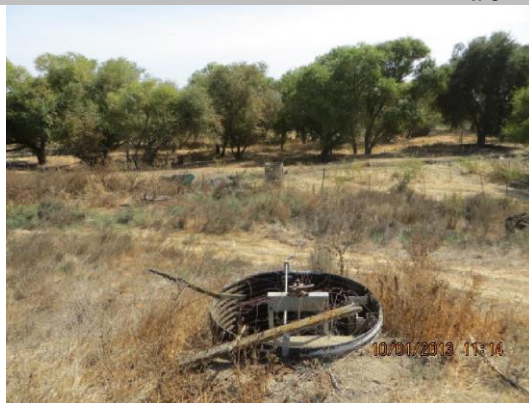
Photo 2 of 3 : UCIP_SP_2018_51330_36804.jpg

LM Start	3.27	Rating **	U	Issue No.	206 (cont)
LM End	3.27	Issue Type +	En	Location *

Slide gate in 60-inch CMP riser on WS shoulder.

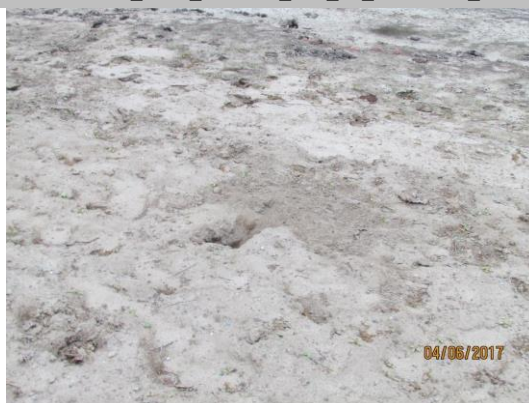
Photo 1 of 1 : SP_2018_RD1602_110_88_20180307_00050.jpg

LM Start	4.35	Rating **	M	Issue No.	88
LM End	4.35	Issue Type +	Ma	Location *	WS
Category	Earthen Levee			GPS Latitude/Longitude	
				Start	End
Item	Animal Control			37.448170 °	37.448170 °
				-121.038072 °	-121.038072 °
DWR ID	DWR_RD1602_01_s_2017_88				
Comment Code					
A3 : No rodents visible, but rodent burrows visible; need to backfill and compact or grout burrows.					
Inspector Comment

View of a rodent hole on the waterside slope of the levee.

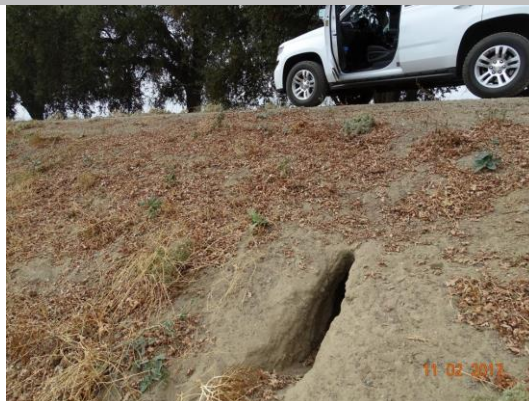
Photo 1 of 1 : SP_2018_RD1602_110_65_20180307_00041.jpg

LM Start	4.60	Rating **	U	Issue No.	65
LM End	4.60	Issue Type +	Ma	Location *	WS
Category	Earthen Levee			GPS Latitude/Longitude	
				Start	End
Item	Animal Control			37.444666 °	37.444666 °
				-121.037748 °	-121.037748 °
DWR ID	DWR_RD1602_01_f_2017_65				
Comment Code					
A3 : No rodents visible, but rodent burrows visible; need to backfill and compact or grout burrows.					
Inspector Comment

View of a rodent hole on the waterside of the levee. Fall 2017

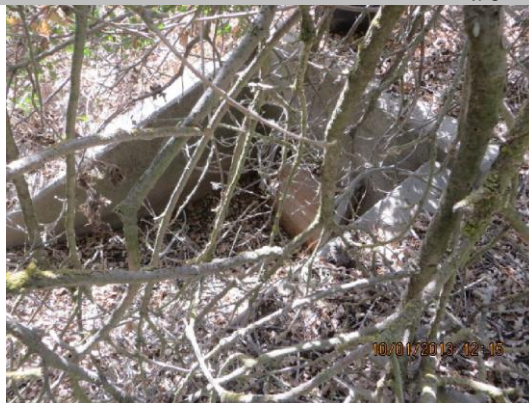
Photo 2 of 3 : UCIP_SP_2018_51336_36821.jpg

LM Start	5.19	Rating **	M	Issue No.	209 (cont)
LM End	5.19	Issue Type +	Ma	Location *

Flapgate in Concrete headwall on WS toe under tree.

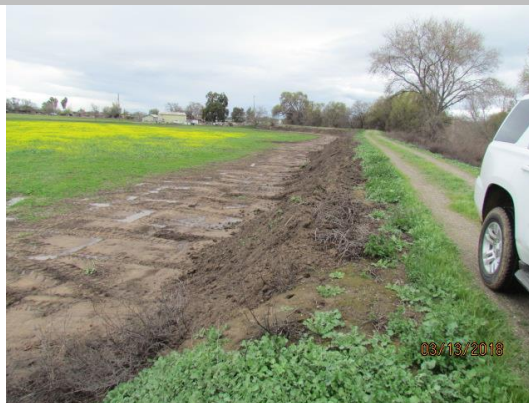
Photo 2 of 3 : SP_2018_RD1602_110_82_20180323_00110.jpg

LM Start	5.24	Rating **	U	Issue No.	82 (cont)	
LM End	5.35	Issue Type +	En	Location *	LS	
Category	Earthen Levee			GPS Latitude/Longitude		
				Start		End
Item	Encroachments			37.436099 °		37.434760 °
				-121.036002 °		-121.035092 °
DWR ID	DWR_RD1602_01_s_2018_82					
Comment Code						
MA : Material						
Inspector Comment						
Farmer or Landowner pile earthen material against landward toe.

Looking north at earthen material pile on landward toe.

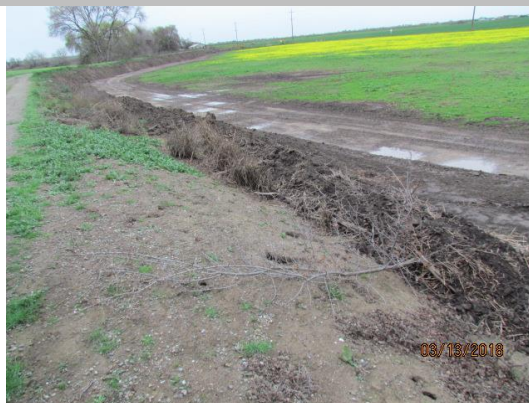
Photo 3 of 3 : SP_2018_RD1602_110_82_20180323_00111.jpg

LM Start	5.24	Rating **	U	Issue No.	82 (cont)
LM End	5.35	Issue Type +	En	Location *	LS

Looking at earthen material pile on landward slope.
