**Flood Control Project Maintenance
Levee Inspections**
LMA District Cover Sheet
Spring 2019 Levee Inspection Results

Reclamation District No. 1602 Del Puerto

Spring 2019 Levee Inspection Results

Waterway			Bank	Unit Miles
Unit No. 01 San Joaquin River			Left	6.24
	Spring (March - May)	Summer (June - August)	(September - November) Fall	Winter (December - February)
Unit Maintenance Rating (Fall Only)				
Date of Inspection	4/16/2019 - 4/16/2019			
DWR Inspector	Corey Fujitani			
Accompanied By	Tony Martinez RD 1602

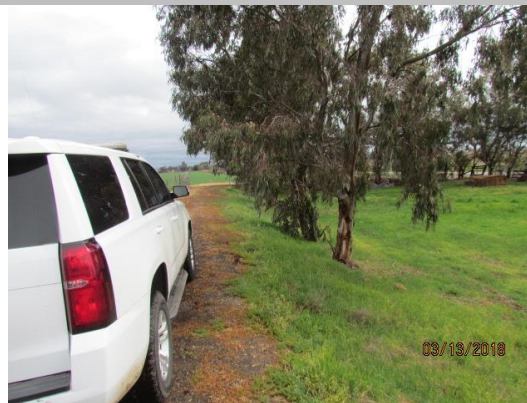
Photo 1 of 1 : SP_2019_RD1602_110_60_20190307_00033.jpg

LM Start	0.09	Rating **	M	Issue No.	60
LM End	0.11	Issue Type +	Ma	Location *	LS
Category	Earthen Levee			GPS Latitude/Longitude	
				Start	End
Item	Trim / Thin Trees			37.477161°	37.477299°
				-121.082504°	-121.082084°
DWR ID	DWR_RD1602_01_s_2018_60				
Comment Code					
T1 : Trim trees to at least five feet above ground level.					
Inspector Comment

Looking upstream at trees on landward slope.

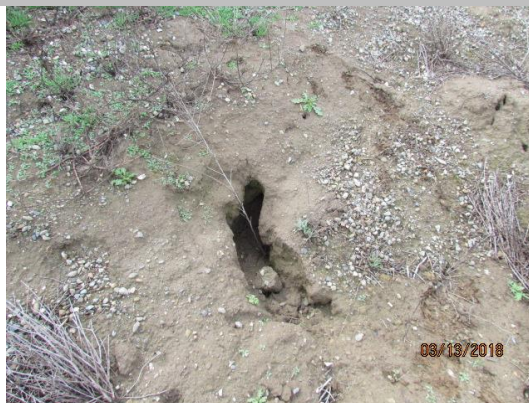
Photo 2 of 2 : SP_2019_RD1602_110_29_20190307_00010.jpg

LM Start	0.26	Rating **	M	Issue No.	29 (cont)
LM End	0.26	Issue Type +	Ma	Location *	WS

Looking at typical rodent holes on waterward slope. (Spring 2018)

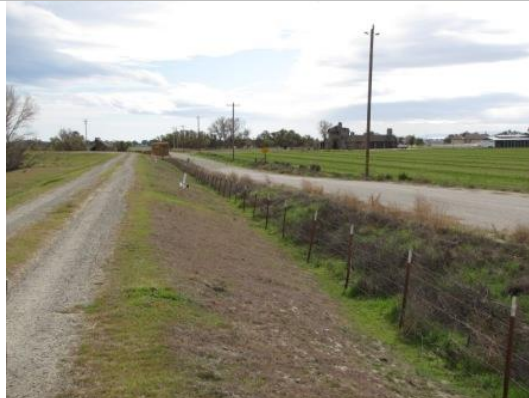
Photo 1 of 1 : SP_2019_RD1602_110_70_20190307_00044.jpg

LM Start	0.60	Rating **	M	Issue No.	70
LM End	0.71	Issue Type +	En	Location *	WS
Category	Earthen Levee			GPS Latitude/Longitude	
				Start	End
Item	Encroachments			37.479967 °	37.478514 °
				-121.074582 °	-121.073435 °
DWR ID	DWR_RD1602_01_s_2012_70				
Comment Code					
FE : Fence					
Inspector Comment					
Barbed wire fence along the landward toe.

View of barbed wire fence at landward toe looking upstream.

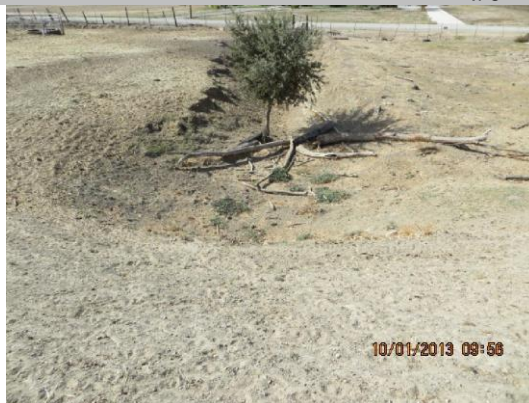
Photo 1 of 3 : UCIP_SP_2019_51634_36723.jpg

Comment Code					
Inspector Comment					
FS_ID:51634 DS_ID:20216 EP_NO: N/A Repair Type: No Action Needed Crossing Status: Found UCIP Comments: 11/18/2016 Crossing has been downgraded from Urgent to No Action Needed the debris blocking the outlet has been cleared. (O. Magana - DWR UCIP)10/01/2013 Flap gate blocked from functioning by soil buildup on WS toe. Soil should be cleared. (W. Wylie - DWR UCIP) FIELD_STRUCT_DESC: 30-inch square reinforced concrete box culvert through levee, 14.4 feet below crown. Concrete "U" headwall on the waterside (WS) and landside (LS) ends. Slide gate in 6-foot by 7-foot concrete surge box is located on the WS shoulder. Flap gate is located on the WS end. [Additional Reference(s): DWR Levee Log, 1992. USACE San Joaquin River O&M Manual Unit 13, April 1964, (HLM 0.78), Drawing No. 7-4-1784]. FS Date: 11/18/2016

Inlet on LS toe.

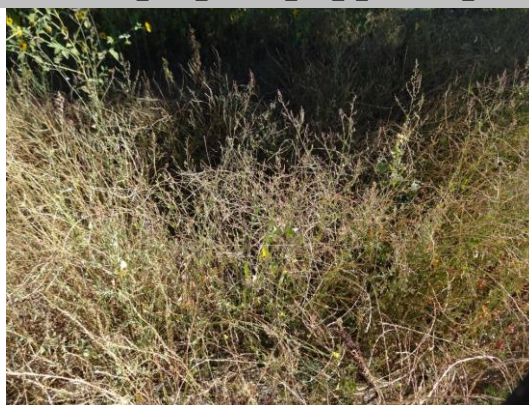
Photo 4 of 4 : SP_2019_RD1602_110_2_20190307_00004.jpg

LM Start	1.05	Rating **	M	Issue No.	2 (cont)
LM End	1.05	Issue Type +	Ma	Location *	WS

Close view of the erosion.

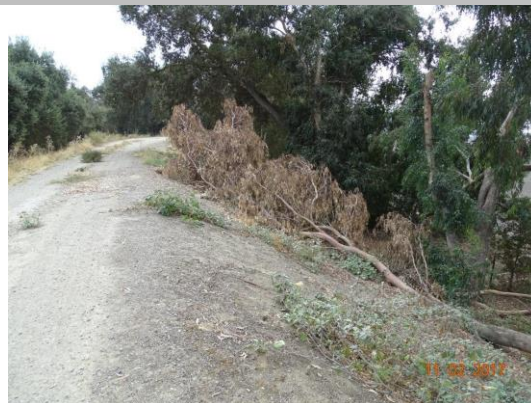
Photo 1 of 1 : SP_2019_RD1602_110_33_20190307_00012.jpg

LM Start	1.57	Rating **	M	Issue No.	33
LM End	1.57	Issue Type +	Ma	Location *	LS
Category	Earthen Levee			GPS Latitude/Longitude	
				Start	End
Item	Encroachments			37.478113 °	37.478113 °
				-121.059287 °	-121.059287 °
DWR ID	DWR_RD1602_01_f_2017_33				
Comment Code					
TR : Tree or limb					
Inspector Comment

View of prunings on the landside of the levee.

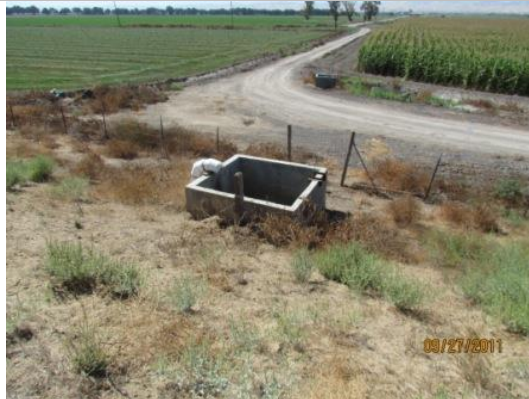
Photo 1 of 1 : SP_2019_RD1602_110_45_20190307_00022.jpg

LM Start	2.03	Rating **	M	Issue No.	45
LM End	2.03	Issue Type +	En	Location *	LS
Category	Earthen Levee			GPS Latitude/Longitude	
				Start	End
Item	Encroachments			37.471734 °	37.471734 °
				-121.057670 °	-121.057670 °
DWR ID	DWR_RD1602_01_s_2012_45				
Comment Code					
EQ : Equipment					
Inspector Comment					
A well is present at the toe of the landside of the slope.

A well is located at the landside toe of the levee. The picture was taken from the crown looking toward the landside of the levee.

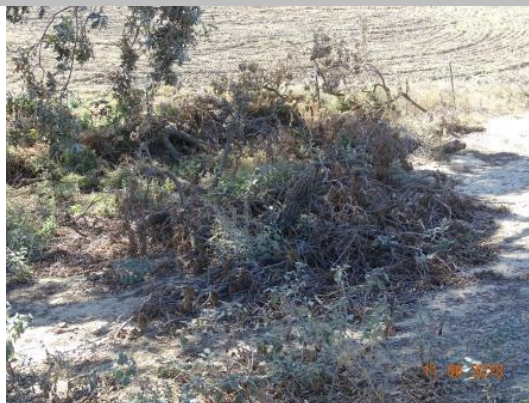
Photo 1 of 1 : SP_2019_RD1602_110_101_20190307_00065.jpg

LM Start	2.19	Rating **	M	Issue No.	101
LM End	2.19	Issue Type +	En	Location *	LS
Category	Earthen Levee			GPS Latitude/Longitude	
				Start	End
Item	Encroachments			37.470210 °	37.470210 °
				-121.055683 °	-121.055683 °
DWR ID	DWR_RD1602_01_f_2018_101				
Comment Code					
PR : Prunings					
Inspector Comment					
Tree limb on landside slope.

pruning pile at landside toe. (Fall 2018)

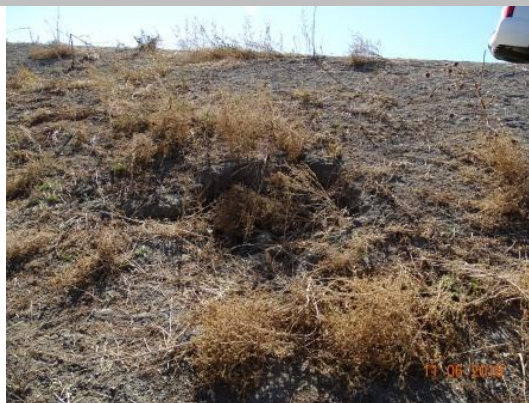
Photo 1 of 2 : SP_2019_RD1602_110_98_20190307_00061.jpg

LM Start	2.78	Rating **	A/W	Issue No.	98
LM End	2.78	Issue Type +	Ma	Location *	WS
Category	Earthen Levee			GPS Latitude/Longitude	
				Start	End
Item	Erosion / Bank Caving			37.466997 °	37.466997 °
				-121.046606 °	-121.046606 °
DWR ID	DWR_RD1602_01_f_2018_98				
Comment Code					
Inspector Comment					
erosion spot at waterside toe

erosion at waterside toe. (Fall 2018)

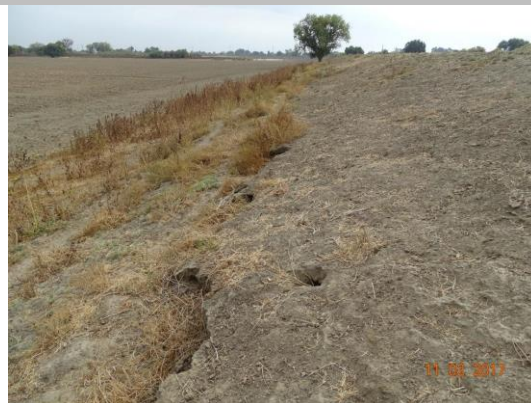
Photo 1 of 1 : SP_2019_RD1602_110_44_20190307_00021.jpg

LM Start	2.82	Rating **	M	Issue No.	44
LM End	2.82	Issue Type +	Ma	Location *	LS
Category	Earthen Levee			GPS Latitude/Longitude	
				Start	End
Item	Animal Control			37.466645 °	37.466645 °
				-121.046148 °	-121.046148 °
DWR ID	DWR_RD1602_01_f_2016_44				
Comment Code					
A3 : No rodents visible, but rodent burrows visible; need to backfill and compact or grout burrows.					
Inspector Comment

View of redox holes on the landside of the levee.

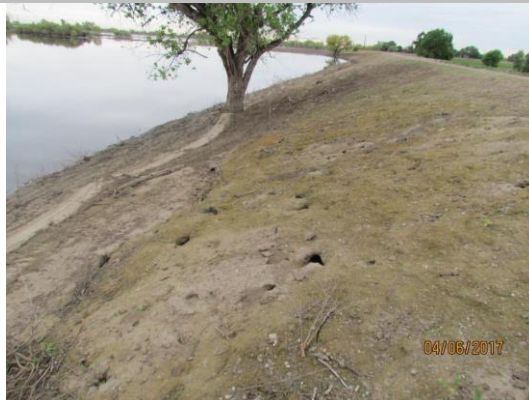
Photo 1 of 1 : SP_2019_RD1602_110_49_20190307_00025.jpg

LM Start	2.89	Rating **	M	Issue No.	49
LM End	2.89	Issue Type +	Ma	Location *	WS
Category	Earthen Levee			GPS Latitude/Longitude	
				Start	End
Item	Animal Control			37.465898 °	37.465898 °
				-121.045209 °	-121.045209 °
DWR ID	DWR_RD1602_01_f_2016_49				
Comment Code					
A3 : No rodents visible, but rodent burrows visible; need to backfill and compact or grout burrows.					
Inspector Comment

View of rodent holes on the waterside slope of the levee. Spring 2017

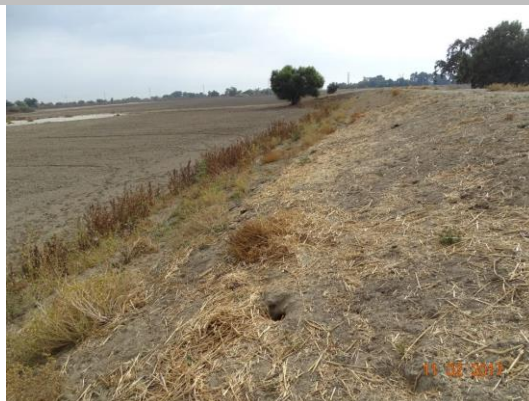
Photo 1 of 1 : SP_2019_RD1602_110_51_20190307_00027.jpg

LM Start	2.95	Rating **	M	Issue No.	51
LM End	2.95	Issue Type +	Ma	Location *	WS
Category	Earthen Levee			GPS Latitude/Longitude	
				Start	End
Item	Animal Control			37.465190 °	37.465190 °
				-121.044584 °	-121.044584 °
DWR ID	DWR_RD1602_01_f_2016_51				
Comment Code					
A3 : No rodents visible, but rodent burrows visible; need to backfill and compact or grout burrows.					
Inspector Comment

View of a rodent hole on the waterside of the levee.

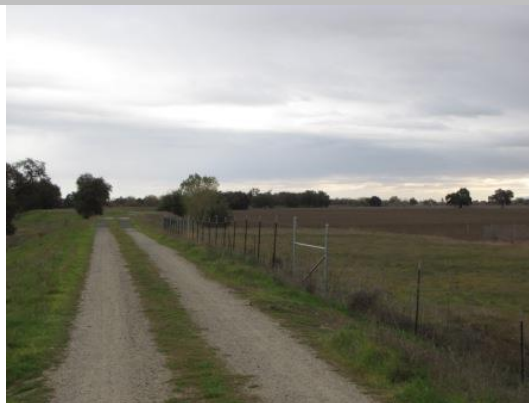
Photo 1 of 2 : SP_2019_RD1602_110_63_20190307_00037.jpg

LM Start	3.94	Rating **	M	Issue No.	63 (cont)
LM End	4.04	Issue Type +	En	Location *	LS

View of a barbed wire fence on the landward slope looking upstream.

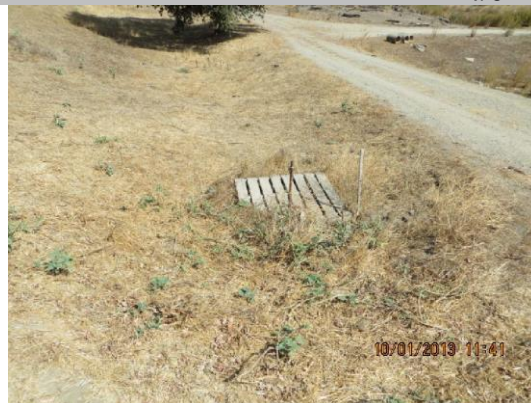
Photo 1 of 3 : UCIP_SP_2019_51332_36819.jpg

LM Start	4.47	Rating **	M	Issue No.	208 (cont)
LM End	4.47	Issue Type +	En	Location *

Slide gate in CMP riser on WS slope.
