**Flood Control Project Maintenance
Levee Inspections**
LMA District Cover Sheet
Spring 2020 Levee Inspection Results

Reclamation District No. 1602 Del Puerto

Spring 2020 Levee Inspection Results

Waterway			Bank	Unit Miles
Unit No. 01 San Joaquin River			Left	6.24
	Spring (March - May)	Summer (June - August)	(September - November) Fall	Winter (December - February)
Unit Maintenance Rating (Fall Only)				
Date of Inspection	4/2/2020 - 4/2/2020			
DWR Inspector	Corey Fujitani			
Accompanied By	Tony Martinez RD 1602

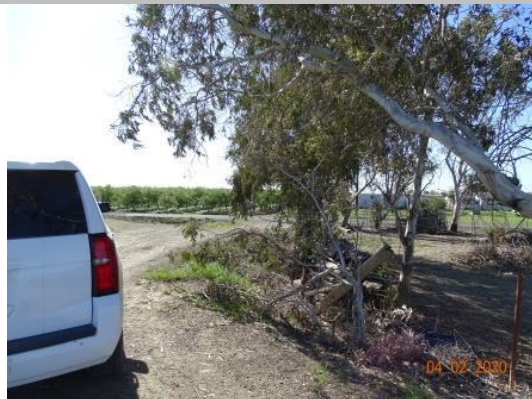
Photo 1 of 1 : SP_2020_RD1602_110_60_20200403_00123.jpg

LM Start	0.09	Rating **	M	Issue No.	60
LM End	0.11	Issue Type +	Ma	Location *	LS
Category	Earthen Levee			GPS Latitude/Longitude	
				Start	End
Item	Trim / Thin Trees			37.477161 °	37.477299 °
				-121.082504 °	-121.082084 °
DWR ID	DWR_RD1602_01_f _ 2019_60				
Comment Code					
T1 : Trim trees to at least five feet above ground level.					
Inspector Comment

View of trees on landside slope looking towards Fig Ave. (Spring 2020)

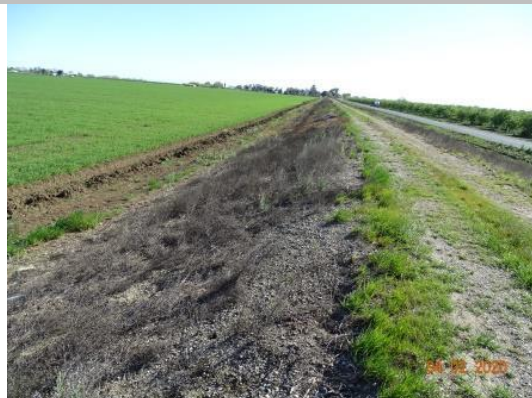
Photo 1 of 1 : SP_2020_RD1602_110_130_20200403_00124.jpg

LM Start	0.13	Rating **	M	Issue No.	130
LM End	0.71	Issue Type +	Ma	Location *	WS
Category	Earthen Levee			GPS Latitude/Longitude	
				Start	End
Item	Vegetation			37.477227 °	37.478520 °
				-121.081812 °	-121.073474 °
DWR ID	DWR_RD1602_01_f _ 2019_130				
Comment Code					
V1 : Control annual grass and weeds on the levee slopes and easements.					
Inspector Comment

Looking East along the waterside slope. (Spring 2020)

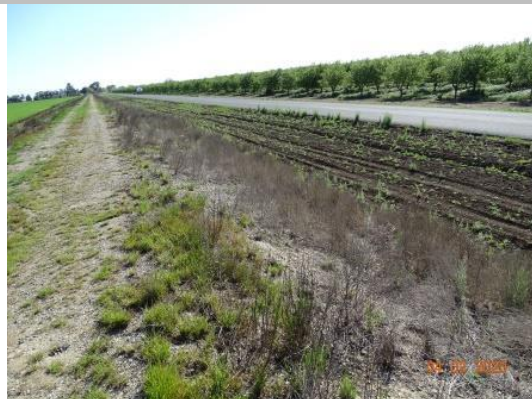
Photo 1 of 1 : SP_2020_RD1602_110_131_20200403_00125.jpg

LM Start	0.13	Rating **	M	Issue No.	131
LM End	1.08	Issue Type +	Ma	Location *	LS
Category	Earthen Levee			GPS Latitude/Longitude	
				Start	End
Item	Vegetation			37.477227 °	37.478468 °
				-121.081811 °	-121.067382 °
DWR ID	DWR_RD1602_01_f_2019_131				
Comment Code					
V1 : Control annual grass and weeds on the levee slopes and easements.					
Inspector Comment

Looking East along the landside slope. (Spring 2020)

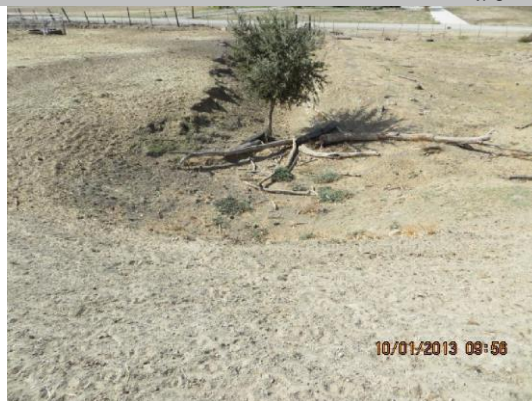
Photo 1 of 3 : UCIP_SP_2020_51634_36723.jpg

DS_ID:20216
FS_ID:51634
EP_NO: N/A
Repair Type: No Action Needed
Crossing Status: Found
UCIP Comments: 11/18/2016 Crossing has been downgraded from Urgent to No Action Needed the debris blocking the outlet has been cleared. (O. Magana - DWR UCIP)10/01/2013 Flap gate blocked from functioning by soil buildup on WS toe. Soil should be cleared. (W. Wylie - DWR UCIP)
FIELD_STRUCT_DESC: 30-inch square reinforced concrete box culvert through levee, 14.4 feet below crown. Concrete "U" headwall on the waterside (WS) and landside (LS) ends. Slide gate in 6-foot by 7-foot concrete surge box is located on the WS shoulder. Flap gate is located on the WS end. [Additional Reference(s): DWR Levee Log, 1992. USACE San Joaquin River O&M Manual Unit 13, April 1964, (HLM 0.78), Drawing No. 7-4-1784].
FS Date: 11/18/2016

Inlet on LS toe.

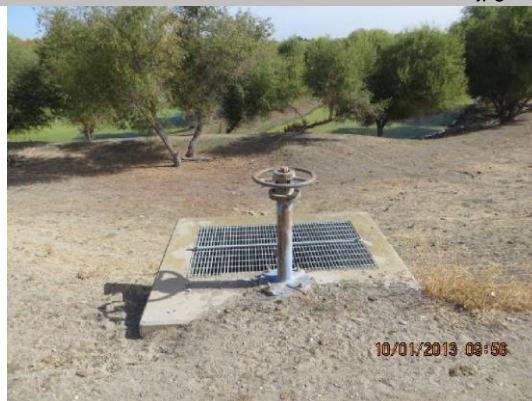
Photo 2 of 3 : UCIP_SP_2020_51634_36722.jpg

Slide gate in concrete box on WS shoulder.

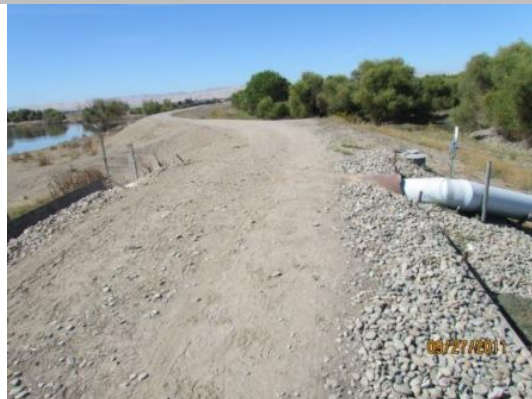
Photo 1 of 1 : SP_2020_RD1602_110_36_20200225_00018.jpg

LM Start	1.00	Rating **	M	Issue No.	36
LM End	1.00	Issue Type +	En	Location *	WS
Category	Earthen Levee			GPS Latitude/Longitude	
				Start	End
Item	Encroachments			37.478810 °	37.478810 °
				-121.068738 °	-121.068738 °
DWR ID	DWR_RD1602_01_s_2012_36				
Comment Code					
RA : Ramp					
Inspector Comment					
Pipe owner placed fill over pipe above crown of levee to build ramp over pipe.

View of the ramp on the crown. The picture was taken from crown looking downstream.

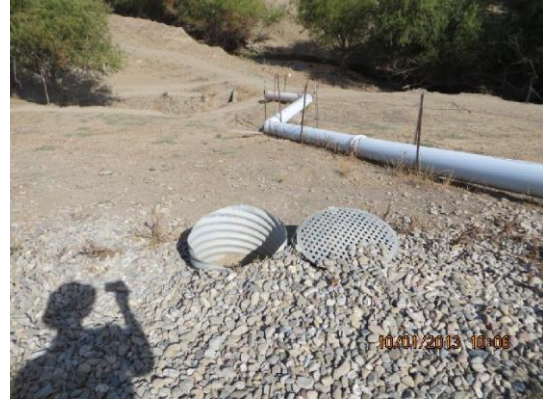
Photo 2 of 3 : UCIP_SP_2020_51636_36757.jpg

Comment Code						
Inspector Comment						
DS_ID:20217 FS_ID:51636 EP_NO: N/A Repair Type: Non-Urgent Crossing Status: Found UCIP Comments: 11/18/2016 Crossing has been downgraded from Urgent to Non-Urgent a flap gate has been added to the WS but pipe is currently not connected to pump. According to Tony Martinez, LMA representative, this crossing is currently not in use. Owner will need to coordinate with CVFPB to obtain permit. (O. Magana - DWR UCIP)10/01/2013 Appears abandoned and if so should be done so properly. Flapgate missing. (W. Wylie - DWR UCIP) FIELD_STRUCT_DESC: *ABANDONED* 1 of 2: 16-inch steel drainage pipe through levee, 17 feet below crown. Pumps on the pump platform are located on the landside (LS). Siphon breaker in 24-inch corrugated metal pipe (CMP) riser is located on the waterside (WS) shoulder. Concrete "U" headwall and flap gate are located on the WS end. [Additional Reference(s): DWR Levee Log, 1992. USACE San Joaquin River O&M Manual Unit 13, April 1964, (HLM 1.01), Drawing No. 7-4-1784]. FS Date: 11/18/2016

Siphon breaker in 24-inch CMP riser on WS shoulder.

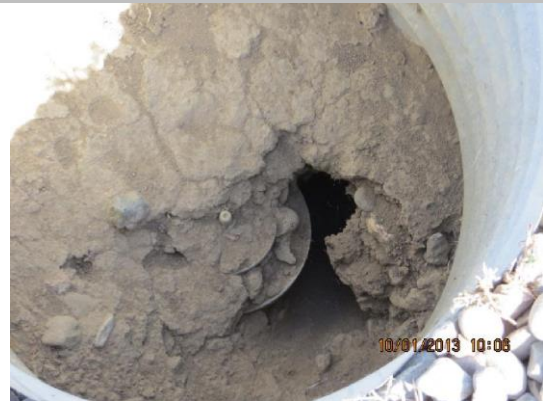
Photo 3 of 3 : UCIP_SP_2020_51636_36756.jpg

Siphon breaker in 24-inch CMP riser on WS shoulder.

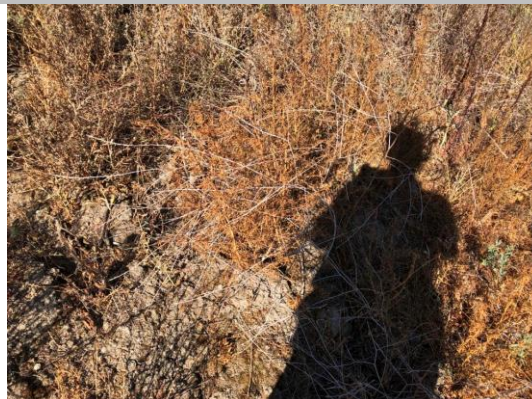
Photo 2 of 3 : SP_2020_RD1602_110_2_20200225_00002.jpg

Site ID: RD1602U01RM97.68
 09/17/2019: No significant change observed. Signs of animal activities at the site.
 09/20/2017: The erosion was discovered during the spring levee inspection. The size of the erosion is roughly estimated due to dense vegetation at the site.

Close view of the erosion.

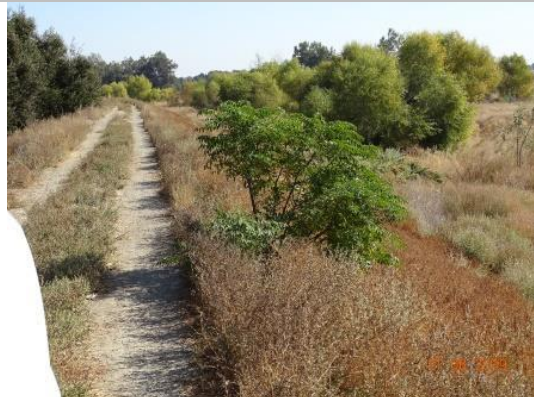
Photo 1 of 1 : SP_2020_RD1602_110_127_20200225_00072.jpg

LM Start	1.09	Rating **	M	Issue No.	127
LM End	1.09	Issue Type +	Ma	Location *	LS
Category	Earthen Levee			GPS Latitude/Longitude	
				Start	End
Item	Trim / Thin Trees			37.478449 °	37.478449 °
				-121.067261 °	-121.067261 °
DWR ID	DWR_RD1602_01_f_2019_127				
Comment Code					
T2 : Thin trees to allow visibility of the ground and room to flood fight.					
Inspector Comment					
Young tree growing in the landside shoulder should be removed before it can establish.

Young tree growing on the landside shoulder should be removed. (Fall 2019)

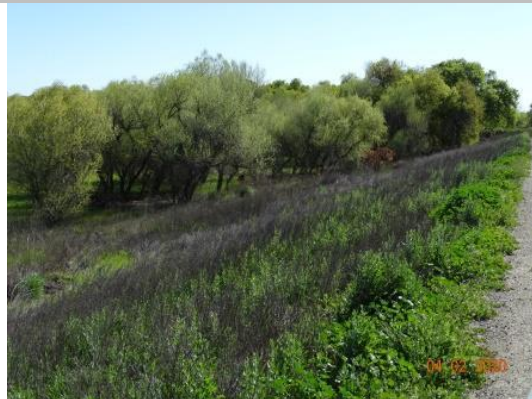
Photo 1 of 1 : SP_2020_RD1602_110_65_20200403_00129.jpg

LM Start	1.34	Rating **	U	Issue No.	65
LM End	1.54	Issue Type +	Ma	Location *	WS
Category	Earthen Levee			GPS Latitude/Longitude	
				Start	End
Item	Vegetation			37.479294 °	37.478348 °
				-121.063091 °	-121.059757 °
DWR ID	DWR_RD1602_01_s_2020_65				
Comment Code					
V1 : Control annual grass and weeds on the levee slopes and easements.					
Inspector Comment

View of the waterside slope looking upstream. (Spring 2020)

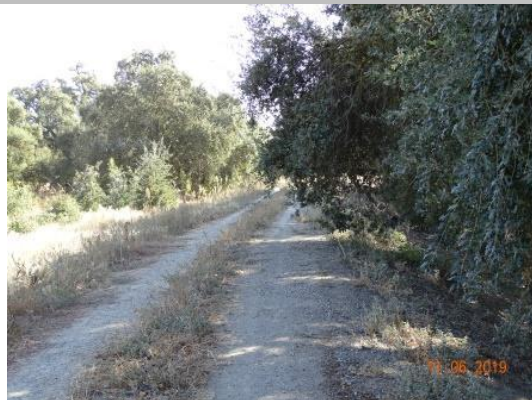
Photo 1 of 1 : SP_2020_RD1602_110_122_20200225_00068.jpg

LM Start	1.55	Rating **	U	Issue No.	122
LM End	1.55	Issue Type +	Ma	Location *	LS
Category	Earthen Levee			GPS Latitude/Longitude	
				Start	End
Item	Trim / Thin Trees			37.478245 °	37.478245 °
				-121.059535 °	-121.059535 °
DWR ID	DWR_RD1602_01_f_2019_122				
Comment Code					
T4 : Trim trees over roadway to at least 12 feet above ground level.					
Inspector Comment

Looking at tree limbs hanging over the landside shoulder and crown. (Fall 2019)

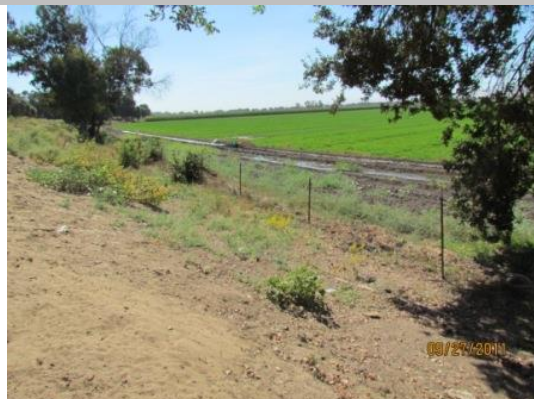
Photo 1 of 1 : SP_2020_RD1602_110_43_20200225_00022.jpg

LM Start	1.61	Rating **	M	Issue No.	43
LM End	2.22	Issue Type +	En	Location *	LS
Category	Earthen Levee			GPS Latitude/Longitude	
				Start	End
Item	Encroachments			37.477663 °	37.470125 °
				-121.058716 °	-121.055244 °
DWR ID	DWR_RD1602_01_s_2012_43				
Comment Code					
FE : Fence					
Inspector Comment					
Fence at the landside toe of the levee.

View of the fence on the landside toe of the levee. The picture was taken from crown looking upstream.

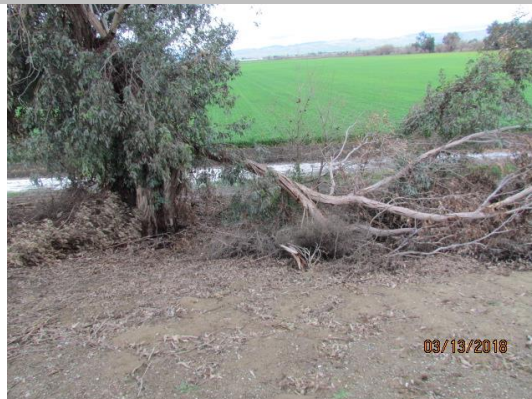
Photo 1 of 1 : SP_2020_RD1602_110_80_20200225_00045.jpg

LM Start	1.65	Rating **	U	Issue No.	80
LM End	1.65	Issue Type +	Ma	Location *	LS
Category	Earthen Levee			GPS Latitude/Longitude	
				Start	End
Item	Encroachments			37.477218 °	37.477218 °
				-121.058505 °	-121.058505 °
DWR ID	DWR_RD1602_01_s_2018_80				
Comment Code					
TR : Tree or limb					
Inspector Comment					
Fallen tree branch on landward slope and toe.

Looking at fallen branch on landward slope and toe.

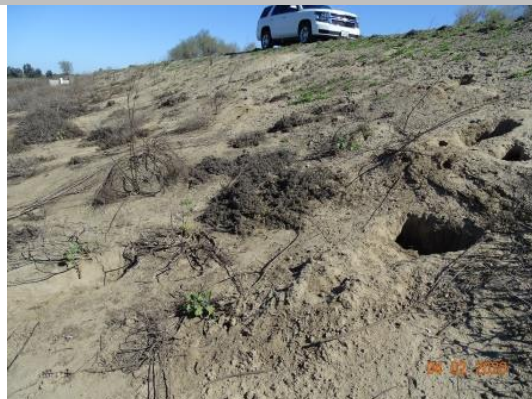
Photo 1 of 2 : SP_2020_RD1602_110_93_20200403_00132.jpg

LM Start	2.07	Rating **	U	Issue No.	93
LM End	2.07	Issue Type +	Ma	Location *	LS
Category	Earthen Levee			GPS Latitude/Longitude	
				Start	End
Item	Animal Control			37.471195 °	37.471195 °
				-121.057356 °	-121.057356 °
DWR ID	DWR_RD1602_01_s_2020_93				
Comment Code					
A3 : No rodents visible, but rodent burrows visible; need to backfill and compact or grout burrows.					
Inspector Comment

View rodent burrows in landside slope. (Spring 2020)

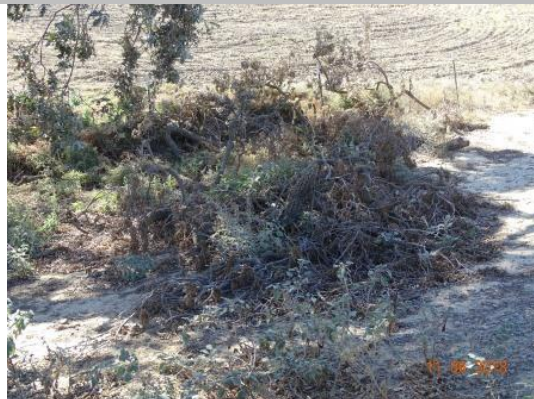
Photo 1 of 1 : SP_2020_RD1602_110_101_20200225_00062.jpg

LM Start	2.19	Rating **	M	Issue No.	101
LM End	2.19	Issue Type +	En	Location *	LS
Category	Earthen Levee			GPS Latitude/Longitude	
				Start	End
Item	Encroachments			37.470210 °	37.470210 °
				-121.055683 °	-121.055683 °
DWR ID	DWR_RD1602_01_f_2018_101				
Comment Code					
PR : Prunings					
Inspector Comment					
Remove pruning pile on landside slope.

Pruning pile at landside toe. (Fall 2018)

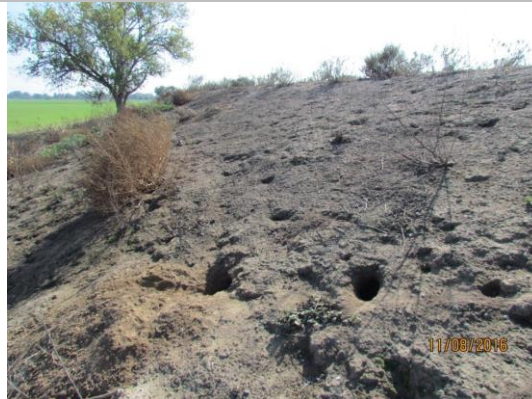
Photo 1 of 1 : SP_2020_RD1602_110_47_20200225_00025.jpg

LM Start	2.85	Rating **	M	Issue No.	47
LM End	2.86	Issue Type +	Ma	Location *	WS
Category	Earthen Levee			GPS Latitude/Longitude	
				Start	End
Item	Animal Control			37.466294 °	37.466166 °
				-121.045693 °	-121.045527 °
DWR ID	DWR_RD1602_01_f _ 2016_47				
Comment Code					
A3 : No rodents visible, but rodent burrows visible; need to backfill and compact or grout burrows.					
Inspector Comment

View of rodent holes on the waterside of the levee. Fall 2016

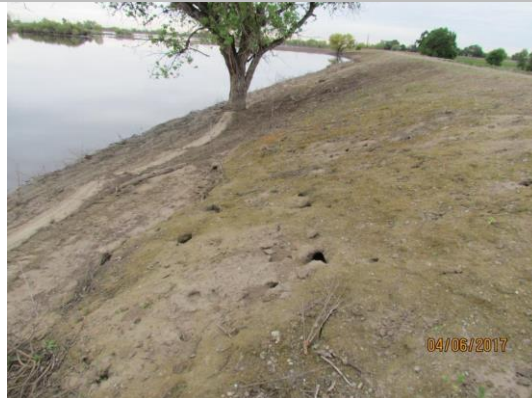
Photo 1 of 1 : SP_2020_RD1602_110_49_20200225_00027.jpg

LM Start	2.89	Rating **	M	Issue No.	49
LM End	2.89	Issue Type +	Ma	Location *	WS
Category	Earthen Levee			GPS Latitude/Longitude	
				Start	End
Item	Animal Control			37.465898 °	37.465898 °
				-121.045209 °	-121.045209 °
DWR ID	DWR_RD1602_01_f_2016_49				
Comment Code					
A3 : No rodents visible, but rodent burrows visible; need to backfill and compact or grout burrows.					
Inspector Comment

View of rodent holes on the waterside slope of the levee. Spring 2017

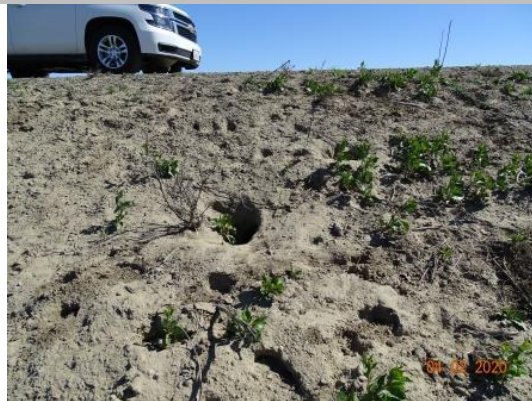
Photo 1 of 1 : SP_2020_RD1602_110_95_20200403_00135.jpg

LM Start	2.98	Rating **	M	Issue No.	95
LM End	2.98	Issue Type +	Ma	Location *	LS
Category	Earthen Levee			GPS Latitude/Longitude	
				Start	End
Item	Animal Control			37.464810 °	37.464810 °
				-121.044248 °	-121.044248 °
DWR ID	DWR_RD1602_01_f _ 2018_95				
Comment Code					
A3 : No rodents visible, but rodent burrows visible; need to backfill and compact or grout burrows.					
Inspector Comment

View of the landside slope from the toe of the levee. (Spring 2020)

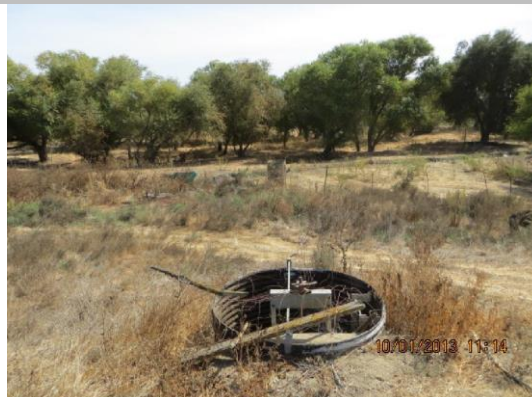
Photo 2 of 3 : UCIP_SP_2020_53522_36804.jpg

DS_ID:20204
FS_ID:53522
EP_NO: 8193
Repair Type: Urgent
Crossing Status: Found
UCIP Comments: 10/19/2018 Pipe is deteriorated on the LS toe (pipe section missing at inlet). This crossing remains Urgent due to the wall deterioration at the inlet. If wall is rusted out at the inlet, need to determine the condition of the pipe section through the levee. According to the LMA representative, this crossing is no longer in use (crossing is abandoned). LMA is interested in abandoning crossing in place. LMA was referred to the CVFPB staff for direction regarding proper action under Title 23 for this crossing. (O. Magana - DWR UCIP)11/18/2016 Same as previous inspection riser cover and handle on slide gate are still missing. Crossing remains Urgent due to the public safety issue of the 60-inch CMP cover still missing. According to Tony Martinez, LMA representative, the condition and future use of this crossing is being evaluated. Owner will need to coordinate with CVFPB for future use requirements or proper abandonment/removal. (O. Magana - DWR UCIP)10/01/2013 Appears abandoned, and if so should be done so properly. No handle on slide gate, no cover on CMP standpipe on WS shoulder. (W. Wylie - DWR UCIP)

Slide gate in 60-inch CMP riser on WS shoulder.

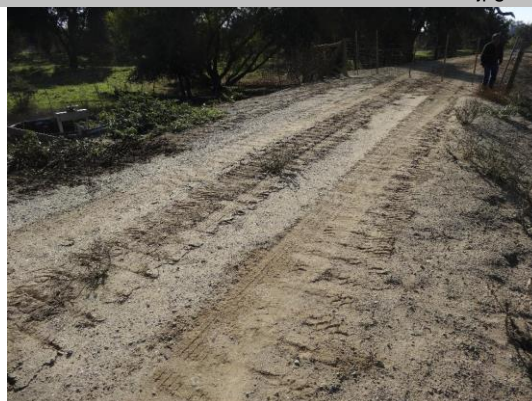
Photo 3 of 3 : UCIP_SP_2020_53522_76527.jpg

Overview of levee crown at pipe crossing.

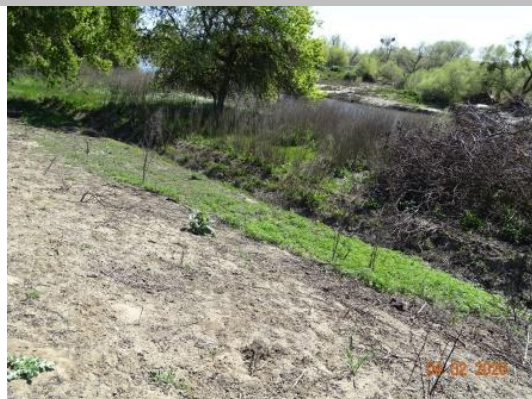
Photo 1 of 3 : SP_2020_RD1602_110_50_20200403_00136.jpg

LM Start	3.34	Rating **	M	Issue No.	50
LM End	3.53	Issue Type +	En	Location *	WS
Category	Earthen Levee			GPS Latitude/Longitude	
				Start	End
Item	Encroachments			37.460644 °	37.458373 °
				-121.042231 °	-121.044081 °
DWR ID	DWR_RD1602_01_s_2012_50				
Comment Code					
DT : Ditch					
Inspector Comment					
A ditch is located on waterside toe of the levee.

Looking downstream along the waterside slope. (Spring 2020)

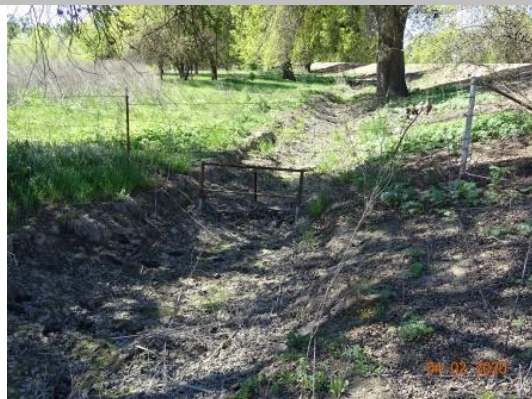
Photo 2 of 3 : SP_2020_RD1602_110_50_20200403_00137.jpg

LM Start	3.34	Rating **	M	Issue No.	50 (cont)
LM End	3.53	Issue Type +	En	Location *	WS

Looking upstream along the waterside toe. (Spring 2020)

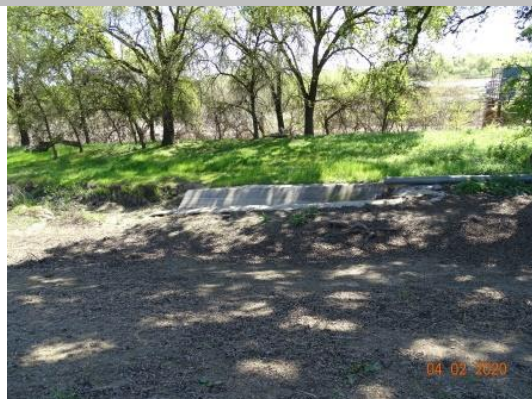
Photo 3 of 3 : SP_2020_RD1602_110_50_20200403_00139.jpg

LM Start	3.34	Rating **	M	Issue No.	50 (cont)
LM End	3.53	Issue Type +	En	Location *	WS

View of upstream end of the the waterside ditch. (Spring 2020)

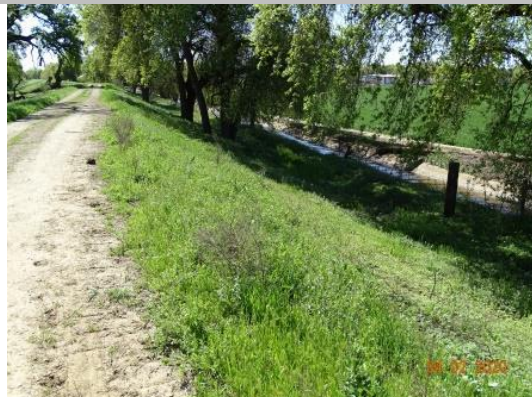
Photo 1 of 1 : SP_2020_RD1602_110_133_20200403_00140.jpg

LM Start	3.68	Rating **	M	Issue No.	133
LM End	4.86	Issue Type +	Ma	Location *	LS
Category	Earthen Levee			GPS Latitude/Longitude	
				Start	End
Item	Vegetation			37.456391 °	37.441215 °
				-121.044430 °	-121.036806 °
DWR ID	DWR_RD1602_01_s_2020_133				
Comment Code					
V1 : Control annual grass and weeds on the levee slopes and easements.					
Inspector Comment

View of the landside slope looking upstream. (Spring 2020)

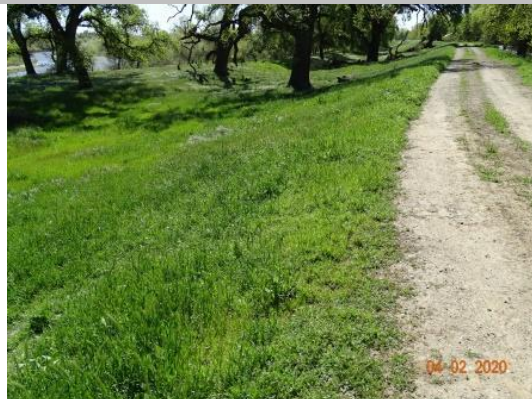
Photo 1 of 1 : SP_2020_RD1602_110_121_20200403_00141.jpg

LM Start	3.68	Rating **	M	Issue No.	121
LM End	4.87	Issue Type +	Ma	Location *	WS
Category	Earthen Levee			GPS Latitude/Longitude	
				Start	End
Item	Vegetation			37.456387 °	37.441178 °
				-121.044428 °	-121.036828 °
DWR ID	DWR_RD1602_01_s_2020_121				
Comment Code					
V1 : Control annual grass and weeds on the levee slopes and easements.					
Inspector Comment

Looking upstream along the waterside slope. (Spring 2020)

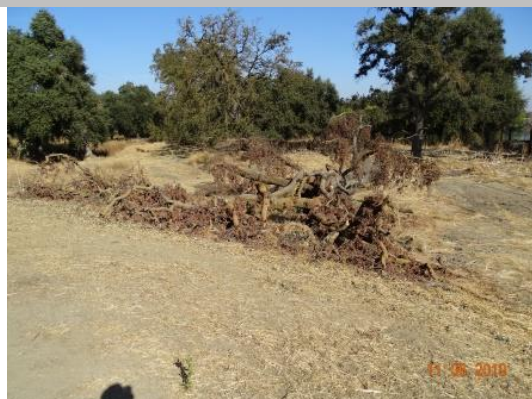
Photo 1 of 1 : SP_2020_RD1602_110_102_20200225_00063.jpg

LM Start	3.69	Rating **	U	Issue No.	102
LM End	3.69	Issue Type +	Ma	Location *	WS
Category	Earthen Levee			GPS Latitude/Longitude	
				Start	End
Item	Encroachments			37.456234 °	37.456234 °
				-121.044194 °	-121.044194 °
DWR ID	DWR_RD1602_01_f_2019_102				
Comment Code					
TR : Tree or limb					
Inspector Comment

View of fallen tree on the waterside slope and toe. (Fall 2019)

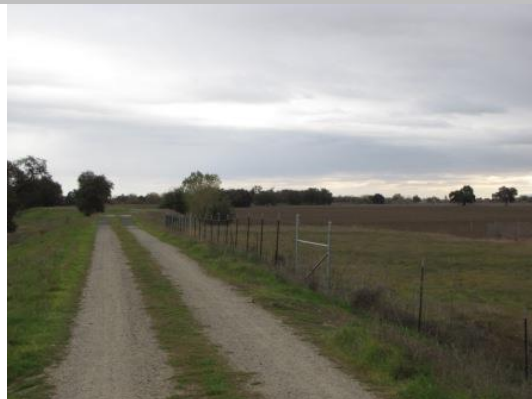
Photo 1 of 2 : SP_2020_RD1602_110_63_20200225_00036.jpg

LM Start	3.93	Rating **	M	Issue No.	63
LM End	4.04	Issue Type +	En	Location *	LS
Category	Earthen Levee			GPS Latitude/Longitude	
				Start	End
Item	Encroachments			37.453226 °	37.451866 °
				-121.042118 °	-121.041206 °
DWR ID	DWR_RD1602_01_s_2012_63				
Comment Code					
FE : Fence					
Inspector Comment					
Fence on landward slope.

View of a barbed wire fence on the landward slope looking upstream.

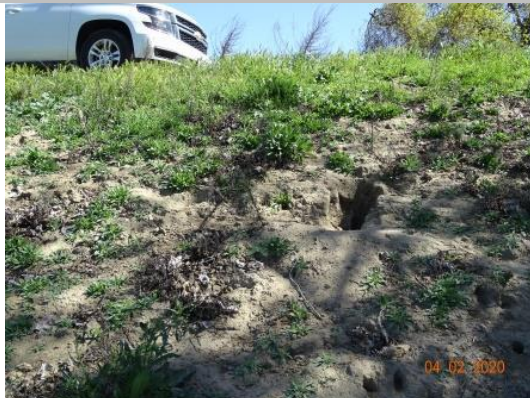
Photo 1 of 2 : SP_2020_RD1602_110_74_20200403_00144.jpg

LM Start	4.04	Rating **	U	Issue No.	74
LM End	4.16	Issue Type +	Ma	Location *	LS
Category	Earthen Levee			GPS Latitude/Longitude	
				Start	End
Item	Animal Control			37.451892 °	37.450563 °
				-121.041168 °	-121.039725 °
DWR ID	DWR_RD1602_01_s_2019_74				
Comment Code					
A1 : Exterminate rodents and backfill and compact or grout burrows.					
Inspector Comment

Looking at the landside slope from the levee toe. (Spring 2020)

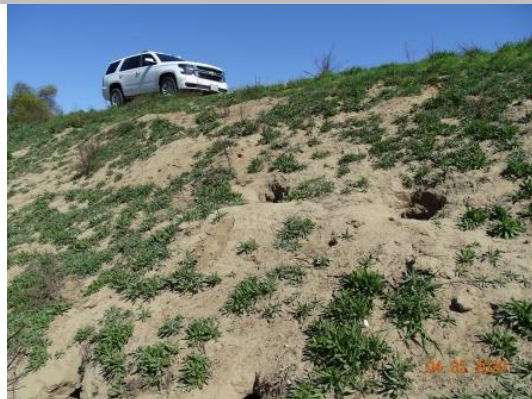
Photo 2 of 2 : SP_2020_RD1602_110_74_20200403_00145.jpg

LM Start	4.04	Rating **	U	Issue No.	74 (cont)
LM End	4.16	Issue Type +	Ma	Location *	LS
Category	Earthen Levee			GPS Latitude/Longitude	
				Start	End
Item	Animal Control			37.451892 °	37.450563 °
				-121.041168 °	-121.039725 °
DWR ID	DWR_RD1602_01_s_2019_74

Looking downstream at the landside slope. (Spring 2020)

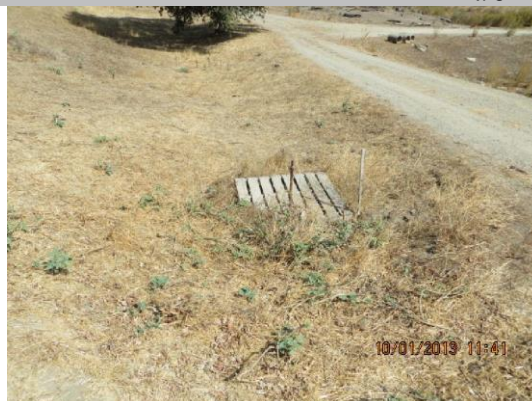
Photo 1 of 3 : UCIP_SP_2020_51332_36819.jpg

DS_ID:20207
FS_ID:51332
EP_NO: 8195
Repair Type: Non-Urgent
Crossing Status: Found
UCIP Comments: 11/18/2016 60-inch riser has a temporary cover therefore crossing has been downgraded from Urgent to Non-Urgent. (O. Magana - DWR UCIP) 10/01/2013 Lid missing from 60-inch CMP riser, may be an attractive nuisance or hazard to public. (W. Wylie - DWR UCIP)
FIELD_STRUCT_DESC: 18-inch steel pipe through levee, 10 feet below crown. Slide gate in 60-inch corrugated metal pipe riser located on the waterside (WS) slope. Concrete discharge box is located on landside (LS) end. Pipe is buried across WS berm to pump located on the riverbank approximately 1,000 feet from the levee. (18-inch pipe authorized under Automatic Board Order (ABO) issued as Permit No. 8195, 1972 - Larry Buehner). [Additional Reference(s): DWR Levee Log, 1992. USACE San Joaquin River O&M Manual Unit 13, April 1964, (HLM 4.51), Drawing No. 7-4-1784].

Slide gate in CMP riser on WS slope.

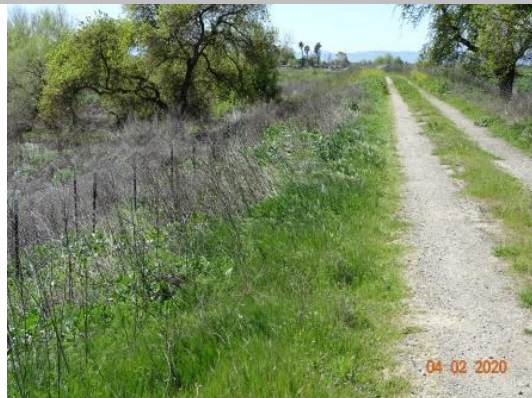
Photo 1 of 1 : SP_2020_RD1602_110_136_20200403_00147.jpg

LM Start	4.87	Rating **	U	Issue No.	136
LM End	5.08	Issue Type +	Ma	Location *	WS
Category	Earthen Levee			GPS Latitude/Longitude	
				Start	End
Item	Vegetation			37.441177 °	37.438233 °
				-121.036828 °	-121.037099 °
DWR ID	DWR_RD1602_01_s_2020_136				
Comment Code					
V1 : Control annual grass and weeds on the levee slopes and easements.					
Inspector Comment

View of waterside slope looking upstream. (Spring 2020)

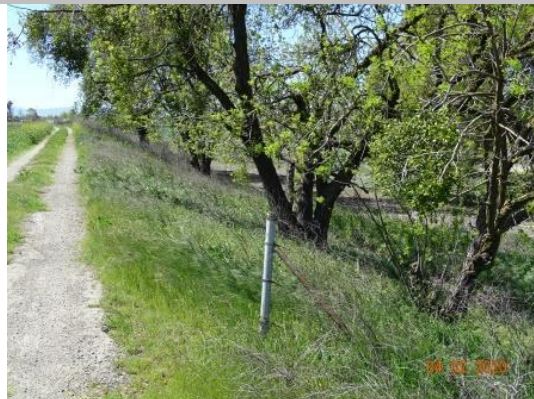
Photo 1 of 1 : SP_2020_RD1602_110_135_20200403_00148.jpg

LM Start	4.87	Rating **	U	Issue No.	135
LM End	5.08	Issue Type +	Ma	Location *	LS
Category	Earthen Levee			GPS Latitude/Longitude	
				Start	End
Item	Vegetation			37.441177 °	37.438233 °
				-121.036829 °	-121.037099 °
DWR ID	DWR_RD1602_01_s_2020_135				
Comment Code					
V1 : Control annual grass and weeds on the levee slopes and easements.					
Inspector Comment

View of the landside slope looking upstream. (Spring 2020)

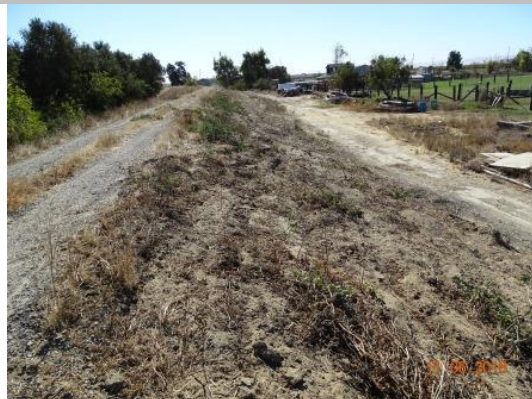
Photo 1 of 2 : SP_2020_RD1602_110_89_20200225_00053.jpg

LM Start	5.08	Rating **	M	Issue No.	89
LM End	5.13	Issue Type +	Ma	Location *	LS
Category	Earthen Levee			GPS Latitude/Longitude	
				Start	End
Item	Slope Stability			37.438249 °	37.437523 °
				-121.037100 °	-121.036958 °
DWR ID	DWR_RD1602_01_f_2018_89				
Comment Code					
S3 : Repair the levee slope damaged by vehicle traffic and prevent access where possible.					
Inspector Comment					
Damage to slope appears to be from vehicle traffic.

View along landside slope looking upstream. (Fall 2018)

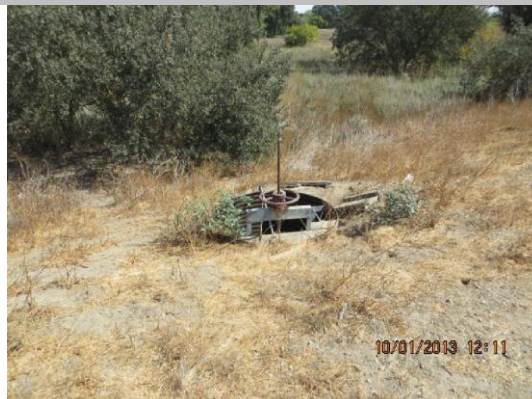
Photo 1 of 3 : UCIP_SP_2020_51336_36822.jpg

DS_ID:20208
FS_ID:51336
EP_NO: N/A
Repair Type: Non-Urgent
Crossing Status: Found
UCIP Comments: 11/18/2016 Same as previous inspection soil and debris prevent flap gate from properly functioning and slide gate won't close due to sediment build up. Crossing has been downgraded from Urgent to Non-Urgent due to no pipe or levee integrity issues observed during the site visit. Need to contact owner to determine status of crossing. If crossing is no longer in use owner will need to coordinate with CVFPB to properly abandon or remove according to Title 23 requirements. (O. Magana - DWR UCIP)10/01/2013 Soil and debris prevent flapgate from proper function. Slide gate won't close completely due to sediment buildup. CMP riser needs cover. (W. Wylie - DWR UCIP)
FIELD_STRUCT_DESC: 24-inch steel pipe through levee, 11.6 feet below crown. Concrete headwall on the landside (LS) end. Concrete "U" headwall and flap gate located on the waterside (WS) end. Slide gate in 60-inch corrugated metal pipe (CMP) riser is located on the WS slope. [Additional Reference(s): DWR Levee Log, 1992. USACE San Joaquin River O&M Manual Unit 13, April 1964, (HLM 5.23), Drawing No. 7-4-1784].

Slide gate in CMP riser on WS slope. Outlet visible under tree in background.

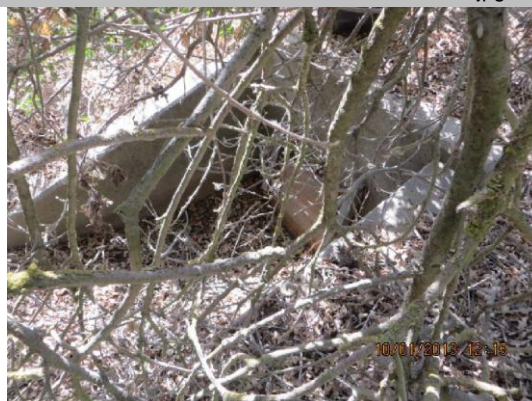
Photo 2 of 3 : UCIP_SP_2020_51336_36821.jpg

Flapgate in Concrete headwall on WS toe under tree.

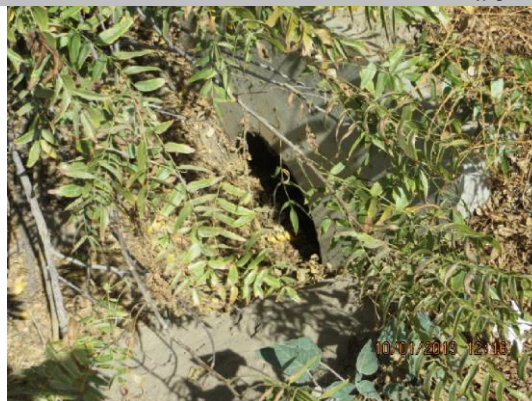
Photo 3 of 3 : UCIP_SP_2020_51336_36820.jpg

Concrete headwall at inlet on LS toe.

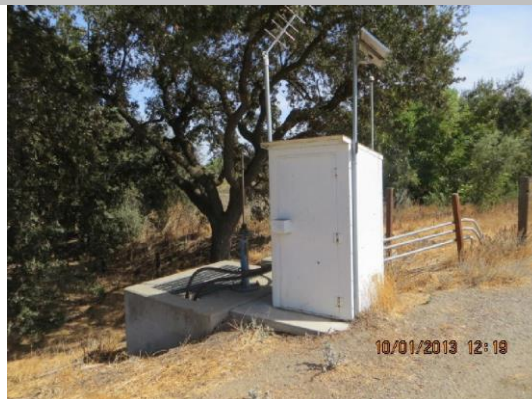
Photo 1 of 2 : UCIP_SP_2020_21665_36829.jpg

Shed with slide gate in Concrete riser on WS shoulder.

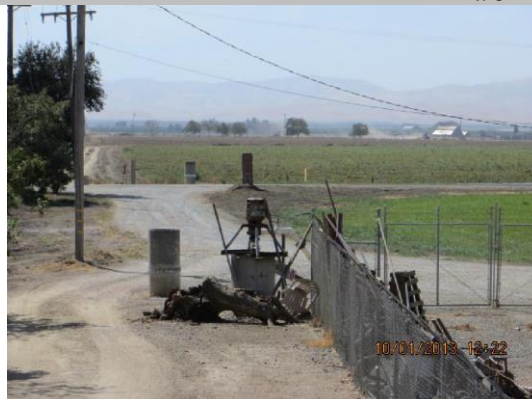
Photo 2 of 2 : UCIP_SP_2020_21665_36828.jpg

Likely risers for pipe off LS toe.

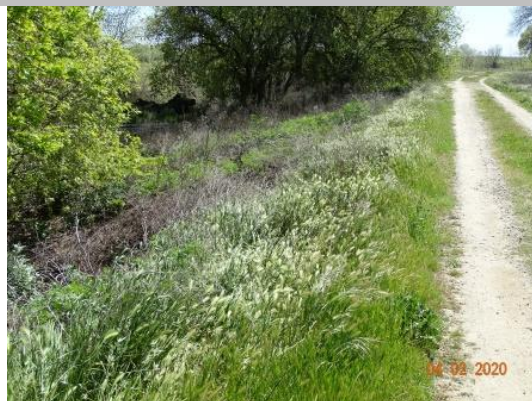
Photo 1 of 1 : SP_2020_RD1602_110_143_20200403_00152.jpg

LM Start	5.25	Rating **	U	Issue No.	143
LM End	5.95	Issue Type +	Ma	Location *	WS
Category	Earthen Levee			GPS Latitude/Longitude	
				Start	End
Item	Vegetation			37.436043 °	37.432237 °
				-121.035914 °	-121.026588 °
DWR ID	DWR_RD1602_01_s_2020_143				
Comment Code					
V1 : Control annual grass and weeds on the levee slopes and easements.					
Inspector Comment

View of vegetation on the waterside slope looking upstream. (Spring 2020)

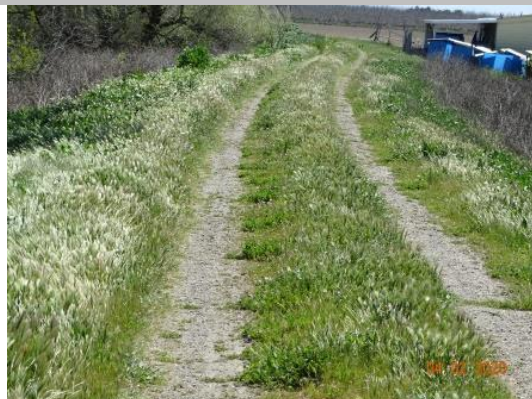
Photo 1 of 1 : SP_2020_RD1602_110_144_20200403_00153.jpg

LM Start	5.41	Rating **	U	Issue No.	144
LM End	5.52	Issue Type +	Ma	Location *	CR
Category	Earthen Levee			GPS Latitude/Longitude	
				Start	End
Item	Vegetation			37.434156 °	37.433128 °
				-121.034470 °	-121.032848 °
DWR ID	DWR_RD1602_01_s_2020_144				
Comment Code					
V9 : Keep the crown roadway free of vegetation.					
Inspector Comment

View of vegetation along the levee crown. (Spring 2020)

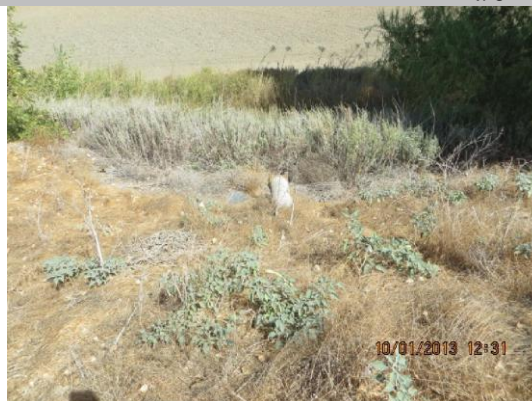
Photo 1 of 1 : UCIP_SP_2020_21674_36854.jpg

LM Start	5.46	Rating **	M	Issue No.	213	
LM End	5.46	Issue Type +	Ma	Location *		
Category	Supplemental			GPS Latitude/Longitude		
				Start		End
Item	DWR UCIP LMA Responsibility			37.433646 °	37.433646 °	
				-121.033846 °	-121.033846 °	
DWR ID	20211					
Comment Code						
Inspector Comment						
DS_ID:20211 FS_ID:21674 EP_NO: N/A Repair Type: Non-Urgent Crossing Status: Found UCIP Comments: 10/01/2013 Pipe appears abandoned and if so should be done so properly. (W. Wylie - DWR UCIP) FIELD_STRUCT_DESC: *ABANDONED* 12-inch drainage pipe of an unknown material through the levee, 6.9 feet below the crown. Flap gate on the waterside (WS) end. Could not locate, March 1984. (Reclamation District No. 1602). [Additional Reference(s): DWR Levee Log, 1992. USACE San Joaquin O&M Manual 13, April 1964, (HLM 5.50), Drawing No. 7-4-1784]. FS Date: 10/1/2013

Pipe and flapgate visible on WS toe.

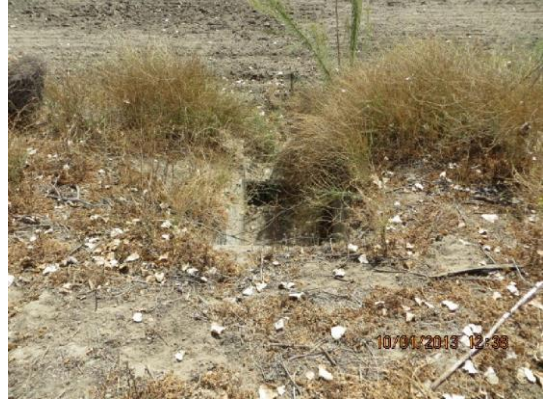
Photo 2 of 3 : UCIP_SP_2020_51337_36877.jpg

Concrete U-shaped headwall on LS toe.

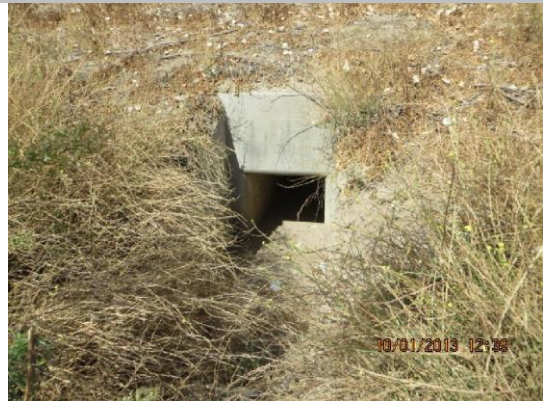
Photo 3 of 3 : UCIP_SP_2020_51337_36876.jpg

Concrete U-shaped headwall on LS toe.

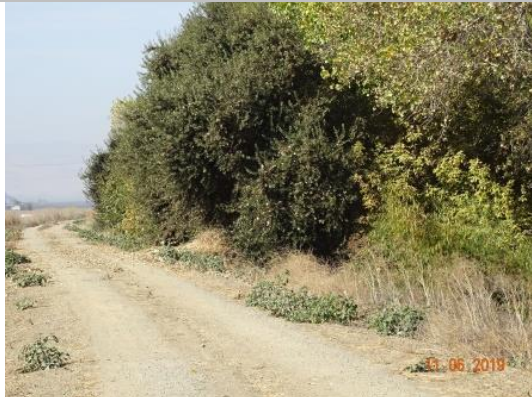
Photo 1 of 2 : SP_2020_RD1602_110_34_20200225_00016.jpg

LM Start	5.78	Rating **	U	Issue No.	34
LM End	5.81	Issue Type +	Ma	Location *	WS
Category	Earthen Levee			GPS Latitude/Longitude	
				Start	End
Item	Trim / Thin Trees			37.433038 °	37.433081 °
				-121.028190 °	-121.027632 °
DWR ID	DWR_RD1602_01_f_2018_34				
Comment Code					
T2 : Thin trees to allow visibility of the ground and room to flood fight.					
Inspector Comment

Looking upstream along the waterside shoulder. (Fall 2019)

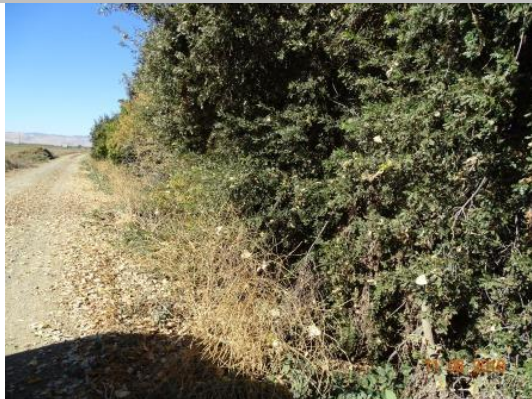
Photo 2 of 2 : SP_2020_RD1602_110_34_20200225_00017.jpg

LM Start	5.78	Rating **	U	Issue No.	34 (cont)
LM End	5.81	Issue Type +	Ma	Location *	WS

Trim tree to 5 feet above ground. (Fall 2018)

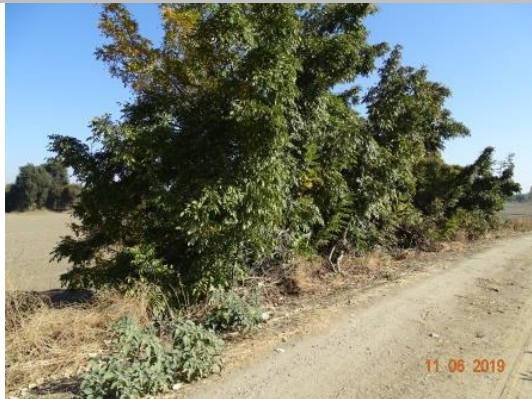
Photo 1 of 1 : SP_2020_RD1602_110_26_20200225_00009.jpg

LM Start	5.86	Rating **	M	Issue No.	26
LM End	5.86	Issue Type +	Ma	Location *	WS
Category	Earthen Levee			GPS Latitude/Longitude	
				Start	End
Item	Trim / Thin Trees			37.433142 °	37.433142 °
				-121.026702 °	-121.026702 °
DWR ID	DWR_RD1602_01_f_2018_26				
Comment Code					
T1 : Trim trees to at least five feet above ground level.					
Inspector Comment

View of trees growing on the waterside slope. (Fall 2019)

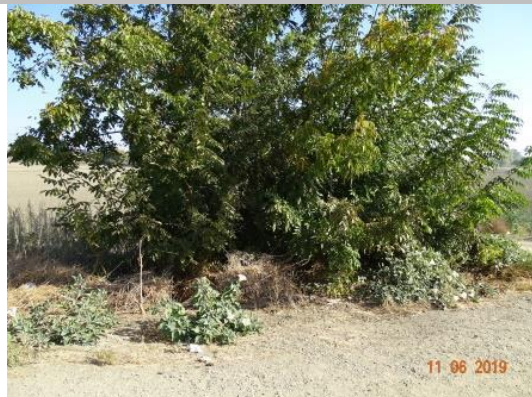
Photo 1 of 1 : SP_2020_RD1602_110_38_20200225_00020.jpg

LM Start	5.90	Rating **	M	Issue No.	38
LM End	5.90	Issue Type +	Ma	Location *	WS
Category	Earthen Levee			GPS Latitude/Longitude	
				Start	End
Item	Trim / Thin Trees			37.432756 °	37.432756 °
				-121.026147 °	-121.026147 °
DWR ID	DWR_RD1602_01_f _ 2019_38				
Comment Code					
T1 : Trim trees to at least five feet above ground level.					
Inspector Comment

View of a tree growing on the waterside slope. (Fall 2019)

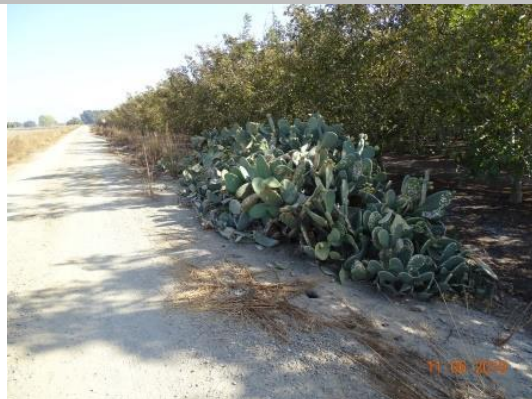
Photo 1 of 2 : SP_2020_RD1602_110_86_20200225_00049.jpg

LM Start	6.13	Rating **	U	Issue No.	86
LM End	6.13	Issue Type +	En	Location *	WS
Category	Earthen Levee			GPS Latitude/Longitude	
				Start	End
Item	Vegetation			37.430181 °	37.430181 °
				-121.028679 °	-121.028679 °
DWR ID	DWR_RD1602_01_s_2020_86				
Comment Code					
V6 : Landscaping					
Inspector Comment					
Cactus blocking view of waterward slope.

Looking at dense cactus growth on the waterside slope. (Fall 2019)

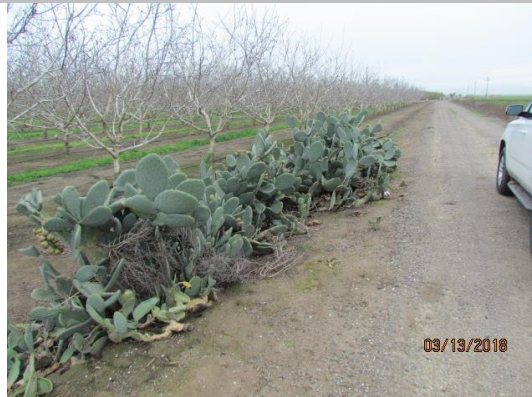
Photo 2 of 2 : SP_2020_RD1602_110_86_20200225_00050.jpg

LM Start	6.13	Rating **	U	Issue No.	86 (cont)
LM End	6.13	Issue Type +	En	Location *	WS

Looking south at dense cactus on waterward slope.

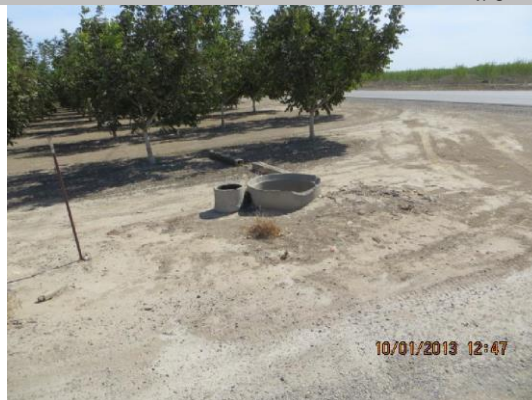
Photo 2 of 3 : UCIP_SP_2020_21683_36881.jpg

Comment Code					
Inspector Comment					
DS_ID:20214 FS_ID:21683 EP_NO: 8194 Repair Type: Non-Urgent Crossing Status: Found UCIP Comments: 10/01/2013 Pipe heavily deteriorated on LS toe. May indicate condition of rest of pipe is bad. Good candidate for video inspection. (W. Wylie - DWR UCIP) FIELD_STRUCT_DESC: 18-inch reinforced concrete irrigation pipe through the levee, 3 feet below the crown. Slide gate in a 36-inch concrete standpipe on the waterside (WS) shoulder. (18-inch concrete pipe was authorized under Automatic Board Order (ABO) issued as Permit No. 8194, 1972 - Ernest F. Nunes). [Additional Reference(s): DWR Levee Log, 1992. USACE San Joaquin O&M Manual 13, April 1964, (HLM 6.28), Drawing No. 7-4-1784]. FS Date: 10/1/2013

LM Start	6.24	Rating **	M	Issue No.	215 (cont)
LM End	6.24	Issue Type +	En	Location *

36-inch concrete standpipe on WS shoulder.
