**Flood Control Project Maintenance  
Levee Inspections  
LMA District Cover Sheet**

**Reclamation District No. 1602 Del Puerto**

**Flood Control Project Maintenance  
Levee Inspections**

**Levee Inspection Report By Mile - Spring 2021**

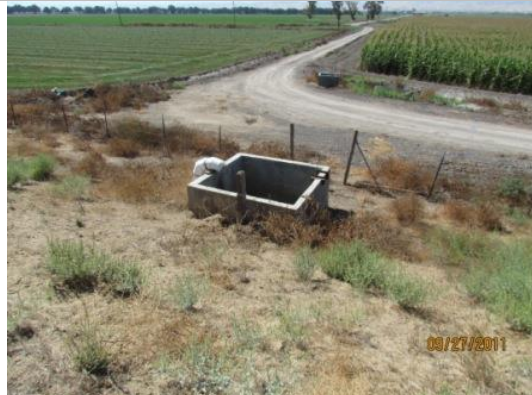
Photo 1 of 1 : SP\_2021\_RD1602\_110\_45\_20210308\_00014.jpg

LM Start	2.03	Rating **	M	Issue No.	45
LM End	2.03	Issue Type +	En	Location *	LS
Category	Earthen Levee			GPS Latitude/Longitude	
				Start	End
Item	Encroachments			37.471734 °	37.471734 °
				-121.057670 °	-121.057670 °
DWR ID	DWR_RD1602_01_s_2012_45				
Comment Code					
EQ : Equipment					
Inspector Comment					
A well is present at the toe of the landside slope.

A well is located at the landside toe of the levee. The picture was taken from the crown looking toward the landside of the levee.

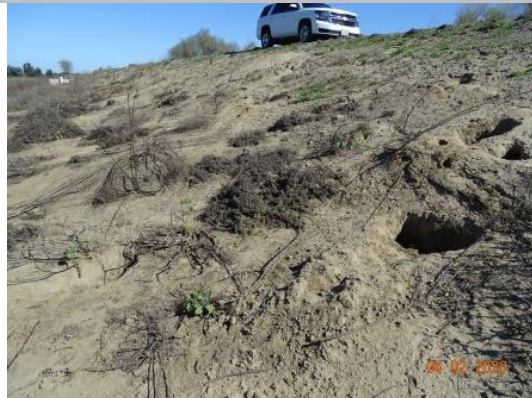
Photo 1 of 1 : SP\_2021\_RD1602\_110\_93\_20210308\_00045.jpg

LM Start	2.07	Rating **	U	Issue No.	93
LM End	2.07	Issue Type +	Ma	Location *	LS
Category	Earthen Levee			GPS Latitude/Longitude	
				Start	End
Item	Animal Control			37.471195 °	37.471195 °
				-121.057356 °	-121.057356 °
DWR ID	DWR_RD1602_01_s_2020_93				
Comment Code					
A3 : No rodents visible, but rodent burrows visible; need to backfill and compact or grout burrows.					
Inspector Comment

View of rodent burrows on the landside slope. (Spring 2020)

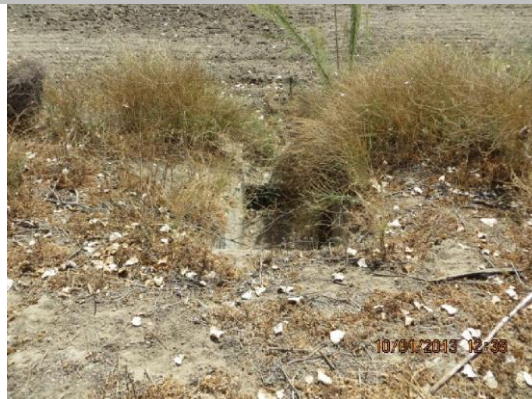
Photo 2 of 3 : UCIP\_SP\_2021\_51337\_36877.jpg

LM Start	<b>5.72</b>	Rating **	M	Issue No.	<b>15 (cont)</b>
LM End	<b>5.72</b>	Issue Type +	Ma	Location *	
Category	Supplemental		GPS Latitude/Longitude		
			Start	End	
Item	DWR UCIP LMA Responsibility		37.433003 °	37.433003 °	
			-121.029346 °	-121.029346 °	
DWR ID	20212

Concrete U-shaped headwall on LS toe.

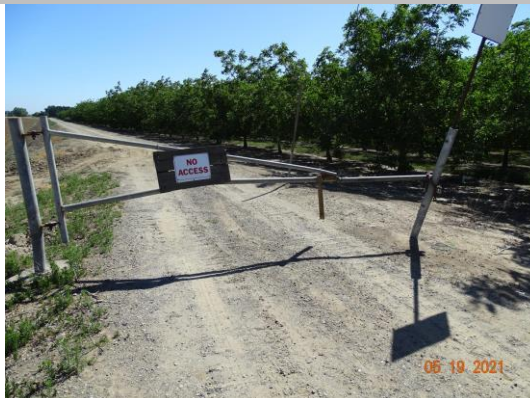
Photo 1 of 1 : SP\_2021\_RD1602\_110\_17\_20210521\_00104.jpg

LM Start	6.23	Rating **	U	Issue No.	17
LM End	6.23	Issue Type +	En	Location *	CR
Category	Earthen Levee			GPS Latitude/Longitude	
				Start	End
Item	Encroachments			37.429109 °	37.429109 °
				-121.029751 °	-121.029751 °
DWR ID	DWR_RD1602_01_s_2021_17				
Comment Code					
FE : Fence					
Inspector Comment					
Landowner has removed LMA's lock from daisy chain on access gate.

View of access gate to levee from Marshall Rd. (Spring 2021)
