**Flood Control Project Maintenance
Levee Inspections
LMA District Cover Sheet**

Reclamation District No. 1602 Del Puerto

**Flood Control Project Maintenance
Levee Inspections**

Levee Inspection Report By Mile - Spring 2022

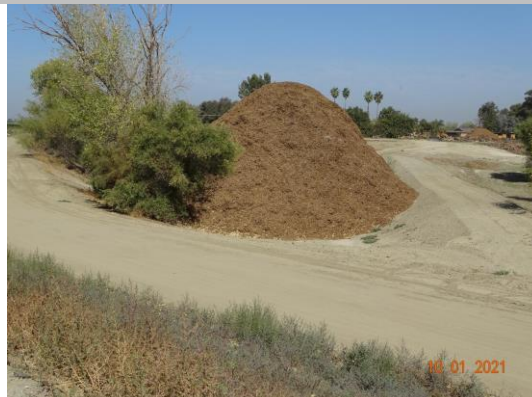
Photo 1 of 1 : SP_2022_RD1602_110_29_20220308_00007.jpg

LM Start	0.61	Rating **	U	Issue No.	29
LM End	0.73	Issue Type +	En	Location *	WS
Category	Rivers, Channels & Designated Floodways			GPS Latitude/Longitude	
				Start	End
Item	Encroachments			37.479815 °	37.478415 °
				-121.074479 °	-121.073284 °
DWR ID	DWR_RD1602_01_f_2021_29				
Comment Code					
Inspector Comment					
Material piled within the channel. Part of bmx course.

Haul road constructed by an adjacent landowner and material piled in the channel. (Fall 2021)

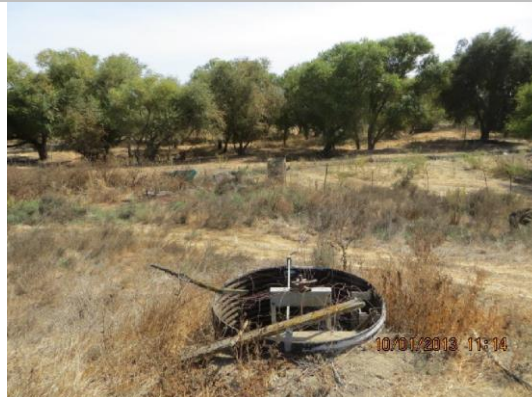
Photo 2 of 3 : UCIP_SP_2022_53522_36804.jpg

Slide gate in 60-inch CMP riser on WS shoulder.

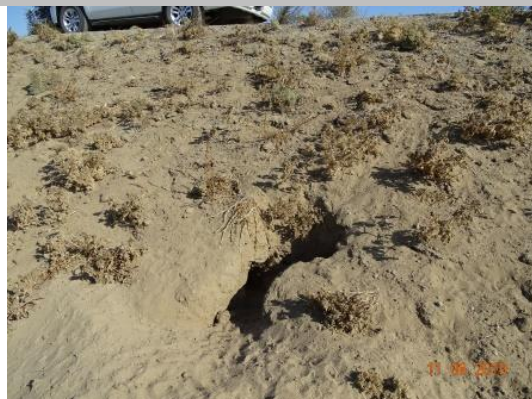
Photo 1 of 1 : SP_2022_RD1602_110_87_20220308_00036.jpg

LM Start	4.21	Rating **	U	Issue No.	87
LM End	4.32	Issue Type +	Ma	Location *	LS
Category	Earthen Levee			GPS Latitude/Longitude	
				Start	End
Item	Animal Control			37.449986 °	37.448492 °
				-121.039249 °	-121.038303 °
DWR ID	DWR_RD1602_01_f_2019_87				
Comment Code					
A1 : Exterminate rodents and backfill and compact or grout burrows.					
Inspector Comment

View of rodent burrows in the landside slope. (Fall 2019)

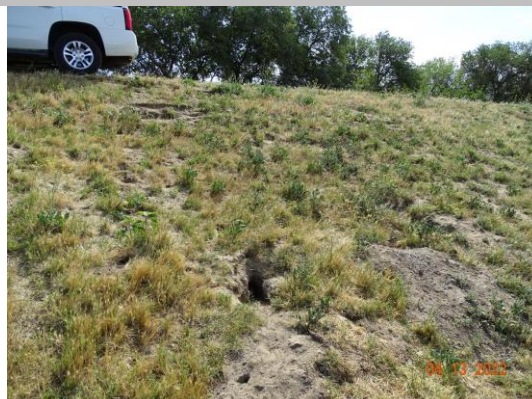
Photo 1 of 1 : SP_2022_RD1602_110_25_20220425_00091.jpg

LM Start	5.07	Rating **	U	Issue No.	25
LM End	5.11	Issue Type +	Ma	Location *	LS
Category	Earthen Levee			GPS Latitude/Longitude	
				Start	End
Item	Animal Control			37.438335 °	37.437817 °
				-121.037133 °	-121.037029 °
DWR ID	DWR_RD1602_01_s_2022_25				
Comment Code					
A3 : No rodents visible, but rodent burrows visible; need to backfill and compact or grout burrows.					
Inspector Comment

View of rodent burrows in the landside slope. (Spring 2022)
