Flood Control Project Maintenance
Levee Inspections
LMA District Cover Sheet

Reclamation District No. 1602 Del Puerto

Waterway			Bank	Unit Miles
Unit No. 01 San Joaquin River			Left	6.24
	Spring (March - May)	Summer (June - August)	(September - November) Fall	Winter (December - February)
Unit Maintenance Rating (Fall Only)				
Date of Inspection	3/27/2024 - 3/27/2024			
DWR Inspector	Nate Hicks			
Accompanied By	Nick Short RD1602

Levee Inspection Report By Mile - Spring 2024

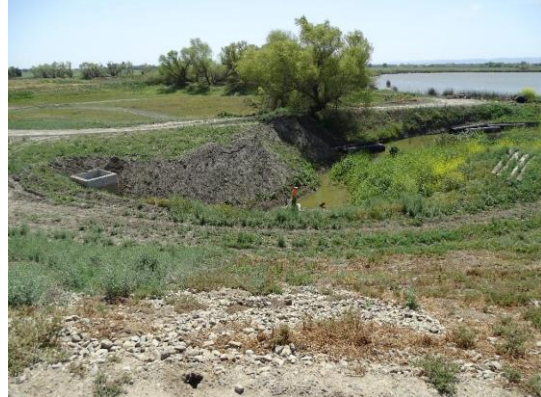
Photo 1 of 2 : UCIP_SP_2024_74536_111245.jpg

Comment Code						
Inspector Comment						
DS_ID:20219 FS_ID:74536 EP_NO: N/A Repair Type: Non-Urgent EVAL Issue: 10, Unauthorized Modification or Non-Compliant Permit Crossing Status: Found UCIP Comments: 04/05/2022 Record remains Non-Urgent. Pump and platform on LS has been removed. The crossing has been capped and exposed on the LS toe. Unable to find a permit for modification. Crossing appears abandoned. Unable to locate a permit and confirm proper pipe abandonment. Recommend owner to contact CVFPB to abandon or remove pipe from levee. (M. Thao - DWR UCIP) 11/18/2016 Crossing has been downgraded from Urgent to Non-Urgent a flap gate has been added to the WS. According to Tony Martinez, LMA representative, this crossing is currently not in use. Owner will need to coordinate with CVFPB to obtain permit. (O. Magana - DWR UCIP) 10/01/2013 Appears abandoned siphon breakers covered in soil and flapgate missing. (W. Wylie - DWR UCIP) FIELD_STRUCT_DESC: 2 of 2: 16-inch steel drainage pipe through levee, 17 feet below crown. Pipe is capped on the landside (LS) end. Pumps on the pump platform are located on LS. Siphon breaker in 24-inch riser located on the waterside (WS) shoulder. Concrete "U" headwall and flap gate are located on the WS end. [Additional Reference(s): DWR Levee Log, 1992 (HLM 1.01). USACE San Joaquin River O&M Manual Unit 13, April 1964, (HLM 1.01), Station 266+68, listed as 16-inch pipe, Drawing No. 7-4-1784]. FS Date: 4/5/2022

LS view: Looking from crown; general overview.

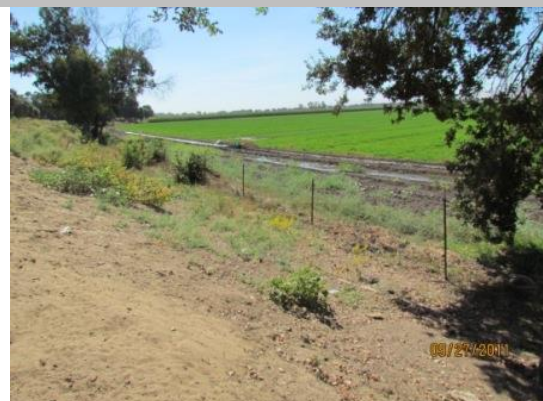
Photo 1 of 1 : SP_2024_RD1602_110_43_20240308_00014.jpg

LM Start	1.61	Rating **	M	Issue No.	43
LM End	2.22	Issue Type +	En	Location *	LS
Category	Earthen Levee			GPS Latitude/Longitude	
				Start	End
Item	Encroachments			37.477663°	37.470125°
				-121.058716°	-121.055244°
DWR ID	DWR_RD1602_01_s_2012_43				
Comment Code					
FE : Fence					
Inspector Comment					
Fence at the landside toe of the levee.

View of the fence on the landside toe of the levee. The picture was taken from crown looking upstream.

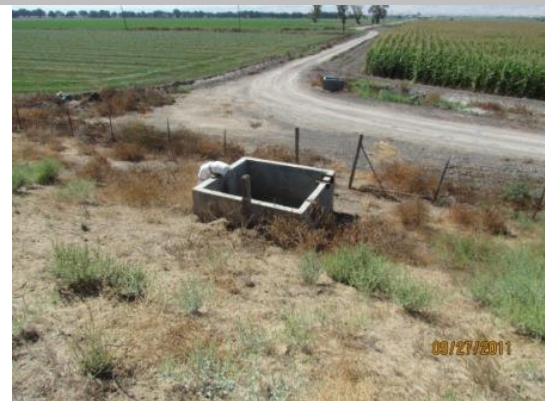
Photo 1 of 1 : SP_2024_RD1602_110_45_20240308_00016.jpg

LM Start	2.03	Rating **	M	Issue No.	45
LM End	2.03	Issue Type +	En	Location *	LS
Category	Earthen Levee			GPS Latitude/Longitude	
				Start	End
Item	Encroachments			37.471734°	37.471734°
				-121.057670°	-121.057670°
DWR ID	DWR_RD1602_01_s_2012_45				
Comment Code					
EQ : Equipment					
Inspector Comment					
A well is present at the toe of the landside slope.

A well is located at the landside toe of the levee. The picture was taken from the crown looking toward the landside of the levee.

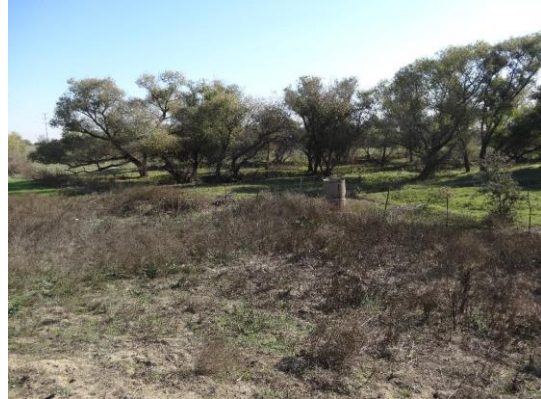
Photo 3 of 3 : UCIP_SP_2024_74530_76530.jpg

Comment Code					
Inspector Comment					
DS_ID:20204 FS_ID:74530 EP_NO: 8193 Repair Type: Urgent EVAL Issue: 1, Pipe Integrity Crossing Status: Found UCIP Comments: 04/05/2022 Record remains Urgent. Pipe inlet within CMP riser is deteriorated. CMP riser cover has broken and fallen into the riser; no cover on the riser causing a safety hazard. Crossing appears abandoned. Recommend owner to contact CVFPB to abandon or remove pipe from levee. (M. Thao - DWR UCIP) 10/19/2018 Pipe is deteriorated on the LS toe (pipe section missing at inlet). This crossing remains Urgent due to the wall deterioration at the inlet. If wall is rusted out at the inlet, need to determine the condition of the pipe section through the levee. According to the LMA representative, this crossing is no longer in use (crossing is abandoned). LMA is interested in abandoning crossing in place. LMA was referred to the CVFPB staff for direction regarding proper action under Title 23 for this crossing. (O. Magana - DWR UCIP) 11/18/2016 Same as previous inspection riser cover and handle on slide gate are still missing. Crossing remains Urgent due to the public safety issue of the 60-inch CMP cover still missing. According to Tony Martinez, LMA representative, the condition and future use of this crossing is being evaluated. Owner will need to coordinate with CVFPB for future use requirements or proper abandonment/removal. (O. Magana - DWR UCIP) 10/01/2013 Appears abandoned, and if so should be done so properly. No handle on slide gate, no cover on CMP standpipe on WS shoulder. (W. Wylie - DWR UCIP) FIELD_STRUCT_DESC: 16-inch steel irrigation pipe through levee, 11.5 feet below crown. Slide gate in 60-inch corrugated metal pipe riser is located on the waterside (WS) slope. Pipe discharges into concrete-lined ditch on the landside (LS) (irrigation pipe was authorized under Automatic Board Order (ABO) issued as Permit No. 8193, 1964 - Sabatte). [Additional Reference(s): DWR Levee Log, 1992 (HLM 3.30). USACE San Joaquin River O&M Manual Unit 13, April 1964, (HLM 3.30), Station 146+62, listed as 16-inch pipe, Drawing No. 7-4-1784]. FS Date: 4/5/2022

LM Start	3.27	Rating **	U	Issue No.	205 (cont)
LM End	3.27	Issue Type +	En	Location *

Concrete riser located in the floodway, photo 1 of 2.

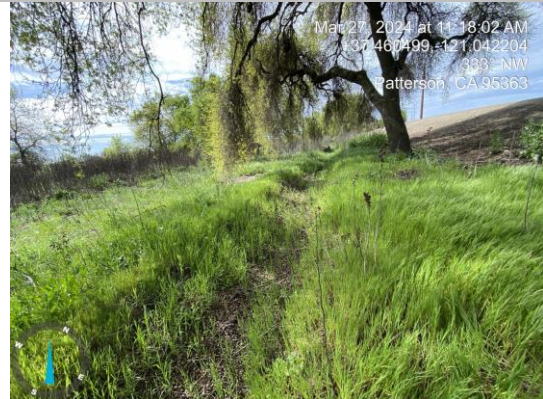
Photo 1 of 1 : SP_2024_RD1602_110_50_20240403_00094.jpg

LM Start	3.34	Rating **	M	Issue No.	50
LM End	3.53	Issue Type +	En	Location *	WS
Category	Earthen Levee			GPS Latitude/Longitude	
				Start	End
Item	Encroachments			37.460644 °	37.458373 °
				-121.042231 °	-121.044081 °
DWR ID	DWR_RD1602_01_s _ 2012_50				
Comment Code					
DT : Ditch					
Inspector Comment					
A ditch is located on the waterside toe of the levee.

Looking upstream along the waterside toe (Spring 2024).

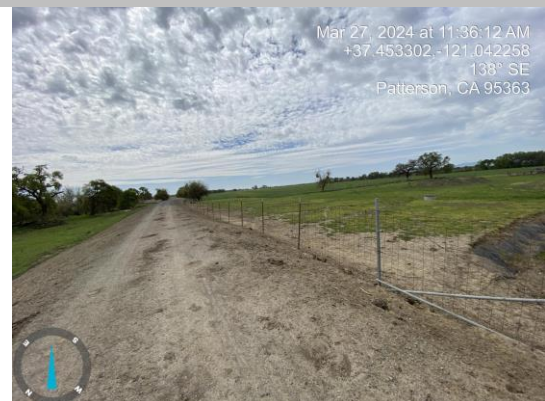
Photo 1 of 1 : SP_2024_RD1602_110_63_20240403_00097.jpg

LM Start	3.93	Rating **	M	Issue No.	63
LM End	4.04	Issue Type +	En	Location *	LS
Category	Earthen Levee			GPS Latitude/Longitude	
				Start	End
Item	Encroachments			37.453226°	37.451866°
				-121.042118°	-121.041206°
DWR ID	DWR_RD1602_01_s_2012_63				
Comment Code					
FE : Fence					
Inspector Comment					
Fence on landward slope.

View of fence along the landside slope and shoulder (Spring 2024).

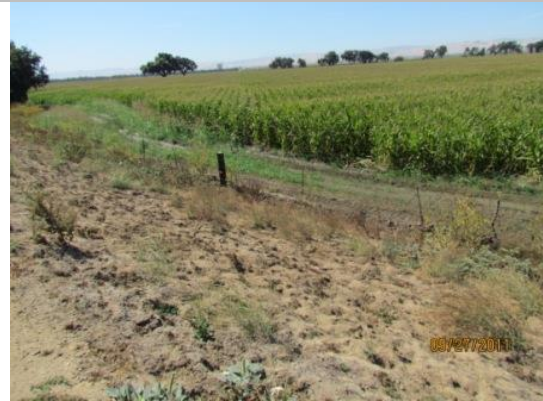
Photo 1 of 1 : SP_2024_RD1602_110_67_20240308_00029.jpg

LM Start	4.42	Rating **	M	Issue No.	67
LM End	4.88	Issue Type +	En	Location *	LS
Category	Earthen Levee			GPS Latitude/Longitude	
				Start	End
Item	Encroachments			37.447213°	37.441014°
				-121.037665°	-121.036932°
DWR ID	DWR_RD1602_01_s_2012_67				
Comment Code					
FE : Fence					
Inspector Comment

View of the fence on the landside toe of the levee. The picture was taken from the crown looking upstream.

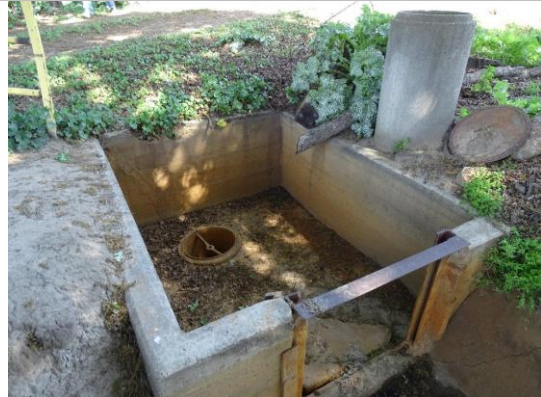
Photo 1 of 2 : UCIP_SP_2024_74531_111172.jpg

LM Start	4.47	Rating **	U	Issue No.	209 (cont)
LM End	4.47	Issue Type +	En	Location *

LS view: Pipe outlet on toe within concrete ditch.

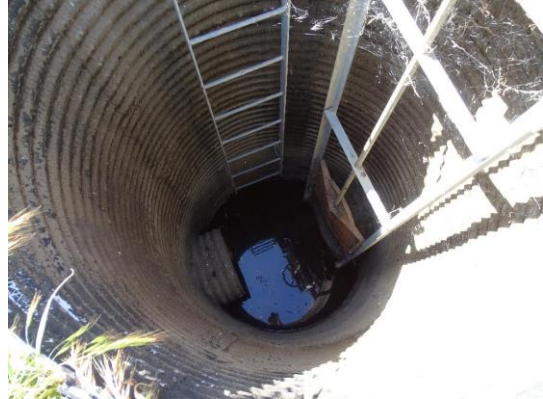
Photo 2 of 2 : UCIP_SP_2024_74358_111161.jpg

LM Start	5.19	Rating **	U	Issue No.	210 (cont)
LM End	5.19	Issue Type +	Ma	Location *	
Category	Supplemental			GPS Latitude/Longitude	
				Start	End
Item	DWR UCIP LMA Responsibility			37.436748 °	37.436748 °
				-121.036597 °	-121.036597 °
DWR ID	20208

WS view: Looking into CMP riser.

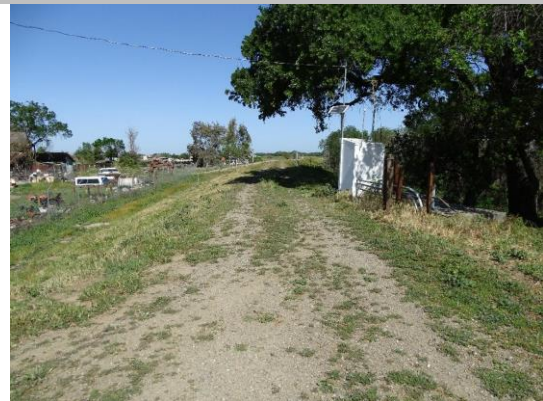
Photo 1 of 3 : UCIP_SP_2024_77639_111146.jpg

Levee crown looking downstream.

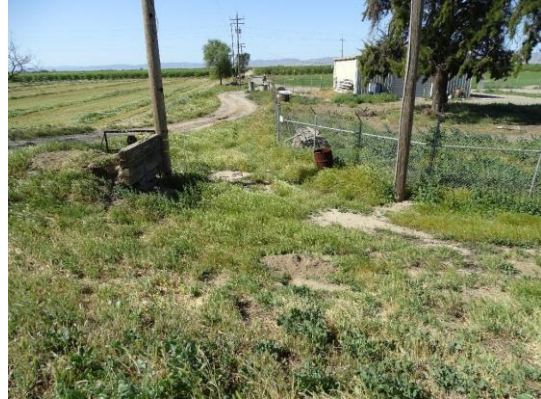
Photo 2 of 3 : UCIP_SP_2024_77639_111141.jpg

LM Start	5.23	Rating **	A	Issue No.	211 (cont)
LM End	5.23	Issue Type +	Ma	Location *	
Category	Supplemental			GPS Latitude/Longitude	
				Start	End
Item	DWR UCIP LMA Responsibility			37.436246°	37.436246°
				-121.036193°	-121.036193°
DWR ID	20209

LS view: Looking from crown; general overview.

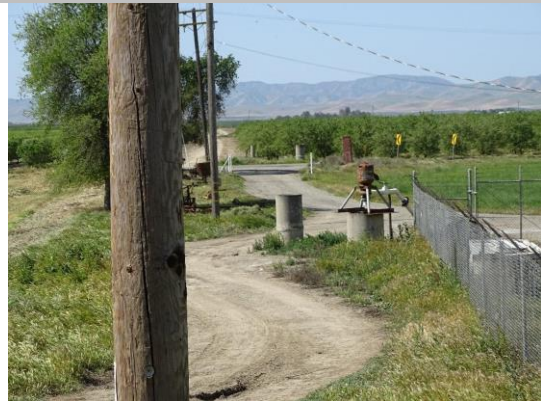
Photo 3 of 3 : UCIP_SP_2024_77639_111145.jpg

LM Start	5.23	Rating **	A	Issue No.	211 (cont)
LM End	5.23	Issue Type +	Ma	Location *

LS view: Likely risers for pipe off LS toe.

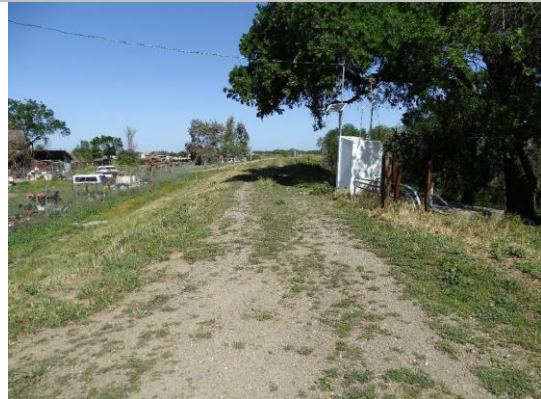
Photo 1 of 3 : UCIP_SP_2024_77640_111150.jpg

LM Start	5.23	Rating **	A	Issue No.	212 (cont)
LM End	5.23	Issue Type +	Ma	Location *

Levee crown looking downstream.

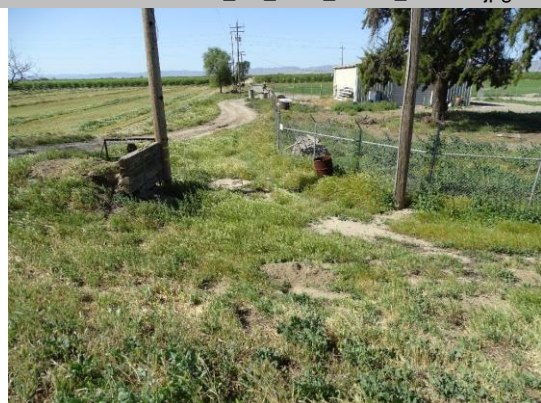
Photo 2 of 3 : UCIP_SP_2024_77640_111147.jpg

LS view: Looking from crown; general overview.

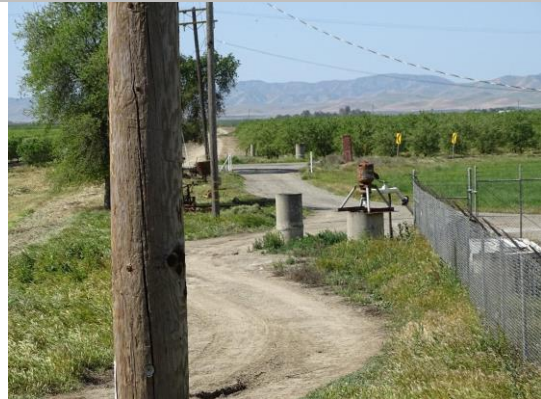
Photo 3 of 3 : UCIP_SP_2024_77640_111149.jpg

LM Start	5.23	Rating **	A	Issue No.	212 (cont)
LM End	5.23	Issue Type +	Ma	Location *	
Category	Supplemental			GPS Latitude/Longitude	
				Start	End
Item	DWR UCIP LMA Responsibility			37.436227°	37.436227°
				-121.036169°	-121.036169°
DWR ID	20222

LS view: Likely risers for pipe off LS toe.

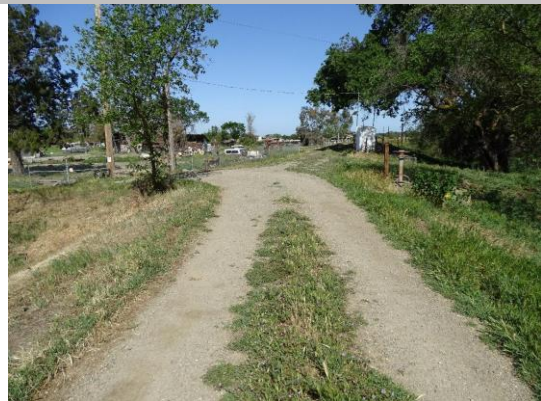
Photo 1 of 3 : UCIP_SP_2024_81195_111126.jpg

DS_ID:20210
FS_ID:81195
EP_NO: N/A
Repair Type: No Action Needed
EVAL Issue:
Crossing Status: Found
UCIP Comments: 04/05/2022 Record remains No Action Needed. DWR DMP internal video inspection has not found pipe integrity issues. LOF of crossing is less or equal to 4.0. Recommend next video inspection in 5 years. No issues observed during inspection. (M. Thao - DWR UCIP)
FIELD_STRUCT_DESC: 30-inch by 30-inch reinforced concrete box drainage culvert through the levee, 12.9 feet below the crown. Slide gate in a concrete surge box on the waterside (WS) slope. Concrete discharge boxes on both ends. [Additional Reference(s): DWR Levee Log, 1992 (HLM 5.28). USACE San Joaquin O&M Manual 13, April 1964, (HLM 5.28), Station 38+58, Drawing No. 7-4-1784].
FS Date: 4/5/2022

Levee crown looking downstream.

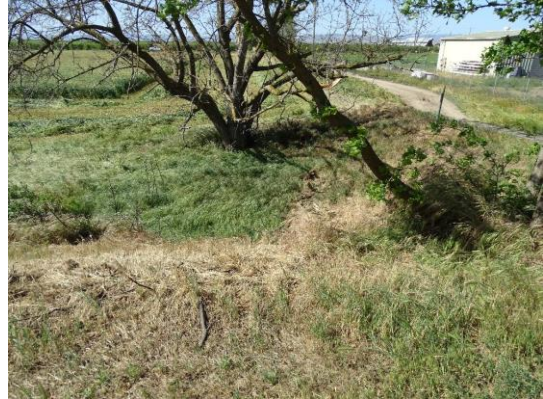
Photo 2 of 3 : UCIP_SP_2024_81195_111127.jpg

LM Start	5.24	Rating **	A	Issue No.	213 (cont)
LM End	5.24	Issue Type +	Ma	Location *	
Category	Supplemental			GPS Latitude/Longitude	
				Start	End
Item	DWR UCIP LMA Responsibility			37.436129°	37.436129°
				-121.036065°	-121.036065°
DWR ID	20210

LS view: Looking from levee crown; general overview.

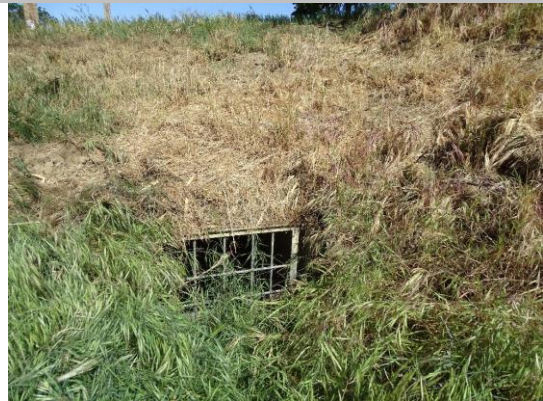
Photo 3 of 3 : UCIP_SP_2024_81195_111128.jpg

LM Start	5.24	Rating **	A	Issue No.	213 (cont)
LM End	5.24	Issue Type +	Ma	Location *

LS view: Concrete inlet on toe.

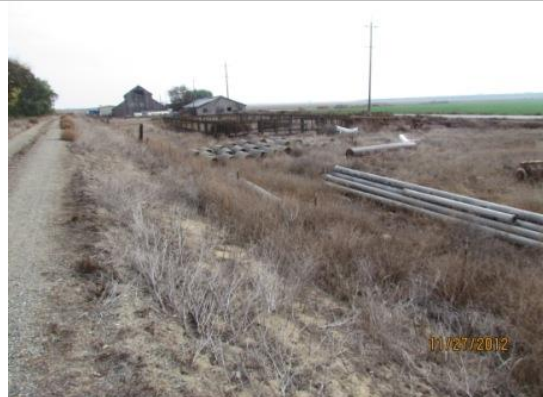
Photo 1 of 1 : SP_2024_RD1602_110_22_20240308_00002.jpg

LM Start	5.38	Rating **	M	Issue No.	22
LM End	5.44	Issue Type +	En	Location *	LS
Category	Earthen Levee			GPS Latitude/Longitude	
				Start	End
Item	Encroachments			37.434447°	37.433791°
				-121.034865°	-121.034000°
DWR ID	DWR_RD1602_01_f_2012_22				
Comment Code					
FE : Fence					
Inspector Comment

A fence was found on the landside toe of the levee looking upstream.

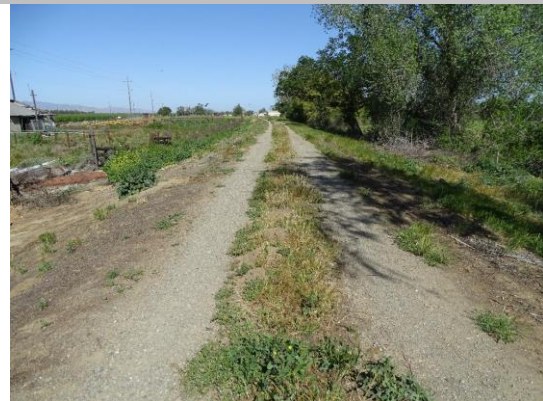
Photo 1 of 3 : UCIP_SP_2024_75650_111112.jpg

Comment Code					
Inspector Comment					
DS_ID:20211 FS_ID:75650 EP_NO: N/A Repair Type: Non-Urgent EVAL Issue: Crossing Status: Found UCIP Comments: 04/05/2022 Record remains Non-Urgent. Crossing appears abandoned. Recommend owner to contact CVFPB to abandon or remove pipe from levee. DWR DMP internal video inspection has not found pipe integrity issues. LOF of crossing is less or equal to 4.0. Recommend next video inspection in 5 years. (M. Thao - DWR UCIP) 10/01/2013 Pipe appears abandoned and if so should be done so properly. (W. Wylie - DWR UCIP) FIELD_STRUCT_DESC: 12-inch CMP drainage pipe through the levee, 6.9 feet below the crown. Flap gate on the waterside (WS) end. [Additional Reference(s): DWR Levee Log, 1992 (HLM 5.50). USACE San Joaquin O&M Manual 13, April 1964, (HLM 5.50), listed as 12-inch pipe, Drawing No. 7-4-1784]. FS Date: 4/5/2022

Levee crown looking downstream.

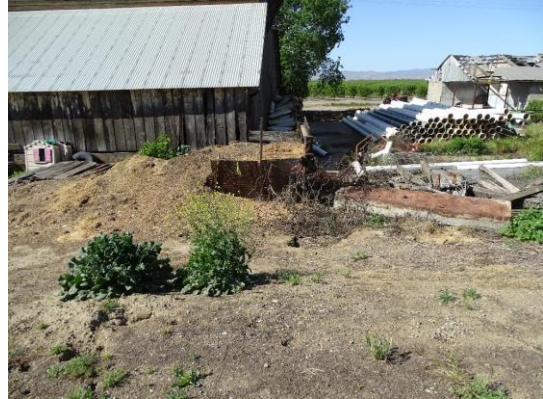
Photo 2 of 3 : UCIP_SP_2024_75650_111113.jpg

LM Start	5.46	Rating **	M	Issue No.	214 (cont)
LM End	5.46	Issue Type +	Ma	Location *	
Category	Supplemental			GPS Latitude/Longitude	
				Start	End
Item	DWR UCIP LMA Responsibility			37.433646 °	37.433646 °
				-121.033846 °	-121.033846 °
DWR ID	20211

LS view: Looking from crown; general overview.

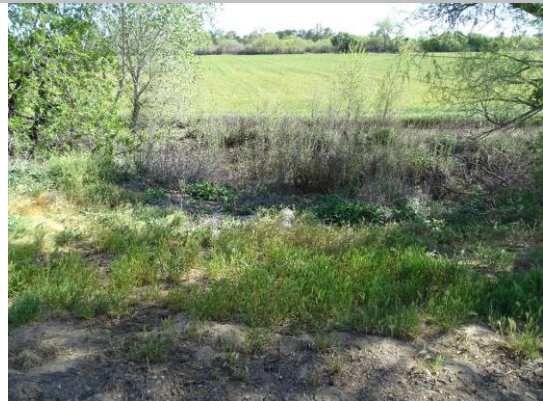
Photo 3 of 3 : UCIP_SP_2024_75650_111114.jpg

LM Start	5.46	Rating **	M	Issue No.	214 (cont)
LM End	5.46	Issue Type +	Ma	Location *

WS view: Looking from crown; 12-inch CMP outlet with flap gate on toe.

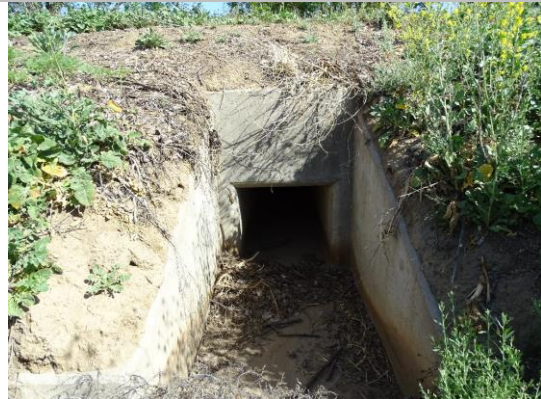
Photo 1 of 2 : UCIP_SP_2024_81197_111109.jpg

LM Start	5.72	Rating **	M	Issue No.	215 (cont)
LM End	5.72	Issue Type +	Ma	Location *

LS view: Close-up view of concrete headwall on toe.

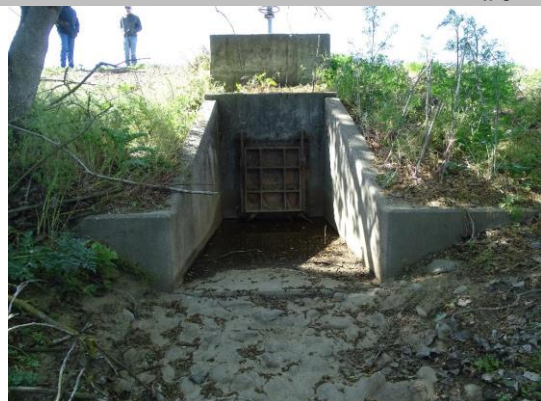
Photo 2 of 2 : UCIP_SP_2024_81197_111111.jpg

WS view: Concrete headwall and flap gate; surge box in the background.

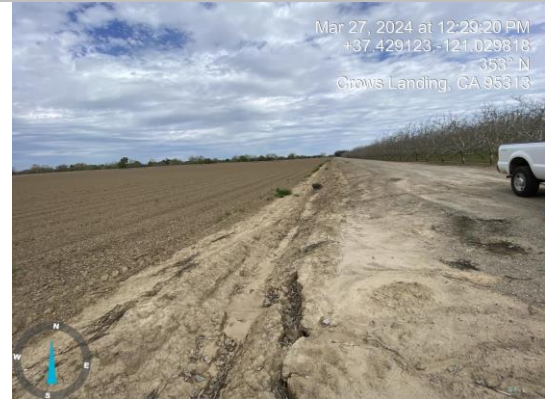
Photo 1 of 1 : SP_2024_RD1602_110_98_20240403_00104.jpg

LM Start	5.90	Rating **	M	Issue No.	98
LM End	6.23	Issue Type +	En	Location *	LS
Category	Earthen Levee			GPS Latitude/Longitude	
				Start	End
Item	Encroachments			37.432770°	37.429128°
				-121.026086°	-121.029741°
DWR ID	DWR_RD1602_01_s_2024_98				
Comment Code					
DT : Ditch					
Inspector Comment					
Landowner has cut a ditch into the landward toe.

View of ditch along the landward toe (Spring 2024).

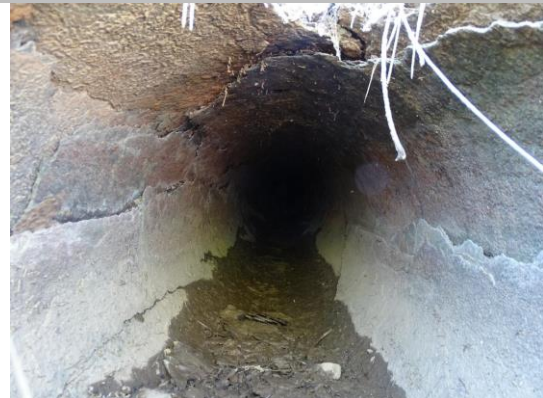
Photo 2 of 2 : UCIP_SP_2024_77638_111106.jpg

Comment Code					
Inspector Comment					
DS_ID:20214 FS_ID:77638 EP_NO: 8194 Repair Type: Urgent EVAL Issue: 1, Pipe Integrity Crossing Status: Found UCIP Comments: 04/05/2022 Record remains Urgent. DMP internal video inspection has found pipe integrity issues. LOF of crossing is between 5 and 6. Crossing will be monitored until funding becomes available to address the issues. (M. Thao - DWR UCIP) 10/01/2013 Pipe heavily deteriorated on LS toe. May indicate condition of rest of pipe is bad. Good candidate for video inspection. (W. Wylie - DWR UCIP) FIELD_STRUCT_DESC: 18-inch reinforced concrete irrigation pipe through the levee, 3 feet below the crown. Slide gate in a 36-inch concrete standpipe on the waterside (WS) shoulder. (18-inch concrete pipe was authorized under Automatic Board Order (ABO) issued as Permit No. 8194, 1972 - Ernest F. Nunes). [Additional Reference(s): DWR Levee Log, 1992 (HLM 6.28). USACE San Joaquin O&M Manual 13, April 1964, (HLM 6.28), Station 0+50A, listed as 18-inch pipe, Drawing No. 7-4-1784]. FS Date: 4/5/2022

LS view: Outlet of irrigation pipe is deteriorated.

LS view: View of inside of pipe outlet.
