**Flood Control Project Maintenance
Levee Inspections**
LMA District Cover Sheet
Spring 2015 Levee Inspection Results

Reclamation District No. 2031 Elliot

Spring 2015 Levee Inspection Results

Waterway		Bank	Unit Miles
Unit No. 01 Stanislaus River		Left	7.07

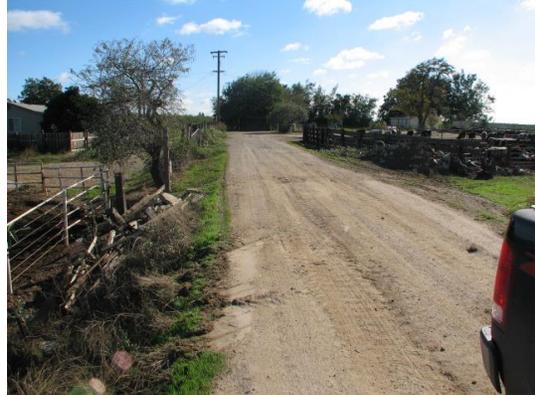
Photo 1 of 1 : SP_2015_RD2031_307_963_20150317_00037.jpg

LM Start	0.00	Rating **	M	Issue No.	963
LM End	0.06	Issue Type +	En	Location *	WS
Category	Earthen Levee		GPS Latitude/Longitude		
			Start	End	
Item	Encroachments		37.710001 °	37.709951 °	
			-121.155391 °	-121.156539 °	
DWR ID	DWR_RD2031_01_s_2012_963				
Action/Comments					
Fence Inspector Comments: Wooden and steel livestock fence and debris limit access to slope.

Fall 2009 photo looking upstream at beginning of unit 1. Water side to the left.

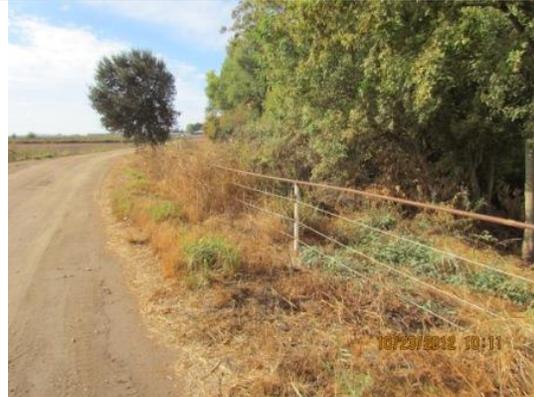
Photo 3 of 3 : SP_2015_RD2031_307_7_20150317_00009.jpg

LM Start	0.34	Rating **	U	Issue No.	7 (cont)
LM End	0.52	Issue Type +	En	Location *	WS
Category	Earthen Levee			GPS Latitude/Longitude	
				Start	End
Item	Encroachments			37.706148 °	37.704030 °
				-121.157975 °	-121.159653 °
DWR ID	DWR_RD2031_01_s_2012_7				
Action/Comments					
Fence Inspector Comments: Fence appears to be completed without CVFPB approval.

View of fence on waterside slope facing downstream.

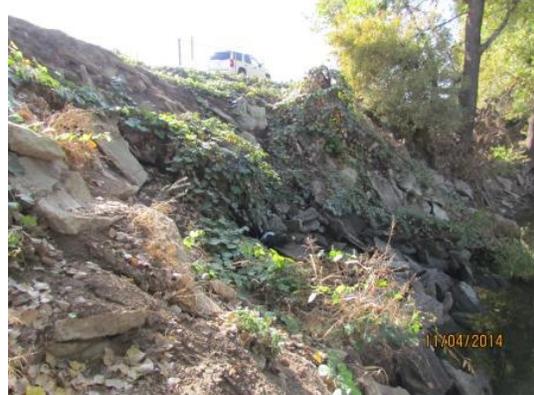
Photo 1 of 1 : SP_2015_RD2031_307_32_20150317_00019.jpg

LM Start	0.45	Rating **	U	Issue No.	32
LM End	0.45	Issue Type +	En	Location *	WS
Category	Interior Drainage & Piping Systems			GPS Latitude/Longitude	
				Start	End
Item	Flap Gates			37.704772 °	37.704772 °
				-121.158990 °	-121.158990 °
DWR ID	DWR_RD2031_01_s_2013_32				
Action/Comments					
Inspector Comments: Canal outlet has no flap gate on waterward side.

View of canal outlet on waterward slope facing downstream.

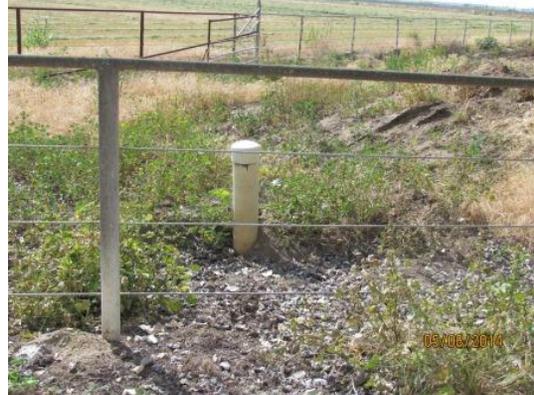
Photo 1 of 1 : SP_2015_RD2031_307_125_20150317_00033.jpg

LM Start	0.47	Rating **	M	Issue No.	125
LM End	0.47	Issue Type +	En	Location *	LS
Category	Earthen Levee			GPS Latitude/Longitude	
				Start	End
Item	Encroachments			37.704537 °	37.704537 °
				-121.159041 °	-121.159041 °
DWR ID	DWR_RD2031_01_s_2014_125				
Action/Comments					
Pipe Inspector Comments: PVC Standpipe at landside levee toe.

View of the PVC standpipe at the landside levee toe.

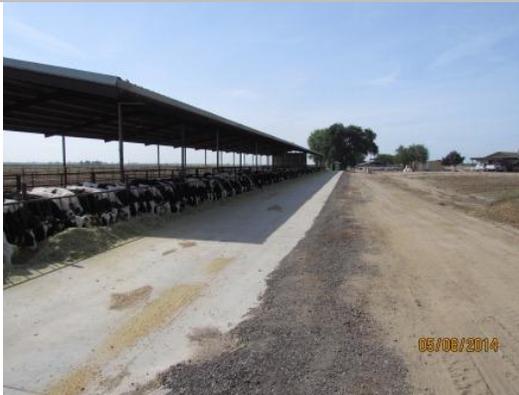
Photo 1 of 1 : SP_2015_RD2031_307_969_20150317_00038.jpg

LM Start	0.54	Rating **	U	Issue No.	969
LM End	0.65	Issue Type +	En	Location *	LS
Category	Earthen Levee		GPS Latitude/Longitude		
			Start	End	
Item	Encroachments		37.703626 °	37.702648 °	
			-121.159714 °	-121.160700 °	
DWR ID	DWR_RD2031_01_s_2012_969				
Action/Comments					
Building Inspector Comments: Corrals and house on levee slope and crown. Demolition in progress.

View of the new coral at the landside levee slope and toe.

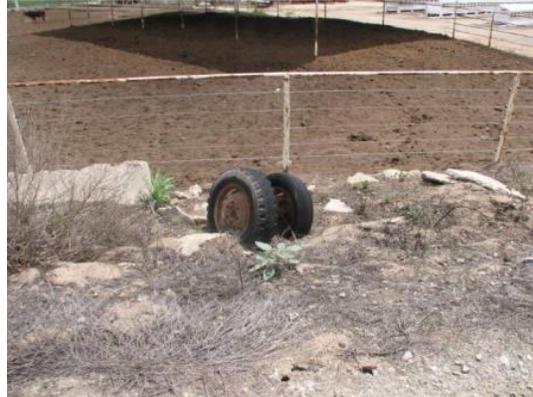
Photo 1 of 1 : SP_2015_RD2031_307_35_20150317_00020.jpg

LM Start	0.65	Rating **	M	Issue No.	35
LM End	0.65	Issue Type +	En	Location *	LS
Category	Earthen Levee		GPS Latitude/Longitude		
			Start	End	
Item	Encroachments		37.702643 °	37.702643 °	
			-121.160867 °	-121.160867 °	
DWR ID	DWR_RD2031_01_s_2012_35				
Action/Comments					
Debris Inspector Comments: Tractor wheels on slope of landside levee.

View of tractor wheels on landward slope. 05/02/2012

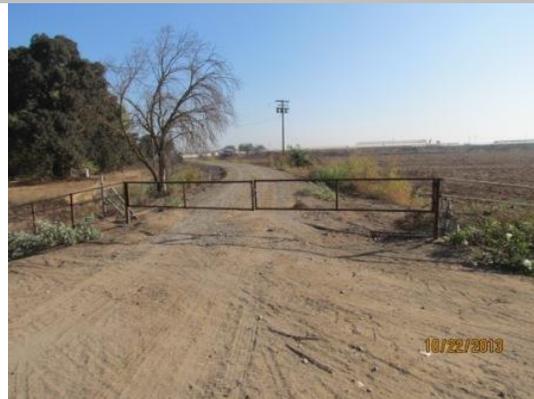
Photo 1 of 1 : SP_2015_RD2031_307_51_20150317_00029.jpg

LM Start	0.92	Rating **	M	Issue No.	51
LM End	0.92	Issue Type +	En	Location *	CR
Category	Earthen Levee			GPS Latitude/Longitude	
				Start	End
Item	Encroachments			37.699727 °	37.699727 °
				-121.163919 °	-121.163919 °
DWR ID	DWR_RD2031_01_f_2013_51				
Action/Comments					
Fence Inspector Comments: Unpermitted gate across levee crown.

View of the gate across levee crown.

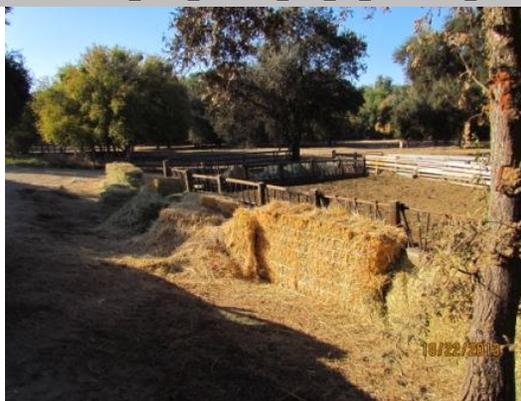
Photo 1 of 1 : SP_2015_RD2031_307_37_20150317_00022.jpg

LM Start	1.85	Rating **	U	Issue No.	37
LM End	1.85	Issue Type +	En	Location *	WS
Category	Earthen Levee		GPS Latitude/Longitude		
			Start	End	
Item	Encroachments		37.695867 °	37.695867 °	
			-121.177638 °	-121.177638 °	
DWR ID	DWR_RD2031_01_s_2012_37				
Action/Comments					
Crops Inspector Comments: Several bales of hay at toe of levee. LMA notified the landowner and still no compliance.

View of the hay bails at the landside levee toe.

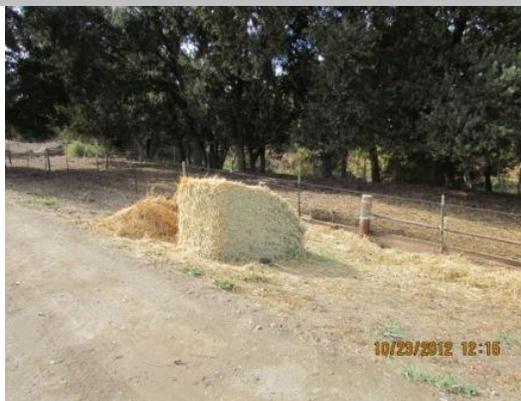
Photo 1 of 1 : SP_2015_RD2031_307_39_20150317_00023.jpg

LM Start	2.15	Rating **	M	Issue No.	39
LM End	2.15	Issue Type +	En	Location *	WS
Category	Earthen Levee			GPS Latitude/Longitude	
				Start	End
Item	Encroachments			37.691687 °	37.691687 °
				-121.178285 °	-121.178285 °
DWR ID	DWR_RD2031_01_f_2012_39				
Action/Comments					
Crops Inspector Comments: Hay bale on waterside levee slope.

View of hay bales at toe of levee on waterward side, facing downstream.
05/02/2012

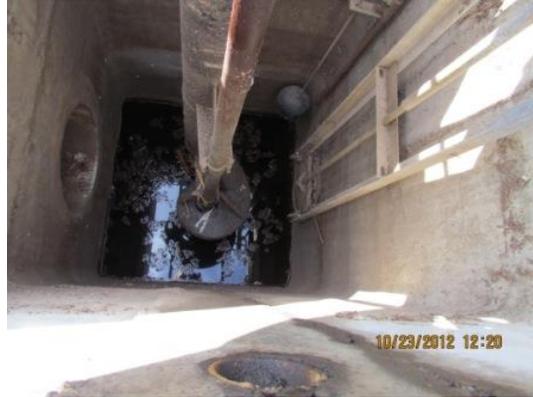
Photo 1 of 3 : SP_2015_RD2031_307_42_20150317_00024.jpg

LM Start	2.39	Rating **	A/W	Issue No.	42
LM End	2.39	Issue Type +	En	Location *	LS
Category	Earthen Levee			GPS Latitude/Longitude	
				Start	End
Item	Encroachments			37.688623 °	37.688623 °
				-121.179767 °	-121.179767 °
DWR ID	DWR_RD2031_01_f_2012_42				
Action/Comments					
Pipe					
Inspector Comments: Flap gate is closed and appears to be operational.

View of the closed slide gate.

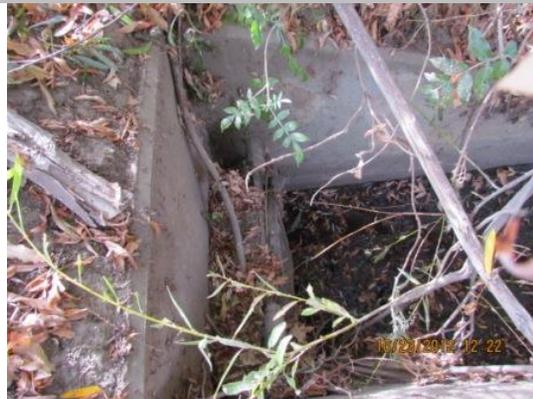
Photo 2 of 3 : SP_2015_RD2031_307_42_20150317_00025.jpg

View of closed flap gate on waterside.

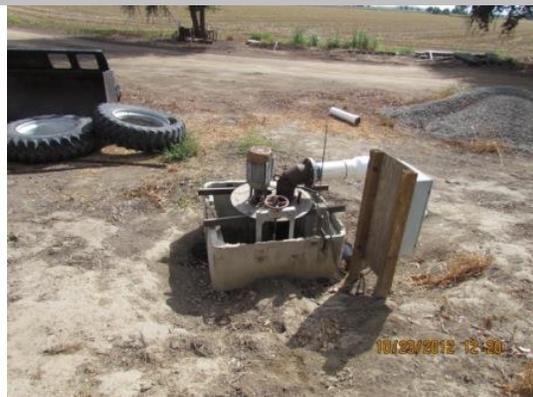
Photo 3 of 3 : SP_2015_RD2031_307_42_20150317_00026.jpg

View of the slide gate lever and well.

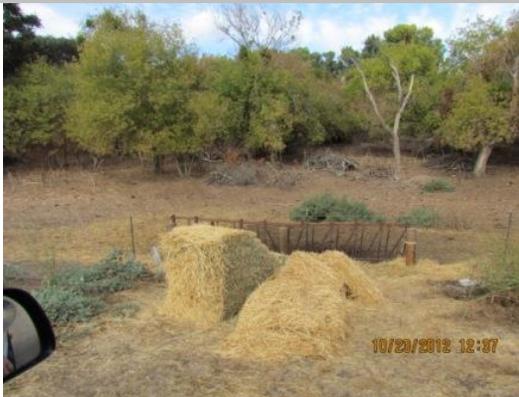
Photo 1 of 1 : SP_2015_RD2031_307_45_20150317_00027.jpg

LM Start	2.62	Rating **	M	Issue No.	45
LM End	2.62	Issue Type +	En	Location *	WS
Category	Earthen Levee			GPS Latitude/Longitude	
				Start	End
Item	Encroachments			37.687146 °	37.687146 °
				-121.183152 °	-121.183152 °
DWR ID	DWR_RD2031_01_f_2012_45				
Action/Comments					
Crops Inspector Comments: Hay bale on waterside levee slope.

View of hay bales at toe of levee on waterward side, facing downstream.

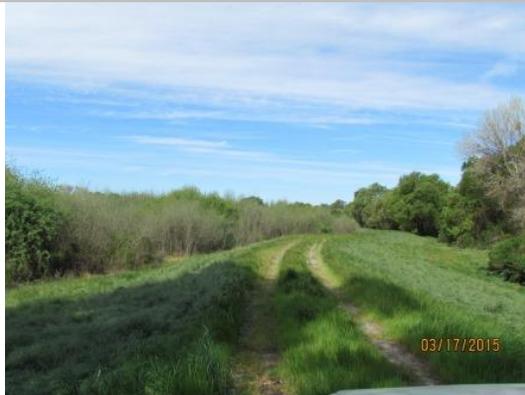
Photo 1 of 1 : SP_2015_RD2031_307_56_20150330_00055.jpg

View of the annual vegetation on the levee crown and slopes.

LM Start	3.73	Rating **	M	Issue No.	56
LM End	4.40	Issue Type +	Ma	Location *	CR
Category	Earthen Levee			GPS Latitude/Longitude	
				Start	End
Item	Vegetation			37.689772 °	37.686397 °
				-121.199569 °	-121.207931 °
DWR ID	DWR_RD2031_01_s_2015_56				
Action/Comments					
Control annual grass and weeds on the levee slopes and easements.

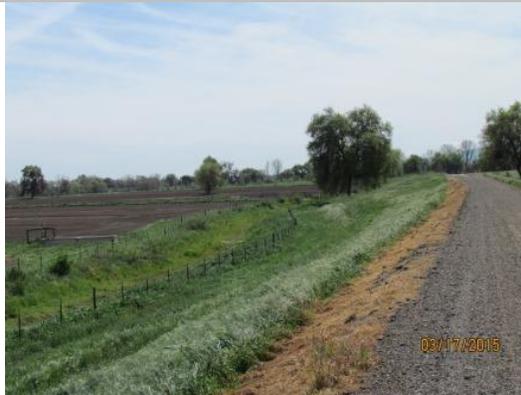
Photo 1 of 1 : SP_2015_RD2031_307_57_20150330_00056.jpg

View of the annual vegetation on the landside levee slope.

LM Start	5.37	Rating **	M	Issue No.	57
LM End	7.07	Issue Type +	Ma	Location *	LS
Category	Earthen Levee		GPS Latitude/Longitude		
			Start	End	
Item	Vegetation		37.677346 °	37.661837 °	
			-121.217537 °	-121.232954 °	
DWR ID	DWR_RD2031_01_s_2015_57				
Action/Comments					
Control annual grass and weeds on the levee slopes and easements.

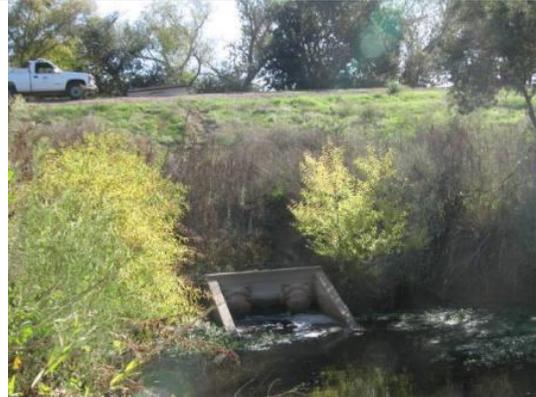
Photo 1 of 2 : SP_2015_RD2031_308_3_20150317_00002.jpg

LM Start	0.22	Rating **	A/W	Issue No.	3
LM End	0.22	Issue Type +	En	Location *	LS
Category	Earthen Levee			GPS Latitude/Longitude	
				Start	End
Item	Encroachments			37.658843 °	37.658843 °
				-121.234271 °	-121.234271 °
DWR ID	DWR_RD2031_02_s_2012_3				
Action/Comments					
Pipe

10/26/2011 Flap gates on landside.

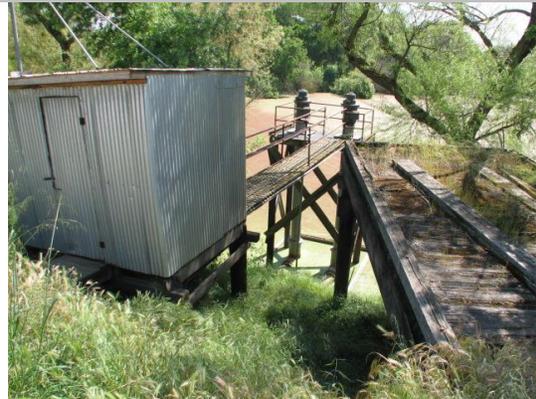
Photo 2 of 2 : SP_2015_RD2031_308_3_20150317_00003.jpg

Drainage discharge pumps and housing on steep waterside slope.

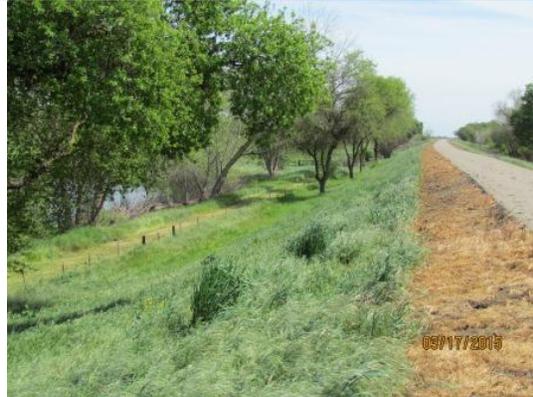
Photo 1 of 1 : SP_2015_RD2031_308_18_20150330_00020.jpg

View of the annual vegetation on the landside levee slope.

LM Start	0.71	Rating **	M	Issue No.	18
LM End	1.40	Issue Type +	Ma	Location *	LS
Category	Earthen Levee			GPS Latitude/Longitude	
				Start	End
Item	Vegetation			37.654134 °	37.648209 °
				-121.230216 °	-121.221174 °
DWR ID	DWR_RD2031_02_s_2015_18				
Action/Comments					
Control annual grass and weeds on the levee slopes and easements.

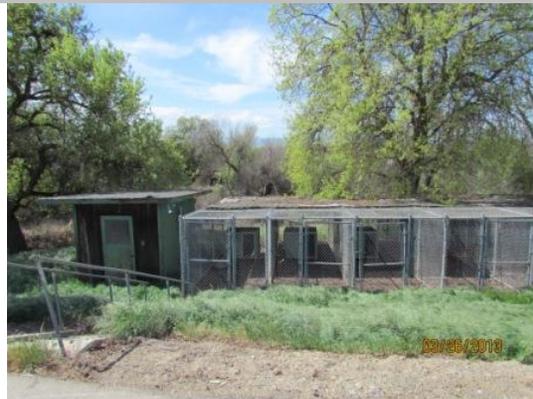
Photo 1 of 1 : SP_2015_RD2031_308_8_20150317_00005.jpg

LM Start	1.28	Rating **	M	Issue No.	8
LM End	1.28	Issue Type +	En	Location *	WS
Category	Earthen Levee			GPS Latitude/Longitude	
				Start	End
Item	Encroachments			37.649918 °	37.649918 °
				-121.221913 °	-121.221913 °
DWR ID	DWR_RD2031_02_s_2013_8				
Action/Comments					
Building

View of the structure at the waterside levee toe.

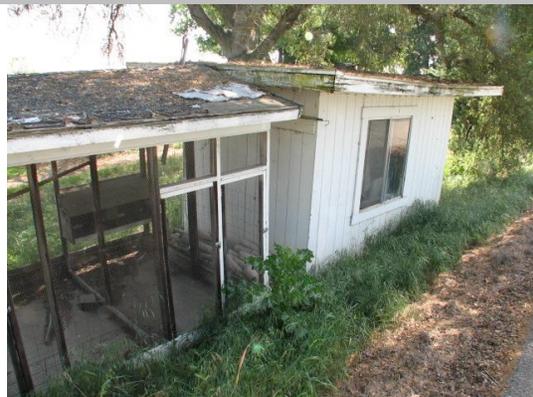
Photo 1 of 1 : SP_2015_RD2031_308_4_20150317_00004.jpg

LM Start	1.35	Rating **	U	Issue No.	4
LM End	1.35	Issue Type +	En	Location *	LS
Category	Earthen Levee			GPS Latitude/Longitude	
				Start	End
Item	Encroachments			37.648898 °	37.648898 °
				-121.221621 °	-121.221621 °
DWR ID	DWR_RD2031_02_s_2012_4				
Action/Comments					
Building

Small structure on levee slope.

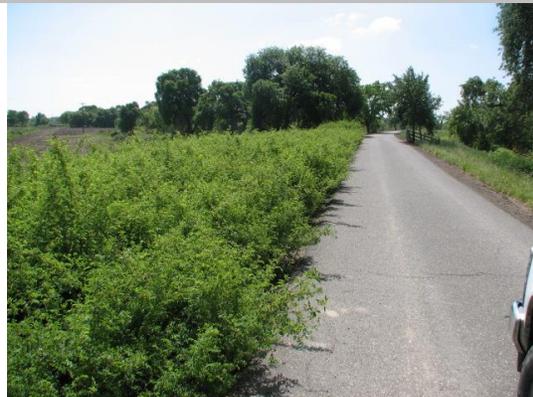
Photo 1 of 1 : SP_2015_RD2031_308_965_20150317_00012.jpg

LM Start	1.44	Rating **	U	Issue No.	965
LM End	1.46	Issue Type +	En	Location *	LS
Category	Earthen Levee		GPS Latitude/Longitude		
			Start	End	
Item	Vegetation		37.647708 °	37.647462 °	
			-121.220873 °	-121.220857 °	
DWR ID	DWR_RD2031_02_s_2012_965				
Action/Comments					
Landscaping Inspector Comments: Wild rose bush on landside slope.

Wild rose on levee slope.

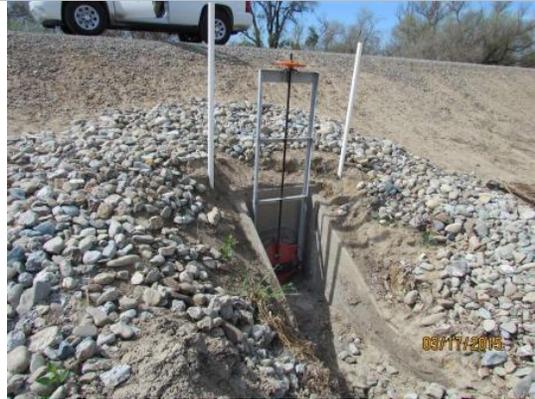
Photo 1 of 1 : SP_2015_RD2031_308_19_20150330_00021.jpg

LM Start	4.16	Rating **	U	Issue No.	19
LM End	4.16	Issue Type +	En	Location *	LS
Category	Earthen Levee			GPS Latitude/Longitude	
				Start	End
Item	Encroachments			37.633392 °	37.633392 °
				-121.190765 °	-121.190765 °
DWR ID	DWR_RD2031_02_s_2015_19				
Action/Comments					
Pipe Inspector Comments: The pipe may be unpermitted. The slidegate is installed on the landside.

View of the pipe and new slide gate.

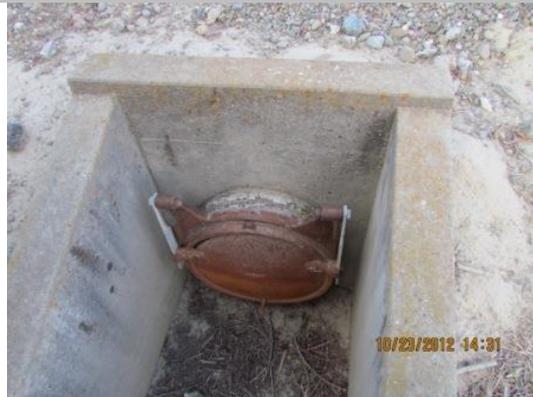
Photo 1 of 1 : SP_2015_RD2031_308_22_20150317_00009.jpg

LM Start	4.53	Rating **	A/W	Issue No.	22
LM End	4.53	Issue Type +	Ma	Location *	WS
Category	Earthen Levee			GPS Latitude/Longitude	
				Start	End
Item	Encroachments			37.630855 °	37.630855 °
				-121.185442 °	-121.185442 °
DWR ID	DWR_RD2031_02_f_2012_22				
Action/Comments					
Pipe Inspector Comments: 36" discharge pipe through the levee with flap gate closed.

View of the closed flap gate on waterside.
