**Flood Control Project Maintenance
Levee Inspections****LMA District Cover Sheet
Spring 2016 Levee Inspection Results****Reclamation District No. 2035 Conaway**

Spring 2016 Levee Inspection Results

Reclamation District No. 2035 Conaway

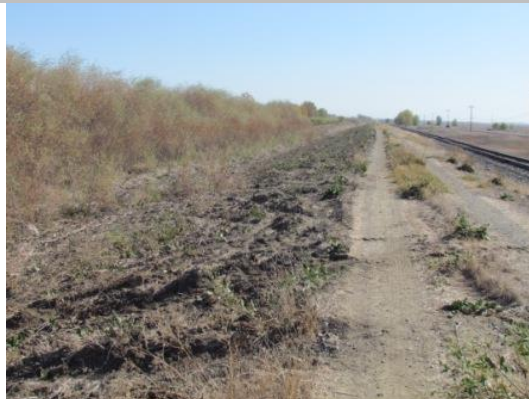
Photo 1 of 1 : SP_2016_RD2035_238_11_20160307_00003.jpg

LM Start	0.03	Rating **	A/W	Issue No.	11
LM End	2.00	Issue Type +	Ma	Location *	WS
Category	Earthen Levee			GPS Latitude/Longitude	
				Start	End
Item	Encroachments			38.677347 °	38.677175 °
				-121.709285 °	-121.672945 °
DWR ID	DWR_RD2035_01_f_2013_11				
Comment Code					
AT : Agricultural tilling					
Inspector Comment					
Discing on the waterward slope can lead to erosion.

This photo was taken from the levee crown facing east looking at discing on the waterward slope. Fall 2013.

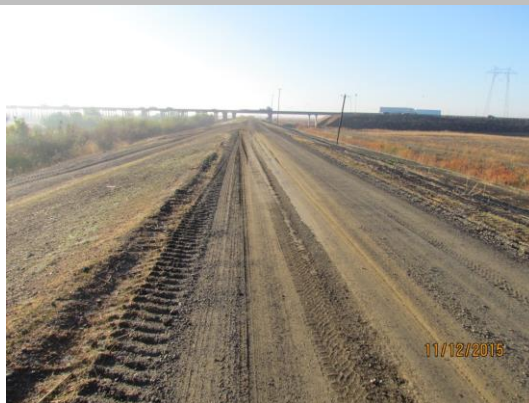
Photo 1 of 1 : SP_2016_RD2035_239_16_20160307_00003.jpg

LM Start	0.10	Rating **	M	Issue No.	16
LM End	0.10	Issue Type +	Ma	Location *	CR
Category	Earthen Levee			GPS Latitude/Longitude	
				Start	End
Item	Crown Surface / Depressions / Rutting			38.675761 °	38.675761 °
				-121.672347 °	-121.672347 °
DWR ID	DWR_RD2035_02_f_2015_16				
Comment Code					
C1 : Add appropriate material and re-grade the levee to bring the crown above the design elevation.					
Inspector Comment

View of the crown of the levee looking downstream. Fall 2015.

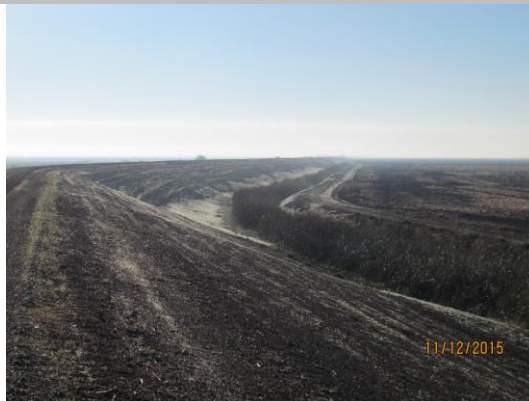
Photo 1 of 2 : SP_2016_RD2035_239_979_20160307_00007.jpg

View of the ditch on the landward side of the levee looking downstream. Fall 2015.

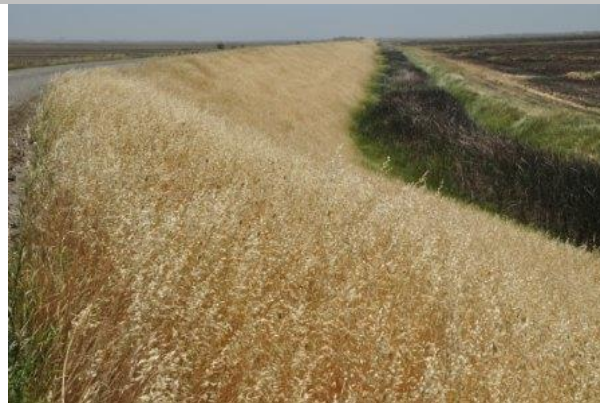
Photo 2 of 2 : SP_2016_RD2035_239_979_20160307_00006.jpg

Drainage ditch at L/S levee toe.

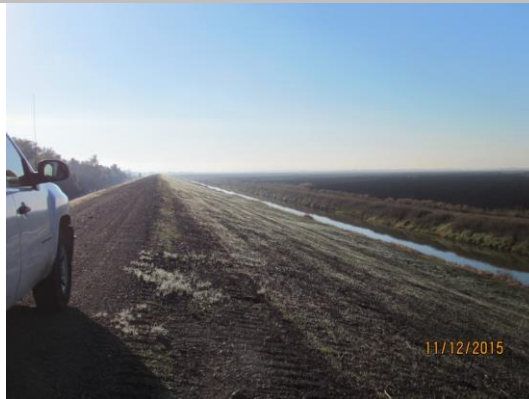
Photo 1 of 2 : SP_2016_RD2035_239_10_20160307_00002.jpg

View of the drainage ditch on the landward side of the levee looking downstream. Fall 2015.

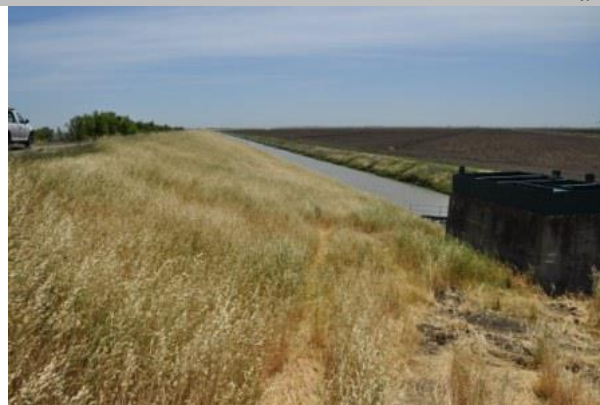
Photo 2 of 2 : SP_2016_RD2035_239_10_20160307_00001.jpg

Drainage ditch at L/S levee toe.

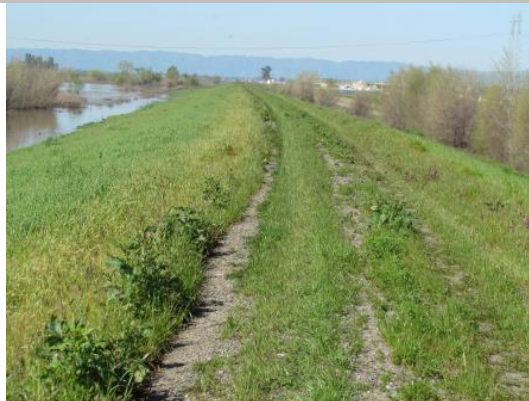
Photo 1 of 1 : SP_2016_RD2035_240_6_20160321_00016.jpg

LM Start	1.63	Rating **	M	Issue No.	6
LM End	2.51	Issue Type +	Ma	Location *	WS
Category	Earthen Levee			GPS Latitude/Longitude	
				Start	End
Item	Vegetation			38.591246 °	38.590805 °
				-121.648896 °	-121.665149 °
DWR ID	DWR_RD2035_03_s_2016_6				
Comment Code					
V1 : Control annual grass and weeds on the levee slopes and easements.					
Inspector Comment

view of vegetation on waterside looking downstream.
