**Flood Control Project Maintenance
Levee Inspections**
LMA District Cover Sheet
Spring 2017 Levee Inspection Results

Reclamation District No. 2035 Conaway

Spring 2017 Levee Inspection Results

Waterway			Bank	Unit Miles
Unit No. 01 Cache Creek Settling Basin			Right	2.01
	Spring (March - May)	Summer (June - August)	(September - November) Fall	Winter (December - February)
Unit Maintenance Rating (Fall Only)				
Date of Inspection	4/18/2017 - 4/18/2017			
DWR Inspector	Sterling York			
Accompanied By	Peter Blum

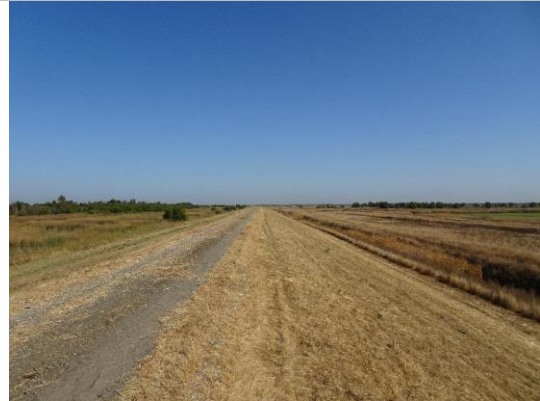
Photo 3 of 3 : UCIP_SP_2017_50078_75935.jpg

Comment Code					
Inspector Comment					
FS_ID:50078 DS_ID:17823 EP_NO: 6123 Repair Type: Urgent Crossing Status: Indicator Found UCIP Comments: 09/14/2016 - No markers present where the pipe crosses levee. pipe vent appears to indicate alignment parallel to the levee at its visible location. However, permit records indicate pipe does cross the levee approximately 75 feet south from the visible well. (T. Hatch/UCIP)04/03/2013 - Need to install gasoline markers through the levee if pipe is still active. (W. Wylie/UCIP) FIELD_STRUCT_DESC: 6-inch soil-proofed steel high pressure gas line through the levee, 2.5 feet below the crown. There is a pipe at vent visible off landside (LS) toe. (Permit No. 6123, 1968 - P.G.&E.) FS Date: 9/14/2016

View along the levee crown looking approximately north. The WS of the levee is on the left. The LS is on the right.
