**Flood Control Project Maintenance
Levee Inspections**
LMA District Cover Sheet
Spring 2018 Levee Inspection Results

Reclamation District No. 2035 Conaway

Spring 2018 Levee Inspection Results

Waterway			Bank	Unit Miles
Unit No. 01 Cache Creek Settling Basin			Right	2.01
	Spring (March - May)	Summer (June - August)	(September - November) Fall	Winter (December - February)
Unit Maintenance Rating (Fall Only)				
Date of Inspection	4/19/2018 - 4/19/2018			
DWR Inspector	Sterling York			
Accompanied By	Peter Blum

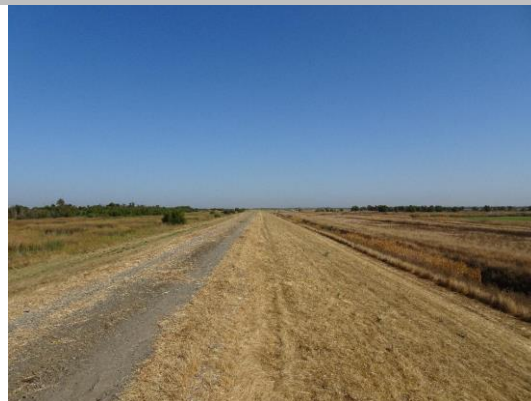
Photo 3 of 3 : UCIP_SP_2018_50078_75935.jpg

FS_ID:50078
DS_ID:17823
EP_NO: 6123
Repair Type: Urgent
Crossing Status: Indicator Found
UCIP Comments: 09/14/2016 - No markers present where the pipe crosses levee. pipe vent appears to indicate alignment parallel to the levee at its visible location. However, permit records indicate pipe does cross the levee approximately 75 feet south from the visible well. (T. Hatch/UCIP)04/03/2013 - Need to install gasline markers through the levee if pipe is still active. (W. Wylie/UCIP)
FIELD_STRUCT_DESC: 6-inch soil-proofed steel high-pressure gas line through the levee, 2.5 feet below the crown. There is a pipe at vent visible off the landside (LS) toe. (Permit No. 6123, 1968 - Pacific Gas and Electric Company [PG&E]). [Additional Reference(s): DWR Levee Log, 1990].
FS Date: 9/14/2016

View along the levee crown looking approximately north. The WS of the levee is on the left. The LS is on the right.
