**Flood Control Project Maintenance
Levee Inspections**
LMA District Cover Sheet
Spring 2020 Levee Inspection Results

Reclamation District No. 2035 Conaway

Spring 2020 Levee Inspection Results

Waterway			Bank	Unit Miles
Unit No. 01 Cache Creek Settling Basin			Right	2.01
	Spring (March - May)	Summer (June - August)	(September - November) Fall	Winter (December - February)
Unit Maintenance Rating (Fall Only)				
Date of Inspection	4/1/2020 - 4/1/2020			
DWR Inspector	Zach Jojola			
Accompanied By

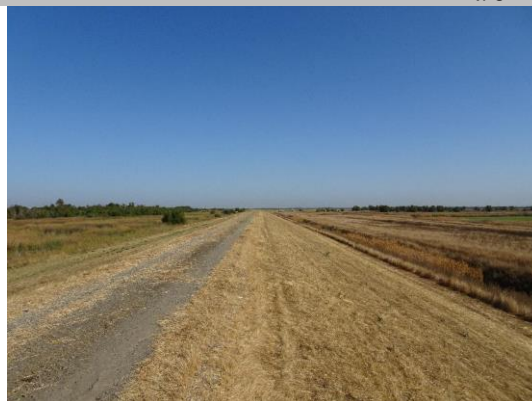
Photo 3 of 3 : UCIP_SP_2020_53430_75935.jpg

LM Start	0.81	Rating **	M	Issue No.	974 (cont)
LM End	0.81	Issue Type +	En	Location *	
Category	Supplemental		GPS Latitude/Longitude		
			Start	End	
Item	DWR UCIP Field Study		38.581057 °	38.581057 °	
			-121.645142 °	-121.645142 °	
DWR ID	17823

View along the levee crown looking approximately north. The WS of the levee is on the left. The LS is on the right.
