**Flood Control Project Maintenance  
Levee Inspections  
LMA District Cover Sheet**

**Reclamation District No. 2035 Conaway**

**Flood Control Project Maintenance  
Levee Inspections**

**Levee Inspection Report By Mile - Spring 2021**

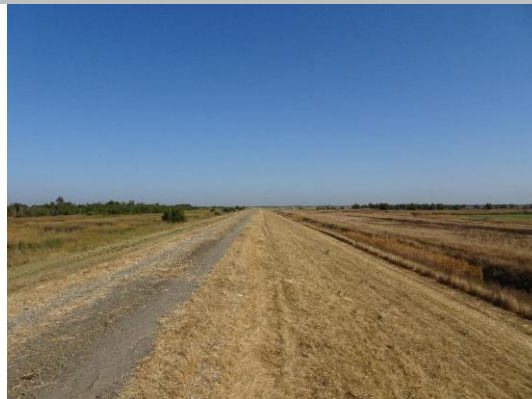
Photo 3 of 3 : UCIP\_SP\_2021\_53430\_75935.jpg

FS\_ID:53430  
DS\_ID:17823  
EP\_NO: 6123  
Repair Type: Non-Urgent  
Crossing Status: Indicator Found  
UCIP Comments: 10/30/2018 Crossing has been downgraded from Urgent to Non-Urgent due to the reclassification of the gas lines. UCIP will need to coordinate with PG&E to determine pipe alignment and pipe status. (O. Magana - DWR UCIP)09/14/2016 - No markers present where the pipe crosses levee. pipe vent appears to indicate alignment parallel to the levee at its visible location. However, permit records indicate pipe does cross the levee approximately 75 feet south from the visible well. (T. Hatch/UCIP)04/03/2013 - Need to install gas line markers through the levee if pipe is still active. (W. Wylie/UCIP) FIELD\_STRUCT\_DESC: 6-inch soil-proofed steel high-pressure gas line through the levee, 2.5 feet below the crown. There is a pipe at vent visible off the landside (LS) toe. (6-inch line authorized under Permit No. 6123, 1968 - Pacific Gas and Electric Company [PG&E]). [Additional Reference(s): DWR Levee Log, 1990].

LM Start	<b>0.81</b>	Rating **	M	Issue No.	<b>1 (cont)</b>
LM End	<b>0.81</b>	Issue Type +	En	Location *	
Category	Supplemental		GPS Latitude/Longitude		
			Start	End	
Item	DWR UCIP Field Study		38.581057 °	38.581057 °	
			-121.645142 °	-121.645142 °	
DWR ID	17823

View along the levee crown looking approximately north. The WS of the levee is on the left. The LS is on the right.
