**Flood Control Project Maintenance  
Levee Inspections  
LMA District Cover Sheet  
Spring 2011 Levee Inspection Results**

**Reclamation District No. 2062 Stewart**

**Spring 2011 Levee Inspection Results**

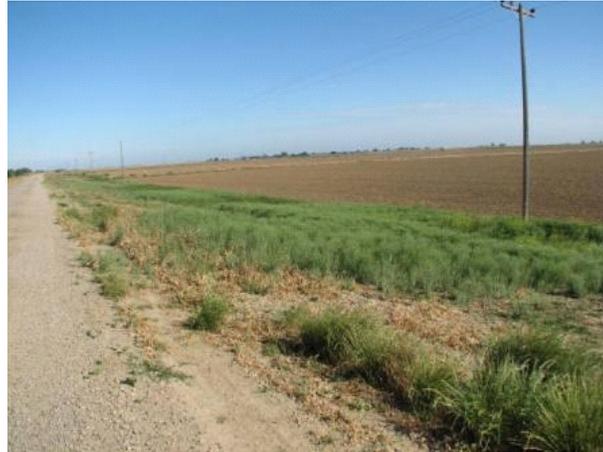
Levee Mile Report Line	5
Start Levee Mile	1.87
End Levee Mile	1.93
Location	Land Side
Category	Earthen Levee
Item	Vegetation
05/11/2011 Vegetation on landside is greater than 12" in height, preventing visibility of the landside slope and toe.	
jeto_s_20110512_473.jpg

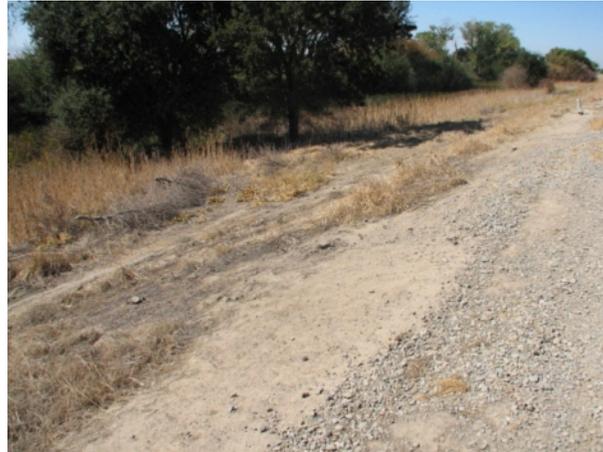
Levee Mile Report Line	8
Start Levee Mile	2.89
End Levee Mile	2.89
Location	Water Side
Category	Earthen Levee
Item	Trim / Thin Trees
Three small stumps on levee slope.	
jeto_s_20110301_167.jpg

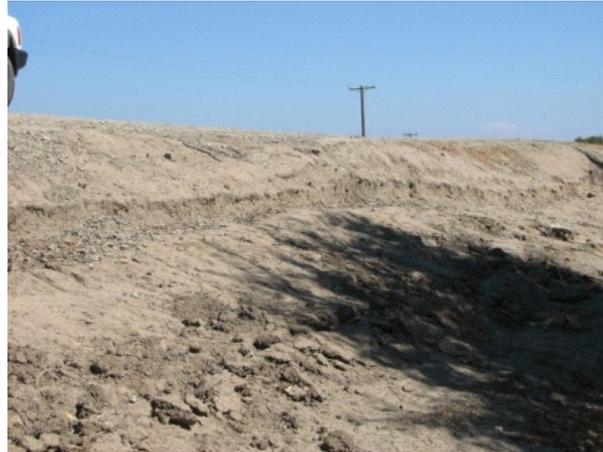
Levee Mile Report Line	13
Start Levee Mile	3.27
End Levee Mile	3.28
Location	Water Side
Category	Supplemental
Item	DWR Erosion Survey
Upstream view of site.	
jeto_s_20110301_161.jpg

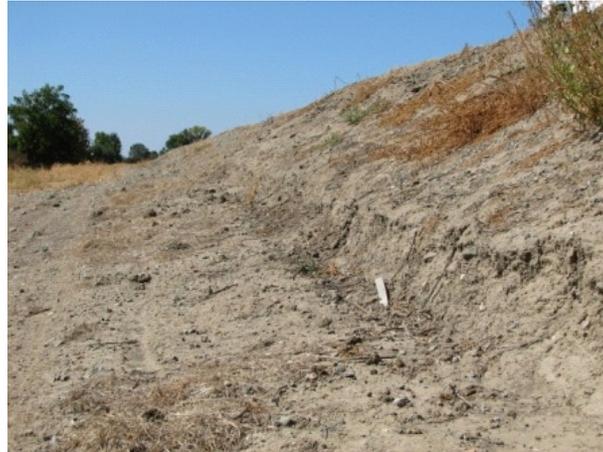
Levee Mile Report Line	15
Start Levee Mile	3.44
End Levee Mile	3.53
Location	Water Side
Category	Supplemental
Item	DWR Erosion Survey
Downstream view of site.	
jeto_s_20110301_164.jpg

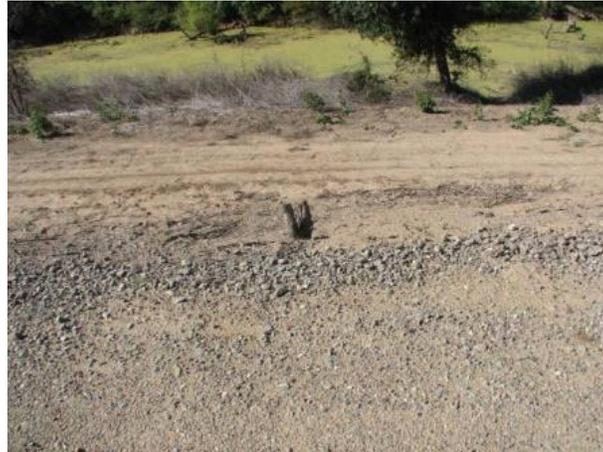
Levee Mile Report Line	16
Start Levee Mile	3.68
End Levee Mile	3.68
Location	Water Side
Category	Earthen Levee
Item	Trim / Thin Trees
05/11/2011 Small stump in waterside slope.	
jeto_s_20110512_474.jpg

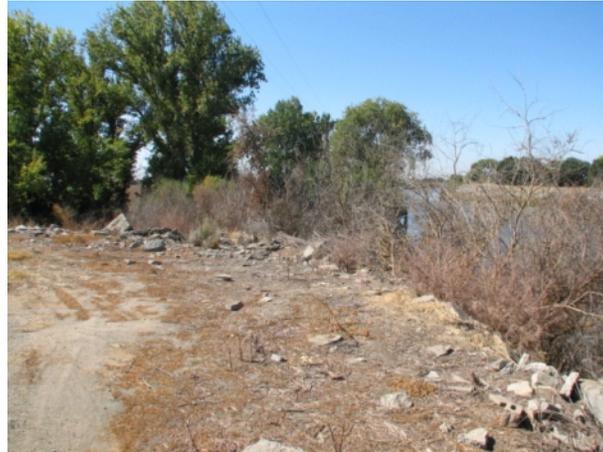
Levee Mile Report Line	1
Start Levee Mile	0.03
End Levee Mile	0.03
Location	Water Side
Category	Earthen Levee
Item	Trim / Thin Trees
<p>Small diameter trees on top 20' of waterside slope obstruct access and visibility. 05/11/2011 issue remains unchanged.</p>	
<p>jeto_s_20110301_178.jpg</p>

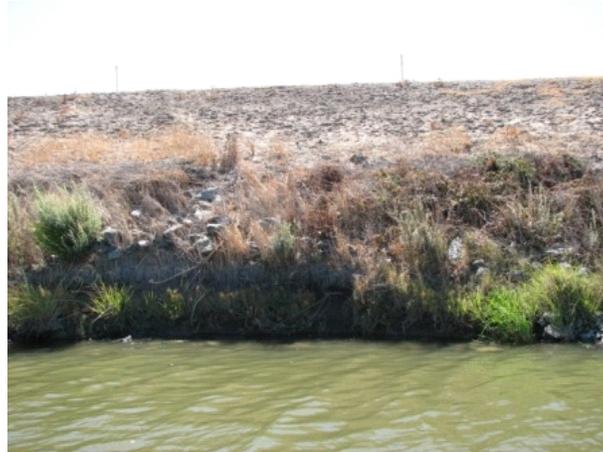
Levee Mile Report Line	3
Start Levee Mile	0.23
End Levee Mile	0.32
Location	Water Side
Category	Supplemental
Item	DWR Erosion Survey
Front view of another 5-ft vertical scarp upstream.	
jeto_s_20110301_176.jpg

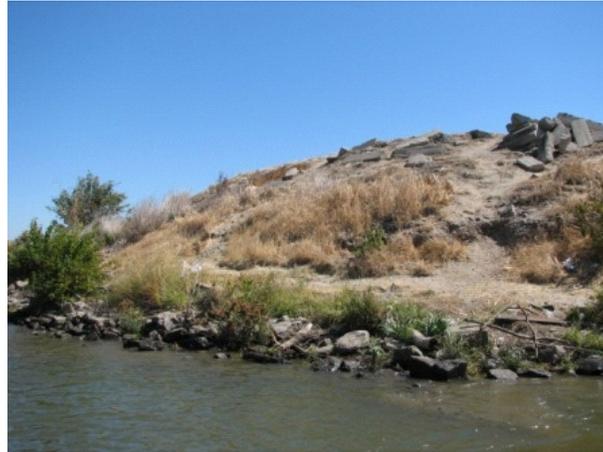
Levee Mile Report Line	6
Start Levee Mile	0.56
End Levee Mile	0.57
Location	Water Side
Category	Supplemental
Item	DWR Erosion Survey
Upstream view of site. Note the series of foot path on the slope.	
jeto_s_20110301_179.jpg

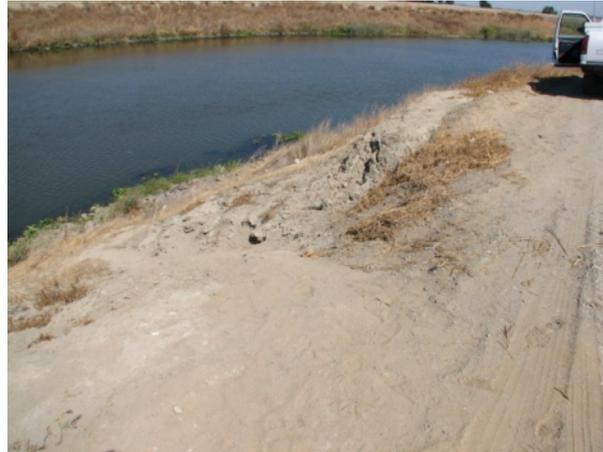
Levee Mile Report Line	10
Start Levee Mile	0.82
End Levee Mile	0.82
Location	Water Side
Category	Earthen Levee
Item	Erosion / Bank Caving
Slope erosion from crown surface runoff and foot traffic.	
jeto_s_20110301_187.jpg

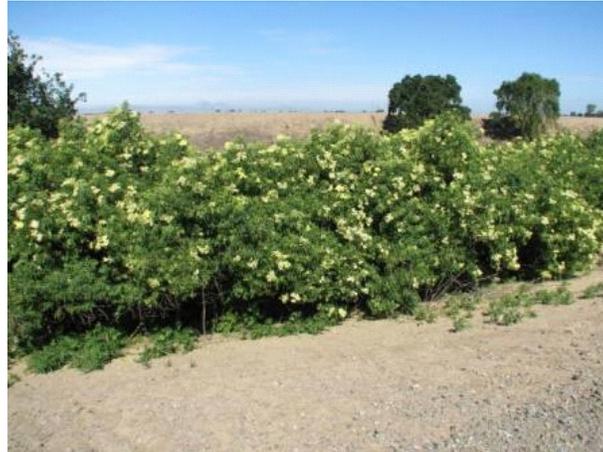
Levee Mile Report Line	15
Start Levee Mile	1.37
End Levee Mile	1.37
Location	Water Side
Category	Earthen Levee
Item	Vegetation
05/11/2011 Elderberry bush on water side slope.	
jeto_s_20110513_478.jpg

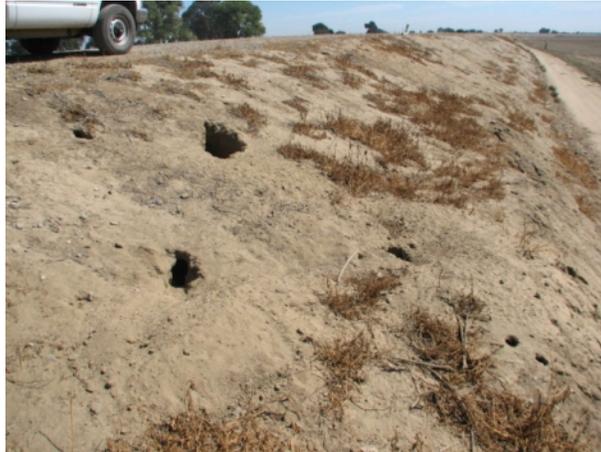
Levee Mile Report Line	33
Start Levee Mile	3.34
End Levee Mile	3.34
Location	Land Side
Category	Earthen Levee
Item	Animal Control
Large animal burrows on landside levee slope.	
jeto_s_20110301_194.jpg
