**Flood Control Project Maintenance  
Levee Inspections****LMA District Cover Sheet****Spring 2012 Levee Inspection Results****Reclamation District No. 2062 Stewart**

**Spring 2012 Levee Inspection Results**

**Reclamation District No. 2062 Stewart**

Waterway				Bank	Unit Miles	Inspection Start/End	Inspector	
Unit No. 01 San Joaquin River				Left	2.69	05/17/2012 05/17/2012	Max Khashchuk

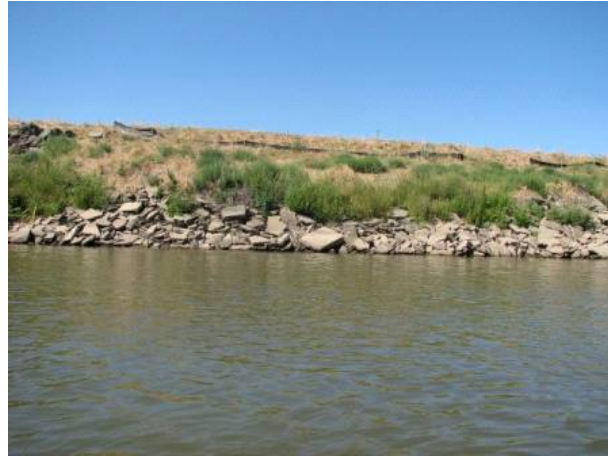
mkhashch\_s\_20120511\_181.jpg

Front view of the rip rap

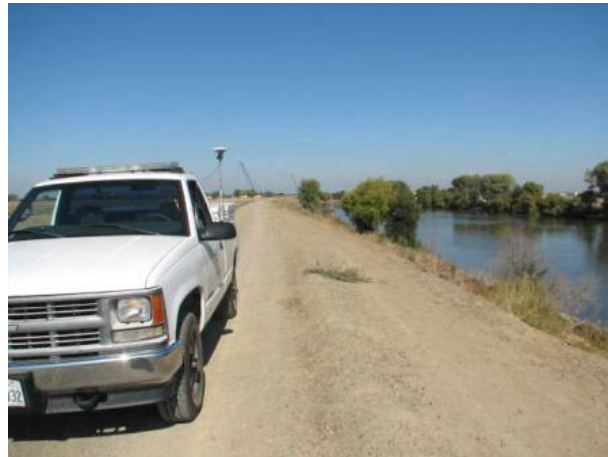
Levee Mile Report Line	9
Start Levee Mile	1.18
End Levee Mile	1.40
Location	Crown
Category	Earthen Levee
Item	Crown Surface / Depressions / Rutting

10/20/2011 Berm is forming on the waterside edge of the crown. Berm is approximately 1' high in places.

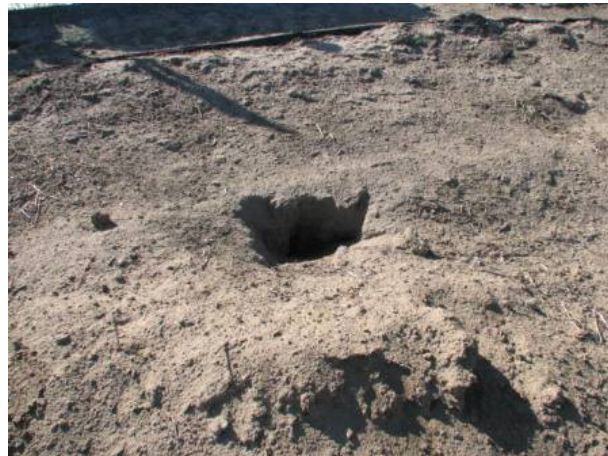
Levee Mile Report Line	11
Start Levee Mile	1.83
End Levee Mile	1.83
Location	Water Side
Category	Earthen Levee
Item	Animal Control

10/20/2011 Large burrow located on waterside slope of levee.

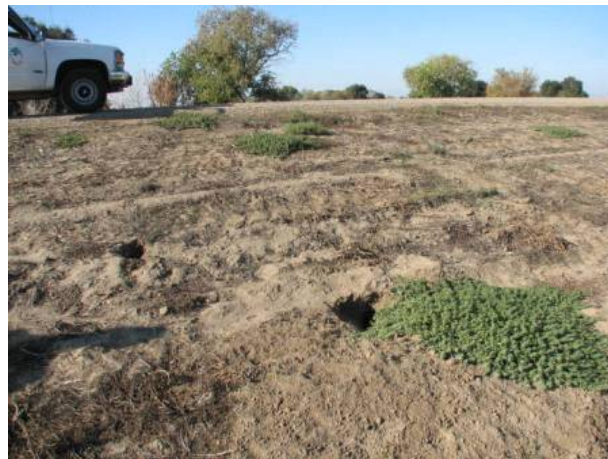
10/20/2011 Active burrow located next to vegetation in photo.

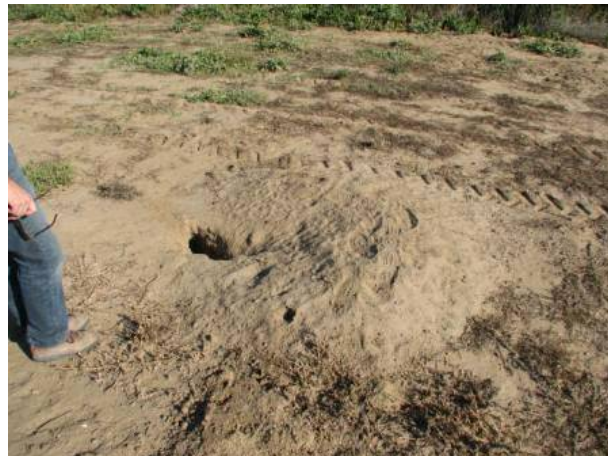
Levee Mile Report Line	7
Start Levee Mile	2.10
End Levee Mile	2.10
Location	Land Side
Category	Earthen Levee
Item	Animal Control

10/20/2011 Photo shows single large burrow, which appears to be active.

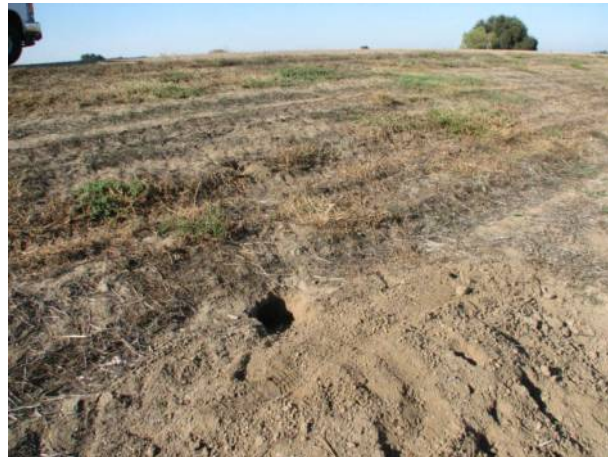
10/20/211 Single large burrow on landside, appears to be active.

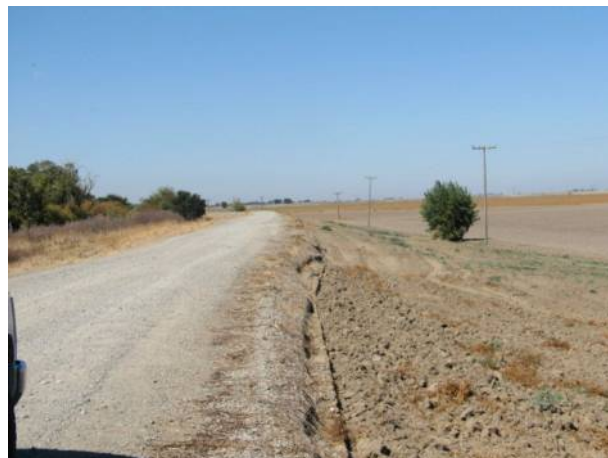
Levee Mile Report Line	10
Start Levee Mile	2.54
End Levee Mile	3.94
Location	Land Side
Category	Earthen Levee
Item	Encroachments

Discing on levee slopes has created a substantial vertical scarp.

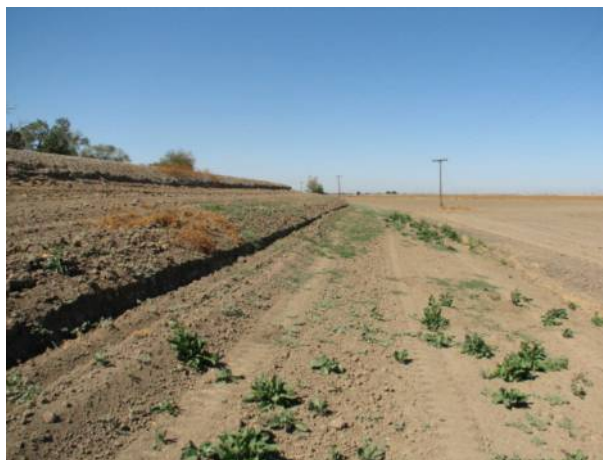
Discing on levee slopes has created two substantial vertical scarps.

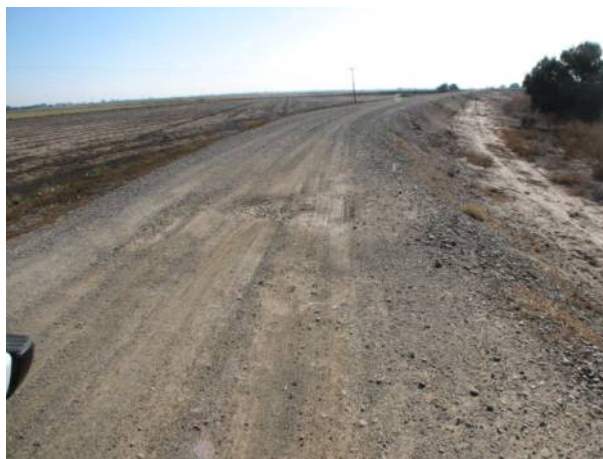
Levee Mile Report Line	11
Start Levee Mile	2.81
End Levee Mile	2.81
Location	Land Side
Category	Earthen Levee
Item	Crown Surface / Depressions / Rutting

10/20/2011 Minor pothole, shows evidence of holding water.

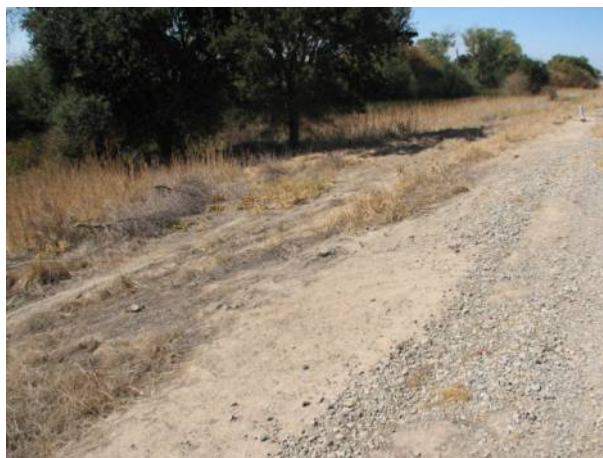
Levee Mile Report Line	12
Start Levee Mile	2.89
End Levee Mile	2.89
Location	Water Side
Category	Earthen Levee
Item	Trim / Thin Trees

Three small stumps on levee slope.

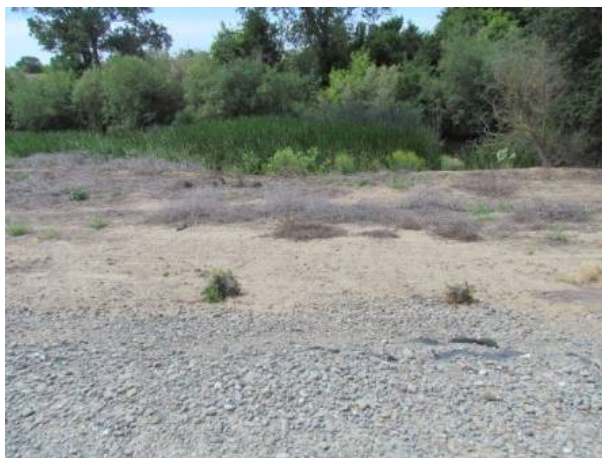
View of tree stumps on waterside slope.  
05/17/2012

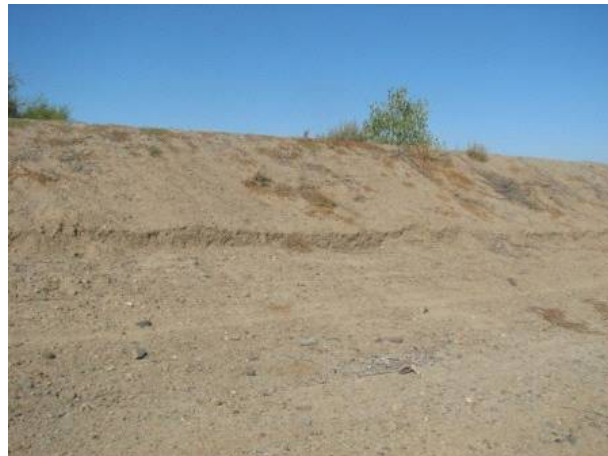
Levee Mile Report Line	20
Start Levee Mile	3.44
End Levee Mile	3.53
Location	Water Side
Category	Supplemental
Item	DWR Erosion Survey

Downstream view of site. Note the vertical scarp at the toe.

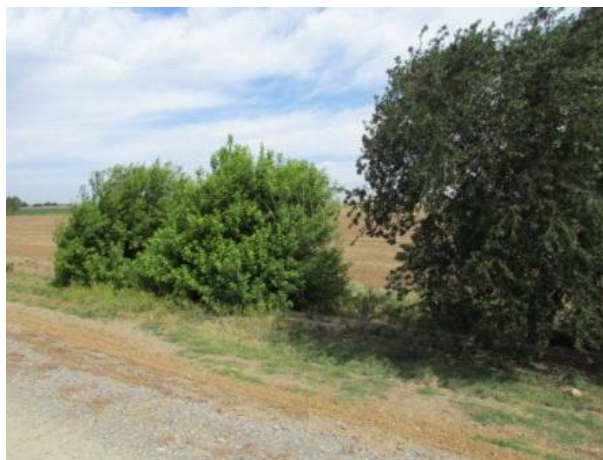
View of bushy trees at levee toe obstructing visibility. 05/17/2012

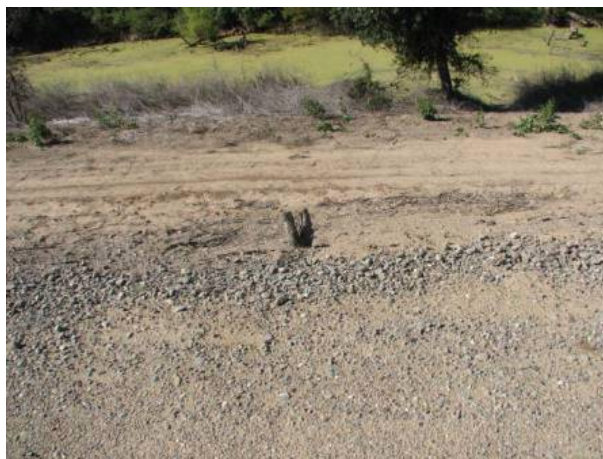
Levee Mile Report Line	22
Start Levee Mile	3.68
End Levee Mile	3.68
Location	Water Side
Category	Earthen Levee
Item	Trim / Thin Trees

05/11/2011 Small stump in waterside slope.

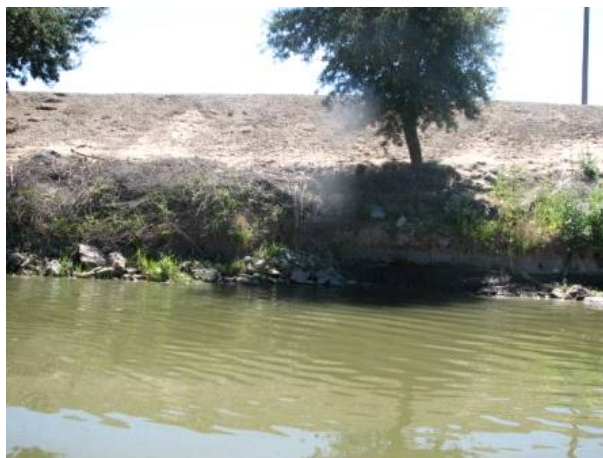
Front view of erosion at the most upstream of the site

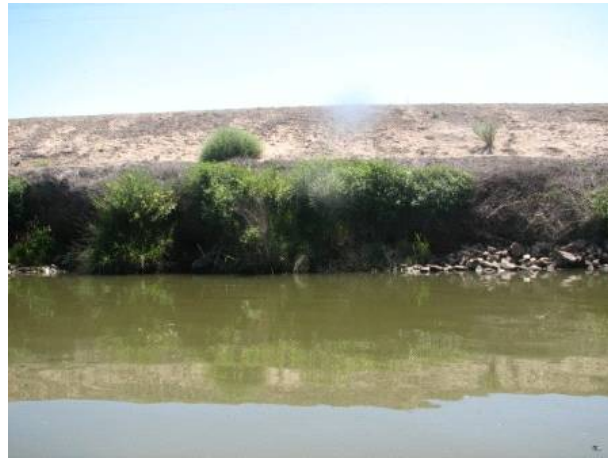
Front view of the erosion. Note the dense vegetation.

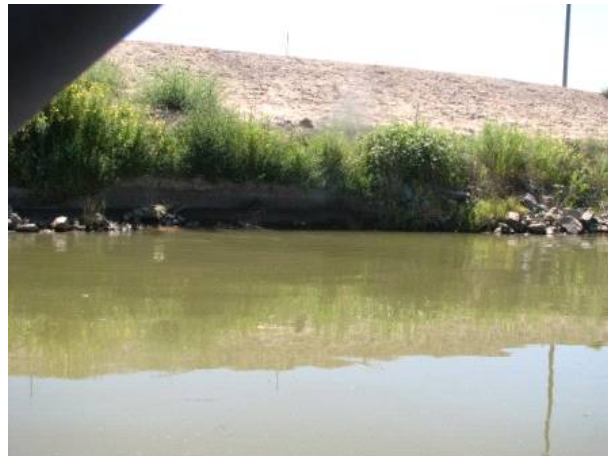
Levee Mile Report Line	4
Start Levee Mile	0.18
End Levee Mile	0.18
Location	Water Side
Category	Supplemental
Item	DWR Erosion Survey

Direct view of the site. The erosion is vertical

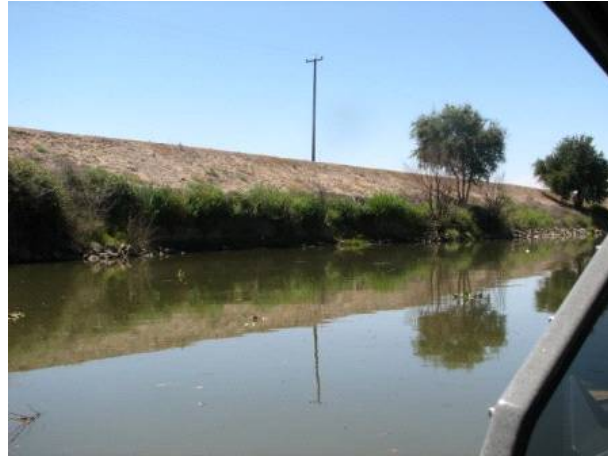
Downstream view of the 5-ft vertical scarp .

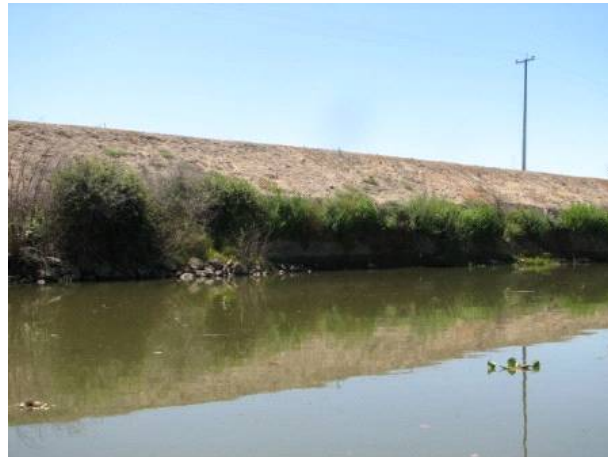
Levee Mile Report Line	5
Start Levee Mile	0.23
End Levee Mile	0.32
Location	Water Side
Category	Supplemental
Item	DWR Erosion Survey

Another view of the same 5-ft scarp.

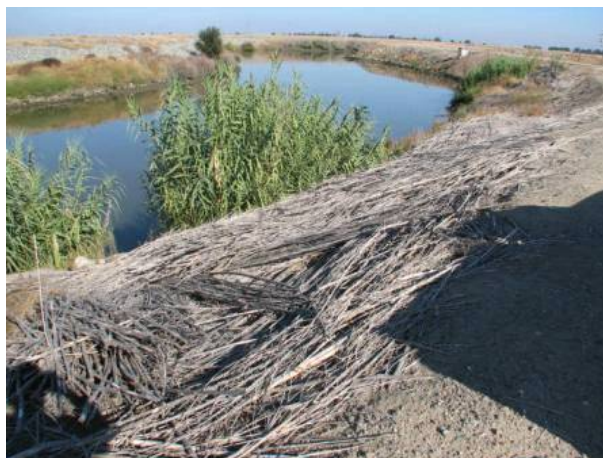
10/20/2011 Bamboo (Arundo) cuttings still present issue is not being addressed.

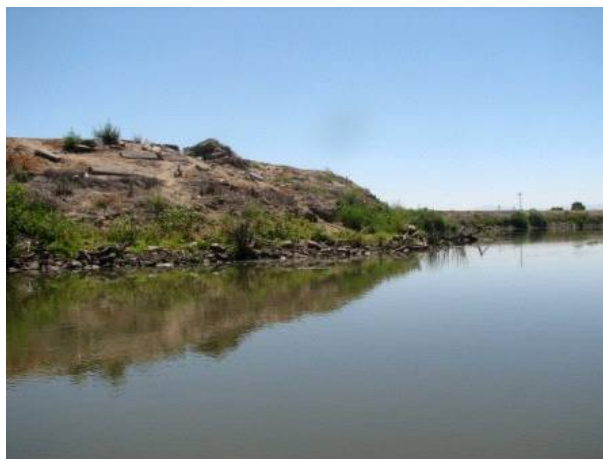
mkhashch\_s\_20120511\_272.jpg

Upstream view of the site.

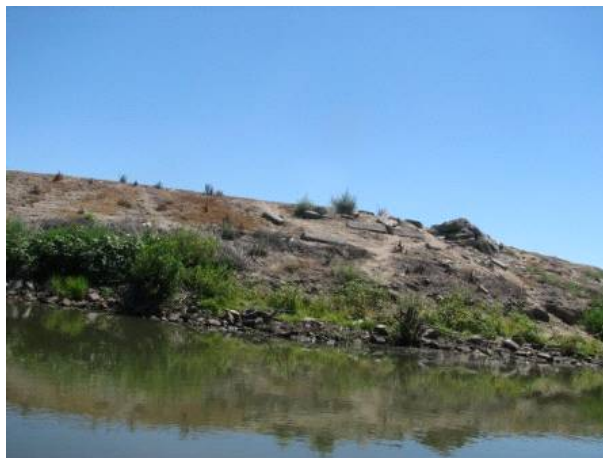
mkhashch\_s\_20120511\_273.jpg

Levee Mile Report Line	9
Start Levee Mile	0.56
End Levee Mile	0.57
Location	Water Side
Category	Supplemental
Item	DWR Erosion Survey

Front view of the site. Previously placed rip rap slipped, exposing the underlying soils and creating a pocket.

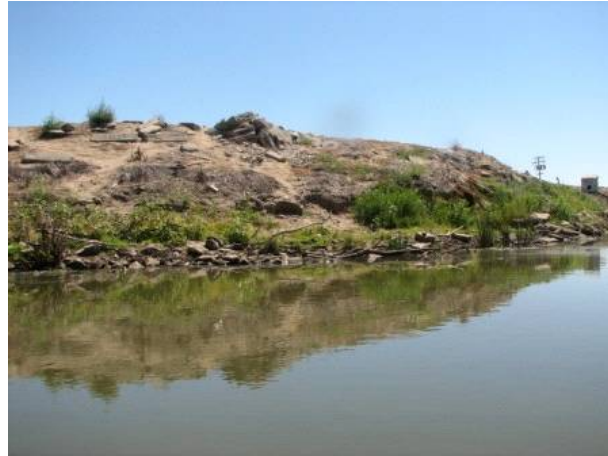
mkhashch\_s\_20120511\_274.jpg

Front view of the site. Rip rap no longer adequately protecting levee slope.

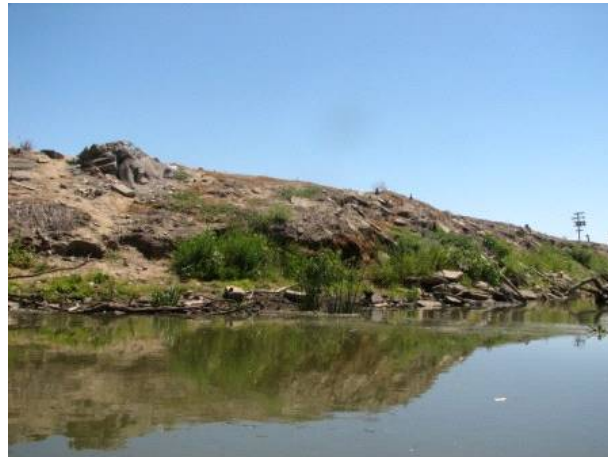
mkhashch\_s\_20120511\_275.jpg

Levee Mile Report Line	9
Start Levee Mile	0.56
End Levee Mile	0.57
Location	Water Side
Category	Supplemental
Item	DWR Erosion Survey

Downstream view of the site.

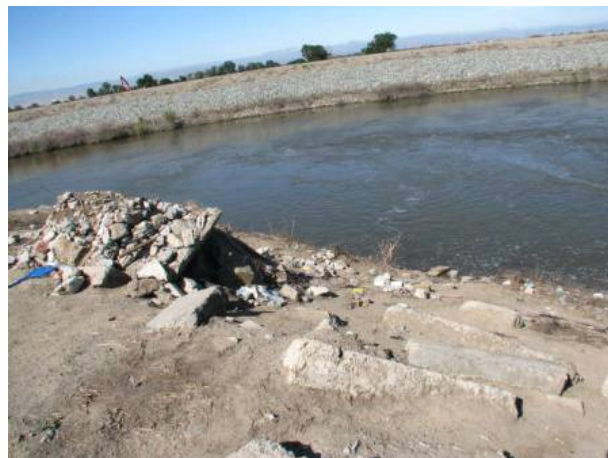
mkhashch\_s\_20120511\_263.jpg

Levee Mile Report Line	10
Start Levee Mile	0.56
End Levee Mile	0.56
Location	Water Side
Category	Earthen Levee
Item	Encroachments

05/11/2011 Trash mixed in with concrete debris pile, needs to be removed.

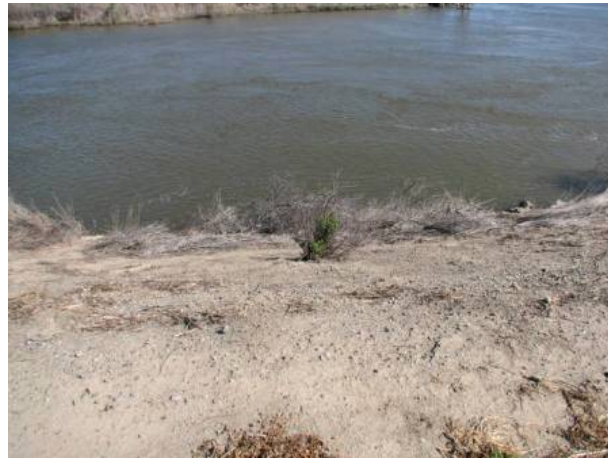
mkhashch\_s\_20120511\_264.jpg

05/11/2011 Stump in slope, new growth in center of photo is at the location of the stump.

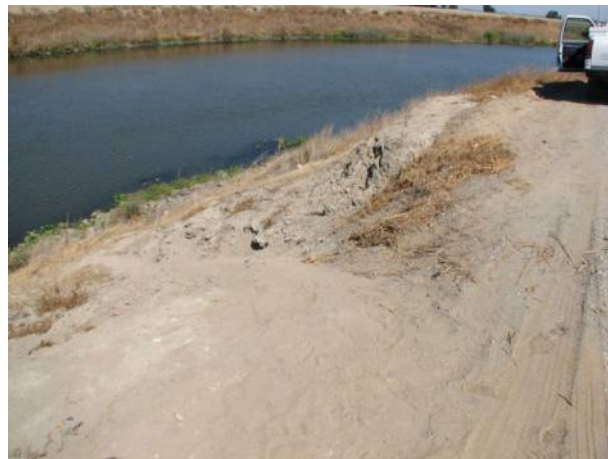
mkhashch\_s\_20120511\_265.jpg

Levee Mile Report Line	13
Start Levee Mile	0.82
End Levee Mile	0.82
Location	Water Side
Category	Earthen Levee
Item	Erosion / Bank Caving

Slope erosion from crown surface runoff and foot traffic.

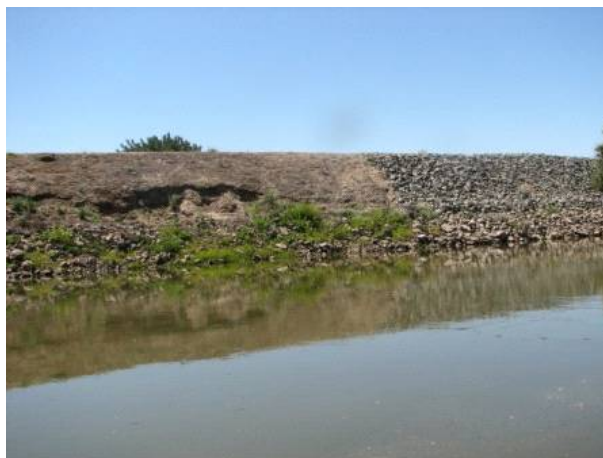
mkhashch\_s\_20120511\_276.jpg

Front view of the site. Existing scalloped erosion is immediately downstream of rip rap section.

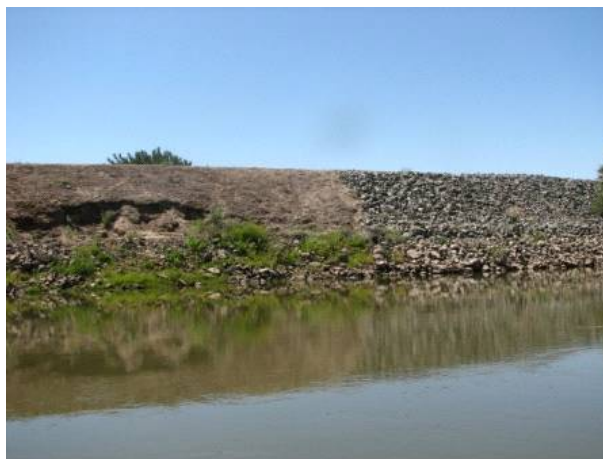
mkhashch\_s\_20120511\_277.jpg

Levee Mile Report Line	14
Start Levee Mile	1.20
End Levee Mile	1.21
Location	Water Side
Category	Supplemental
Item	DWR Erosion Survey

Upstream view of the site

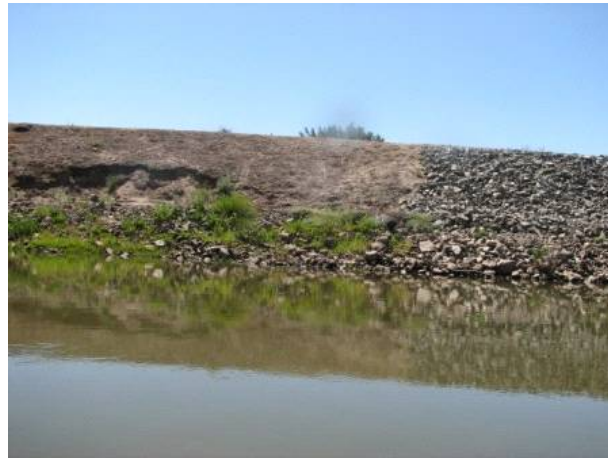
mkhashch\_s\_20120511\_279.jpg

Front view of the site just above existing rip rap.

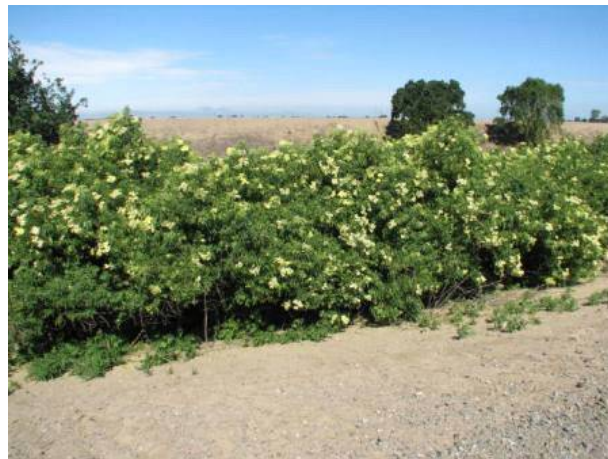
mkhashch\_s\_20120511\_267.jpg

Levee Mile Report Line	16
Start Levee Mile	1.37
End Levee Mile	1.37
Location	Water Side
Category	Earthen Levee
Item	Vegetation

05/11/2011 Elderberry bush on water side slope.

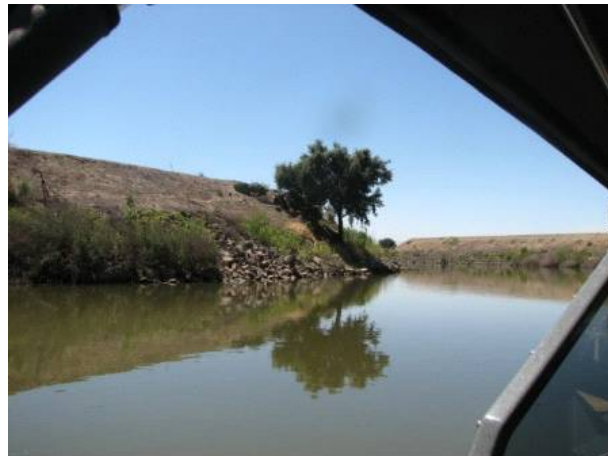
mkhashch\_s\_20120511\_280.jpg

Levee Mile Report Line	17
Start Levee Mile	1.42
End Levee Mile	1.43
Location	Water Side
Category	Supplemental
Item	DWR Erosion Survey

Upstream view of the site where a small to medium sized Oak tree is located.

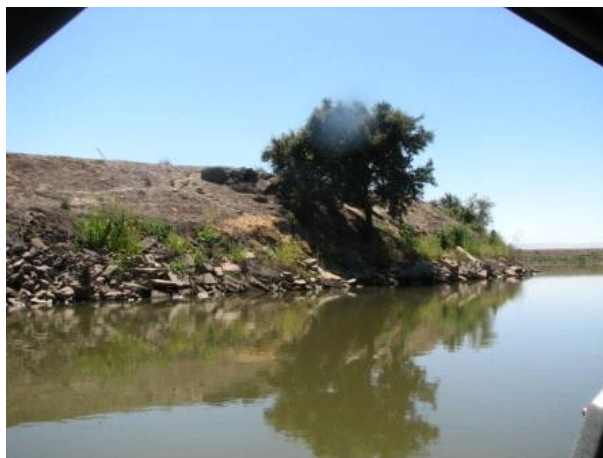
mkhashch\_s\_20120511\_281.jpg

A closer look of the site

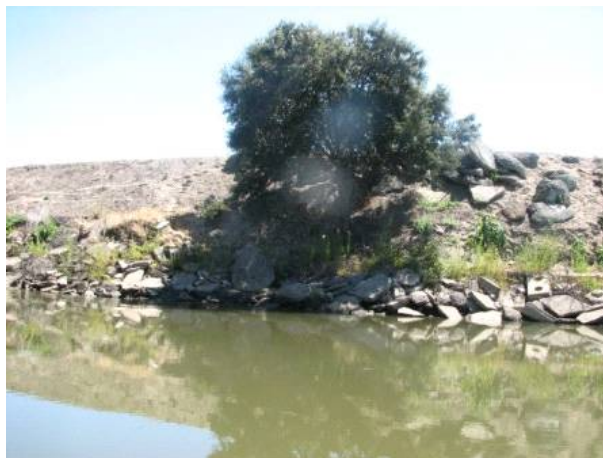
mkhashch\_s\_20120511\_283.jpg

Downstream view of the site.

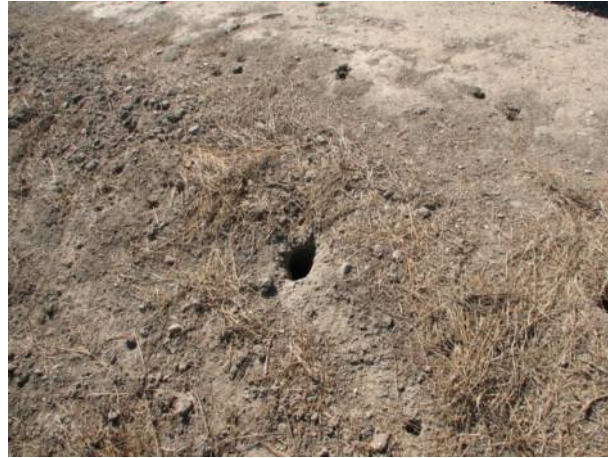
mkhashch\_s\_20120511\_285.jpg

Animal burrows on levee slope.
