**Flood Control Project Maintenance
Levee Inspections****LMA District Cover Sheet****Spring 2014 Levee Inspection Results****Reclamation District No. 2062 Stewart**

Spring 2014 Levee Inspection Results

Reclamation District No. 2062 Stewart

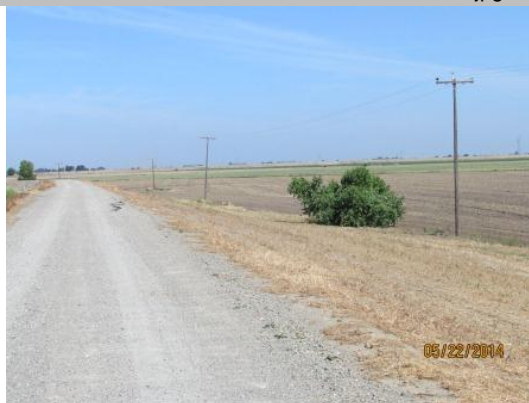
Photo 1 of 1 : mkhashch_s_20140527_01048.jpg

LM Start	2.63	Rating **	A	Issue No.	5
LM End	2.63	Issue Type +	Ma	Location *	LS
Category	Earthen Levee			GPS Latitude/Longitude	
				Start	End
Item	Vegetation			37.801935 °	37.801935 °
				-121.368416 °	-121.368416 °
DWR ID	DWR_RD2062_02_s _ 2014_5				
Action/Comments					
Control annual grass and weeds on the levee slopes and easements.

View of acceptable vegetation control on the landside levee slope.

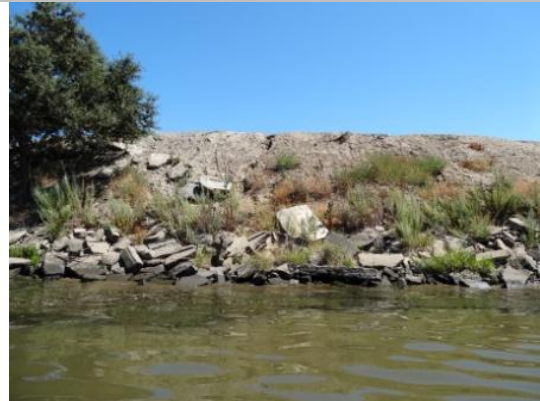
Photo 1 of 1 : mkhashch_s_20140428_00668.jpg

LM Start	1.42	Rating **	U	Issue No.	20
LM End	1.43	Issue Type +	Ma	Location *	WS
Category	Supplemental			GPS Latitude/Longitude	
				Start	End
Item	DWR Erosion Survey			37.821380 °	37.821380 °
				-121.376900 °	-121.376900 °
DWR ID	DWR_RD2062_03_s _ 2014_20				
Action/Comments					
Inspector Comments: 08/13/2013: No significant change observed. 08/07/2012: The site has been visited by boat survey. No significant change observed 08/23/2011: No significant changes observed on site. 09/07/2010: No significant changes observed on site. There is a small-to medium sized Oak tree on the mid-slope just above rip rap. Some of the rip rap has collapsed, creating a pocket erosion just above the existing toe rip rap and upstream of the Oak tree. 08/06/2010: Recommended as local maintenance issue, per CLRO. 03/09/2010: As discussed with Michael Moncrief of MBK Engineer, site will be 'addressed' in 2010. 09/29/2009: No major change since last visit; sliding of the rip rap at the base of the lone tree; there is noticeable man-made trail and foot traffic extending from the crown to the toe; much of the broken concrete used as temporary rip rap has slid, exposing portion of the bare levee slope; recommended as local maintenance issue, per CLRO CES Evaluation 2008 Report; Site # is the same as RM31.3, LM1.45; previously rated "M". 11/05/2008: Portion of rip rap collapsing. 09/14/2006: Portion of rip rap along the slope has collapsed; exposed levee section is starting to erode, exposing roots from the nearby tree. [2013 Site ID:RD2062U03RM31.28]

Front view of the site.

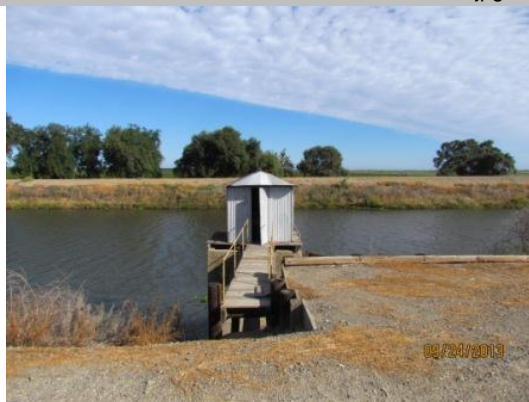
Photo 1 of 1 : mkhashch_s_20140428_00667.jpg

LM Start	2.15	Rating **	A/W	Issue No.	19
LM End	2.15	Issue Type +	Ma	Location *	WS
Category	Earthen Levee			GPS Latitude/Longitude	
				Start	End
Item	Encroachments			37.818645 °	37.818645 °
				-121.364894 °	-121.364894 °
DWR ID	DWR_RD2062_03_s _ 2012_19				
Action/Comments					
Pipe					
Inspector Comments: Irrigation intake.

View of the pump house on the waterside levee slope.

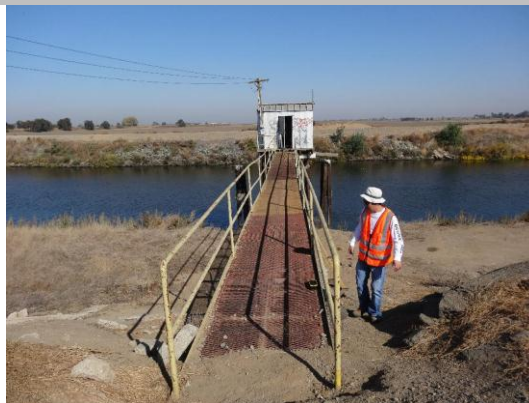
Photo 1 of 1 : UCIP_3354.jpg

LM Start	5.45	Rating **	M	Issue No.	30
LM End	5.45	Issue Type +	En	Location *	LS
Category	Supplemental			GPS Latitude/Longitude	
				Start	End
Item	DWR UCIP Field Study			37.807305 °	37.807305 °
				-121.331290 °	-121.331290 °
DWR ID	DWR_RD2062_03_s _ 2014_30				
Action/Comments					
Inspector Comments: FS_ID:23142					
EP_NO: N/A					
Repair Type:					
Crossing Status:					
UCIP Comments: - siphon breakers not protected flow meter and gage station on waterside pump house on wooden pile structure.					
Walkway to the pumphouse.					
FIELD_STRUCT_DESC: 1 of 2: Two 16-inch pipes through the levee 4.0 feet below the crown. Pump in the pump house on pile structure in the stream. Siphon breakers on the landward slope. Concrete distribution box on landside berm.					
FS Date: 10/22/2013

WS view: steel walkway to pump house in the stream.
