**Flood Control Project Maintenance  
Levee Inspections**  
**LMA District Cover Sheet**  
**Spring 2016 Levee Inspection Results**

**Reclamation District No. 2062 Stewart**

**Spring 2016 Levee Inspection Results**

Waterway	Bank	Unit Miles
Unit No. 01 San Joaquin River	Left	2.64

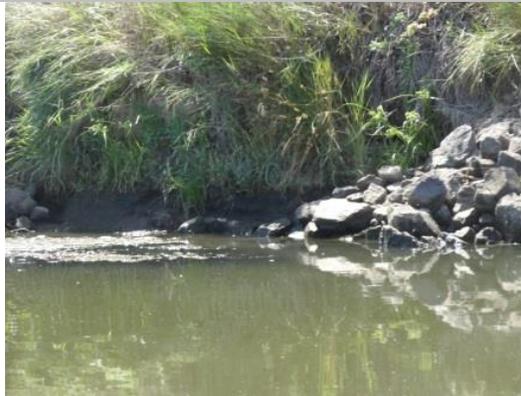
Photo 2 of 3 : SP\_2016\_RD2062\_311\_8\_20160229\_00014.jpg

LM Start	<b>0.00</b>	Rating **	U	Issue No.	<b>8 (cont)</b>
LM End	<b>0.09</b>	Issue Type +	Ma	Location *	WS

Close view of the erosion.

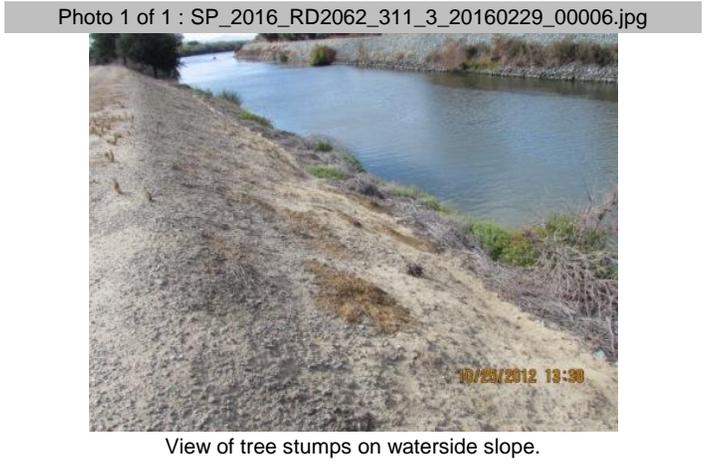
LM Start	<b>0.08</b>	Rating **	N	Issue No.	<b>3</b>
LM End	<b>0.08</b>	Issue Type +	Ma	Location *	WS
Category	Earthen Levee		GPS Latitude/Longitude		
			Start	End	
Item	Trim / Thin Trees		37.809727°	37.809727°	
			-121.389100°	-121.389100°	
DWR ID	DWR_RD2062_03_f_2012_3				
Comment Code					
T5 : Tree stumps.					
Inspector Comment

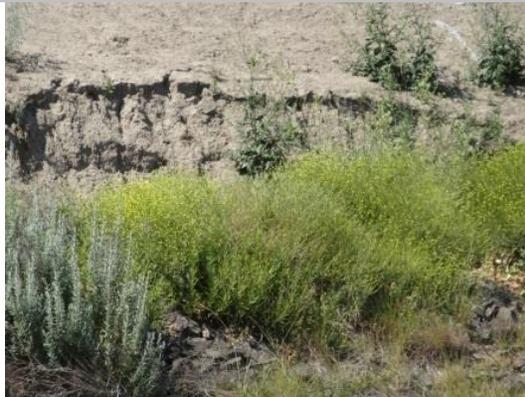
Photo 1 of 2 : SP\_2016\_RD2062\_311\_4\_20160229\_00007.jpg

LM Start	<b>1.18</b>	Rating **	U	Issue No.	<b>4 (cont)</b>
LM End	<b>1.19</b>	Issue Type +	Ma	Location *	WS

Close view of the site.
