**Flood Control Project Maintenance
Levee Inspections**
LMA District Cover Sheet
Spring 2017 Levee Inspection Results

Reclamation District No. 2062 Stewart

Spring 2017 Levee Inspection Results

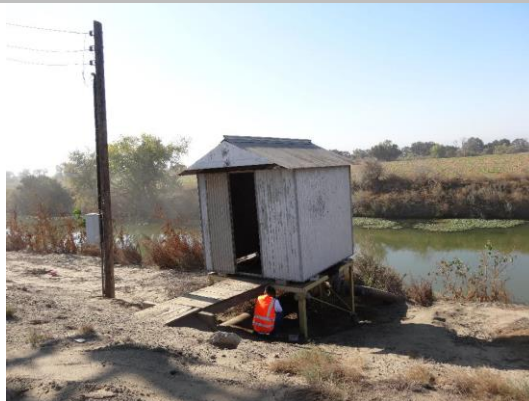
Photo 1 of 3 : UCIP_SP_2017_23181_39792.jpg

LM Start	0.75	Rating **	M	Issue No.	13 (cont)
LM End	0.75	Issue Type +	En	Location *	WS

WS view: pipe, walkway, service pole, and pumphouse on levee slope.

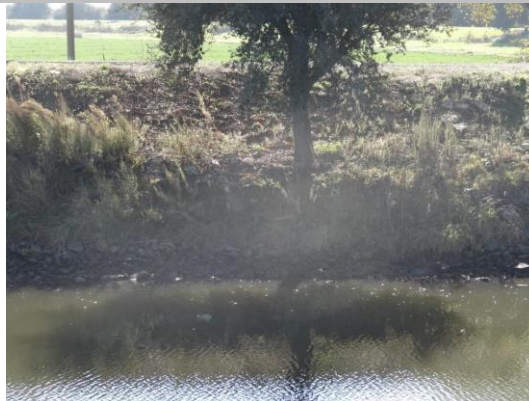
Photo 1 of 2 : SP_2017_RD2062_311_2_20170313_00003.jpg

LM Start	0.02	Rating **	M	Issue No.	2 (cont)
LM End	0.03	Issue Type +	Ma	Location *	WS

Front view of the erosion site. Note the large tree above the erosion.

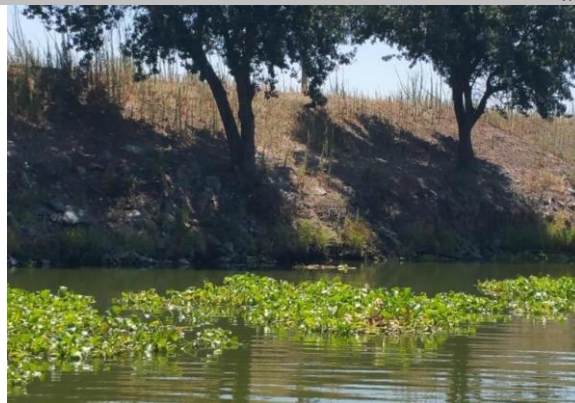
Photo 1 of 2 : SP_2017_RD2062_311_4_20170313_00005.jpg

LM Start	0.10	Rating **	U	Issue No.	4 (cont)
LM End	0.11	Issue Type +	Ma	Location *	WS

Front view of the site.

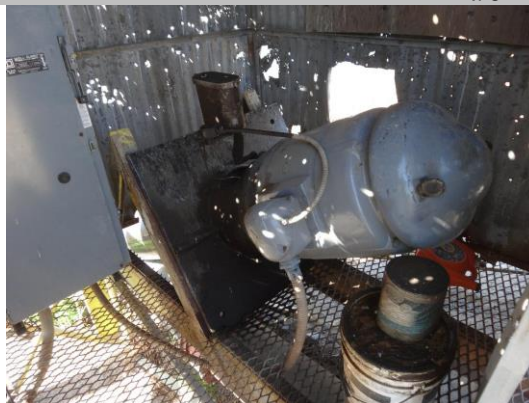
Photo 3 of 3 : UCIP_SP_2017_50455_40156.jpg

Comment Code					
Inspector Comment					
FS_ID:50455 DS_ID:19200 EP_NO: 2029 Repair Type: Urgent Crossing Status: Found UCIP Comments: 08/31/2016: Sloughing of LS slope beneath exposed section of pipe. Overflow pipe has been replaced on WS, though I could not locate a permit for that work. (K. Fazel - UCIP)10/22/2013:- pits and holes on overflow pipe on waterside.- underpinning at pump support.- slope erosion on both sides of the levee.- 2-inch electric conduit on waterside and power pole on landside. (P. Amatya - DWR) FIELD_STRUCT_DESC: 16-inch steel irrigation pipe through the levee, 8 feet below the crown. Siphon breaker on the landside (LS) slope. Pump house on the waterside (WS) slope. Distribution box on the LS. 2-inch electric conduit on the WS and power pole on the LS. Newly installed (as of 2016) overflow pipe with shutoff valve on WS. (Permit No. 2029, 1954 - Island RD2062) [Additional Reference(s): DWR Levee Log, 2007]. FS Date: 8/31/2016

WS view: slant pump in pumphouse on levee slope.

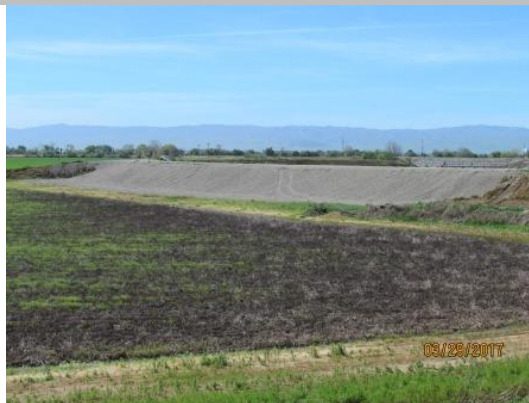
Photo 1 of 1 : SP_2017_RD2062_311_19_20170405_00049.jpg

LM Start	0.69	Rating **	A	Issue No.	19
LM End	0.76	Issue Type +	Ob	Location *	LS
Category	Earthen Levee			GPS Latitude/Longitude	
				Start	End
Item	Seepage / Sandboils			37.814487 °	37.815509 °
				-121.381418 °	-121.381546 °
DWR ID	DWR_RD2062_03_s_2017_19				
Comment Code					
Inspector Comment					
LMA installed seepage blanket in February 2017.

View of the seepage blanket on the levee slope and toe.

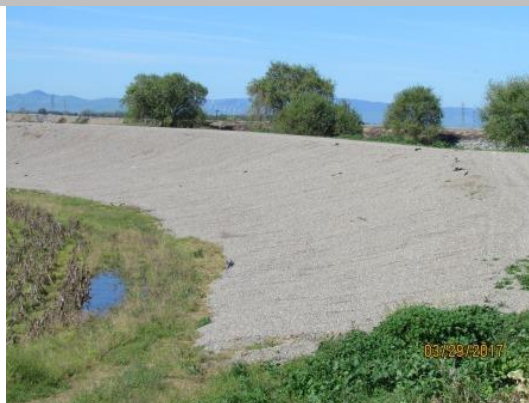
Photo 1 of 1 : SP_2017_RD2062_311_16_20170405_00048.jpg

LM Start	1.00	Rating **	A	Issue No.	16
LM End	1.46	Issue Type +	Ob	Location *	LS
Category	Earthen Levee			GPS Latitude/Longitude	
				Start	End
Item	Seepage / Sandboils			37.817243 °	37.821667 °
				-121.378636 °	-121.375671 °
DWR ID	DWR_RD2062_03_s_2017_16				
Comment Code					
Inspector Comment					
LMA installed seepage blanket in February 2017.

View of the seepage blanket on levee slope and toe.

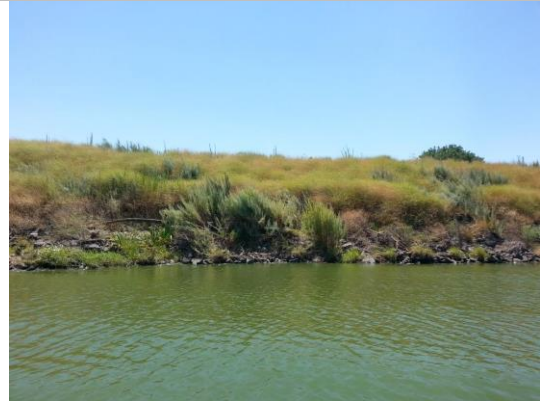
Photo 1 of 1 : SP_2017_RD2062_311_17_20170313_00016.jpg

09/28/2009: No major change observed; section of rip rap has slipped, creating a terraced effect; dense vegetation growth; recommended as a local maintenance issue, per CLRO CES Evaluation 2008 Report; Site # is the same as RM31.12,LM1.25; previously rated "U".					
09/14/2006: 1-2' into prism. [2016 Site ID:RD2062U03RM31.12]

Front view of the site.

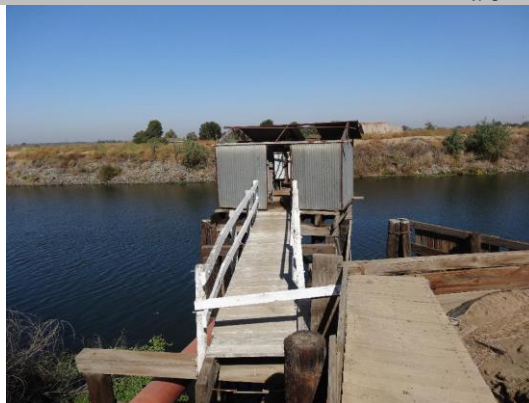
Photo 1 of 3 : UCIP_SP_2017_23311_40175.jpg

LM Start	2.77	Rating **	M	Issue No.	45 (cont)
LM End	2.77	Issue Type +	En	Location *	LS

WS view: wooden walkway to pumphouse, pumphouse on wooden pile structure in the stream.

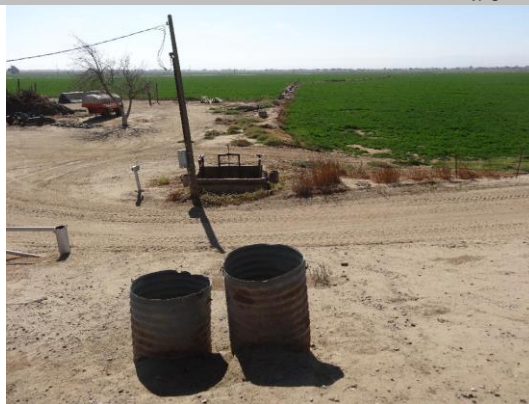
Photo 3 of 3 : UCIP_SP_2017_23312_40180.jpg

LS view: two CMP risers on levee slope, concrete distribution box, and service pole across the dirt road, off the levee toe.

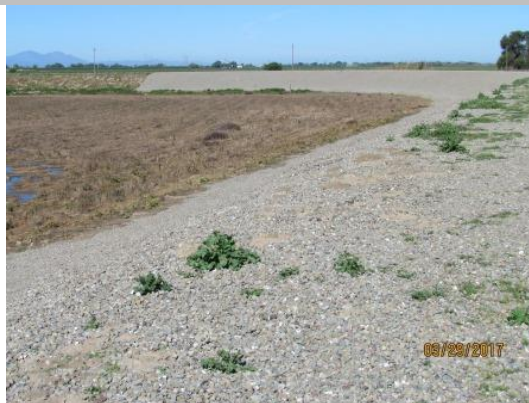
Photo 1 of 1 : SP_2017_RD2062_311_15_20170405_00046.jpg

LM Start	3.21	Rating **	A	Issue No.	15
LM End	3.36	Issue Type +	Ob	Location *	LS
Category	Earthen Levee			GPS Latitude/Longitude	
				Start	End
Item	Seepage / Sandboils			37.819923 °	37.819433 °
				-121.348350 °	-121.346213 °
DWR ID	DWR_RD2062_03_s_2017_15				
Comment Code					
Inspector Comment					
LMA installed seepage blanket in February 2017.

View of the seepage blanket on the levee slope and toe.

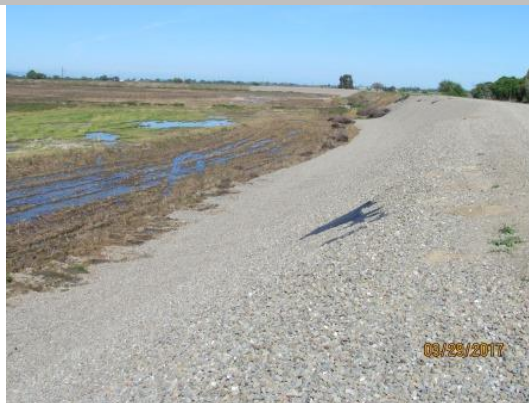
Photo 1 of 1 : SP_2017_RD2062_311_14_20170405_00044.jpg

LM Start	3.52	Rating **	A	Issue No.	14
LM End	3.61	Issue Type +	Ob	Location *	LS
Category	Earthen Levee			GPS Latitude/Longitude	
				Start	End
Item	Seepage / Sandboils			37.817956 °	37.816948 °
				-121.344041 °	-121.342931 °
DWR ID	DWR_RD2062_03_s_2017_14				
Comment Code					
Inspector Comment					
LMA installed seepage blanket in February 2017.

View of the seepage blanket on levee slope.

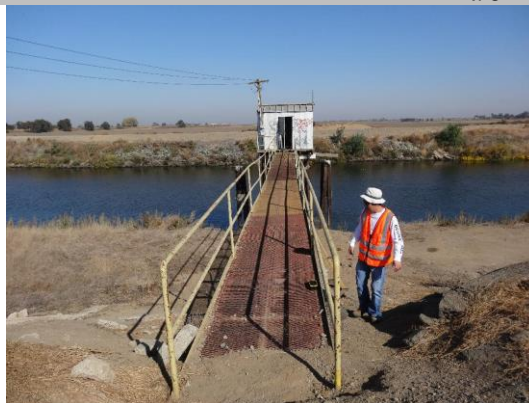
Photo 1 of 3 : UCIP_SP_2017_23142_39549.jpg

LM Start	5.37	Rating **	M	Issue No.	47 (cont)
LM End	5.37	Issue Type +	En	Location *	LS

WS view: steel walkway to pump house in the stream.

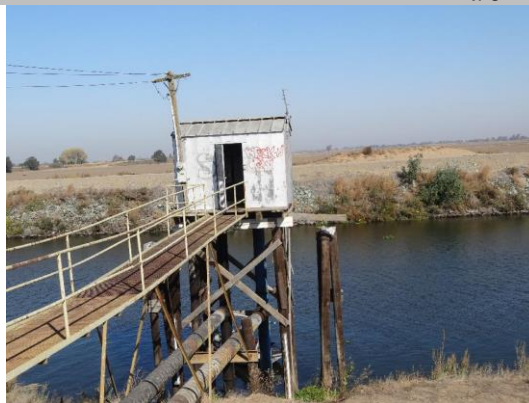
Photo 3 of 3 : UCIP_SP_2017_23142_39547.jpg

LM Start	5.37	Rating **	M	Issue No.	47 (cont)
LM End	5.37	Issue Type +	En	Location *	LS
Category	Supplemental			GPS Latitude/Longitude	
				Start	End
Item	DWR UCIP Field Study			37.807305 °	37.807305 °
				-121.331290 °	-121.331290 °
DWR ID					
Comment Code					
Inspector Comment					
FS_ID:23142 DS_ID:19203 EP_NO: N/A Repair Type: Non-Urgent Crossing Status: Found UCIP Comments: - siphon breakers not protected.- flow meter and gage station on waterside.- pump house on wooden pile structure. Walkway to the pumphouse. FIELD_STRUCT_DESC: 1 of 2: Two 16-inch pipes through the levee 4.0 feet below the crown. Pump in the pump house on pile structure in the stream. Siphon breakers on the landward slope. Concrete distribution box on landside berm. FS Date: 10/22/2013

WS view: pump house on wooden pipe structure in the stream. Two steel pipes under the walkway.

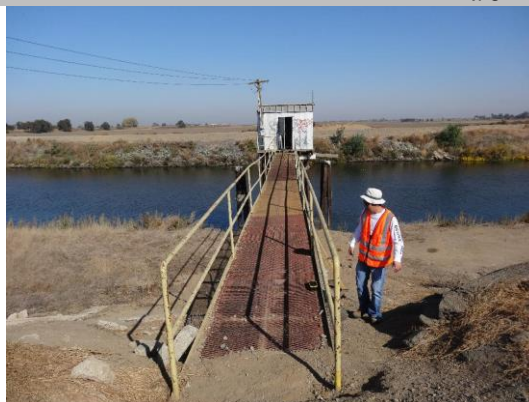
Photo 1 of 3 : UCIP_SP_2017_23140_39531.jpg

LM Start	5.37	Rating **	M	Issue No.	48
LM End	5.37	Issue Type +	En	Location *	LS
Category	Supplemental			GPS Latitude/Longitude	
				Start	End
Item	DWR UCIP Field Study			37.807305 °	37.807305 °
				-121.331276 °	-121.331276 °
DWR ID					
Comment Code					
Inspector Comment					
FS_ID:23140 DS_ID:19206 EP_NO: N/A Repair Type: Non-Urgent Crossing Status: Found UCIP Comments: - siphon breakers not protected.- flow meter and gage station on waterside.- pump house on wooden pile structure. Walkway to the pumphouse. FIELD_STRUCT_DESC: 2 of 2: Two 16-inch pipes through the levee 4.0 feet below the crown. Pump in the pump house on pile structure in the stream. Walkway to the pumphouse. Siphon breakers on the landward slope. Concrete distribution box on landside berm. FS Date: 10/22/2013

WS view: steel walkway to pump house in the stream.

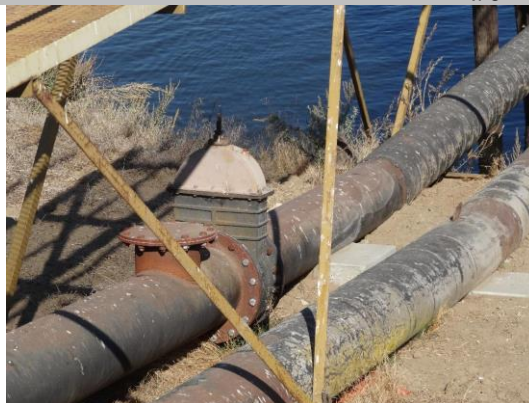
Photo 2 of 3 : UCIP_SP_2017_23140_39530.jpg

LM Start	5.37	Rating **	M	Issue No.	48 (cont)
LM End	5.37	Issue Type +	En	Location *	LS

WS view: two 16-inch pipes under walkway. Gate valve without handle on one of the pipes.

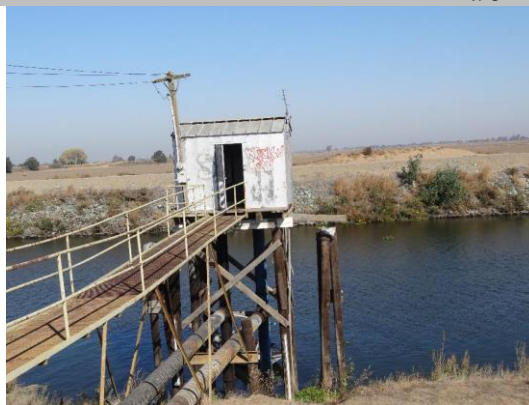
Photo 3 of 3 : UCIP_SP_2017_23140_39529.jpg

WS view: pump house on wooden pipe structure in the stream. Two steel pipes under the walkway.
