**Flood Control Project Maintenance  
Levee Inspections**  
**LMA District Cover Sheet**  
**Spring 2018 Levee Inspection Results**

**Reclamation District No. 2062 Stewart**

**Levee Inspection Report By Mile - Spring 2018**

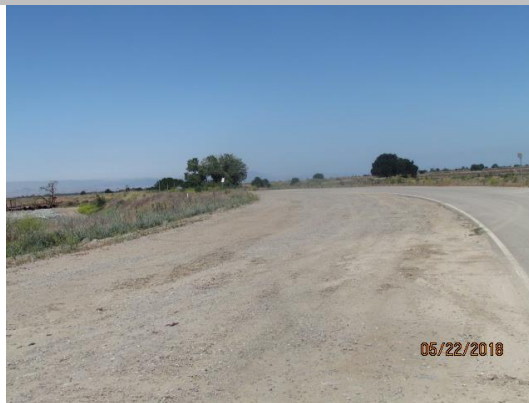
Photo 1 of 1 : SP\_2018\_RD2062\_309\_6\_20180523\_00011.jpg

LM Start	0.00	Rating **	M	Issue No.	6
LM End	2.64	Issue Type +	Ma	Location *	LS
Category	Earthen Levee			GPS Latitude/Longitude	
				Start	End
Item	Vegetation			37.807505 °	37.787249 °
				-121.328103 °	-121.308947 °
DWR ID	DWR_RD2062_01_s_2018_6				
Comment Code					
V1 : Control annual grass and weeds on the levee slopes and easements.					
Inspector Comment

Looking downstream at typical view of landward slope.

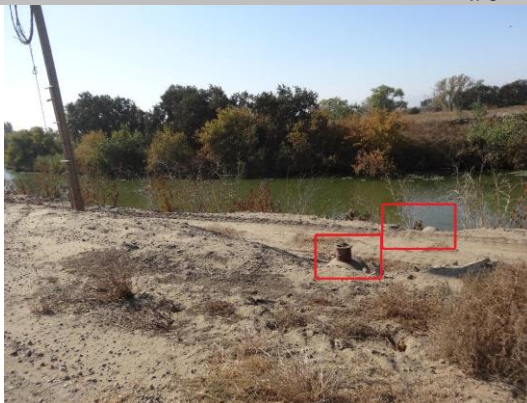
Photo 1 of 3 : UCIP\_SP\_2018\_23110\_39398.jpg

LM Start	0.56	Rating **	M	Issue No.	16	
LM End	0.56	Issue Type +	En	Location *		
Category	Supplemental			GPS Latitude/Longitude		
				Start	End	
Item	DWR UCIP Field Study			37.784380 °	37.784380 °	
				-121.338985 °	-121.338985 °	
DWR ID						
Comment Code						
Inspector Comment						
FS_ID:23110						
DS_ID:24697						
EP_NO: N/A						
Repair Type: Non-Urgent						
Crossing Status: Found						
UCIP Comments: Found on field with the help of USACE 2012 PI						
Report.Needs proper abandonment.						
FIELD_STRUCT_DESC: *ABANDONED* 24-inch steel irrigation						
discharge pipe through the levee, at an unknown depth. Damaged						
siphon breaker on the waterside (WS) slope. Pump on a concrete sump						
in an irrigation ditch on the landside (LS). Service pole on the LS slope.						
Pump disconnected from the service pole.						
FS Date: 10/23/2013

WS view: power pole (left), siphon breaker (marked- left), and steel pipe (right) on levee slope.

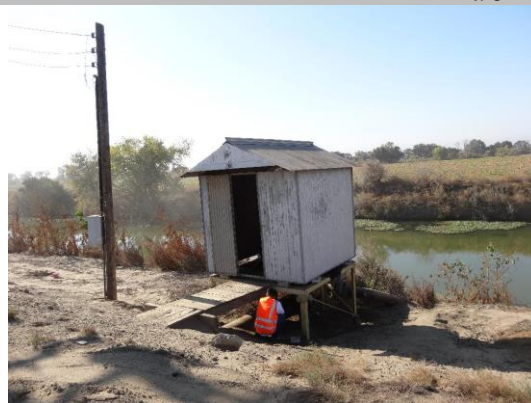
Photo 1 of 3 : UCIP\_SP\_2018\_23181\_39792.jpg

WS view: pipe, walkway, service pole, and pumphouse on levee slope.

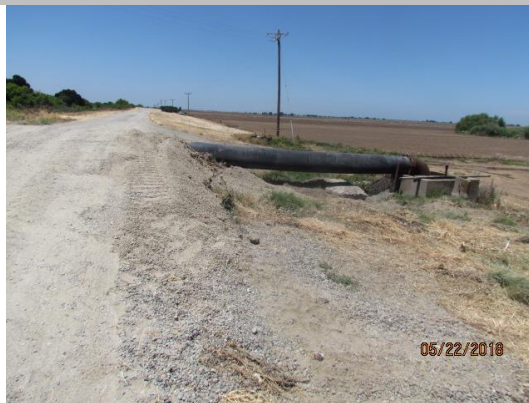
Photo 2 of 4 : SP\_2018\_RD2062\_310\_14\_20180523\_00032.jpg

Looking south at installation (pipe) on landward slope. (Spring 2018)

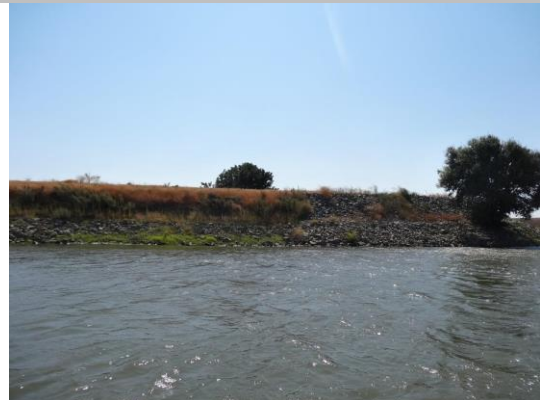
Photo 2 of 3 : SP\_2018\_RD2062\_311\_8\_20180503\_00023.jpg

Front view of the site.
