**Flood Control Project Maintenance
Levee Inspections**
LMA District Cover Sheet
Spring 2019 Levee Inspection Results

Reclamation District No. 2062 Stewart

Spring 2019 Levee Inspection Results

Waterway			Bank	Unit Miles
Unit No. 01 San Joaquin River			Left	2.64
	Spring (March - May)	Summer (June - August)	(September - November) Fall	Winter (December - February)
Unit Maintenance Rating (Fall Only)				
Date of Inspection	5/21/2019 - 5/21/2019			
DWR Inspector	Alberto De Leon			
Accompanied By	Tim Mello RD2062

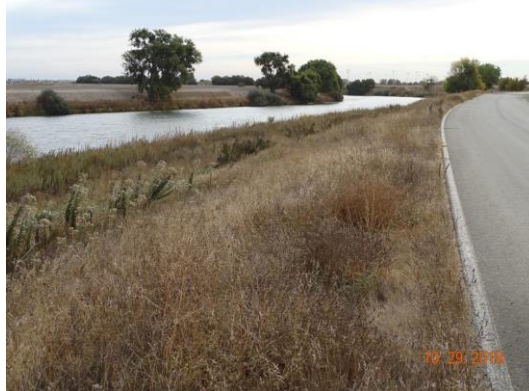
Photo 1 of 2 : SP_2019_RD2062_309_6_20190313_00001.jpg

LM Start	0.00	Rating **	M	Issue No.	6
LM End	2.63	Issue Type +	Ma	Location *	WS
Category	Earthen Levee			GPS Latitude/Longitude	
				Start	End
Item	Vegetation			37.807505 °	37.787249 °
				-121.328103 °	-121.308947 °
DWR ID	DWR_RD2062_01_f_2018_6				
Comment Code					
V1 : Control annual grass and weeds on the levee slopes and easements.					
Inspector Comment

Typical view of levee slopes.

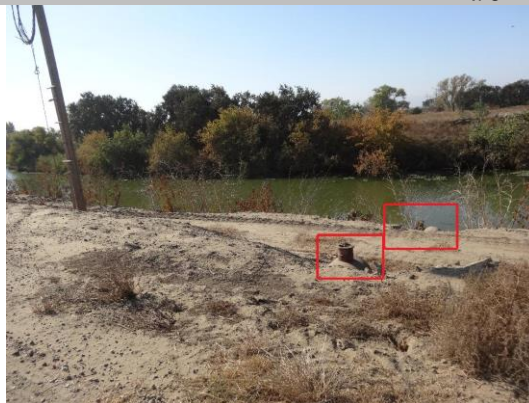
Photo 1 of 3 : UCIP_SP_2019_23110_39398.jpg

LM Start	0.56	Rating **	M	Issue No.	23	
LM End	0.56	Issue Type +	En	Location *		
Category	Supplemental			GPS Latitude/Longitude		
				Start	End	
Item	DWR UCIP Field Study			37.784380 °	37.784380 °	
				-121.338985 °	-121.338985 °	
DWR ID	24697					
Comment Code						
Inspector Comment						
FS_ID:23110						
DS_ID:24697						
EP_NO: N/A						
Repair Type: Non-Urgent						
Crossing Status: Found						
UCIP Comments: Found on field with the help of USACE 2012 PI						
Report.Needs proper abandonment.						
FIELD_STRUCT_DESC: *ABANDONED* 24-inch steel irrigation						
discharge pipe through the levee, at an unknown depth. Damaged						
siphon breaker on the waterside (WS) slope. Pump on a concrete sump						
in an irrigation ditch on the landside (LS). Service pole on the LS slope.						
Pump disconnected from the service pole.						
FS Date: 10/23/2013

WS view: power pole (left), siphon breaker (marked- left), and steel pipe (right) on levee slope.

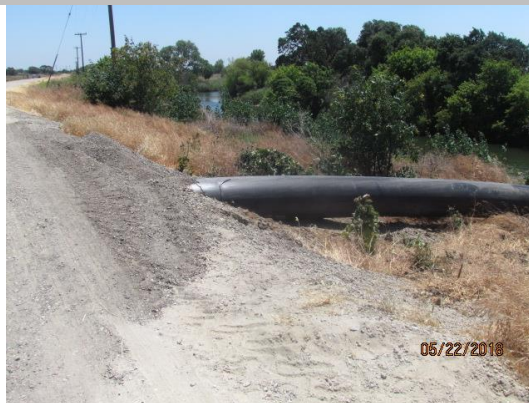
Photo 2 of 4 : SP_2019_RD2062_310_15_20190313_00009.jpg

Looking northeast at pipes on waterward slope. (Spring 2018)

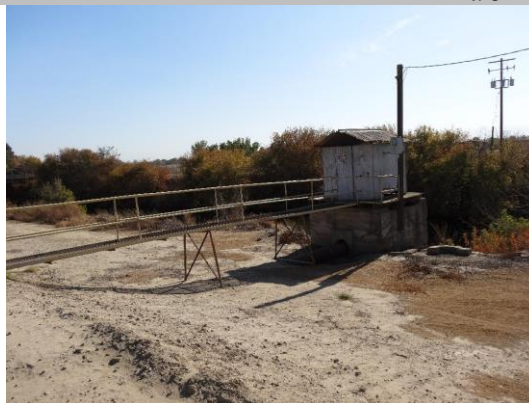
Photo 1 of 3 : UCIP_SP_2019_51468_39195.jpg

WS view: pipe, walkway, and pumphouse on levee berm. Service pole on waterside.

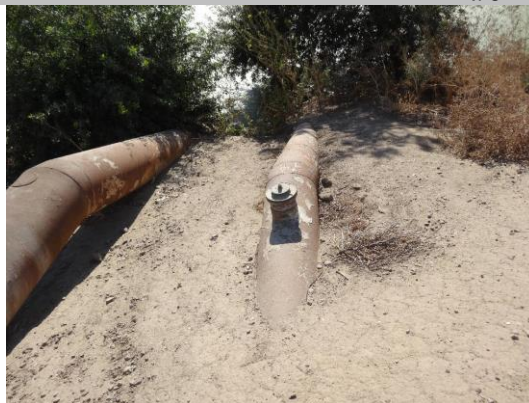
Photo 1 of 3 : UCIP_SP_2019_23023_39082.jpg

WS view: exposed 18-inch pipe with siphon breaker on levee slope.
Exposed 24-inch pipe (left).

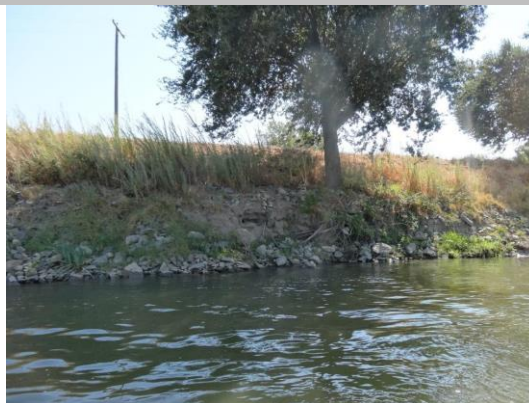
Photo 2 of 4 : SP_2019_RD2062_311_1_20190313_00002.jpg

Close view of the erosion.

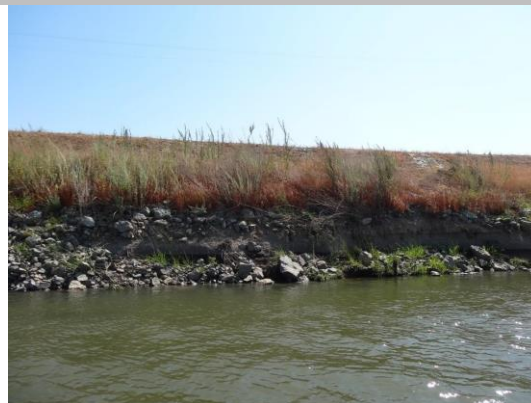
Photo 1 of 3 : SP_2019_RD2062_311_3_20190313_00009.jpg

LM Start	0.17	Rating **	M	Issue No.	3
LM End	0.17	Issue Type +	Ma	Location *	WS
Category	Supplemental			GPS Latitude/Longitude	
				Start	End
Item	DWR Erosion Survey			37.810268 °	37.810268 °
				-121.387495 °	-121.387495 °
DWR ID	DWR_RD2062_03_s_2018_3				
Comment Code					
Inspector Comment					
09/13/2017: No significant change observed.					
07/25/2016: No significant change observed.					
06/25/2015: No significant change observed.					
07/02/2014: No significant change observed.					
08/13/2013: No significant change observed.					
08/07/2012: The site has been visited by boat survey. No significant change observed					
08/23/2011: The protection at the levee toe has been washed away.					
[2017 Site ID:RD2062U03RM30.1]

Direct view of the site.

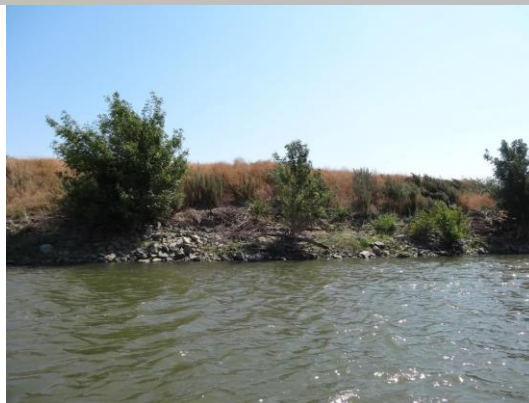
Photo 1 of 3 : SP_2019_RD2062_311_7_20190313_00019.jpg

Close view of the site.

11/05/2008: Site is located inside of a bend; scarp looks to be into the levee prism; piles of concrete chunks placed on the slope, with some of them already starting to slide. [2017 Site ID:RD2062U03RM30.43]

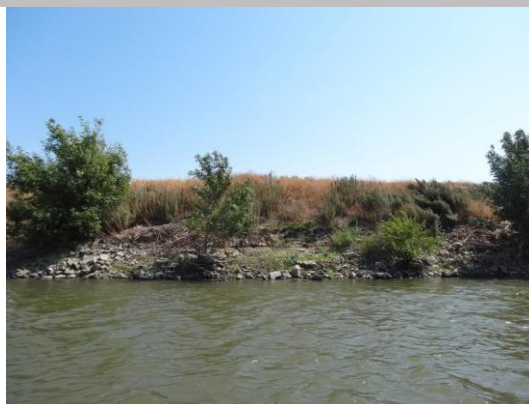
Photo 2 of 3 : SP_2019_RD2062_311_7_20190313_00020.jpg

Front view of the site.

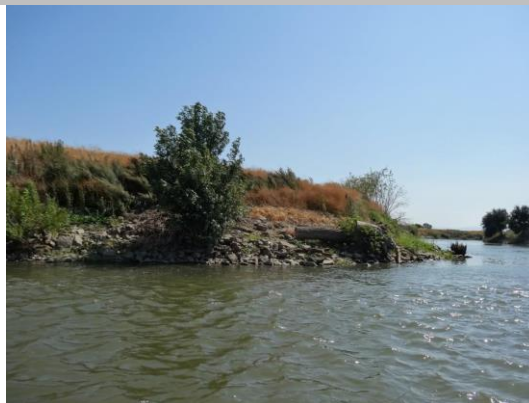
Photo 3 of 3 : SP_2019_RD2062_311_7_20190313_00021.jpg

Front view of the site.

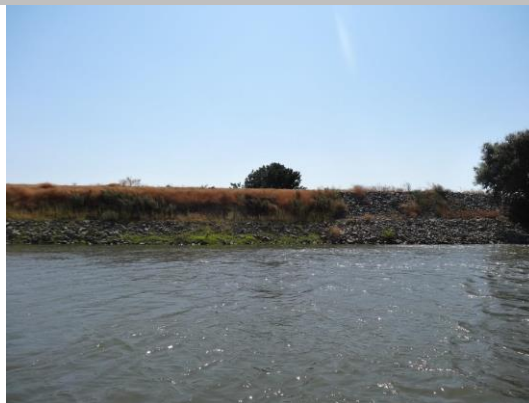
Photo 1 of 3 : SP_2019_RD2062_311_8_20190313_00022.jpg

Front view of the site.

09/28/2009: No major change observed; section of rip rap has slipped, creating a terraced effect; dense vegetation growth; recommended as a local maintenance issue, per CLRO CES Evaluation 2008 Report; Site # is the same as RM31.12,LM1.25; previously rated "U".						
09/14/2006: 1-2' into prism. [2017 Site ID:RD2062U03RM31.12]

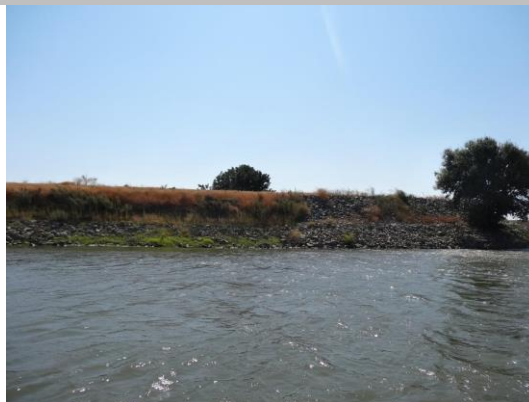
Photo 2 of 3 : SP_2019_RD2062_311_8_20190313_00023.jpg

Front view of the site.

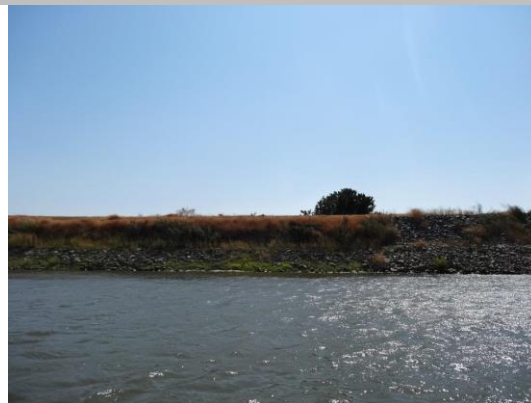
Photo 3 of 3 : SP_2019_RD2062_311_8_20190313_00024.jpg

Front view of the site.

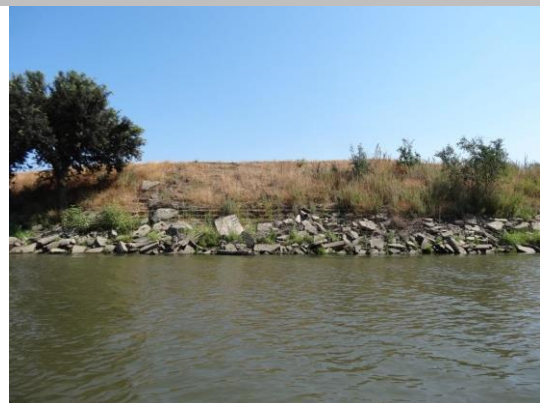
Photo 2 of 4 : SP_2019_RD2062_311_9_20190313_00026.jpg

Close view of the site.
