**Flood Control Project Maintenance
Levee Inspections
LMA District Cover Sheet**

Reclamation District No. 2062 Stewart

**Flood Control Project Maintenance
Levee Inspections**

Levee Inspection Report By Mile - Spring 2022

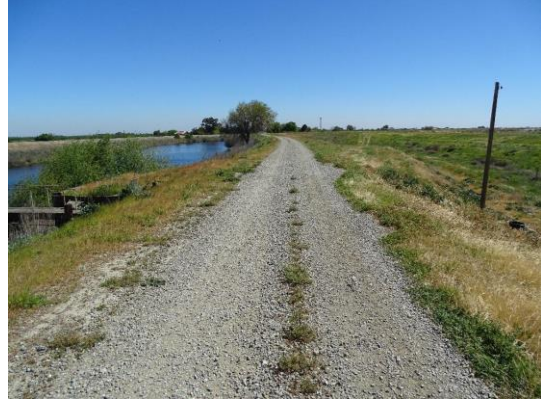
Photo 1 of 3 : UCIP_SP_2022_72765_109186.jpg

| FS_ID:72765 DS_ID:19201 EP_NO: N/A Repair Type: Non-Urgent Crossing Status: Found UCIP Comments: 03/22/2022 Record updated from No Action Needed to Non-Urgent. No permit has been identified authorizing pipe. (D.Sanoski - DWR UCIP) 11/15/2016 Per phone conversation with Lyn Hale of RD2062, steel riser that housed the air relief valve was knocked over by a mower. The hole in the levee slope was created by this mistake and not indicative of pipe failure. A new HDPE standpipe was installed on 11/11/2016. This crossing has been downgraded from Urgent to No Action Needed. (K. Fazel - UCIP)11/11/2016 Per email exchange between John Hale of RD2062 and Max Khashchuk, the hole in the levee has been repaired and standpipe installed in its place. Unclear whether pipe itself was repaired. Awaiting more information from LMA. (K. Fazel - UCIP)09/28/2016 DWR FPIIB Inspector Max Khashchuk provided the attached photo showing a hole in the LS slope likely resulting from failure in pipe. Crossing has been upgraded from No Action Needed to Urgent. (K. Fazel - UCIP) FIELD_STRUCT_DESC: 18-inch concrete encased steel irrigation discharge pipe through the levee, 10 feet below the crown. Two cutoff walls. Pump in a pump house on a concrete sump in the stream. Gate valve under walkway on the waterside (WS). Flap gate in a concrete distribution box on the landside (LS). 2-inch electrical conduit on the WS to the service pole at the LS toe. Timber bulkhead and pad on the WS slope. High-density polyethylene (HDPE) standpipe houses air relief valve on the LS slope. Installed by USACE in 1963. [Additional Reference(s): DWR Levee Log, 2007. USACE San Joaquin O&M Manual 9, April 1964, (HLM 2.16)]. FS Date: 3/22/2022 12:53:42 PM | | | | | |

Top of Levee: view of crown.

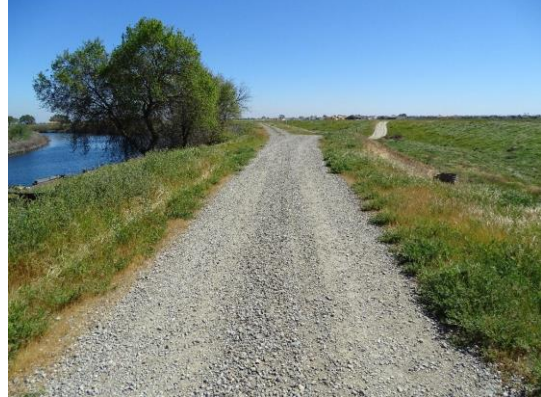
Photo 1 of 3 : UCIP_SP_2022_72770_109191.jpg

| FS_ID:72770 DS_ID:19202 EP_NO: 2505 Repair Type: Non-Urgent Crossing Status: Found UCIP Comments: 03/22/2022 Record remains Non-Urgent. Maintenance compliance issue with risers filled with soil. (D.Sanoski - DWR UCIP) 10/22/2013 Pumphouse roof missing, siphon breaker buried by dirt in CMP riser, and 2.25 inch electric conduit and power pole on landside. (P. Khoi - DWR UCIP) FIELD_STRUCT_DESC: 2 of 2: 16-inch irrigation discharge pipe of an unknown material through the levee, 6.5 feet below the crown. Pump in a pump house on a pile structure in the stream. Timber walkway to the pump. Siphon breaker in a corrugated metal pipe (CMP) riser on the landside (LS) slope. Concrete distribution box at the LS toe. Timber bulkhead and slab on the waterside (WS) slope. Installed by USACE in 1963. (Plans for the installation of two irrigation pumps on the bank to replace an existing pumping plant at this location authorized under Permit No. 2505, 1959 - Reclamation District No. 2062). [Additional Reference(s): DWR Levee Log, 2007. USACE San Joaquin O&M Manual 9, April 1964, (HLM 2.81)]. FS Date: 3/22/2022 12:57:00 PM | | | | | | |

Top of Levee: view of crown.

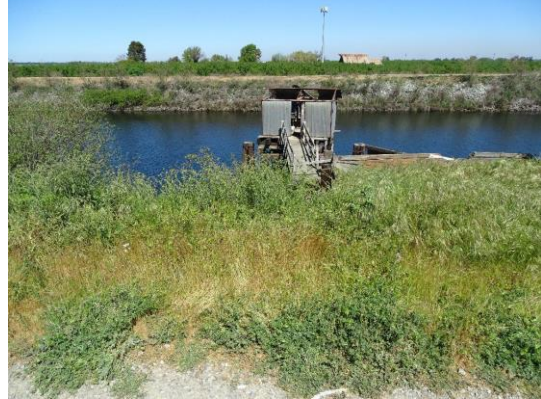
Photo 3 of 3 : UCIP_SP_2022_72770_109194.jpg

Water-Side: view of slope.

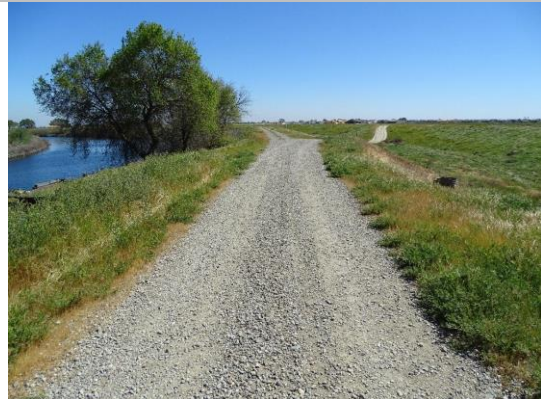
Photo 1 of 3 : UCIP_SP_2022_72771_109195.jpg

FS_ID:72771
DS_ID:19205
EP_NO: 2505
Repair Type: Non-Urgent
Crossing Status: Found
UCIP Comments: 03/22/2022 Record remains Non-Urgent.
Maintenance compliance issue with risers filled with soil. (D.Sanoski - DWR UCIP)
10/22/2013 Pumphouse roof missing, siphon breaker buried by dirt in CMP riser, and 2.25 inch electric conduit and power pole on landside. (P. Khoi - DWR UCIP)
FIELD_STRUCT_DESC: 1 of 2: 14-inch irrigation discharge pipe of an unknown material through the levee, 6.5 feet below the crown. Pump in a pump house on a pile structure in the stream. Timber walkway to the pump. Siphon breaker in a corrugated metal pipe (CMP) riser on the landside (LS) slope. Concrete distribution box at the LS toe. Timber bulkhead and slab on the waterside (WS) slope. Installed by USACE in 1963. (Plans for the installation of two irrigation pumps on the bank to replace an existing pumping plant at this location authorized under Permit No. 2505, 1959 - Reclamation District No. 2062). [Additional Reference(s): DWR Levee Log, 2007. USACE San Joaquin O&M Manual 9, April 1964, (HLM 2.81)].

Top of Levee: view of crown.

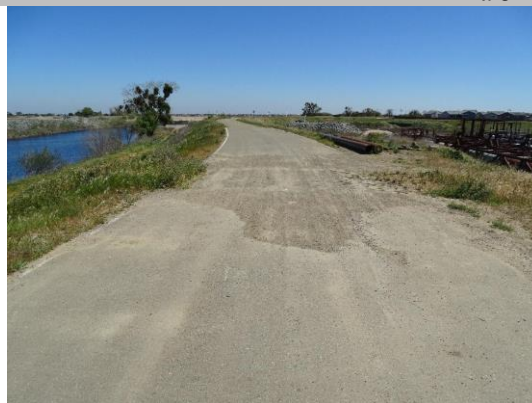
Photo 1 of 3 : UCIP_SP_2022_72768_109200.jpg

| FS_ID:72768 DS_ID:19203 EP_NO: N/A Repair Type: Non-Urgent Crossing Status: Found UCIP Comments: 03/22/2022 Record remains Non-Urgent. No permit has been identified authorizing pipe. Crossing appears abandoned. Not found on LS, pipes cut on WS near water line, and pumphouse removed. (D.Sanoski - DWR UCIP) 10/22/2013 Siphon breakers not protected, flow meter and gage station on waterside, pump house on wooden pile structure, and walkway to the pumphouse. (P. Khoi - DWR UCIP) FIELD_STRUCT_DESC: 1 of 2: 16-inch irrigation discharge pipe of an unknown material through the levee, 4 feet below the crown. Pump in a pump house on a pile structure in the stream. Walkway to the pump house. Siphon breaker on the landside (LS) slope. Concrete distribution box on the LS berm. [Additional Reference(s): DWR Levee Log, 2007. USACE San Joaquin O&M Manual 9, April 1964, (HLM 5.45)]. FS Date: 3/22/2022 1:09:31 PM | | | | | | |

Top of Levee: view of crown.

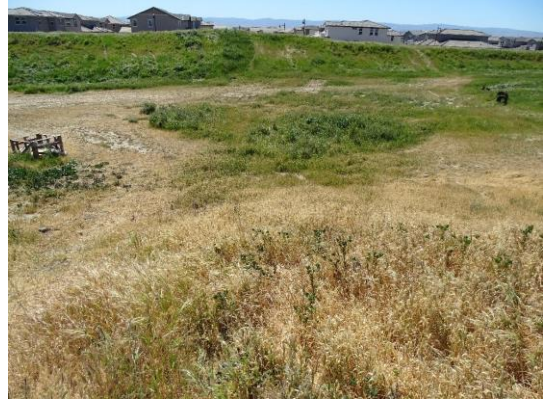
Photo 2 of 3 : UCIP_SP_2022_72768_109201.jpg

Land-Side: view of slope.

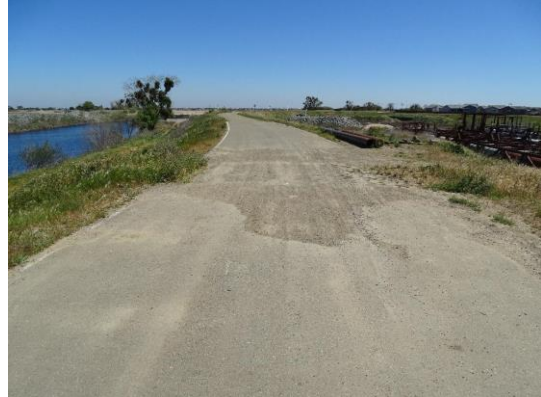
Photo 1 of 3 : UCIP_SP_2022_72769_109205.jpg

| FS_ID:72769 DS_ID:19206 EP_NO: N/A Repair Type: Non-Urgent Crossing Status: Found UCIP Comments: 03/22/2022 Record remains Non-Urgent. No permit has been identified authorizing pipe. Crossing appears abandoned. Not found on LS, pipes cut on WS near water line, and pumphouse removed. (D.Sanoski - DWR UCIP) 10/22/2013 Siphon breakers not protected, flow meter and gage station on waterside, pump house on wooden pile structure, and walkway to the pumphouse. (P. Khoi - DWR UCIP) FIELD_STRUCT_DESC: 2 of 2: 16-inch irrigation discharge pipe of an unknown material through the levee, 4 feet below the crown. Pump in a pump house on a pile structure in the stream. Walkway to the pump house. Siphon breaker on the landside (LS) slope. Concrete distribution box on the LS berm. [Additional Reference(s): DWR Levee Log, 2007. USACE San Joaquin O&M Manual 9, April 1964, (HLM 5.45)]. FS Date: 3/22/2022 1:13:49 PM | | | | | | |

Top of Levee: view of crown.

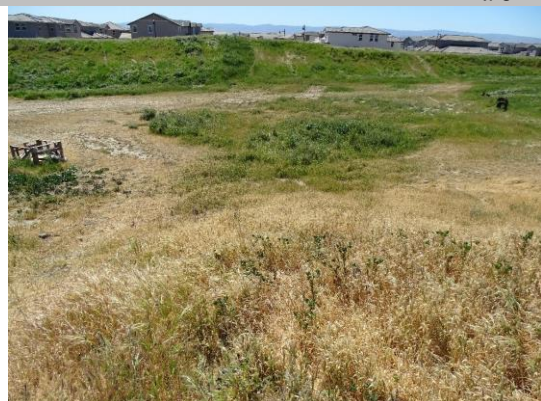
Photo 2 of 3 : UCIP_SP_2022_72769_109206.jpg

Land-Side: view of slope.
