**Flood Control Project Maintenance
Levee Inspections**

Fall 2011 Levee Maintenance Deficiency Summary Report

San Joaquin River Basin

Reclamation District No. 2063 Crows Landing

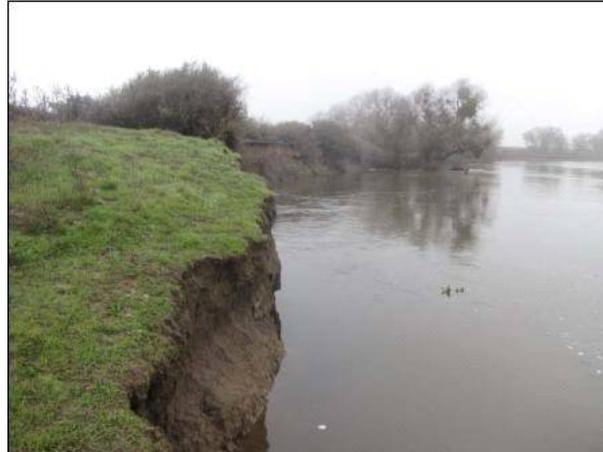
Levee Mile Report Line	18
Start Levee Mile	3.07
End Levee Mile	3.26
Location	Water Side
Category	Supplemental
Item	DWR Erosion Survey
Looking south from station 0+00. Image taken by Herman Phillips	
SJR2011_RD2063U01RM103.49_1.jpg

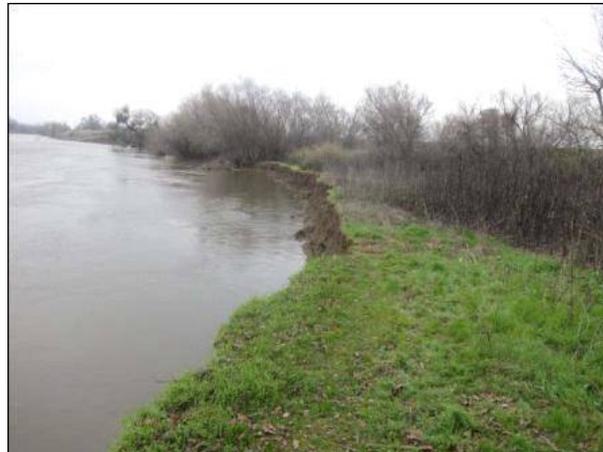
Levee Mile Report Line	18
Start Levee Mile	3.07
End Levee Mile	3.26
Location	Water Side
Category	Supplemental
Item	DWR Erosion Survey
Looking north from station 10+00. Image taken by Herman Phillips	
SJR2011_RD2063U01RM103.49_2.jpg

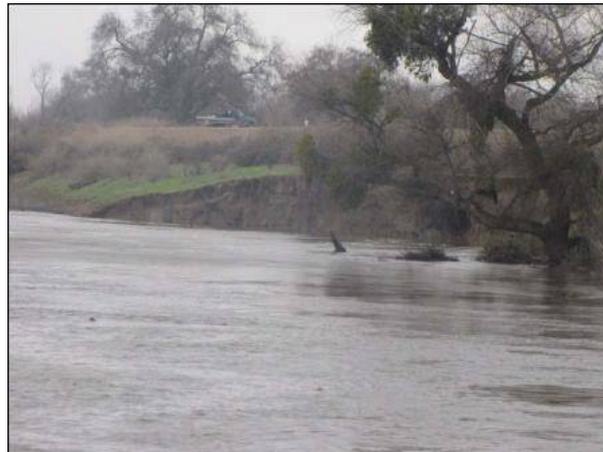
Levee Mile Report Line	18
Start Levee Mile	3.07
End Levee Mile	3.26
Location	Water Side
Category	Supplemental
Item	DWR Erosion Survey
Looking north at station 0+00. Image taken by Herman Phillips	
SJR2011_RD2063U01RM103.49_3.jpg

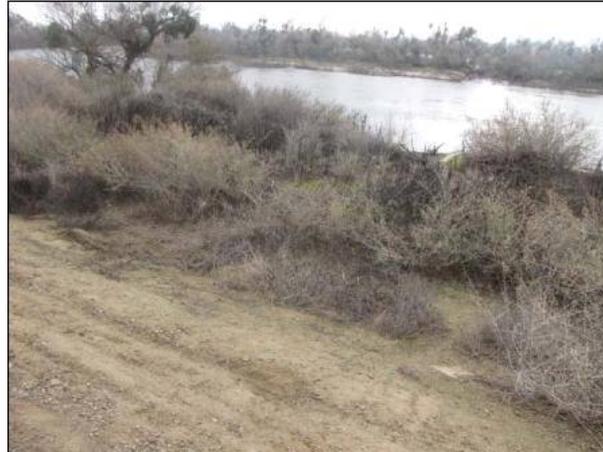
Levee Mile Report Line	18
Start Levee Mile	3.07
End Levee Mile	3.26
Location	Water Side
Category	Supplemental
Item	DWR Erosion Survey
Looking west at berm from station 1+00. Image taken by Herman Phillips	
SJR2011_RD2063U01RM103.49_4.jpg
