**Flood Control Project Maintenance  
Levee Inspections**

**Fall 2015 Levee Maintenance Deficiency Summary Report  
Overall LMA & Unit Ratings, including DWR Erosion Survey**

**San Joaquin River Basin**

**Reclamation District No. 2063 Crows Landing**

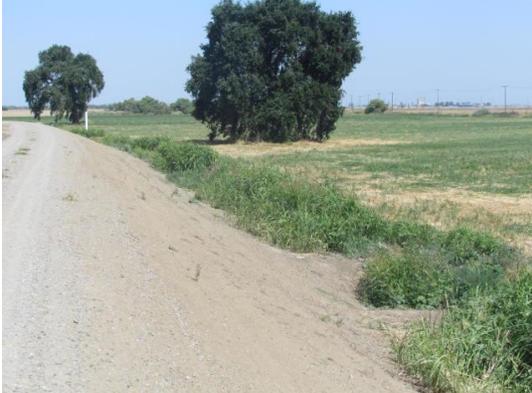
Photo 1 of 1 : FA\_2015\_RD2063\_112\_38\_20150914\_00011.jpg

LM Start	<b>3.35</b>	Rating **	A/W	Issue No.	<b>38</b>
LM End	<b>3.64</b>	Issue Type +	Ma	Location *	LS
Category	Earthen Levee		GPS Latitude/Longitude		
			Start	End	
Item	Vegetation		37.440438 °	37.436906 °	
			-121.020487 °	-121.017835 °	
DWR ID	DWR_RD2063_01_f_2012_38				
Action/Comments					
Remove the wild growth other than native grasses from the levee slopes. Inspector Comments: Control Johnson grass at landward toe.

Looking south at vegetation at landward toe.

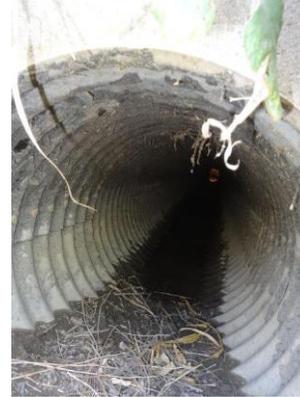
Photo 1 of 3 : UCIP\_FA\_2015\_1340.jpg

**Action/Comments**  
 Inspector Comments: FS\_ID:24583  
 DS\_ID:22096  
 EP\_NO: N/A  
 FS\_HLM: 4.0838  
 Repair Type: Non-Urgent  
 Crossing Status: Found  
 UCIP Comments: - new flap gate on waterside.- cleaning of outlet and inlet pipes required.  
 FIELD\_STRUCT\_DESC: 24-inch CM pipe through the levee 12.0 feet below the crown. Flap gate on the waterwad end. Concrete headwall on both ends. Installed by USCE 1961. O&M Manual SJR 006, Sept. 1961  
 FS Date: 11/05/2013

LM Start	<b>4.02</b>	Rating **	M	Issue No.	<b>991 (cont)</b>
LM End	<b>4.02</b>	Issue Type +	En	Location *	LS

LS view: inside view of the CM pipe on levee toe.
