**Flood Control Project Maintenance
Levee Inspections**

Maintenance Issue Types Only, Levee Inspection Report By Mile - Fall 2018

Reclamation District No. 2064 River Junction

Waterway	Bank	Unit Miles	Inspection Start/End	Inspector
Unit No. 01 San Joaquin River	Right	5.56	10/05/2018 10/05/2018	Luz Dial

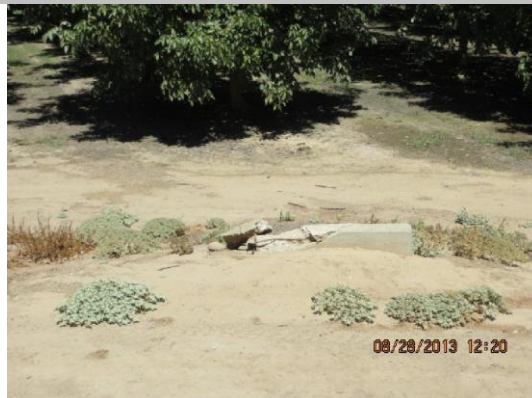
Photo 1 of 3 : UCIP_FA_2018_19122_32083.jpg

LM Start	4.78	Rating **	A/W	Issue No.	46
LM End	4.78	Issue Type +	Ma	Location *	
Category	Supplemental			GPS Latitude/Longitude	
				Start	End
Item	DWR UCIP LMA Responsibility			37.696888 °	37.696888 °
				-121.196511 °	-121.196511 °
DWR ID	20552				
Comment Code					
Inspector Comment					
FS_ID:19122 DS_ID:20552 EP_NO: N/A Repair Type: No Action Needed Crossing Status: Found UCIP Comments: FIELD_STRUCT_DESC: 30-inch corrugated metal drainage pipe through the levee, 8.5 feet below the crown. Concrete U-shaped headwalls on both ends. Flap gate on the waterside (WS) end. Two corrugated metal cutoff walls. Grouted spillway on the WS. [Additional Reference(s): DWR Levee Log, 2005. USACE San Joaquin O&M Manual 3, December 1968, (HLM 4.73)]. FS Date: 8/28/2013

Concrete headwall on LS toe.

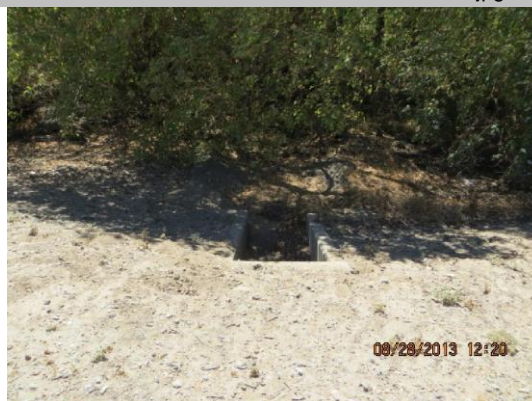
Photo 2 of 3 : UCIP_FA_2018_19122_32082.jpg

LM Start	4.78	Rating **	A/W	Issue No.	46 (cont)
LM End	4.78	Issue Type +	Ma	Location *	
Category	Supplemental			GPS Latitude/Longitude	
				Start	End
Item	DWR UCIP LMA Responsibility			37.696888 °	37.696888 °
				-121.196511 °	-121.196511 °
DWR ID	20552				
Comment Code					
Inspector Comment					
FS_ID:19122 DS_ID:20552 EP_NO: N/A Repair Type: No Action Needed Crossing Status: Found UCIP Comments: FIELD_STRUCT_DESC: 30-inch corrugated metal drainage pipe through the levee, 8.5 feet below the crown. Concrete U-shaped headwalls on both ends. Flap gate on the waterside (WS) end. Two corrugated metal cutoff walls. Grouted spillway on the WS. [Additional Reference(s): DWR Levee Log, 2005. USACE San Joaquin O&M Manual 3, December 1968, (HLM 4.73)]. FS Date: 8/28/2013

Concrete headwall on WS toe.
