**Flood Control Project Maintenance  
Levee Inspections**

**Maintenance Issue Types Only, Levee Inspection Report By Mile - Fall 2019**

**Reclamation District No. 2064 River Junction**

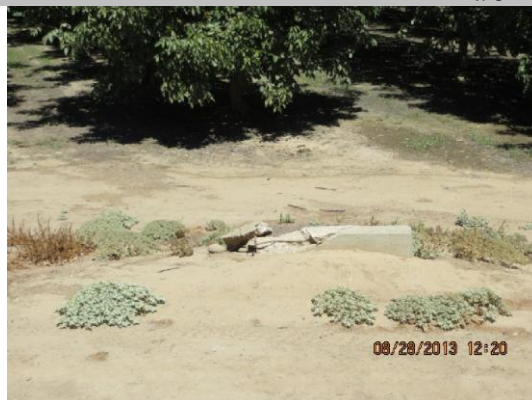
Photo 1 of 3 : UCIP\_FA\_2019\_19122\_32083.jpg

LM Start	4.78	Rating **	A/W	Issue No.	53
LM End	4.78	Issue Type +	Ma	Location *	
Category	Supplemental			GPS Latitude/Longitude	
				Start	End
Item	DRAFT DWR UCIP LMA Responsibility			37.696888 °	37.696888 °
				-121.196511 °	-121.196511 °
DWR ID	20552				
Comment Code					
Inspector Comment					
DS_ID:20552 FS_ID:19122 EP_NO: N/A Repair Type: No Action Needed Crossing Status: Found UCIP Comments: FIELD_STRUCT_DESC: 30-inch corrugated metal drainage pipe through the levee, 8.5 feet below the crown. Concrete U-shaped headwalls on both ends. Flap gate on the waterside (WS) end. Two corrugated metal cutoff walls. Grouted spillway on the WS. [Additional Reference(s): DWR Levee Log, 2005. USACE San Joaquin O&M Manual 3, December 1968, (HLM 4.73)]. FS Date: 8/28/2013

Concrete headwall on LS toe.

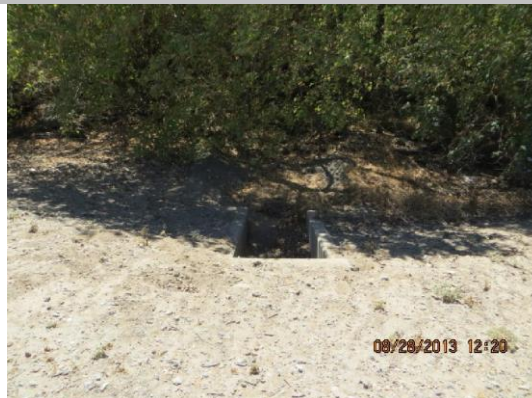
Photo 2 of 3 : UCIP\_FA\_2019\_19122\_32082.jpg

LM Start	4.78	Rating **	A/W	Issue No.	53 (cont)
LM End	4.78	Issue Type +	Ma	Location *	
Category	Supplemental			GPS Latitude/Longitude	
				Start	End
Item	DRAFT DWR UCIP LMA Responsibility			37.696888 °	37.696888 °
				-121.196511 °	-121.196511 °
DWR ID	20552				
Comment Code					
Inspector Comment					
DS_ID:20552 FS_ID:19122 EP_NO: N/A Repair Type: No Action Needed Crossing Status: Found UCIP Comments: FIELD_STRUCT_DESC: 30-inch corrugated metal drainage pipe through the levee, 8.5 feet below the crown. Concrete U-shaped headwalls on both ends. Flap gate on the waterside (WS) end. Two corrugated metal cutoff walls. Grouted spillway on the WS. [Additional Reference(s): DWR Levee Log, 2005. USACE San Joaquin O&M Manual 3, December 1968, (HLM 4.73)]. FS Date: 8/28/2013

Concrete headwall on WS toe.

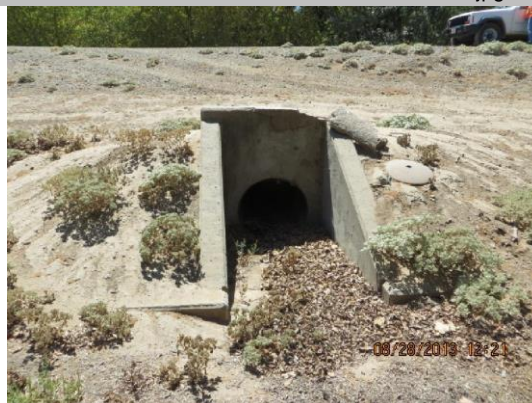
Photo 3 of 3 : UCIP\_FA\_2019\_19122\_32081.jpg

Concrete headwall on LS toe.

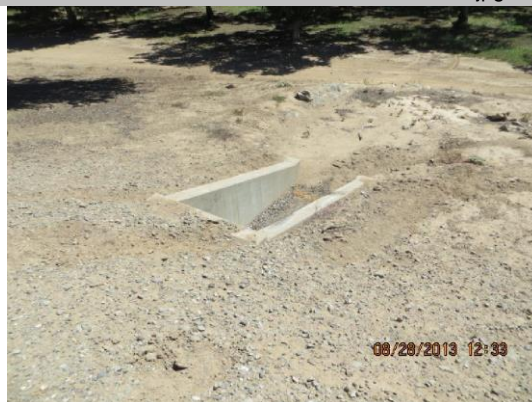
Photo 1 of 3 : UCIP\_FA\_2019\_22794\_38851.jpg

LM Start	5.10	Rating **	A/W	Issue No.	57	
LM End	5.10	Issue Type +	Ma	Location *		
Category	Supplemental			GPS Latitude/Longitude		
				Start		End
Item	DRAFT DWR UCIP LMA Responsibility			37.697483 °		37.697483 °
				-121.191332 °		-121.191332 °
DWR ID	20554					
Comment Code						
Inspector Comment						
DS_ID:20554						
FS_ID:22794						
EP_NO: N/A						
Repair Type: No Action Needed						
Crossing Status: Found						
UCIP Comments:						
FIELD_STRUCT_DESC: 30-inch corrugated metal drainage pipe through the levee, 8 feet below the crown. Concrete U-shaped headwalls on both ends. Flap gate on the waterside (WS) end. Two corrugated metal cutoff walls. Grouted spillway on the WS. [Additional Reference(s): DWR Levee Log, 2005. USACE San Joaquin O&M Manual 3, December 1968, (HLM 5.05)].						
FS Date: 8/28/2013

Concrete U shaped headwall on WS toe.
