**Flood Control Project Maintenance
Levee Inspections**

Maintenance Issue Types Only, Levee Inspection Report By Mile - Spring 2019

Reclamation District No. 2075 McMullin

Waterway	Bank	Unit Miles	Inspection Start/End	Inspector
Unit No. 01 San Joaquin River	Right	7.45	05/15/2019 05/15/2019	Alberto De Leon

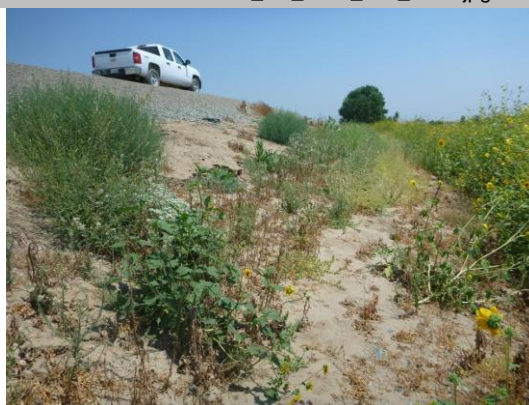
Photo 1 of 3 : LEVAL_SP_2019_579_4263.jpg

LM Start	5.87	Rating **	A/W	Issue No.	28
LM End	6.33	Issue Type +	Ma	Location *	WS
Category	Supplemental			GPS Latitude/Longitude	
				Start	End
Item	2017 Storm Damage			37.721710 °	37.720960 °
				-121.267490 °	-121.259830 °
DWR ID	DWR_RD2075_01_f_2017_28				
Comment Code					
Inspector Comment					
Levee Evaluation Comments					
Description:Slope protection repairs are needed along the waterside slope due to erosion and riprap displacement from high water. Based upon levee inspections, it was determined the waterside levee slope is eroding, deteriorating, and degrading. The eroded levee sections need to be restored back to design standards to prevent further deterioration and damage.					
Site ID No:579					
Site Designation:LMA-485					
Repair Type: Erosion					
Rating:Area of Concern					
Field Date:8/10/2017					
Notes: Berm present on LS. LMA 486 is combined with this site.

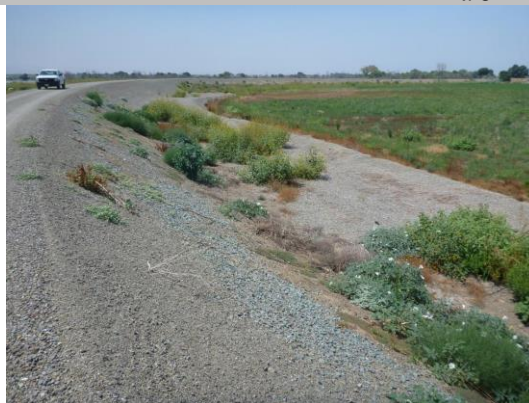
Photo 2 of 3 : LEVAL_SP_2019_579_4264.jpg

LM Start	5.87	Rating **	A/W	Issue No.	28 (cont)
LM End	6.33	Issue Type +	Ma	Location *	WS
Category	Supplemental			GPS Latitude/Longitude	
				Start	End
Item	2017 Storm Damage			37.721710 °	37.720960 °
				-121.267490 °	-121.259830 °
DWR ID	DWR_RD2075_01_f_2017_28

Comment Code					
Inspector Comment					
Levee Evaluation Comments					
Description:Slope protection repairs are needed along the waterside slope due to erosion and riprap displacement from high water. Based upon levee inspections, it was determined the waterside levee slope is eroding, deteriorating, and degrading. The eroded levee sections need to be restored back to design standards to prevent further deterioration and damage.					
Site ID No:579					
Site Designation:LMA-485					
Repair Type: Erosion					
Rating:Area of Concern					
Field Date:8/10/2017					
Notes: Berm present on LS. LMA 486 is combined with this site.
