**Flood Control Project Maintenance
Levee Inspections**

**Fall 2010 Levee Maintenance Deficiency Summary Report
Overall LMA & Unit Ratings, including DWR Erosion Survey**

San Joaquin River Basin

Reclamation District No. 2089 Stark

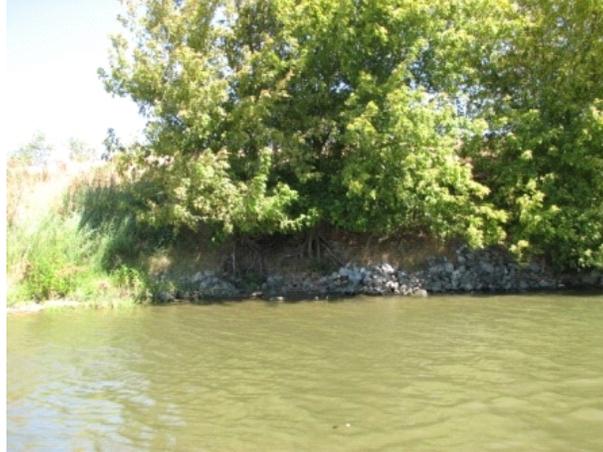
Levee Mile Report Line	10
Start Levee Mile	0.42
End Levee Mile	0.43
Location	Water Side
Category	Supplemental
Item	DWR Erosion Survey
<p>Front view of Sycamore trees with roots exposed. Note existing toe revetment.</p>	
<p>SJR2010_RM28.35U2LM.42RBc.jpg</p>

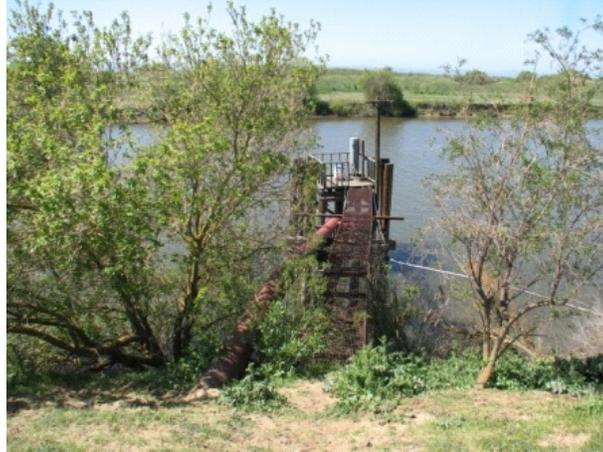
Levee Mile Report Line	12
Start Levee Mile	0.56
End Levee Mile	0.56
Location	Water Side
Category	Earthen Levee
Item	Encroachments
Irrigation intake pump and pipe at waterside slope.	
jpaasch_f_20100923_361.jpg

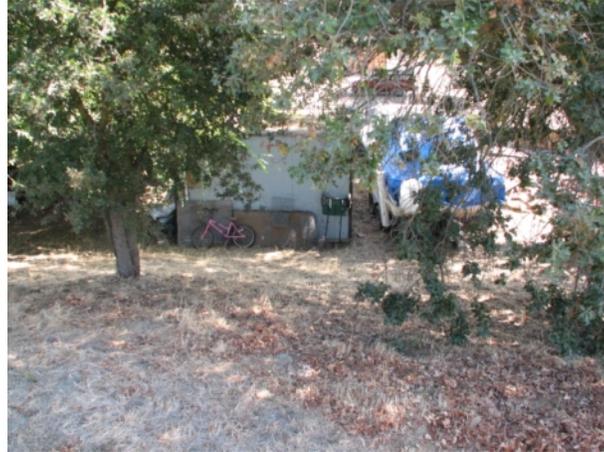
Levee Mile Report Line	29
Start Levee Mile	1.28
End Levee Mile	1.33
Location	Land Side
Category	Earthen Levee
Item	Encroachments
<p>Fall 2009 photo: Buildings and patio decks are built within 10-ft of the levee slope.</p>	
<p>jpaasch_f_20100923_364.jpg</p>
