**Flood Control Project Maintenance  
Levee Inspections****LMA District Cover Sheet****Spring 2012 Levee Inspection Results****Reclamation District No. 2089 Stark**

**Levee Inspection Report By Mile - Spring 2012**

**Reclamation District No. 2089 Stark**

Waterway				Bank	Unit Miles	Inspection Start/End	Inspector
Unit No. 01 Old River				Right	1.53	05/24/2012 05/24/2012	Max Khashchuk

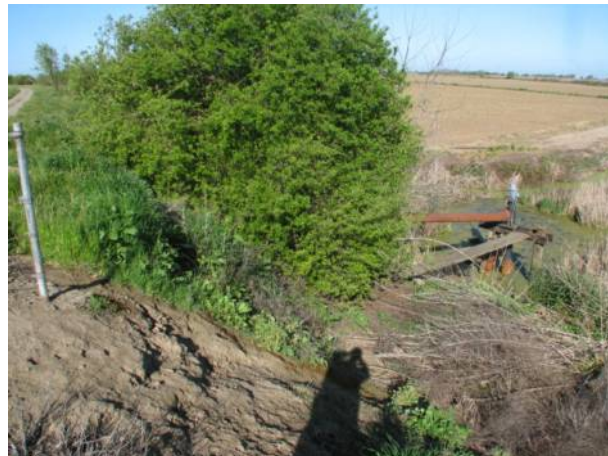
Levee Mile Report Line	6
Start Levee Mile	0.04
End Levee Mile	0.04
Location	Land Side
Category	Earthen Levee
Item	Trim / Thin Trees

Trees on landside slope limit access and visibility.

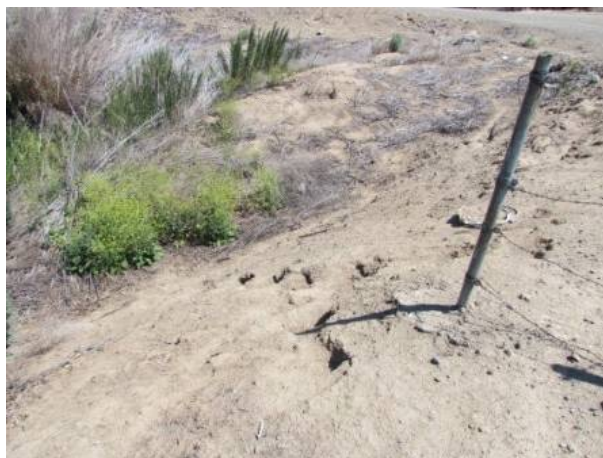
mkhashch\_s\_20120525\_393.jpg

View of steps in the landside slope just behind the post. 05/24/2012

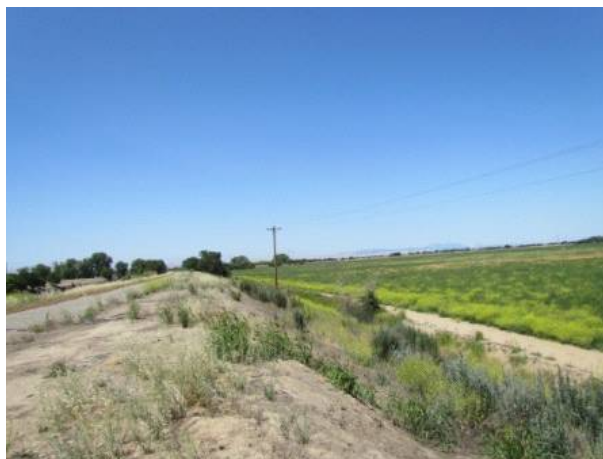
Levee Mile Report Line	9
Start Levee Mile	0.09
End Levee Mile	0.43
Location	Land Side
Category	Earthen Levee
Item	Vegetation

View of uncontrolled annual grass on landside levee slope. 05/24/2012

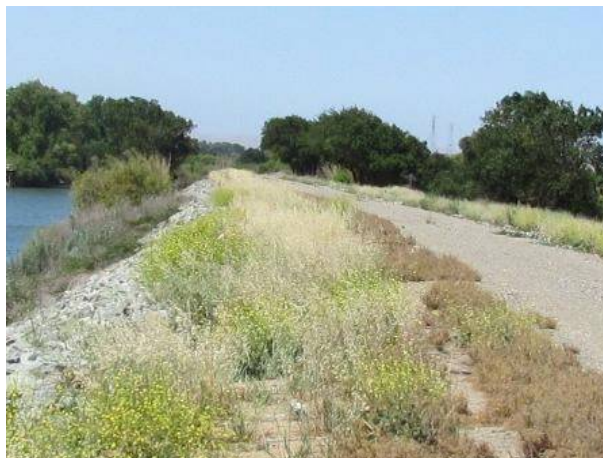
Levee Mile Report Line	10
Start Levee Mile	0.10
End Levee Mile	0.29
Location	Water Side
Category	Earthen Levee
Item	Vegetation

View of tall grass blocking visibility of waterside levee hinge and slope. 05/24/2012

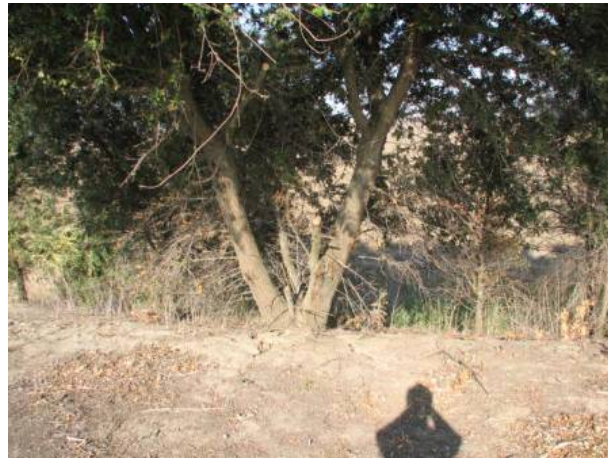
mkhashch\_s\_20120511\_147.jpg

11/10/2011 Tree has been limbed up, but still needs to be cleared around the bottom to permit access to the slope in the event of a flood fight.

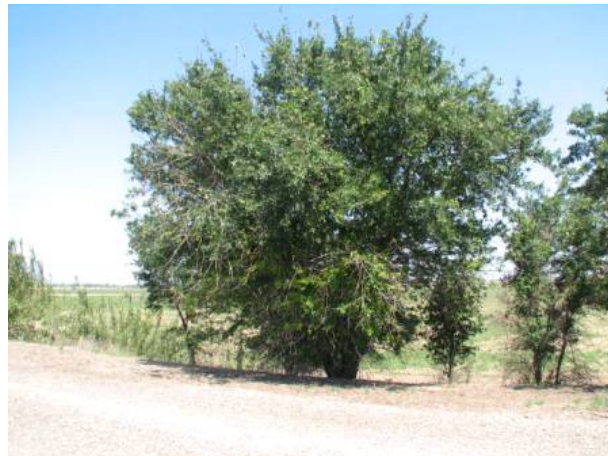
mkhashch\_s\_20120511\_148.jpg

05/24/2011 Tree must be trimmed up 5'. Issue noted in Fall 2010 inspection.

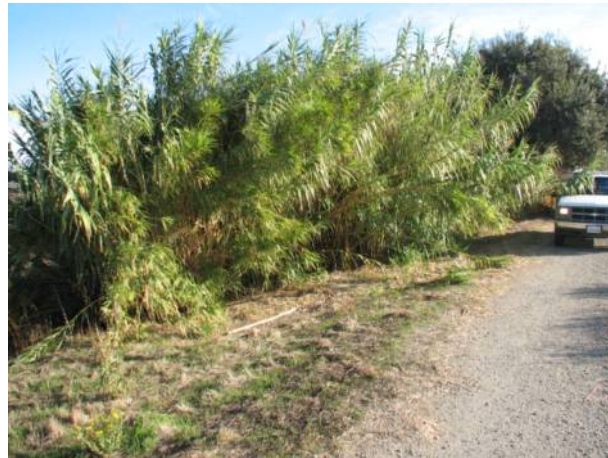
mkhashch\_s\_20120511\_149.jpg

Bamboo on levee slope and crown obstruct access and visibility.

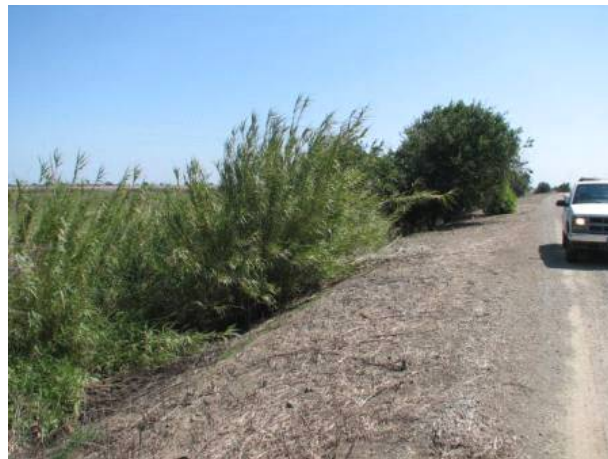
Levee Mile Report Line	16
Start Levee Mile	0.24
End Levee Mile	0.24
Location	Land Side
Category	Earthen Levee
Item	Vegetation

05/24/2011 Bamboo has been trimmed back off of crown, but still completely blocks access and visibility.

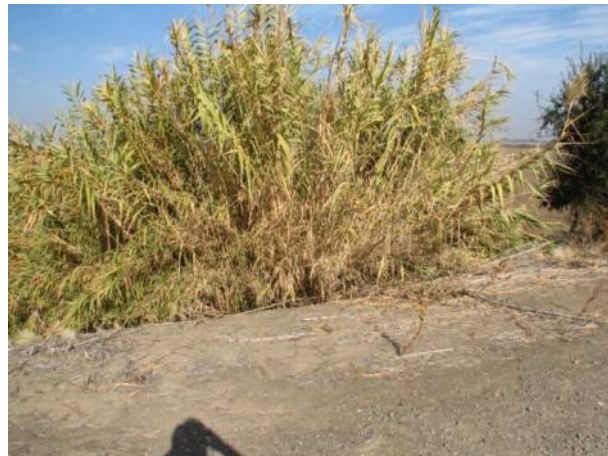
Levee Mile Report Line	16
Start Levee Mile	0.24
End Levee Mile	0.24
Location	Land Side
Category	Earthen Levee
Item	Vegetation

11/10/2011 Arundo has been trimmed back, but vegetation on the landside slope must be cleared to 15' beyond the toe.

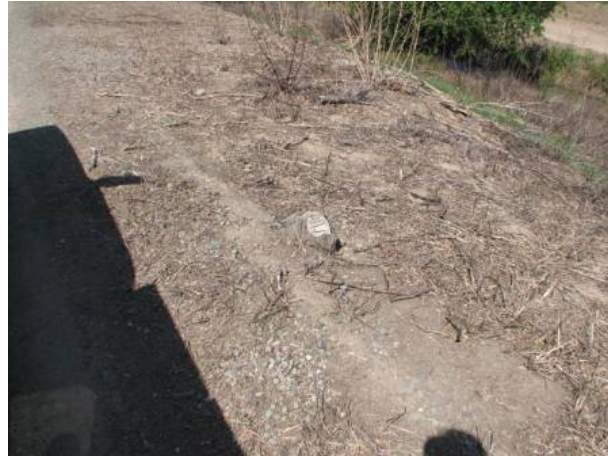
mkhashch\_s\_20120511\_095.jpg

05/24/2011 Stump is located in center of photo.

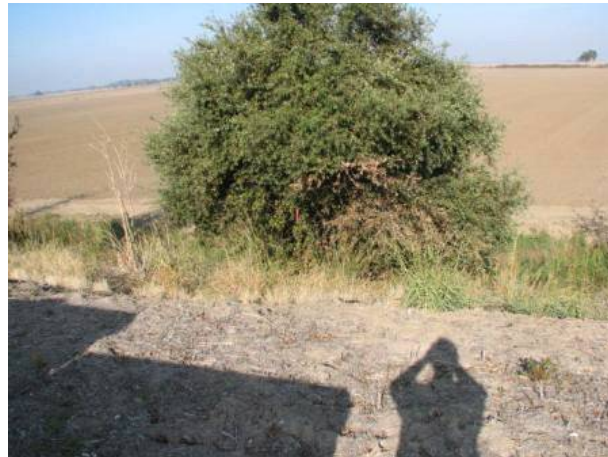
Levee Mile Report Line	18
Start Levee Mile	0.26
End Levee Mile	0.26
Location	Land Side
Category	Earthen Levee
Item	Trim / Thin Trees

11/10/2011 Tree obstructs visibility and access to slope, needs to be limbed up to 5'.

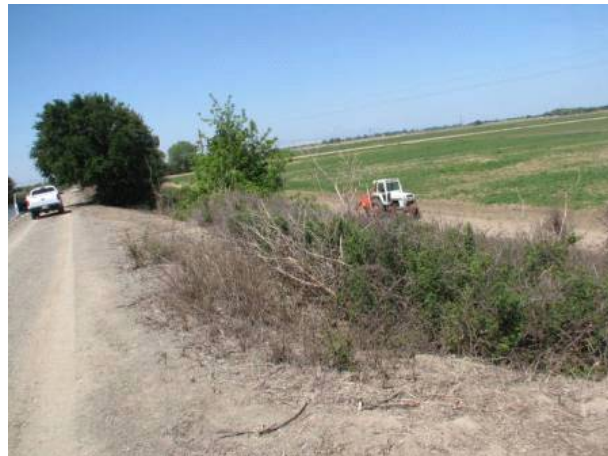
Levee Mile Report Line	19
Start Levee Mile	0.27
End Levee Mile	0.39
Location	Land Side
Category	Earthen Levee
Item	Vegetation

05/24/2011 Thick brush and wild rose completely block access and visibility of landside slope and toe.

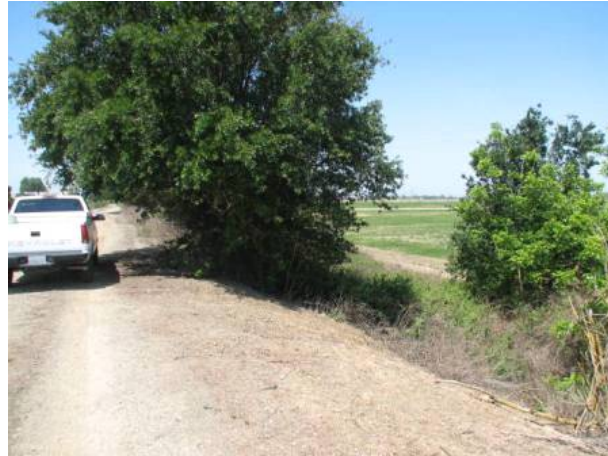
Levee Mile Report Line	20
Start Levee Mile	0.29
End Levee Mile	0.34
Location	Land Side
Category	Earthen Levee
Item	Trim / Thin Trees
05/24/2011 Numerous trees and thick vegetation in area, trees need to be trimmed to 12' above roadway and up 5' on landside slope and toe to allow access and visibility.	
mkhashch_s_20120511_104.jpg

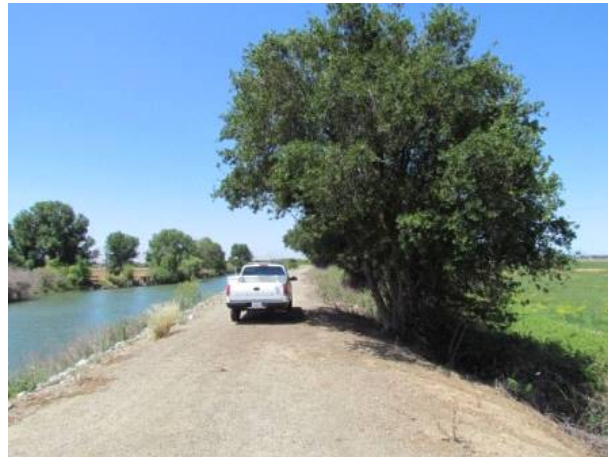
Levee Mile Report Line	20
Start Levee Mile	0.29
End Levee Mile	0.34
Location	Land Side
Category	Earthen Levee
Item	Trim / Thin Trees
Numerous trees and thick vegetation in area, trees are trimmed to 12' above roadway but not 5' on landside slope and toe to allow access and visibility.	
mkhashch_s_20120525_397.jpg

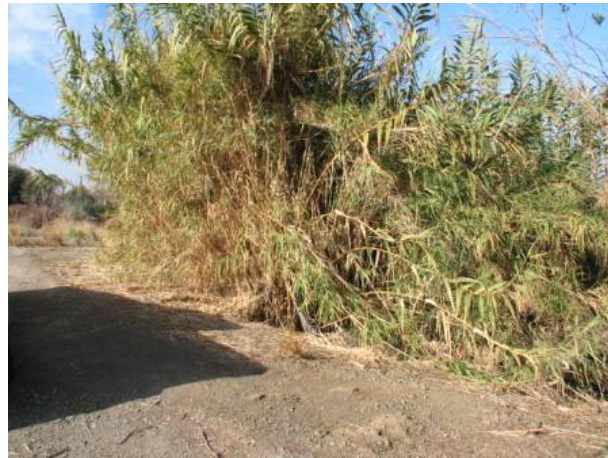
mkhashch\_s\_20120511\_107.jpg

11/10/2011 Arundo has been trimmed back from the road, but needs to be removed to so that it does not obstruct visibility and access to the landside slope.

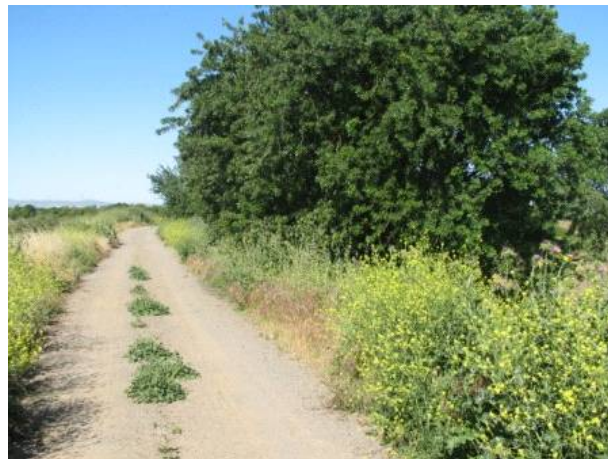
Levee Mile Report Line	22
Start Levee Mile	0.38
End Levee Mile	0.38
Location	Land Side
Category	Earthen Levee
Item	Trim / Thin Trees

Trees on levee slope obstruct access and visibility.

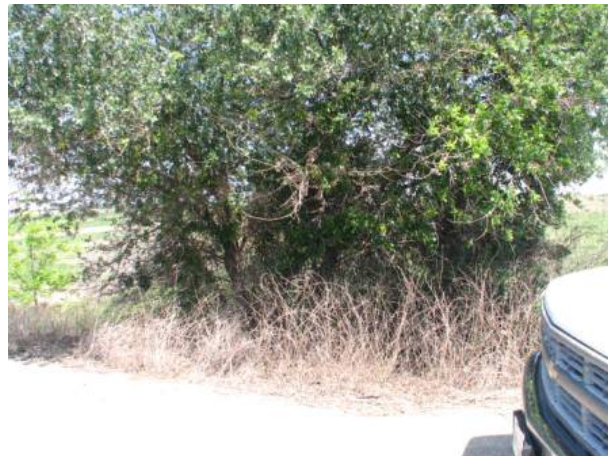
Levee Mile Report Line	23
Start Levee Mile	0.39
End Levee Mile	0.39
Location	Land Side
Category	Earthen Levee
Item	Trim / Thin Trees

05/24/2011 Tree needs to be trimmed up 5' to allow access and visibility to landside slope.

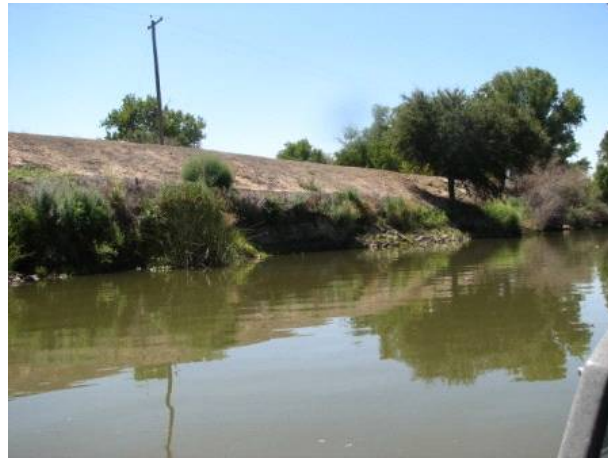
mkhashch\_s\_20120511\_142.jpg

DWR ID: DWR_RD2089_01_s_2012_26									
24	0.41	0.41	Supplemental	DWR Erosion Survey	WSA/W Ma	Inspector Comments: 08/23/2011: Boat survey uncovered a 10-ft vertical scarp just upstream of the revetment. Vegetation and trees on site. 09/07/2010: Site appears to have been repaired by placing shot rock as rip rap protection. Note patches of seasonal grass on revetment. It is recommended that an inspection in the near future be conducted to verify the condition of the revetment. Site was previously rated "M". 08/06/2010: Recommended as local maintenance issue, per CLRO. 09/28/2009: Rock protection was recently placed along the upper slope; photographs need to be updated; site is recommended for annual assessment and monitoring of erosion site, per CLRO CES Evaluation 2008 Report; Site # is the same as RM29.84, LM0.30; previously rated "M". 11/05/2008: Two sites have been combined as one supersite; steep ws slope and downstream of a pump. 10/20/2006: Visited site 10/20/2006. [2011 Site ID: RD2089U01RM29.83]	37.809530 ° -121.392160 °	37.809530 ° -121.392160 °	52 Y

Upstream view of the scarp at the levee toe

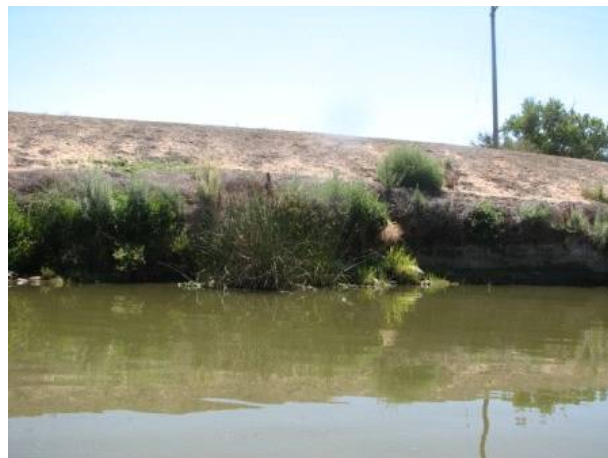
mkhashch\_s\_20120511\_144.jpg

Front view of the repaired site.

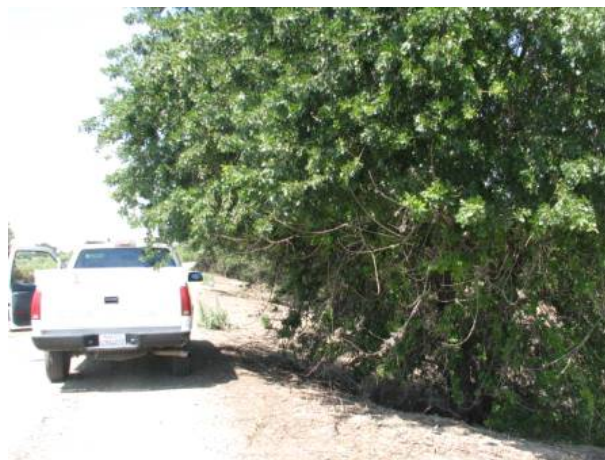
mkhashch\_s\_20120511\_113.jpg

05/24/2011 Trees need to be trimmed to 12' over roadway and up 5' on levee slope to allow access and visibility.

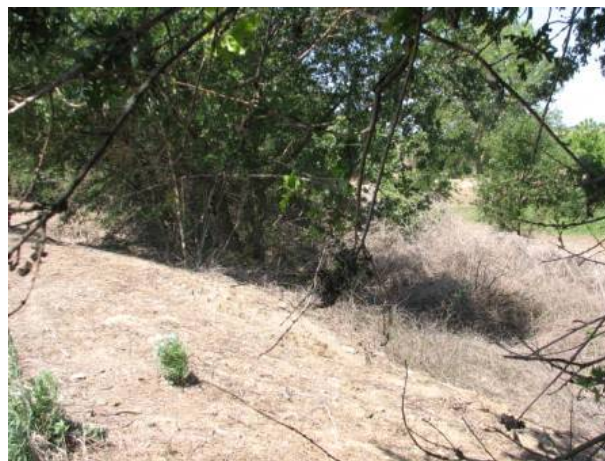
Levee Mile Report Line	26
Start Levee Mile	0.42
End Levee Mile	0.48
Location	Land Side
Category	Earthen Levee
Item	Vegetation

05/24/2011 Photo shows thick dead vegetation and continuation of trees in area that are preventing access and visibility of landside slope and toe.

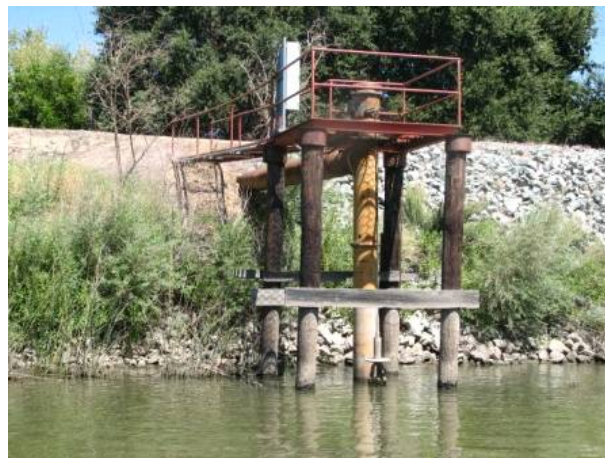
Levee Mile Report Line	27
Start Levee Mile	0.45
End Levee Mile	0.45
Location	Water Side
Category	Supplemental
Item	DWR Erosion Survey

Front view of the site. Note the color of material around the pipe crossing.

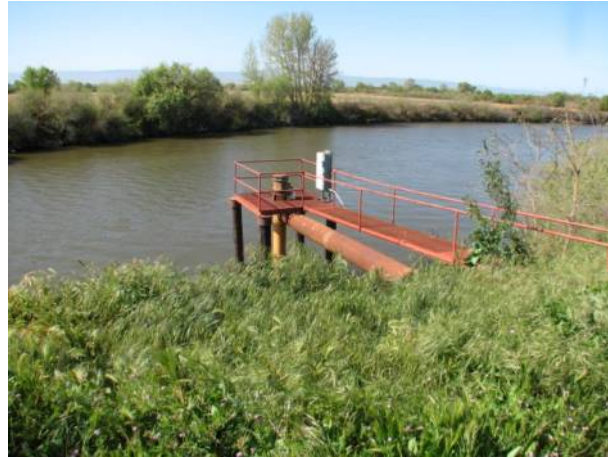
mkhashch\_s\_20120511\_097.jpg

Irrigation intake pump and pipe at LM 0.46.

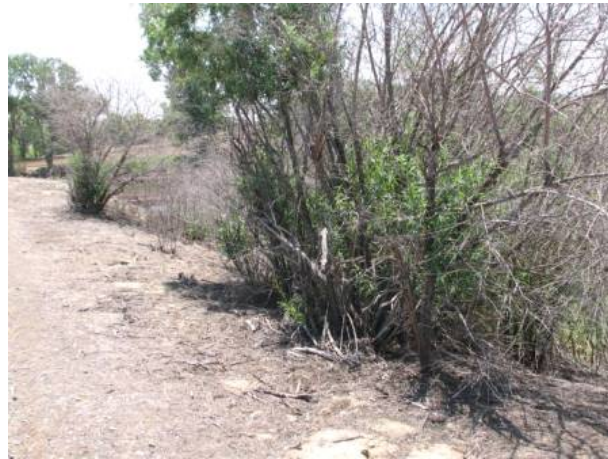
Levee Mile Report Line	29
Start Levee Mile	0.50
End Levee Mile	0.50
Location	Water Side
Category	Earthen Levee
Item	Trim / Thin Trees

05/24/2011 Trees on waterside need to be thinned to allow access and visibility of top 20' of waterside slope.

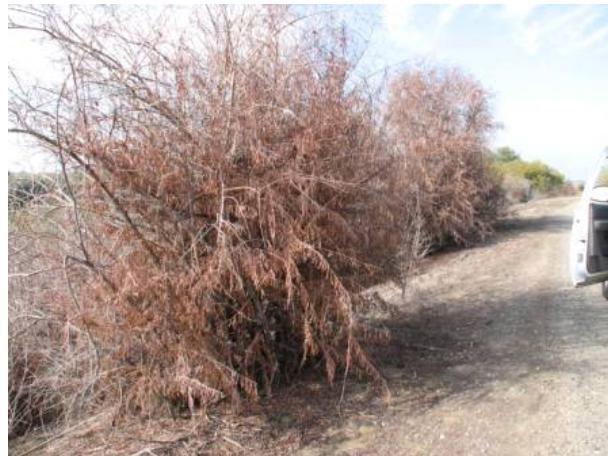
Levee Mile Report Line	29
Start Levee Mile	0.50
End Levee Mile	0.50
Location	Water Side
Category	Earthen Levee
Item	Trim / Thin Trees

11/10/2011 Woody vegetation needs to be cleared off of the upper 20' of the waterside slope.

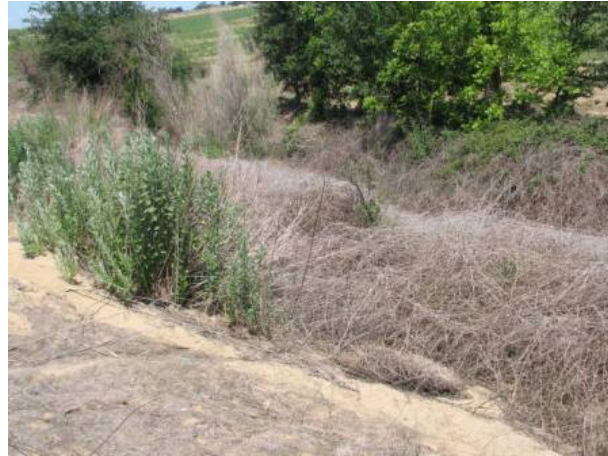
Levee Mile Report Line	30
Start Levee Mile	0.50
End Levee Mile	0.50
Location	Land Side
Category	Earthen Levee
Item	Vegetation
05/24/2011 Dead brush is too thick to allow access and visibility of landside slope and toe.	
mkhashch_s_20120511_117.jpg

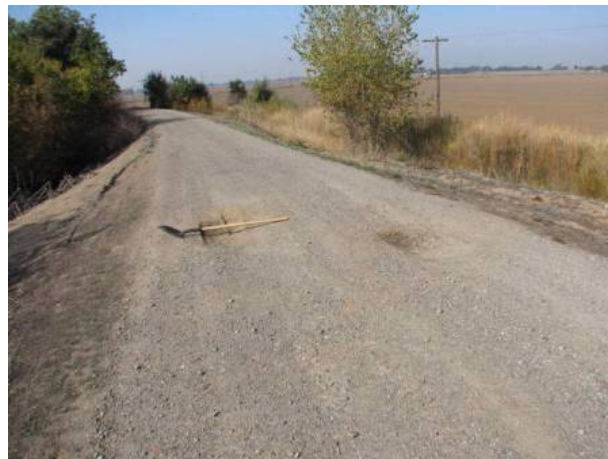
31	0.56	0.56	Earthen Levee	Crown Surface / Depressions / Rutting	CR	M Ma	C3 : Add appropriate gravel or road base. Grade and compact. Inspector Comments: 11/10/2011 Minor depressions will cause ponding.	37.810087 ° -121.394200 °	37.810087 ° -121.394200 °	14 Y
DWR ID: DWR_RD2089_01_s_2012_14										
32	0.60	0.60	Earthen Levee	Trim / Thin Trees	LS	M Ma	T1 : Trim trees to at least five feet above ground level. Inspector Comments: 05/24/2011 Issue remains unchanged since Fall 2010, photo attached	37.810230 ° -121.394967 °	37.810230 ° -121.394967 °	950 Y
DWR ID: DWR_RD2089_01_s_2012_950										
33	0.64	1.53	Earthen Levee	Vegetation	WS	U Ma	V2 : Remove the wild growth other than native grasses from the levee slopes. Inspector Comments: 11/10/2011 Waterside vegetation is too thick to allow access and visibility.	37.810048 ° -121.395762 °	37.806534 ° -121.407531 °	18 Y
DWR ID: DWR_RD2089_01_s_2012_18

Levee Mile Report Line	31
Start Levee Mile	0.56
End Levee Mile	0.56
Location	Crown
Category	Earthen Levee
Item	Crown Surface / Depressions / Rutting
11/10/2011 Depressions in crown.	
mkhashch_s_20120511_101.jpg

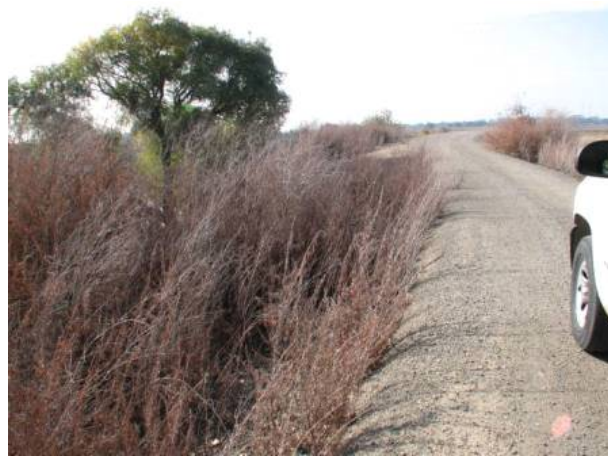
mkhashch\_s\_20120511\_105.jpg

11/10/2011 Vegetation needs to be cleared on the upper 20' of the waterside slope.

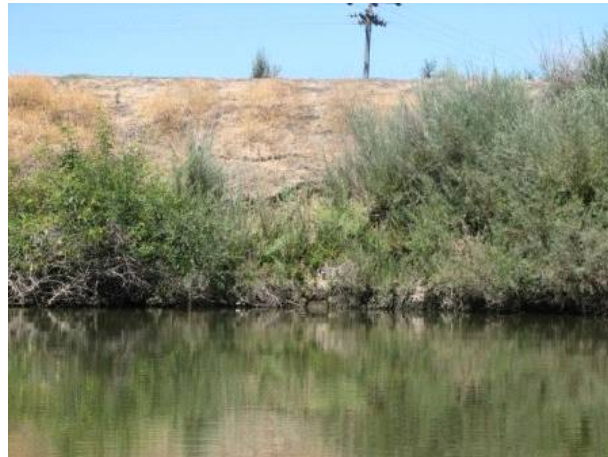
Levee Mile Report Line	35
Start Levee Mile	0.66
End Levee Mile	0.66
Location	Water Side
Category	Supplemental
Item	DWR Erosion Survey

Front view of the site. The scarp is visible on the slope.

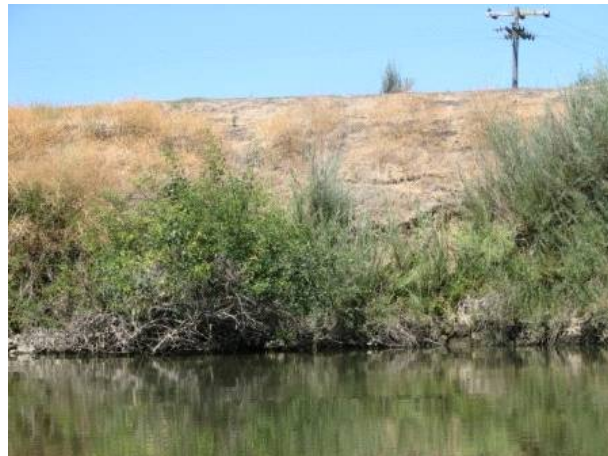
Levee Mile Report Line	35
Start Levee Mile	0.66
End Levee Mile	0.66
Location	Water Side
Category	Supplemental
Item	DWR Erosion Survey

Downstream view of the site. Note the very dense white willow thickets on site.

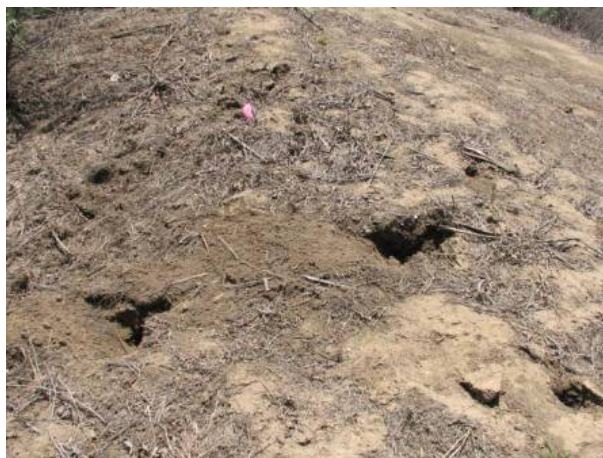
mkhashch\_s\_20120511\_119.jpg

05/24/2011 Two active burrows shown in photo.

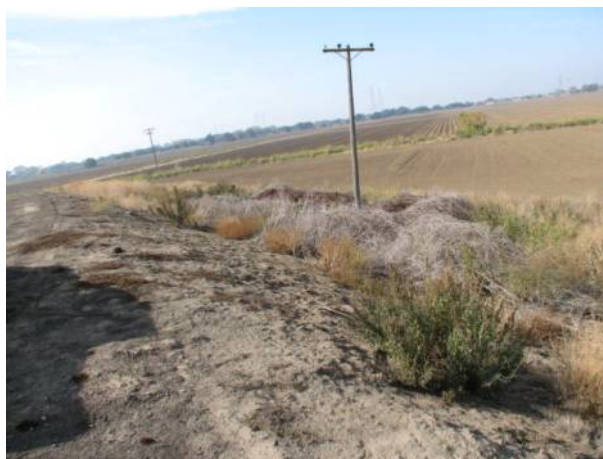
Levee Mile Report Line	38
Start Levee Mile	0.73
End Levee Mile	0.77
Location	Land Side
Category	Earthen Levee
Item	Vegetation

11/10/2011 Vegetation obstructs visibility of slope and toe.

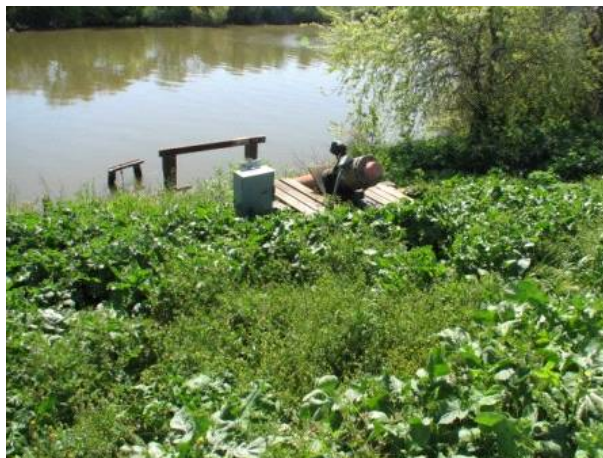
Levee Mile Report Line	39
Start Levee Mile	0.82
End Levee Mile	0.82
Location	Water Side
Category	Earthen Levee
Item	Encroachments

Irrigation intake pump and pipe on levee slope.

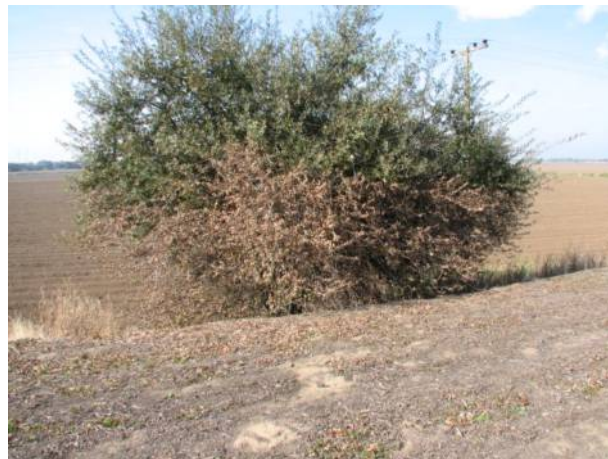
Levee Mile Report Line	41
Start Levee Mile	0.88
End Levee Mile	0.88
Location	Land Side
Category	Earthen Levee
Item	Trim / Thin Trees

11/10/2011 Tree appears to have been sprayed, needs to be limbed up 5' to allow for visibility of slope and toe.

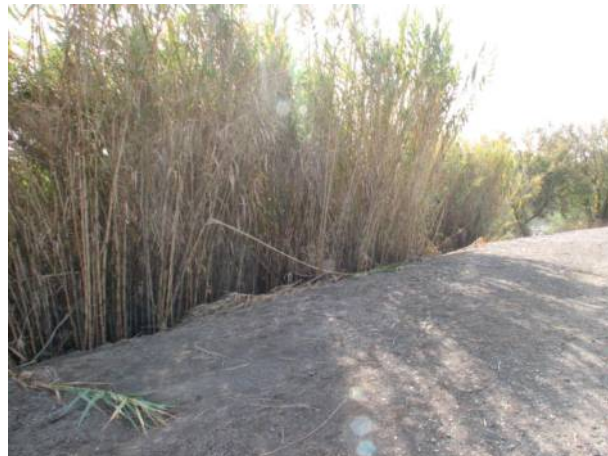
Levee Mile Report Line	42
Start Levee Mile	0.96
End Levee Mile	0.96
Location	Water Side
Category	Earthen Levee
Item	Vegetation

11/10/2011 Arundo on upper 20' of waterside slope.

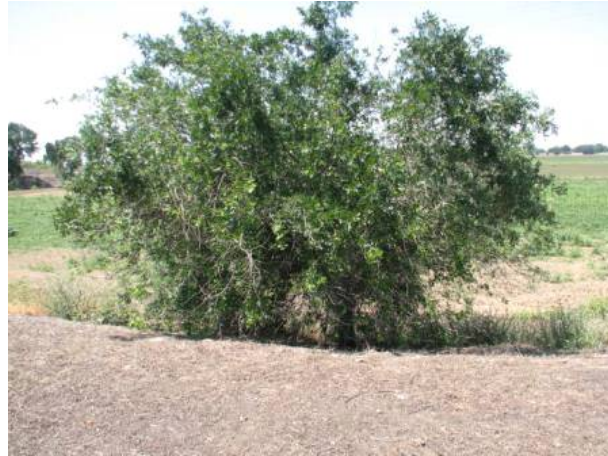
05/24/2011 Tree needs to be trimmed up 5'.

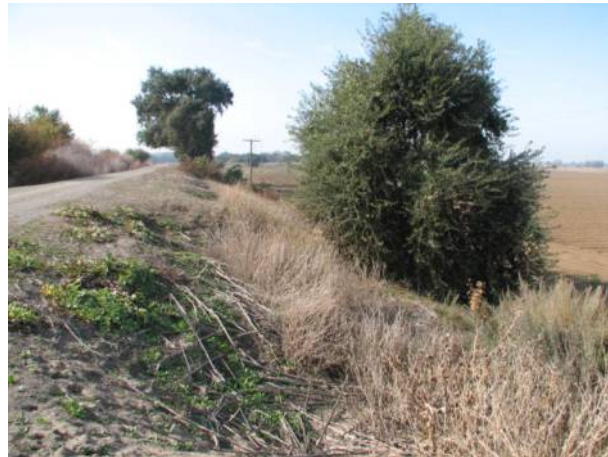
Levee Mile Report Line	44
Start Levee Mile	0.98
End Levee Mile	0.98
Location	Land Side
Category	Earthen Levee
Item	Vegetation

11/10/2011 Vegetation obstructs visibility of the slope and toe.

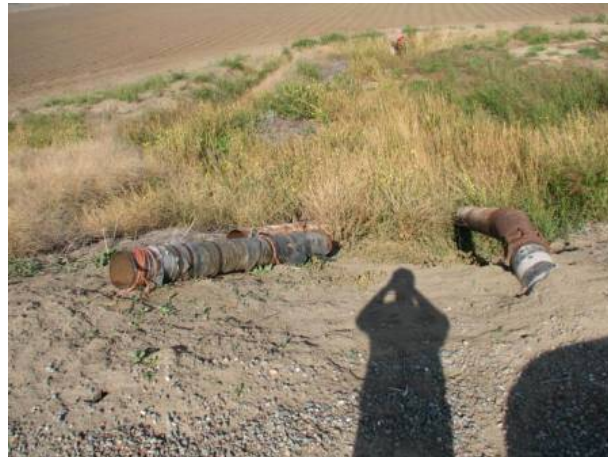
11/10/2011 Section of ductilie iron pipe that  
spears to be left from a pipe repair. Needs to be  
removed.

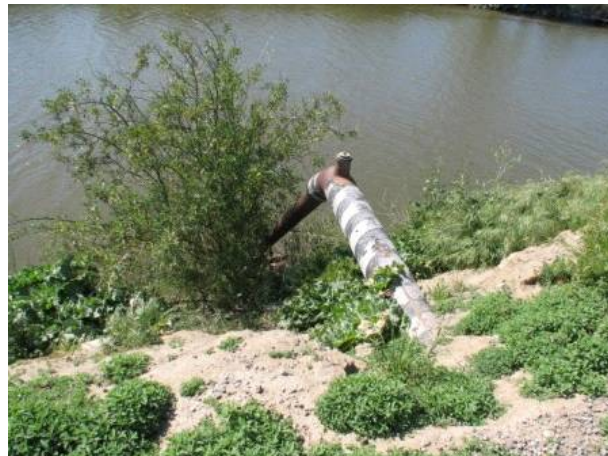
Levee Mile Report Line	50
Start Levee Mile	1.16
End Levee Mile	1.16
Location	Water Side
Category	Earthen Levee
Item	Encroachments

Drainage discharge into Old River.

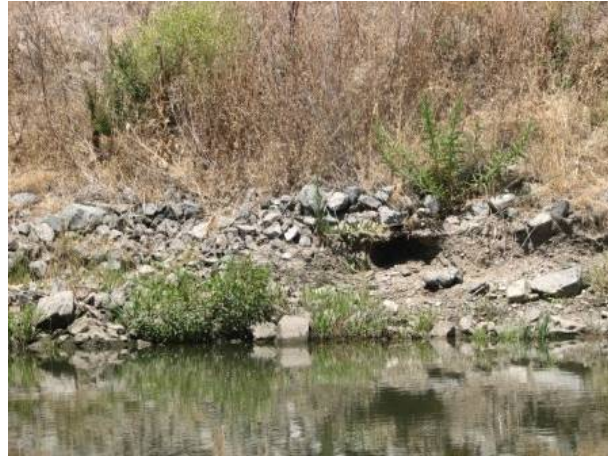
A close view of the minor erosion activities.

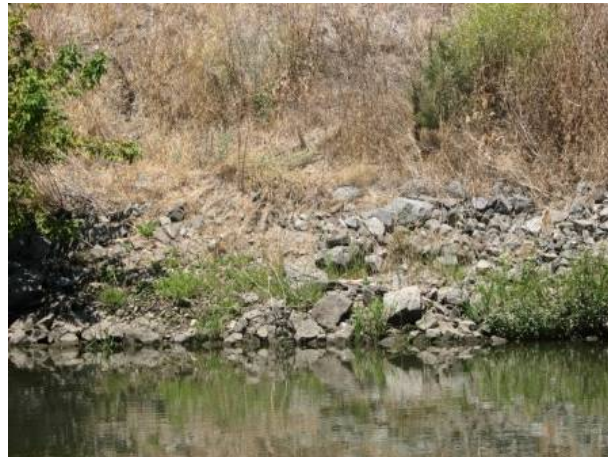
Levee Mile Report Line	51
Start Levee Mile	1.18
End Levee Mile	1.18
Location	Water Side
Category	Supplemental
Item	DWR Erosion Survey

Front view of the site.

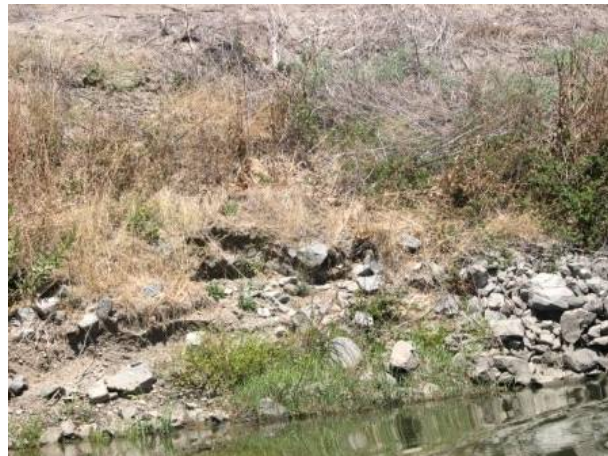
Levee Mile Report Line	51
Start Levee Mile	1.18
End Levee Mile	1.18
Location	Water Side
Category	Supplemental
Item	DWR Erosion Survey

Close view of the minor erosion activities.

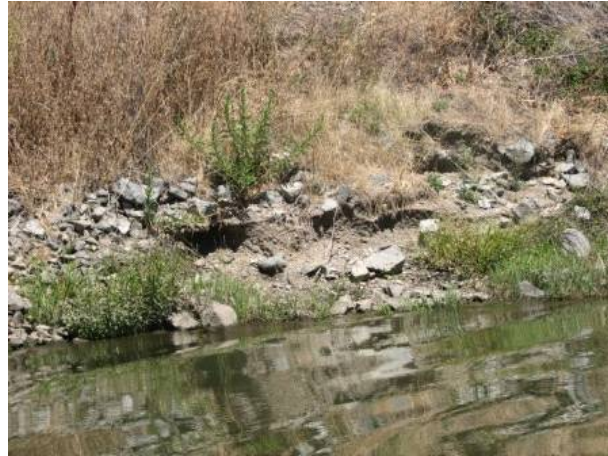
Close view of the minor erosion activities.

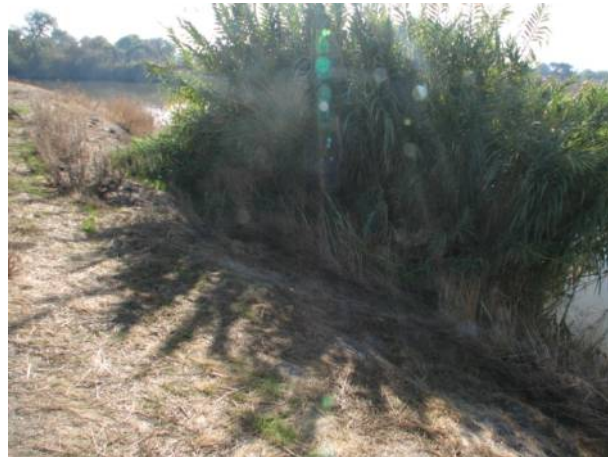
Levee Mile Report Line	52
Start Levee Mile	1.22
End Levee Mile	1.22
Location	Water Side
Category	Earthen Levee
Item	Vegetation

Bamboo on waterside levee slope obstructs access and visibility.

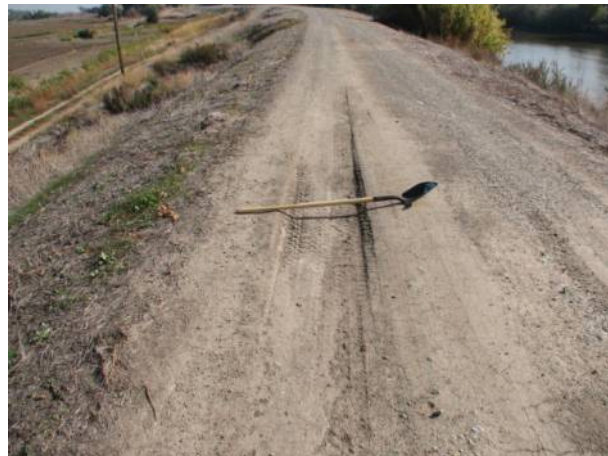
Levee Mile Report Line	53
Start Levee Mile	1.25
End Levee Mile	1.25
Location	Crown
Category	Earthen Levee
Item	Crown Surface / Depressions / Rutting

11/10/2011 Depression in roadway.

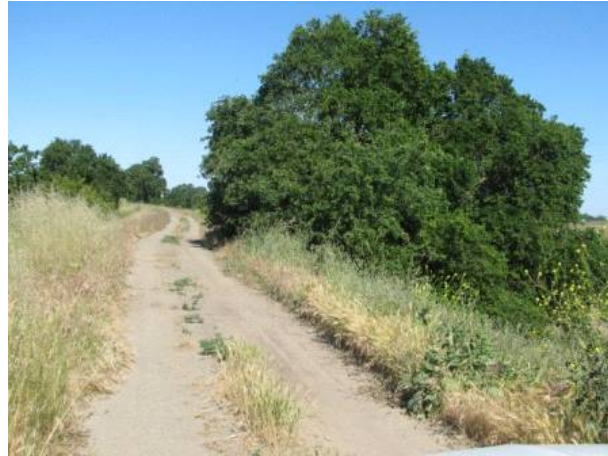
Levee Mile Report Line	54
Start Levee Mile	1.26
End Levee Mile	1.26
Location	Land Side
Category	Earthen Levee
Item	Trim / Thin Trees
Trees on levee slope obstruct access and visibility.	
mkhashch_s_20120511_102.jpg

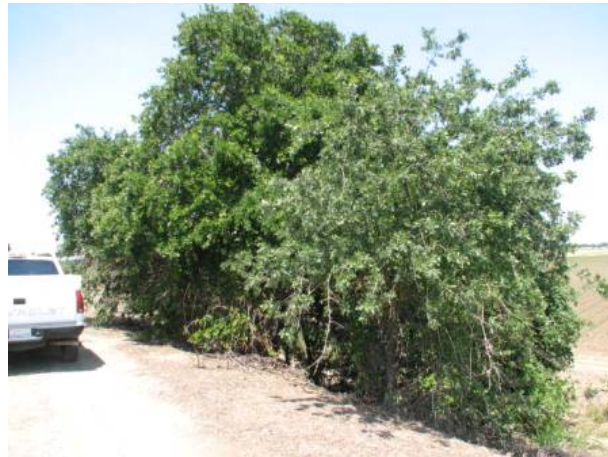
Levee Mile Report Line	54
Start Levee Mile	1.26
End Levee Mile	1.26
Location	Land Side
Category	Earthen Levee
Item	Trim / Thin Trees
05/24/2011 Trees have been trimmed since Fall 2010 inspection, however they still need to be trimmed up 5' to allow visibility of slope and access in a flood fight.	
mkhashch_s_20120511_103.jpg

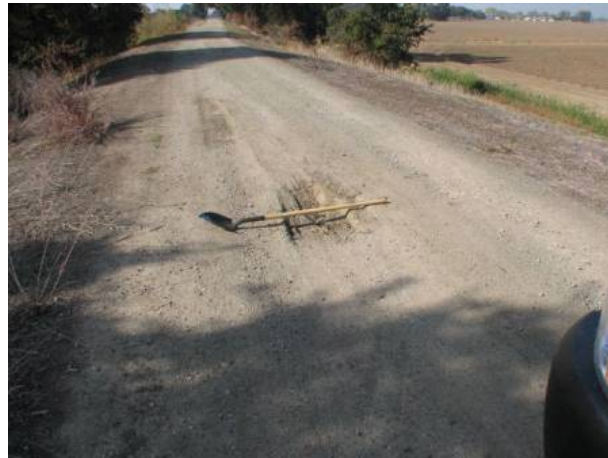
Levee Mile Report Line	56
Start Levee Mile	1.38
End Levee Mile	1.38
Location	Crown
Category	Earthen Levee
Item	Crown Surface / Depressions / Rutting
11/10/2011 Roadway depression.	
mkhashch_s_20120511_128.jpg

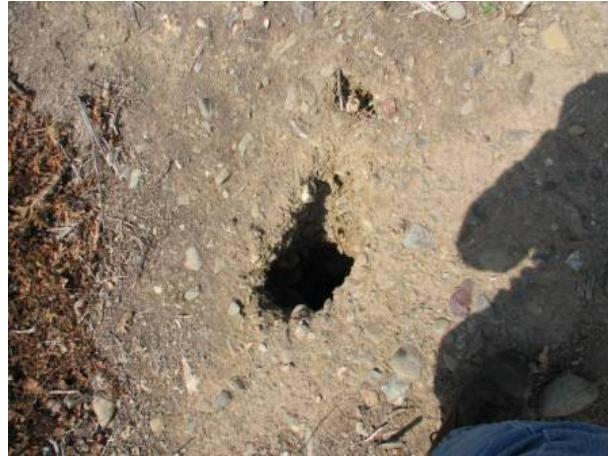
Levee Mile Report Line	61
Start Levee Mile	1.47
End Levee Mile	1.47
Location	Water Side
Category	Earthen Levee
Item	Animal Control
11/10/2011 Deep burrow on waterside.	
mkhashch_s_20120511_133.jpg

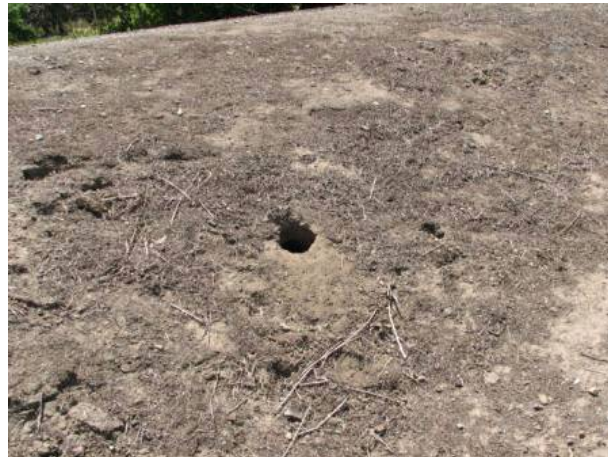
Levee Mile Report Line	6
Start Levee Mile	0.38
End Levee Mile	0.38
Location	Land Side
Category	Earthen Levee
Item	Animal Control
05/24/2011 Active rodent burrow.	
mkhashch_s_20120511_170.jpg

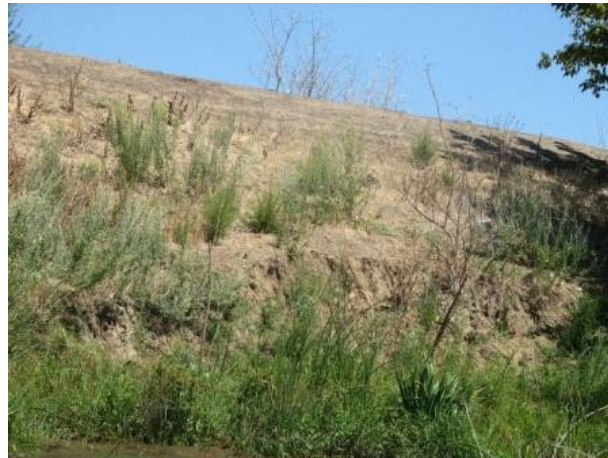
A closer look of the site with minor erosions.

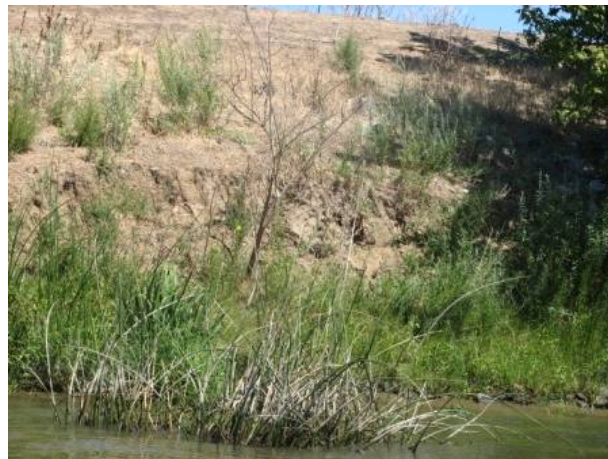
Levee Mile Report Line	8
Start Levee Mile	0.42
End Levee Mile	0.43
Location	Water Side
Category	Supplemental
Item	DWR Erosion Survey

A closer look of the site with minor erosions.

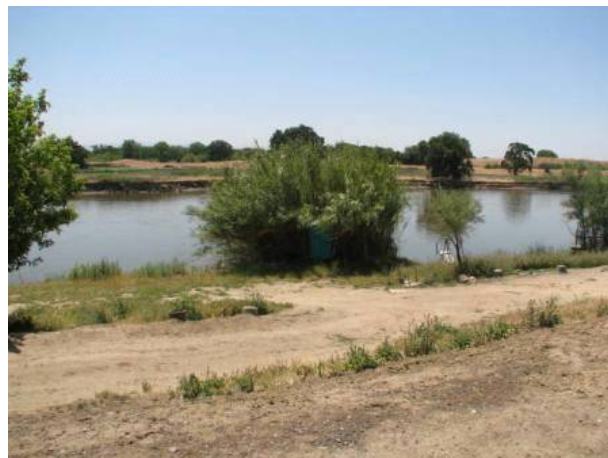
Levee Mile Report Line	9
Start Levee Mile	0.46
End Levee Mile	0.46
Location	Water Side
Category	Earthen Levee
Item	Encroachments

05/24/2011 Portable toilet is in the shadows in the center of the photo at the water's edge.

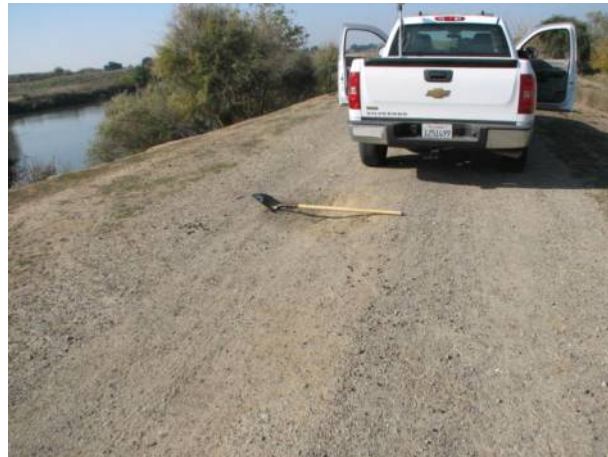
Levee Mile Report Line	11
Start Levee Mile	0.49
End Levee Mile	0.49
Location	Crown
Category	Earthen Levee
Item	Crown Surface / Depressions / Rutting
11/10/2011 Depression in crown needs to be filled.	
mkhashch_s_20120511_163.jpg

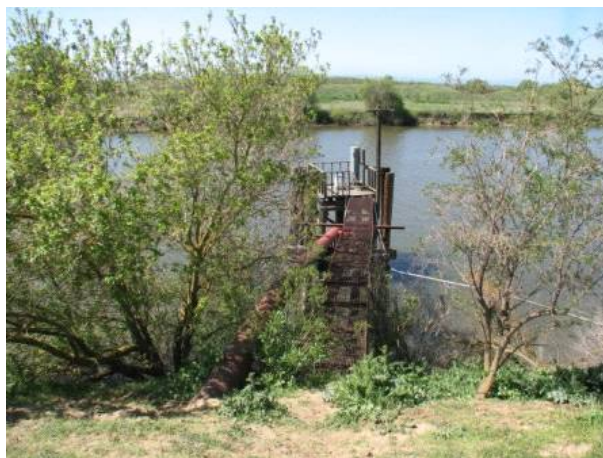
Irrigation intake pump and pipe at waterside slope.

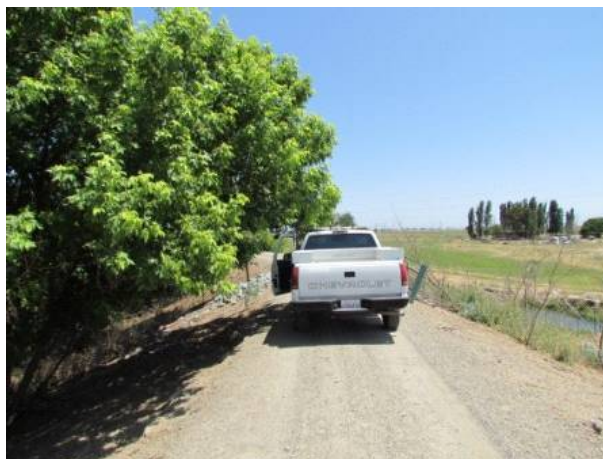
Levee Mile Report Line	14
Start Levee Mile	0.70
End Levee Mile	0.70
Location	Water Side
Category	Earthen Levee
Item	Trim / Thin Trees

View of low hanging branches over waterside slope and crown. 05/24/2012

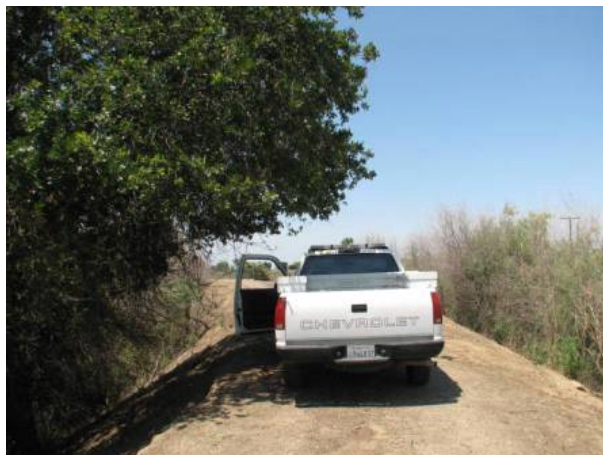
Levee Mile Report Line	15
Start Levee Mile	0.82
End Levee Mile	0.82
Location	Water Side
Category	Earthen Levee
Item	Trim / Thin Trees

05/24/2011 Trees need to be trimmed up 12' over road.

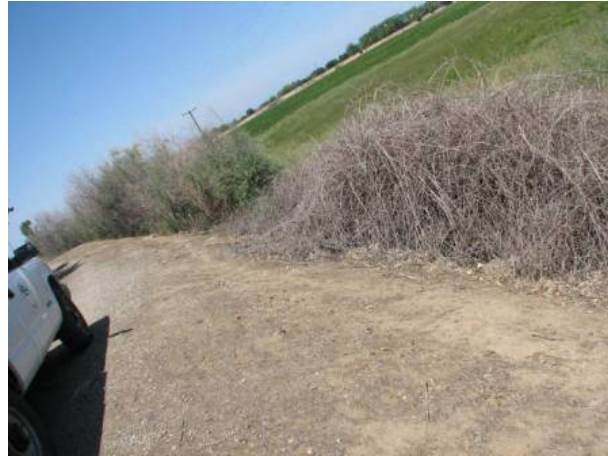
05/24/2011 Extremely thick dead brush prevents access and visibility.

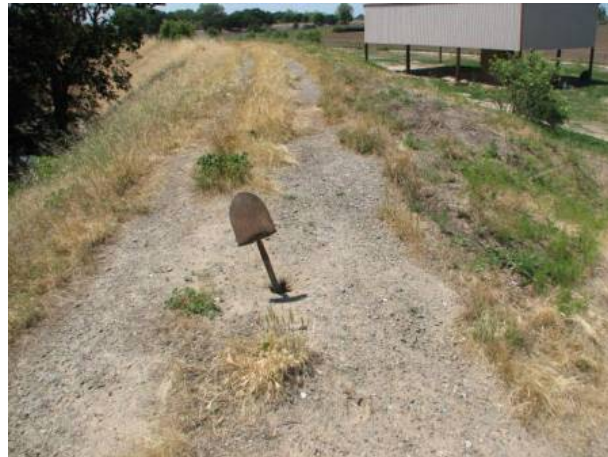
Levee Mile Report Line	21
Start Levee Mile	0.87
End Levee Mile	0.92
Location	Land Side
Category	Earthen Levee
Item	Animal Control

05/24/2011 Deep vertical burrow in levee crown.

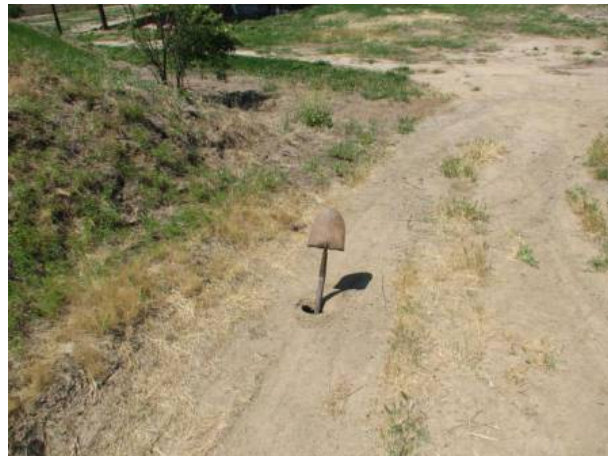
Levee Mile Report Line	21
Start Levee Mile	0.87
End Levee Mile	0.92
Location	Land Side
Category	Earthen Levee
Item	Animal Control

05/24/2011 Deep vertical burrow in ramp on land side of levee.

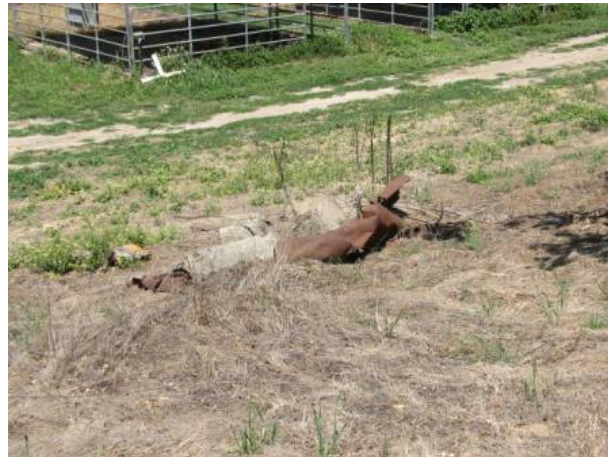
Levee Mile Report Line	23
Start Levee Mile	0.99
End Levee Mile	0.99
Location	Land Side
Category	Earthen Levee
Item	Encroachments
05/24/2011 Concrete and metal debris at landside toe needs to be removed.	
mkhashch_s_20120511_172.jpg

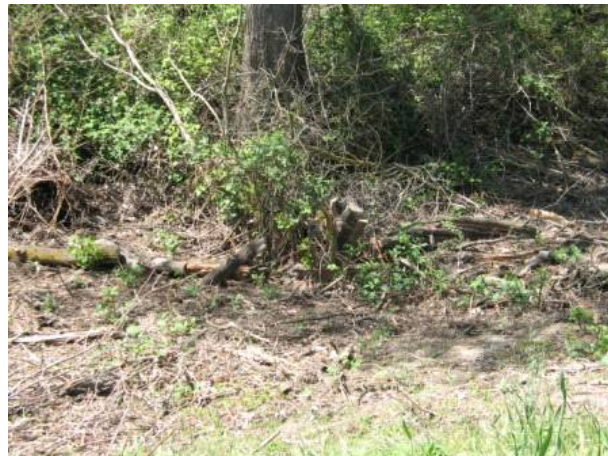
Levee Mile Report Line	25
Start Levee Mile	1.07
End Levee Mile	1.07
Location	Water Side
Category	Earthen Levee
Item	Trim / Thin Trees
Tree stump >2" left after vegetation and tree removal.	
mkhashch_s_20120511_173.jpg

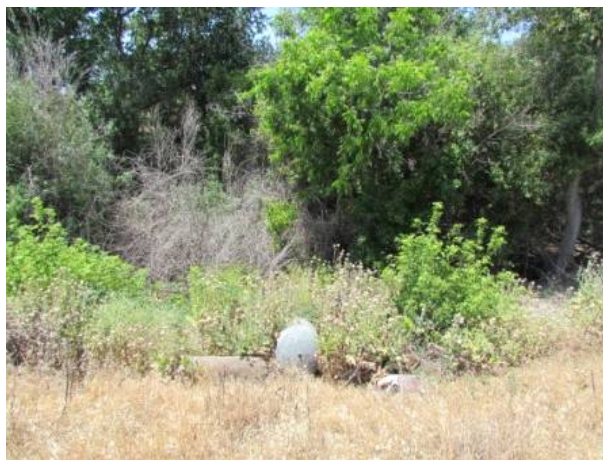
View of water tanks disposed on waterside slope.

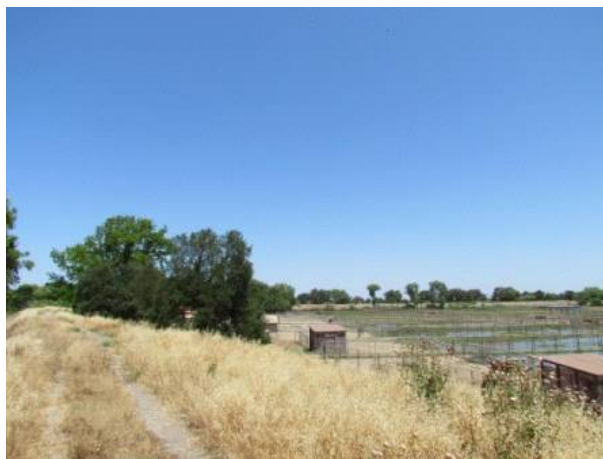
Levee Mile Report Line	28
Start Levee Mile	1.18
End Levee Mile	1.18
Location	Land Side
Category	Earthen Levee
Item	Vegetation

View of tall annual grass on landside levee slope and crown. 05/24/2012
