**Flood Control Project Maintenance  
Levee Inspections****LMA District Cover Sheet****Spring 2013 Levee Inspection Results****Reclamation District No. 2089 Stark**

**Levee Inspection Report By Mile - Spring 2013**

**Reclamation District No. 2089 Stark**

Waterway				Bank	Unit Miles	Inspection Start/End	Inspector
Unit No. 01 Old River				Right	1.53	05/16/2013 05/16/2013	Maksim Khashchuk

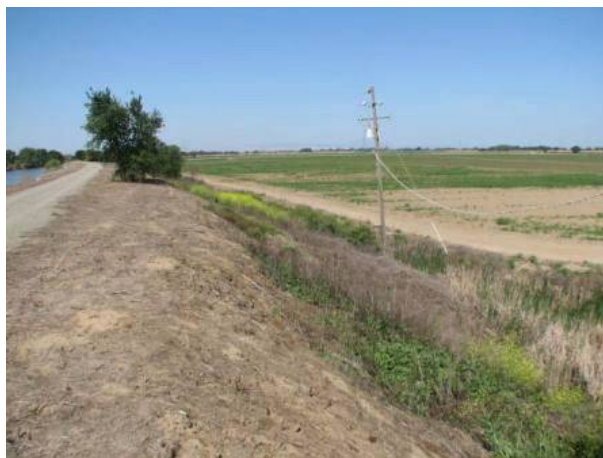
mkhashch\_s\_20130225\_490.jpg

05/24/2011 Ditch flows parallel with the utility line shown in the photo.

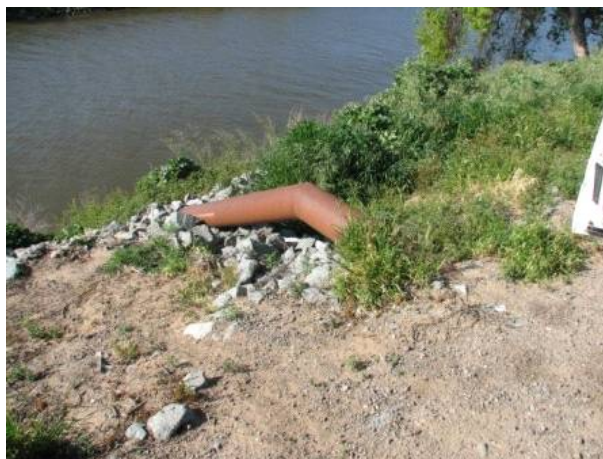
mkhashch\_s\_20130225\_488.jpg

Levee Mile Report Line	7
Start Levee Mile	0.04
End Levee Mile	0.04
Location	Land Side
Category	
Item	Encroachments

Waterside of drainage discharge to Old River.

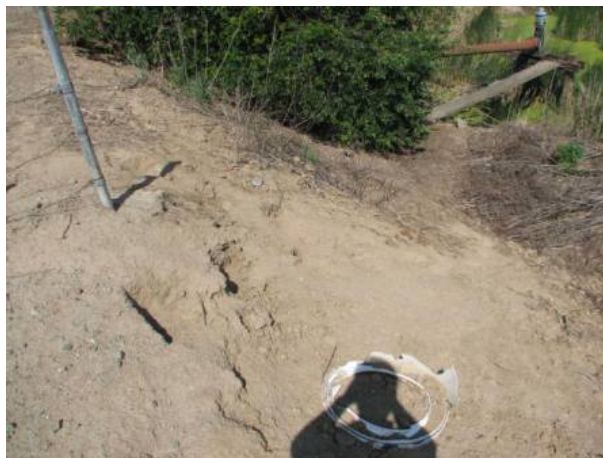
mkhashch\_s\_20130225\_482.jpg

Levee Mile Report Line	8
Start Levee Mile	0.04
End Levee Mile	0.04
Location	Land Side
Category	
Item	Encroachments

05/24/2011 Steps are hard to discern in the photo, the top two steps are casting the two shadows located between the post and the photographer's shadow.

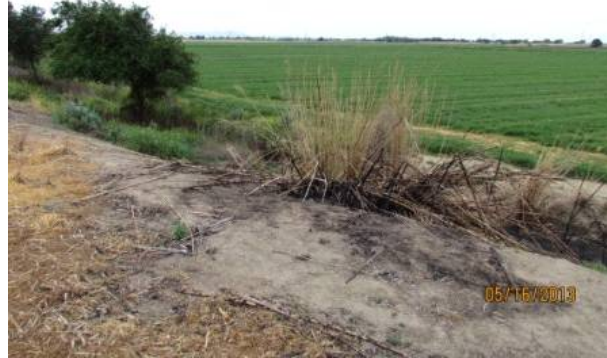
mkhashch\_s\_20130520\_738.JPG

Levee Mile Report Line	14
Start Levee Mile	0.24
End Levee Mile	0.24
Location	Land Side
Category	
Item	Vegetation

LMA is actively trying to remove vegetation on the landside toe.

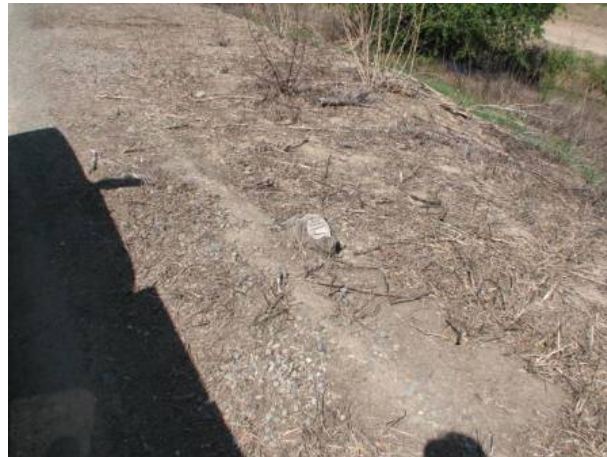
mkhashch\_s\_20130225\_489.jpg

Levee Mile Report Line	15
Start Levee Mile	0.26
End Levee Mile	0.26
Location	Land Side
Category	
Item	Trim / Thin Trees

05/24/2011 Stump is located in center of photo.

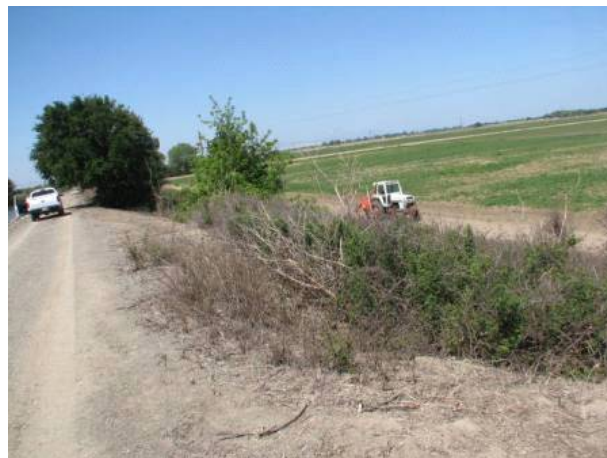
mkhashch\_s\_20130225\_493.jpg

Levee Mile Report Line	17
Start Levee Mile	0.27
End Levee Mile	0.39
Location	Land Side
Category	
Item	Vegetation

05/24/2011 Thick brush and wild rose completely block access and visibility of landside slope and toe.

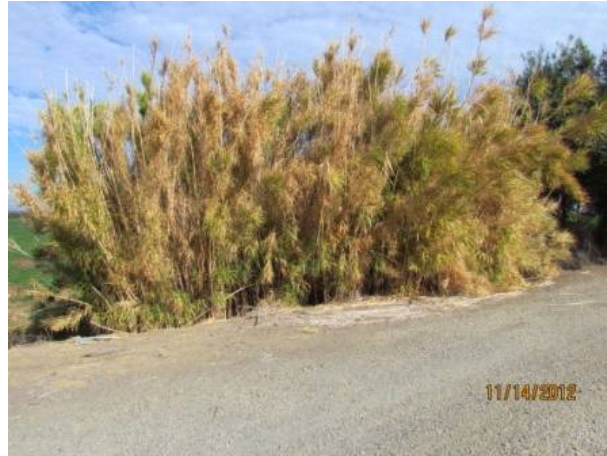
mkhashch\_s\_20130225\_500.JPG

Levee Mile Report Line	19
Start Levee Mile	0.34
End Levee Mile	0.34
Location	Land Side
Category	
Item	Vegetation

Arundo has been trimmed back from the road, but needs to be removed to so that it does not obstruct visibility and access to the landside toe.

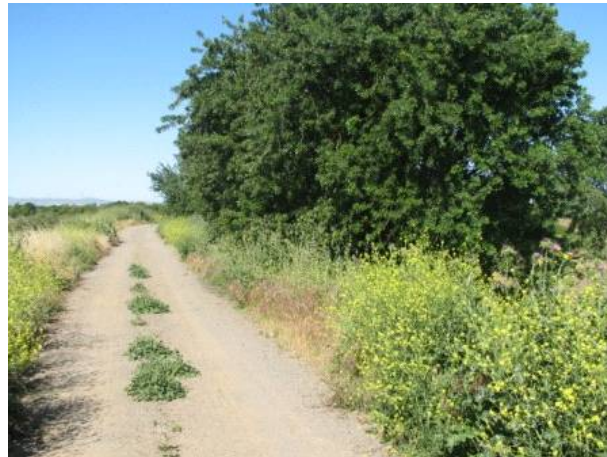
mkhashch\_s\_20130225\_536.jpg

Levee Mile Report Line	20
Start Levee Mile	0.38
End Levee Mile	0.38
Location	Land Side
Category	
Item	Trim / Thin Trees

Trees on levee slope obstruct access and visibility.

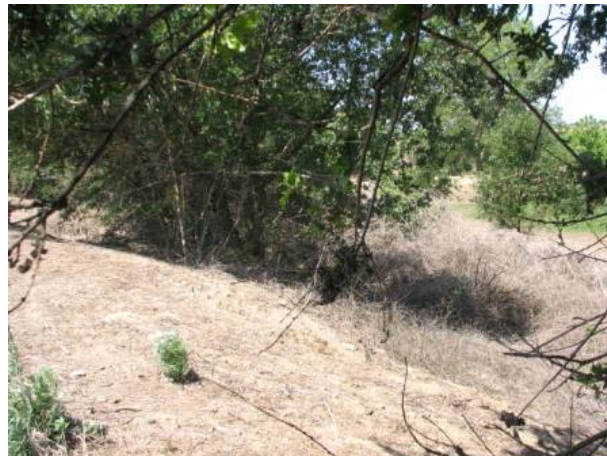
mkhashch\_s\_20130225\_507.jpg

Levee Mile Report Line	23
Start Levee Mile	0.42
End Levee Mile	0.48
Location	Land Side
Category	
Item	Vegetation

05/24/2011 Photo shows thick dead vegetation and continuation of trees in area that are preventing access and visibility of landside slope and toe.

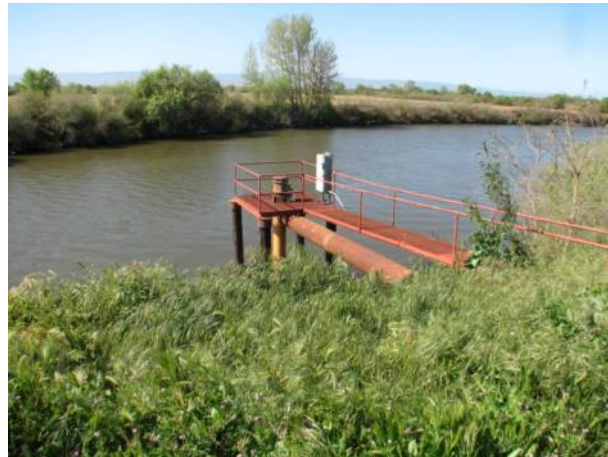
mkhashch\_s\_20130225\_491.jpg

Levee Mile Report Line	25
Start Levee Mile	0.47
End Levee Mile	0.47
Location	Water Side
Category	
Item	Encroachments

Irrigation intake pump and pipe at LM 0.46.

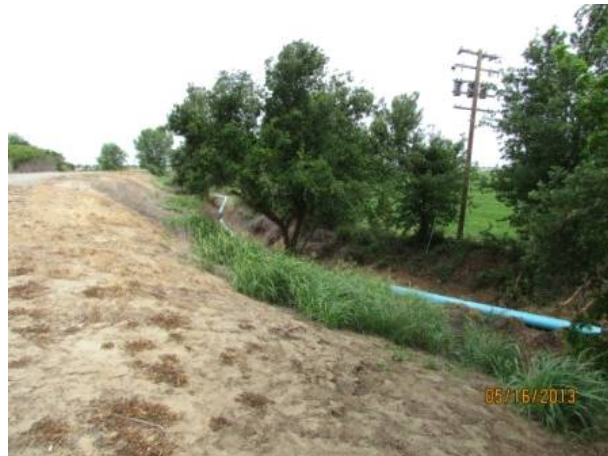
mkhashch\_s\_20130520\_739.JPG

Levee Mile Report Line	26
Start Levee Mile	0.47
End Levee Mile	0.74
Location	Water Side
Category	
Item	Encroachments

View of the ditch at the landside levee toe with an 18 inch pipe placed in the ditch, facing downstream. The pipe will be the primary path to convey water for irrigation.

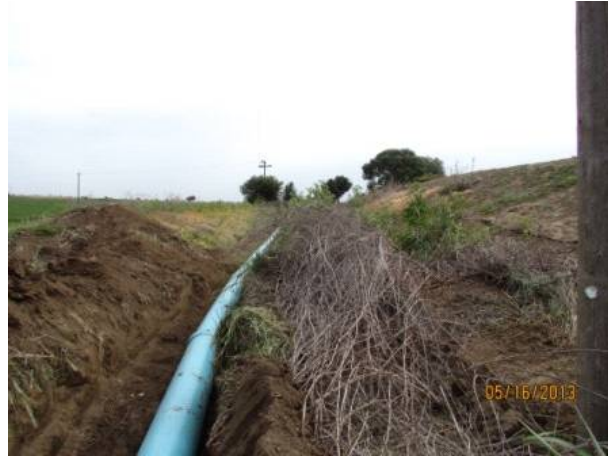
mkhashch\_s\_20130520\_740.JPG

Another view of the ditch and pipe at the landside toe of the levee, facing upstream.

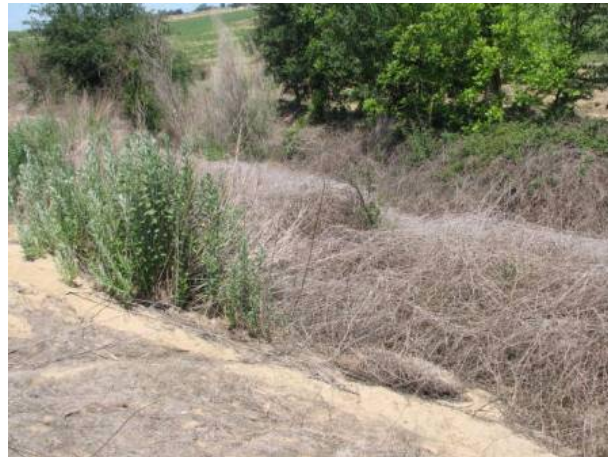
mkhashch\_s\_20130225\_510.jpg

Levee Mile Report Line	28
Start Levee Mile	0.50
End Levee Mile	0.50
Location	Land Side
Category	
Item	Vegetation

05/24/2011 Dead brush is too thick to allow access and visibility of landside slope and toe.

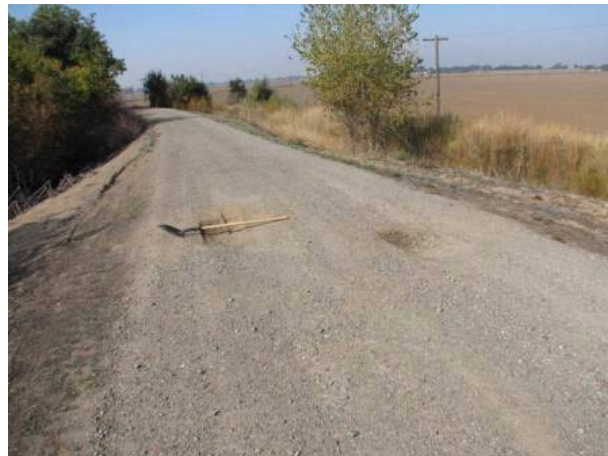
mkhashch\_s\_20130225\_495.jpg

Levee Mile Report Line	29
Start Levee Mile	0.56
End Levee Mile	0.56
Location	Crown
Category	
Item	Crown Surface / Depressions / Rutting

11/10/2011 Depressions in crown.

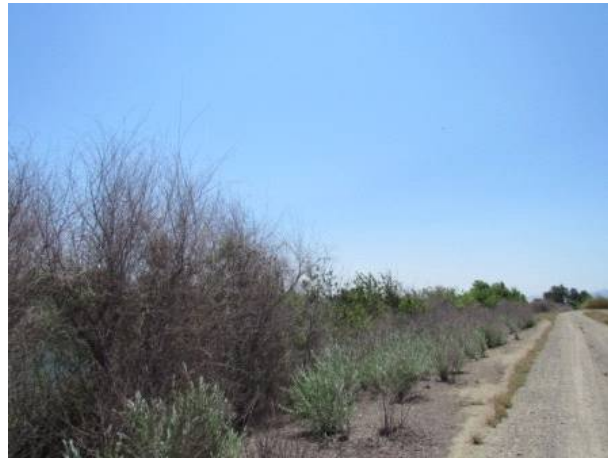
mkhashch\_s\_20130225\_515.jpg

View of tall weeds and brush obstructing visibility on waterside slope. 05/24/2012

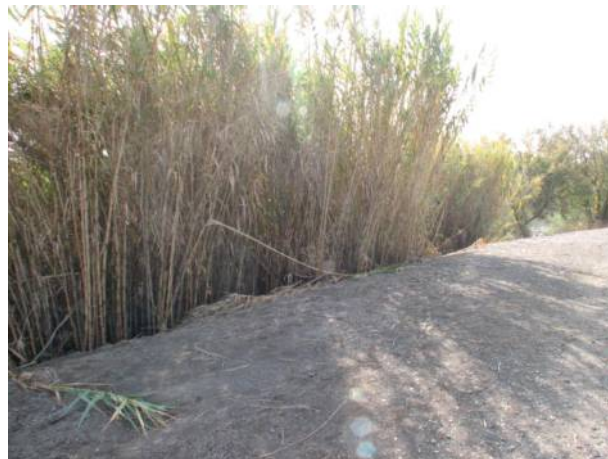
mkhashch\_s\_20130225\_513.jpg

Levee Mile Report Line	40
Start Levee Mile	0.96
End Levee Mile	0.96
Location	Water Side
Category	
Item	Vegetation

11/10/2011 Arundo on upper 20' of waterside slope.

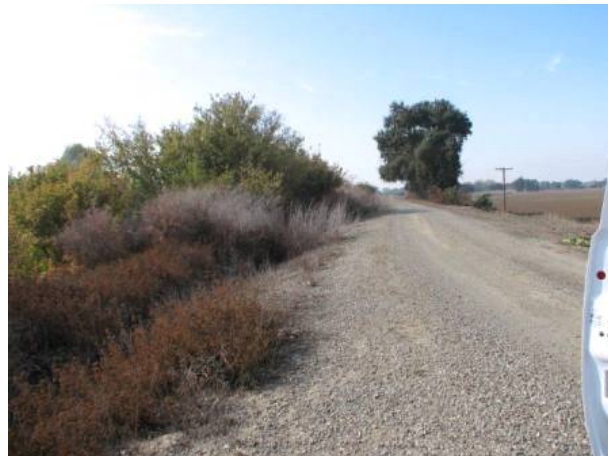
mkhashch\_s\_20130225\_514.jpg

Levee Mile Report Line	43
Start Levee Mile	0.98
End Levee Mile	1.07
Location	Water Side
Category	
Item	Vegetation

11/10/2011 Thick vegetation on upper 20' of waterside slope.

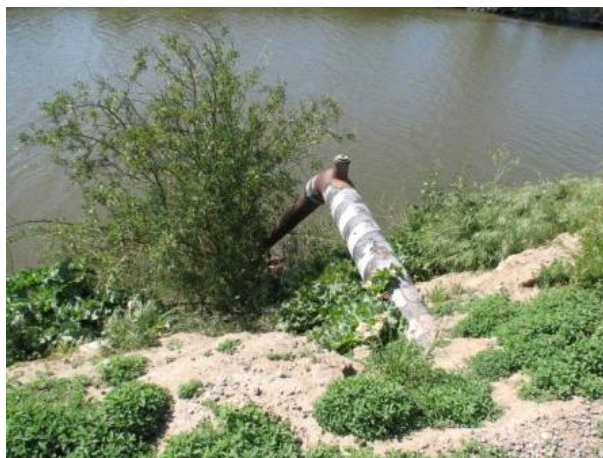
mkhashch\_s\_20130225\_502.jpg

Drainage discharge into Old River.

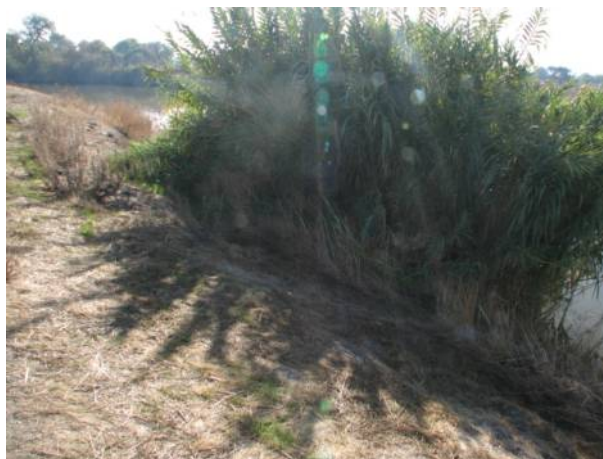
mkhashch\_s\_20130225\_504.jpg

Levee Mile Report Line	49
Start Levee Mile	1.22
End Levee Mile	1.22
Location	Water Side
Category	
Item	Vegetation

Bamboo on waterside levee slope obstructs access and visibility.

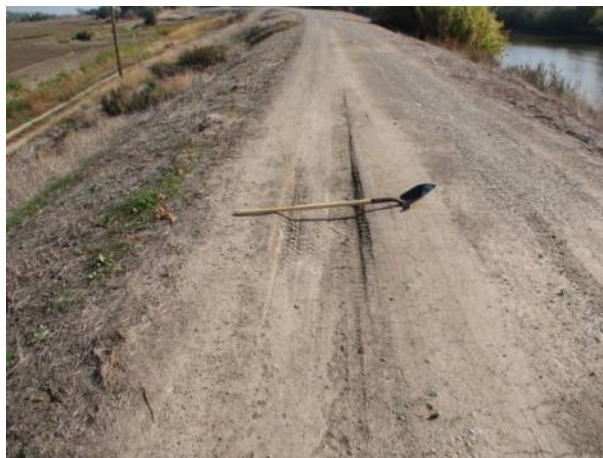
mkhashch\_s\_20130225\_521.jpg

Levee Mile Report Line	50
Start Levee Mile	1.25
End Levee Mile	1.25
Location	Crown
Category	
Item	Crown Surface / Depressions / Rutting

11/10/2011 Depression in roadway.

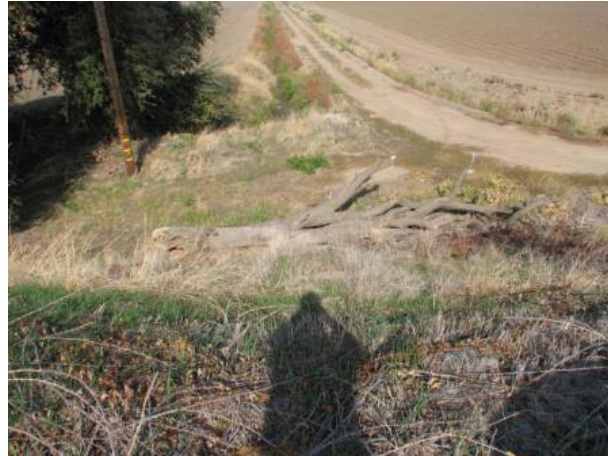
Levee Mile Report Line	55
Start Levee Mile	1.43
End Levee Mile	1.43
Location	Land Side
Category	
Item	Encroachments
11/10/2011 Downed tree at toe needs to be removed.	
mkhashch_s_20130225_524.jpg

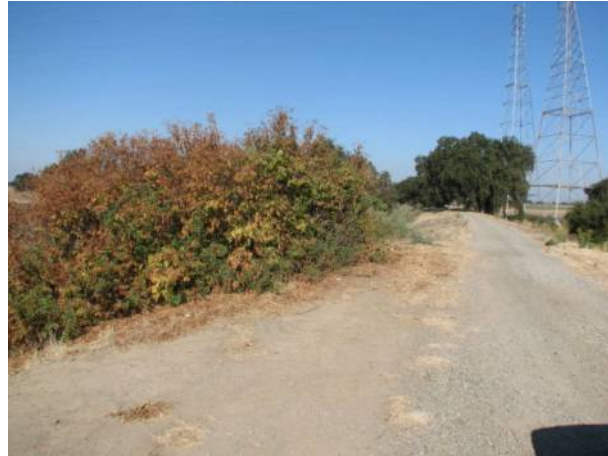
Levee Mile Report Line	3
Start Levee Mile	0.08
End Levee Mile	0.08
Location	Water Side
Category	
Item	Vegetation
Fall 2009 photo of unacceptable vegetation on levee slope.	
mkhashch_s_20130225_541.jpg

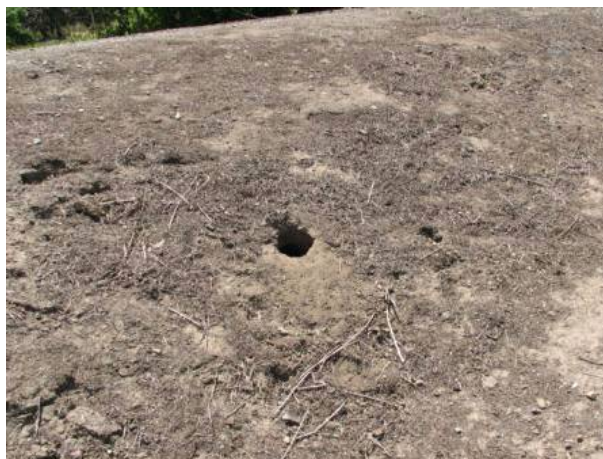
mkhashch\_s\_20130225\_553.jpg

Levee Mile Report Line	6
Start Levee Mile	0.38
End Levee Mile	0.38
Location	Land Side
Category	
Item	Animal Control

05/24/2011 Active rodent burrow.

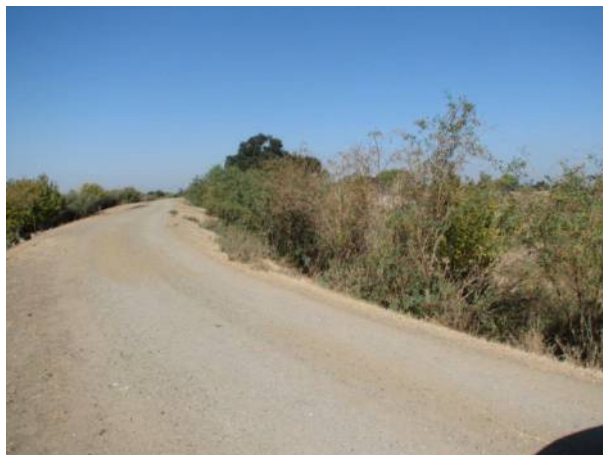
mkhashch\_s\_20130225\_543.jpg

Levee Mile Report Line	7
Start Levee Mile	0.40
End Levee Mile	0.66
Location	Land Side
Category	
Item	Vegetation

Fall 2009 photo: Brush on landside toe limits visibility and accessibility.

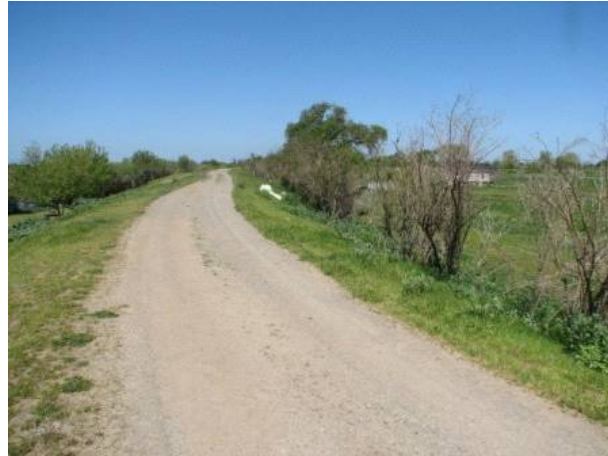
Levee Mile Report Line	7
Start Levee Mile	0.40
End Levee Mile	0.66
Location	Land Side
Category	
Item	Vegetation
Brush on landside slope limits access.	
mkhashch_s_20130225_544.jpg

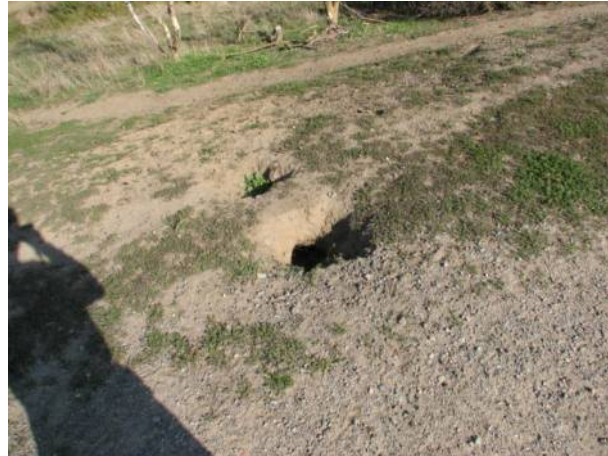
Levee Mile Report Line	10
Start Levee Mile	0.49
End Levee Mile	0.49
Location	Crown
Category	
Item	Animal Control
11/10/2011 Two large burrows on crown, need to be filled.	
mkhashch_s_20130225_547.jpg

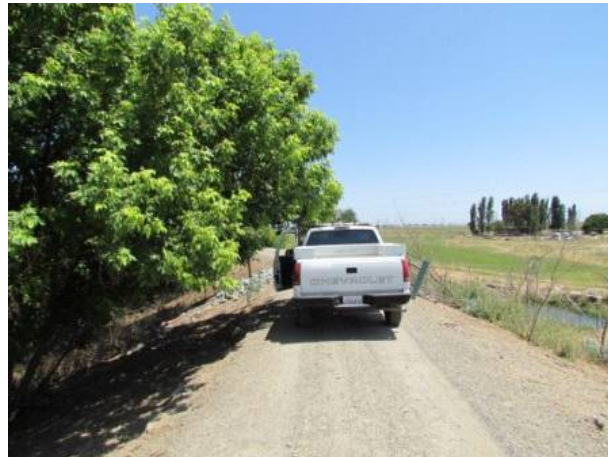
mkhashch\_s\_20130225\_564.jpg

Levee Mile Report Line	14
Start Levee Mile	0.70
End Levee Mile	0.70
Location	Water Side
Category	
Item	Trim / Thin Trees

View of low hanging branches over waterside slope and crown. 05/24/2012

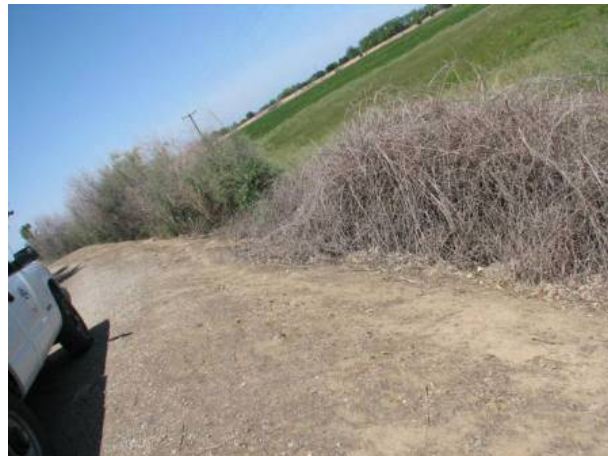
mkhashch\_s\_20130225\_557.jpg

Levee Mile Report Line	16
Start Levee Mile	0.82
End Levee Mile	0.86
Location	Land Side
Category	
Item	Vegetation

05/24/2011 Extremely thick dead brush prevents access and visibility.

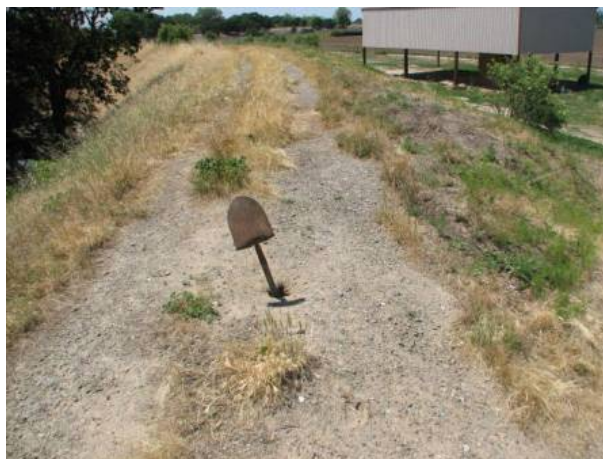
mkhashch\_s\_20130225\_559.jpg

Levee Mile Report Line	21
Start Levee Mile	0.87
End Levee Mile	0.92
Location	Land Side
Category	
Item	Animal Control

05/24/2011 Deep vertical burrow in levee crown.

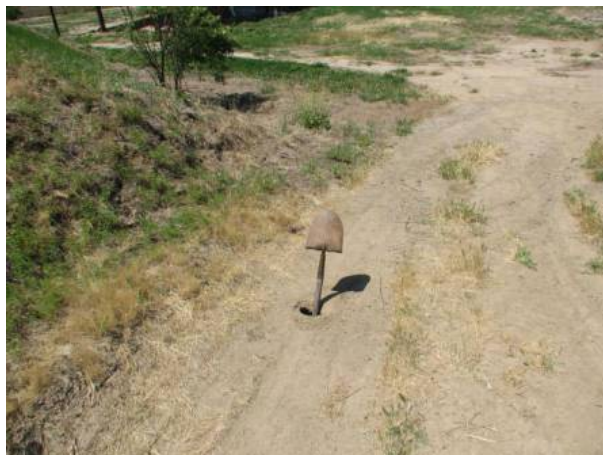
mkhashch\_s\_20130225\_560.jpg

Levee Mile Report Line	21
Start Levee Mile	0.87
End Levee Mile	0.92
Location	Land Side
Category	
Item	Animal Control

05/24/2011 Deep vertical burrow in ramp on land side of levee.

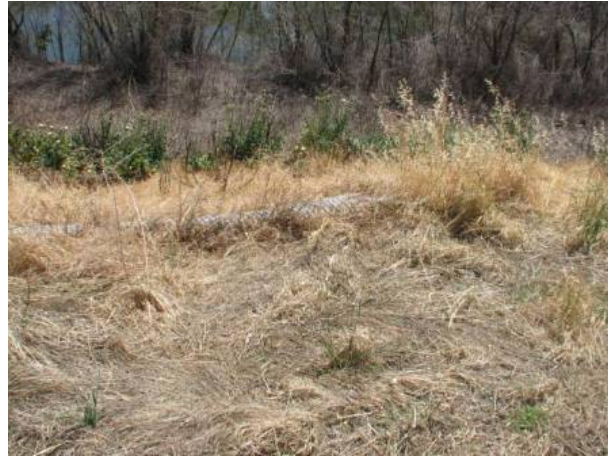
Levee Mile Report Line	22
Start Levee Mile	0.95
End Levee Mile	0.95
Location	Water Side
Category	
Item	Encroachments
05/24/2011 Old CMP left on waterside levee slope, needs to be removed.	
mkhashch_s_20130225_561.jpg

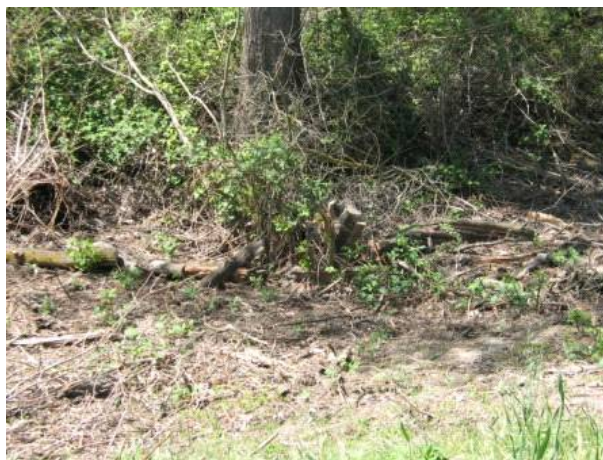
Levee Mile Report Line	26
Start Levee Mile	1.07
End Levee Mile	1.07
Location	Water Side
Category	
Item	Trim / Thin Trees
Tree stump >2" left after vegetation and tree removal.	
mkhashch_s_20130225_556.jpg

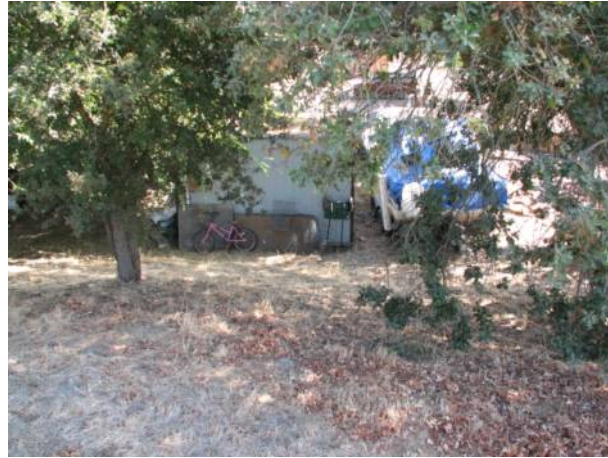
mkhashch\_s\_20130225\_551.jpg

Fall 2009 photo: Buildings and patio decks are built within 10-ft of the levee slope.
