**Flood Control Project Maintenance
Levee Inspections****LMA District Cover Sheet****Spring 2014 Levee Inspection Results****Reclamation District No. 2089 Stark**

Spring 2014 Levee Inspection Results

Reclamation District No. 2089 Stark

| Waterway | | | Bank | Unit Miles |
|--|---|---|---|---|
| Unit No. 01 Old River | | | Right | 1.53 |

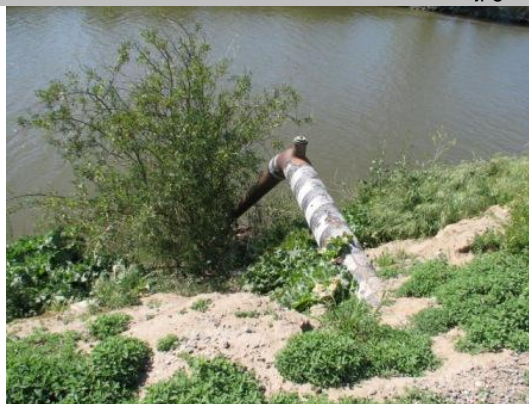
Photo 1 of 1 : mkhashch_s_20140428_00721.jpg

Drainage discharge into Old River.

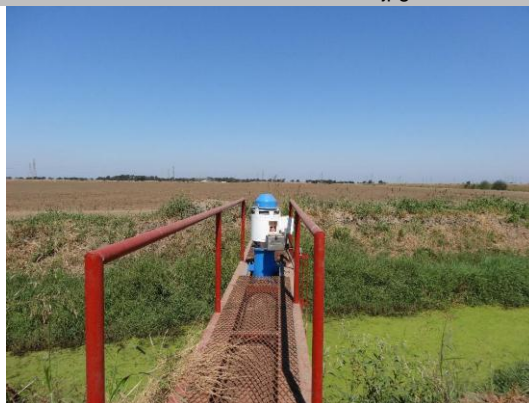
Photo 1 of 1 : UCIP_2767.jpg

WS view: walkway and pump on piling structure in the channel.

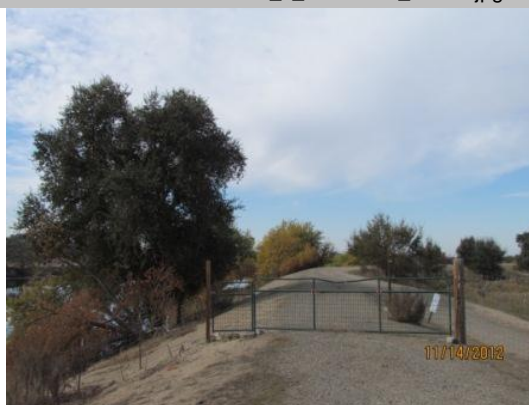
Photo 1 of 1 : mkhashch_s_20140428_00747.jpg

View of gate across levee crown.

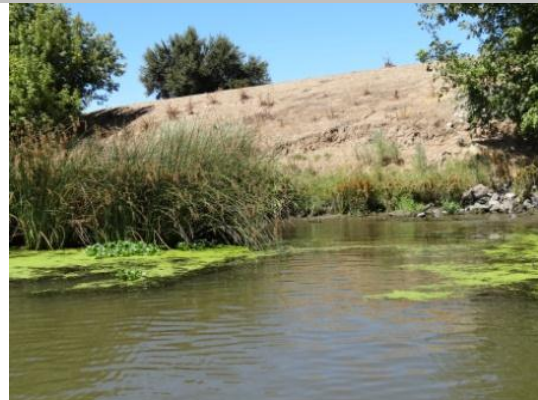
Photo 1 of 1 : mkhashch_s_20140428_00746.jpg

| Inspector Comments: 08/13/2013: No significant change observed. 08/07/2012: The site has been visited by boat survey. No significant change observed 08/23/2011: No significant changes observed on site. 09/07/2010: Site consists of a jutting rip rap that has created an eddy, scouring the levee slope. Most sections of the toe and lower slope are lined with rip rap. However, the rip rap is sloughing on the mid slope and at the toe, exposing the underlying soils and tree roots. The remaining revetment is no longer adequately protecting the slope. There are 3 Sycamore trees at the toe with exposed tree roots. 08/05/2010: Recommended for repair, per CLRO. 09/28/2009: Pocket erosion on lower slope just above the toe rip rap; protruding rip rap upstream is creating an eddy, scouring the levee slope; Site # is the same as RM28.40,LM0.30; previously rated "U"; pictures will be made available during the next survey. 11/05/2008: Cut into levee profile; riprap slide; rodent holes; pictures do not match GPS and current condition. [2013 Site ID:RD2089U02RM28.35] | | | | | |

Close view of the site.

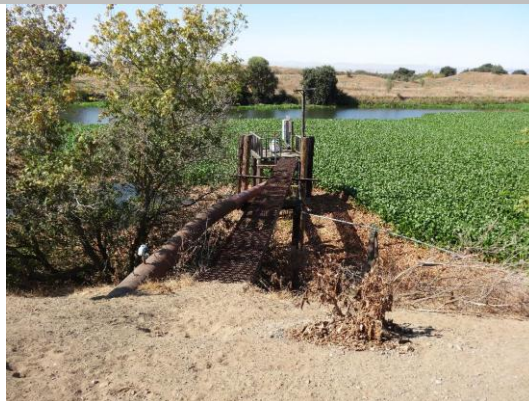
Photo 1 of 1 : UCIP_2722.jpg

| UCIP Comments: - air relief valve on waterside. Needs repair. | | | | | |

WS view: pipe and pump on piling structure in water channel.

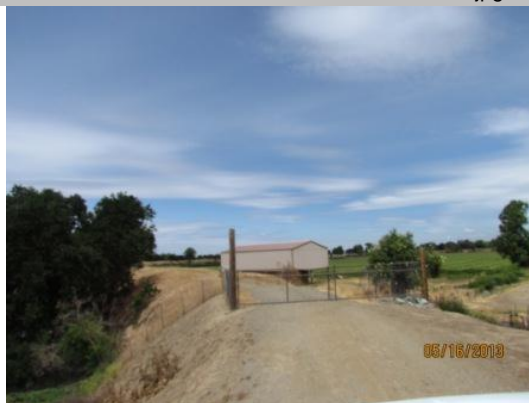
Photo 1 of 1 : mkhashch_s_20140428_00752.jpg

| Inspector Comments: Gate across levee crown. | | | | | |

View of the fence gate across levee crown.
