**Flood Control Project Maintenance
Levee Inspections**
LMA District Cover Sheet
Spring 2015 Levee Inspection Results

Reclamation District No. 2089 Stark

Spring 2015 Levee Inspection Results

Levee Inspection Report By Mile - Spring 2015

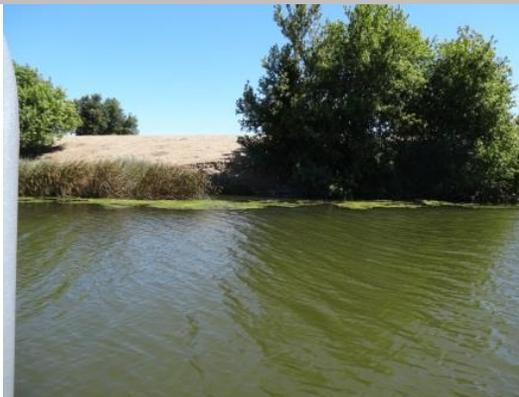
Photo 1 of 1 : SP_2015_RD2089_317_1_20150317_00001.jpg

LM Start	0.40	Rating **	M	Issue No.	1
LM End	0.40	Issue Type +	Ma	Location *	WS
Category	Supplemental			GPS Latitude/Longitude	
				Start	End
Item	DWR Erosion Survey			37.809960 °	37.809960 °
				-121.413200 °	-121.413200 °
DWR ID	DWR_RD2089_02_s_2015_1				
Action/Comments					
Inspector Comments: 07/02/2014: No significant change observed. 08/13/2013: No significant change observed. 08/07/2012: The site has been visited by boat survey. No significant change observed. 08/23/2011: No significant change observed on site. 09/07/2010: Site consists of a jutting rip rap that has created an eddy,

View of the site from the survey boat.

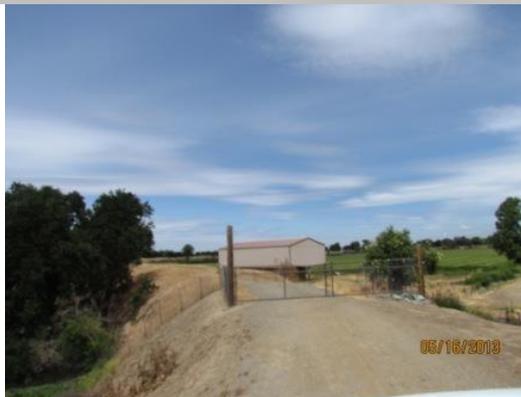
Photo 1 of 1 : SP_2015_RD2089_317_9_20150317_00010.jpg

LM Start	0.84	Rating **	A/W	Issue No.	9
LM End	0.84	Issue Type +	En	Location *	CR
Category	Earthen Levee		GPS Latitude/Longitude		
			Start	End	
Item	Encroachments		37.814881 °	37.814881 °	
			-121.414676 °	-121.414676 °	
DWR ID	DWR_RD2089_02_s_2012_9				
Action/Comments					
Fence Inspector Comments: Gate across levee crown.

View of the fence gate across levee crown.
