**Flood Control Project Maintenance
Levee Inspections**
LMA District Cover Sheet
Spring 2016 Levee Inspection Results

Reclamation District No. 2089 Stark

Spring 2016 Levee Inspection Results

Waterway			Bank	Unit Miles
Unit No. 01 Old River			Right	1.51
	Spring (March - May)	Summer (June - August)	(September - November) Fall	Winter (December - February)
Unit Maintenance Rating (Fall Only)				
Date of Inspection	3/15/2016 - 3/15/2016			
DWR Inspector	Maksim Khashchuk			
Accompanied By

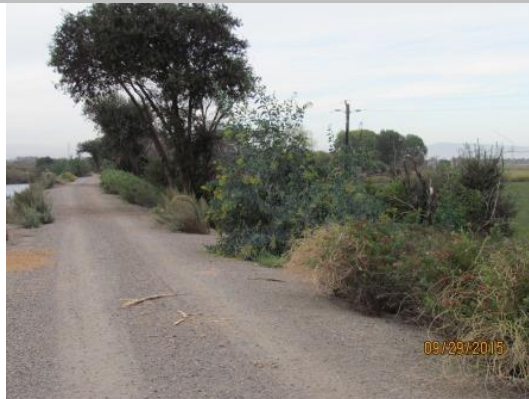
Photo 1 of 1 : SP_2016_RD2089_316_12_20160229_00011.jpg

LM Start	0.27	Rating **	U	Issue No.	12
LM End	0.39	Issue Type +	Ma	Location *	LS
Category	Earthen Levee			GPS Latitude/Longitude	
				Start	End
Item	Vegetation			37.810319 °	37.809740 °
				-121.389510 °	-121.391645 °
DWR ID	DWR_RD2089_01_s_2012_12				
Comment Code					
V2 : Remove the wild growth other than native grasses from the levee slopes.					
Inspector Comment					
Access and visibility completely blocked. 11/10/2011 issue has not changed.

Thick brush and wild rose completely block access and visibility of landside slope and toe.

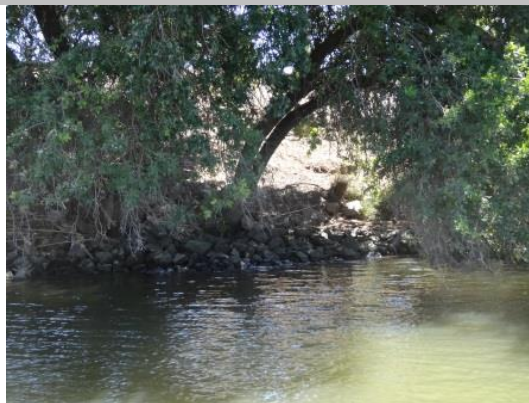
Photo 1 of 2 : SP_2016_RD2089_317_1_20160229_00001.jpg

LM Start	0.40	Rating **	M	Issue No.	1 (cont)
LM End	0.41	Issue Type +	Ma	Location *	WS

View of the site from the survey boat.

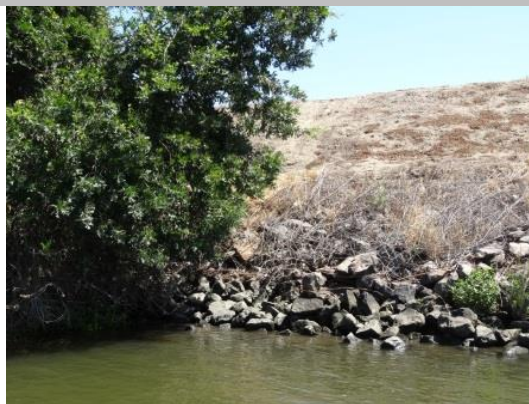
Photo 2 of 2 : SP_2016_RD2089_317_1_20160229_00002.jpg

View of the site from the survey boat.

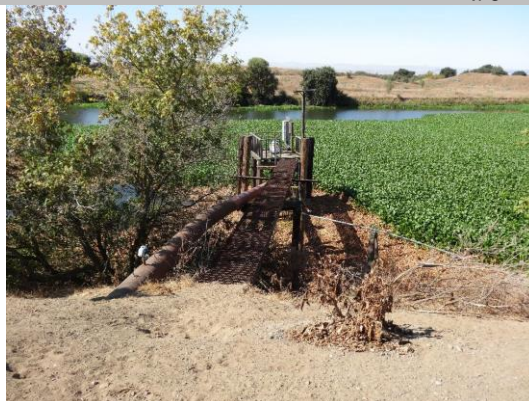
Photo 1 of 2 : UCIP_SP_2016_21676_36861.jpg

LM Start	0.54	Rating **	M	Issue No.	58 (cont)
LM End	0.54	Issue Type +	En	Location *	WS

WS view: pipe and pump on piling structure in water channel.

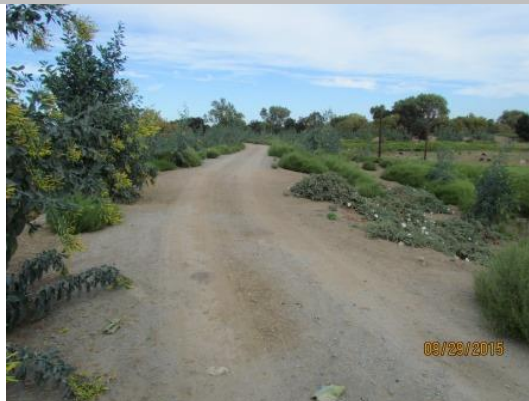
Photo 2 of 4 : SP_2016_RD2089_317_35_20160229_00028.jpg

LM Start	0.54	Rating **	M	Issue No.	35 (cont)
LM End	0.54	Issue Type +	Ma	Location *	CR

View of the levee crown depression looking downstream.

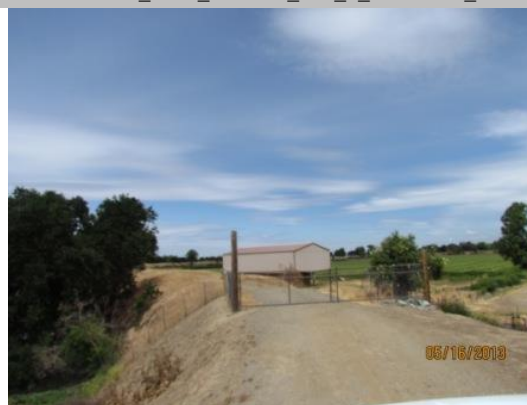
Photo 1 of 1 : SP_2016_RD2089_317_9_20160229_00010.jpg

LM Start	0.84	Rating **	M	Issue No.	9
LM End	0.84	Issue Type +	En	Location *	CR
Category	Earthen Levee			GPS Latitude/Longitude	
				Start	End
Item	Encroachments			37.814881 °	37.814881 °
				-121.414676 °	-121.414676 °
DWR ID	DWR_RD2089_02_s _ 2012_9				
Comment Code					
FE : Fence					
Inspector Comment					
Gate across levee crown.

View of the fence gate across levee crown.

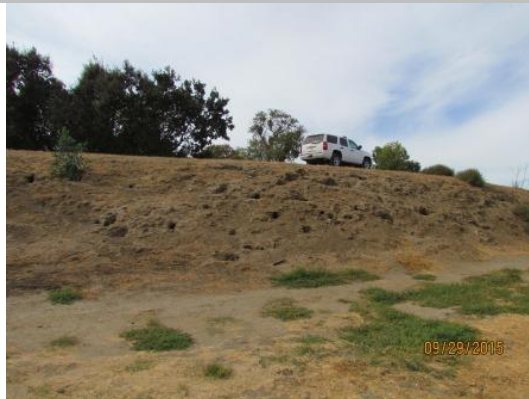
Photo 3 of 3 : SP_2016_RD2089_317_40_20160229_00034.jpg

LM Start	0.85	Rating **	U	Issue No.	40 (cont)
LM End	0.90	Issue Type +	Ma	Location *	LS
Category	Earthen Levee			GPS Latitude/Longitude	
				Start	End
Item	Animal Control			37.814997 °	37.814970 °
				-121.414774 °	-121.415767 °
DWR ID	DWR_RD2089_02_s _ 2012_40				
Comment Code					
A1 : Exterminate rodents and backfill and compact or grout burrows.					
Inspector Comment					
Numerous burrows on landside slope adjacent to hay storage area. Deep burrows in crown and landside ramp.

View of the multiple rodent holes on the landside levee slope.

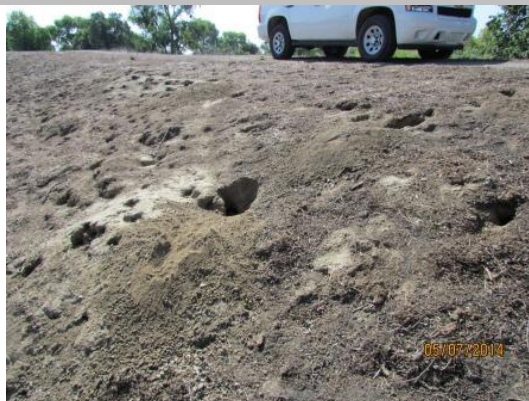
Photo 1 of 1 : SP_2016_RD2089_317_5_20160229_00006.jpg

LM Start	0.95	Rating **	U	Issue No.	5
LM End	0.95	Issue Type +	Ma	Location *	LS
Category	Earthen Levee			GPS Latitude/Longitude	
				Start	End
Item	Animal Control			37.814915 °	37.814915 °
				-121.416606 °	-121.416606 °
DWR ID	DWR_RD2089_02_s_2014_5				
Comment Code					
A1 : Exterminate rodents and backfill and compact or grout burrows.					
Inspector Comment

View of the rodent holes on the landside levee slope.

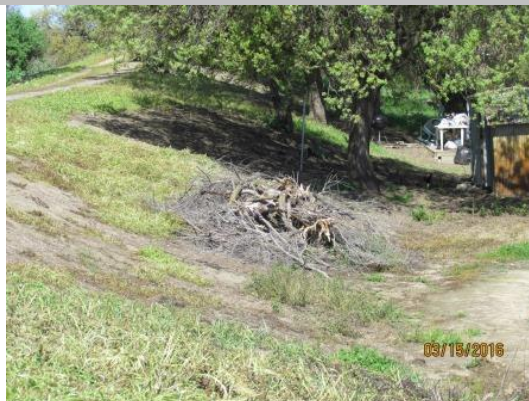
Photo 1 of 1 : SP_2016_RD2089_317_37_20160321_00049.jpg

LM Start	1.24	Rating **	U	Issue No.	37
LM End	1.24	Issue Type +	En	Location *	LS
Category	Earthen Levee			GPS Latitude/Longitude	
				Start	End
Item	Encroachments			37.818097 °	37.818097 °
				-121.419709 °	-121.419709 °
DWR ID	DWR_RD2089_02_s_2016_37				
Comment Code					
PR : Prunings					
Inspector Comment

View of the prunings on the landside levee slope.
