**Flood Control Project Maintenance
Levee Inspections**
LMA District Cover Sheet
Spring 2017 Levee Inspection Results

Reclamation District No. 2089 Stark

Spring 2017 Levee Inspection Results

Waterway	Bank	Unit Miles
Unit No. 01 Old River	Right	1.51

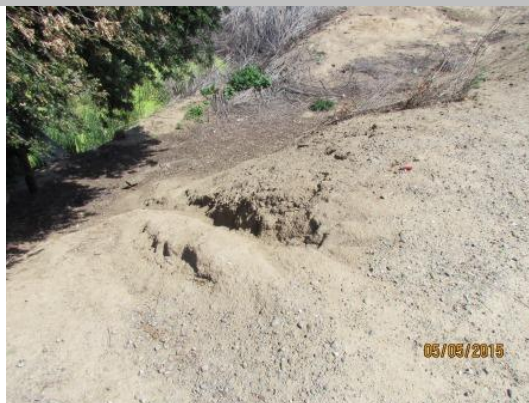
Photo 1 of 1 : SP_2017_RD2089_316_1_20170407_00001.jpg

LM Start	0.03	Rating **	M	Issue No.	1
LM End	0.03	Issue Type +	Ma	Location *	LS
Category	Earthen Levee			GPS Latitude/Longitude	
				Start	End
Item	Encroachments			37.811508 °	37.811508 °
				-121.385464 °	-121.385464 °
DWR ID	DWR_RD2089_01_s_2012_1				
Comment Code					
ST : Stairway					
Inspector Comment					
Steps have been cut into the levee slope, this could become an erosion point, please fill and compact.

View of the stairs eroding into the landside levee slope.

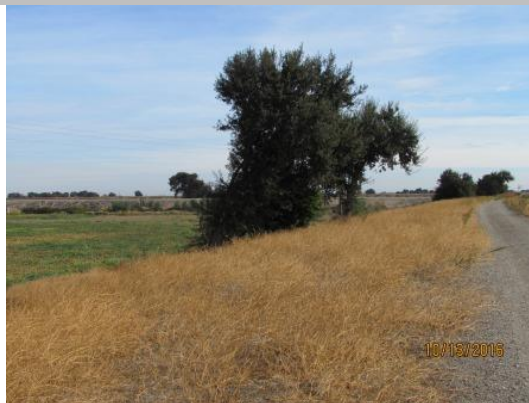
Photo 1 of 1 : SP_2017_RD2089_316_30_20170407_00022.jpg

LM Start	0.04	Rating **	M	Issue No.	30
LM End	0.24	Issue Type +	Ma	Location *	LS
Category	Earthen Levee			GPS Latitude/Longitude	
				Start	End
Item	Vegetation			37.811474 °	37.810451 °
				-121.385573 °	-121.389109 °
DWR ID	DWR_RD2089_01_f_2016_30				
Comment Code					
V1 : Control annual grass and weeds on the levee slopes and easements.					
Inspector Comment

View of the vegetation on the landside levee slope.

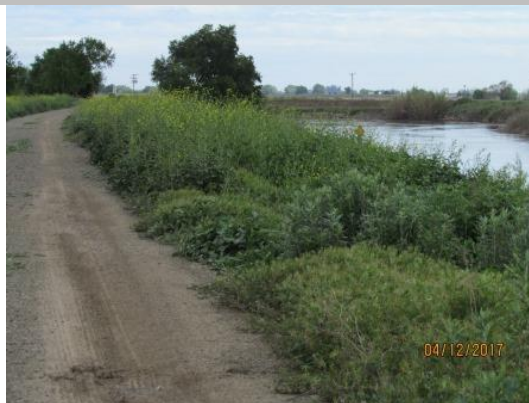
Photo 1 of 1 : SP_2017_RD2089_316_35_20170417_00054.jpg

LM Start	0.04	Rating **	U	Issue No.	35
LM End	0.20	Issue Type +	Ma	Location *	WS
Category	Earthen Levee			GPS Latitude/Longitude	
				Start	End
Item	Vegetation			37.811445 °	37.810673 °
				-121.385704 °	-121.388374 °
DWR ID	DWR_RD2089_01_s_2017_35				
Comment Code					
V1 : Control annual grass and weeds on the levee slopes and easements.					
Inspector Comment

View of the tall vegetation on the levee slope.

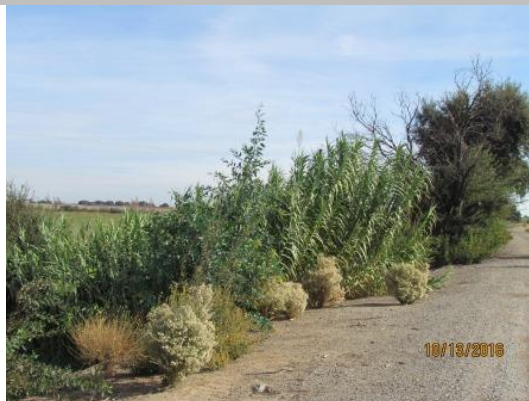
Photo 1 of 2 : SP_2017_RD2089_316_19_20170407_00012.jpg

LM Start	0.33	Rating **	U	Issue No.	19 (cont)
LM End	0.33	Issue Type +	Ma	Location *	LS

View of the arundo back on the landside levee slope. Fall 2016

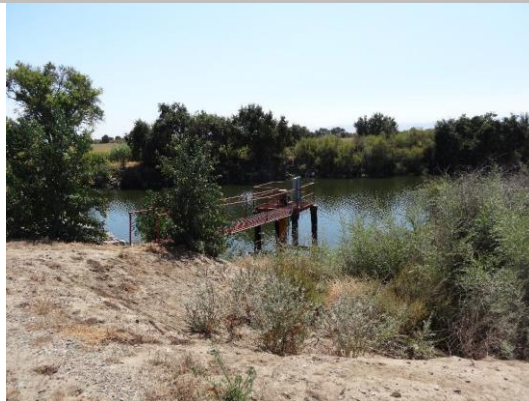
Photo 1 of 3 : UCIP_SP_2017_21635_36742.jpg

LM Start	0.46	Rating **	M	Issue No.	958
LM End	0.46	Issue Type +	En	Location *	LS
Category	Supplemental			GPS Latitude/Longitude	
				Start	End
Item	DWR UCIP Field Study			37.809501 °	37.809501 °
				-121.392798 °	-121.392798 °
DWR ID					
Comment Code					
Inspector Comment					
FS_ID:21635					
DS_ID:23042					
EP_NO: 5641					
Repair Type: Non-Urgent					
Crossing Status: Found					
UCIP Comments: - damaged siphon breaker.- most of the pipe on					
landside exposed on levee slope.					
FIELD_STRUCT_DESC: 20-inch steel pipe and electric conduit through					
the levee, 5.8 feet below the crown, pump on pile structure in the					
stream. Siphon breaker on the landward slope. (App. No. 5641- Ted					
Stark)					
FS Date: 9/12/2013

WS view: walkway to pump platform and pump on steel piling structure in the channel.

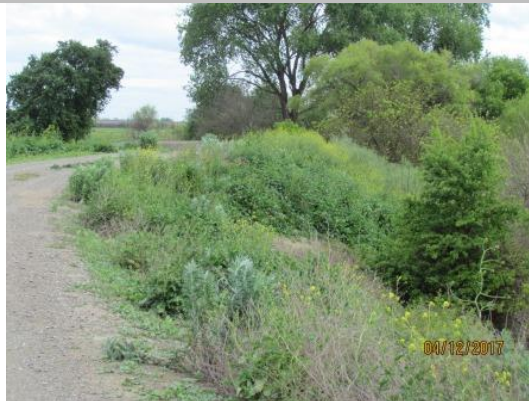
Photo 1 of 2 : SP_2017_RD2089_316_29_20170417_00053.jpg

LM Start	0.50	Rating **	U	Issue No.	29
LM End	0.71	Issue Type +	Ma	Location *	WS
Category	Earthen Levee			GPS Latitude/Longitude	
				Start	End
Item	Vegetation			37.809814 °	37.809452 °
				-121.393481 °	-121.397013 °
DWR ID	DWR_RD2089_01_f_2016_29				
Comment Code					
V2 : Remove the wild growth other than native grasses from the levee slopes.					
Inspector Comment					
Tumbleweeds and other tall vegetation are on the levee slope.

View of the tall vegetation on the levee slope.

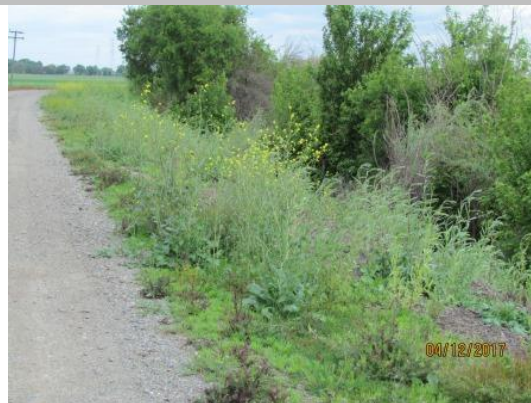
Photo 1 of 2 : SP_2017_RD2089_316_21_20170417_00052.jpg

LM Start	0.82	Rating **	M	Issue No.	21
LM End	0.88	Issue Type +	Ma	Location *	WS
Category	Earthen Levee			GPS Latitude/Longitude	
				Start	End
Item	Vegetation			37.808043 °	37.807284 °
				-121.397853 °	-121.397718 °
DWR ID	DWR_RD2089_01_f_2016_21				
Comment Code					
V2 : Remove the wild growth other than native grasses from the levee slopes.					
Inspector Comment					
Willows starting to encroach onto levee crown.

The willows are starting to creep up the levee slope.

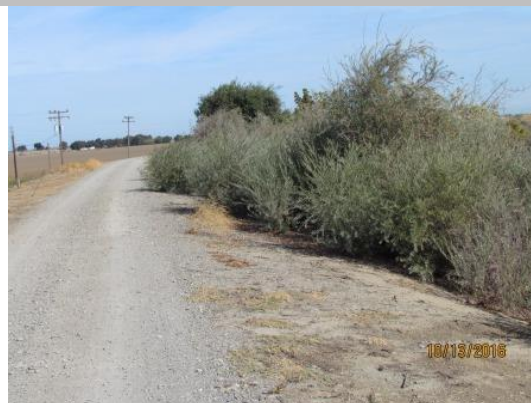
Photo 2 of 2 : SP_2017_RD2089_316_21_20170407_00015.jpg

View of the vegetation on the waterside levee slope. The willows were trimmed back.

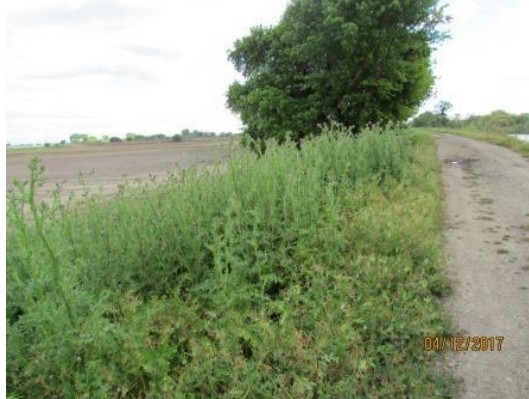
Photo 1 of 1 : SP_2017_RD2089_316_32_20170417_00051.jpg

LM Start	1.06	Rating **	U	Issue No.	32
LM End	1.24	Issue Type +	Ma	Location *	LS
Category	Earthen Levee			GPS Latitude/Longitude	
				Start	End
Item	Vegetation			37.805882 °	37.805847 °
				-121.399790 °	-121.403082 °
DWR ID	DWR_RD2089_01_s _ 2017_32				
Comment Code					
V2 : Remove the wild growth other than native grasses from the levee slopes.					
Inspector Comment

View of the tall vegetation on the levee slope.

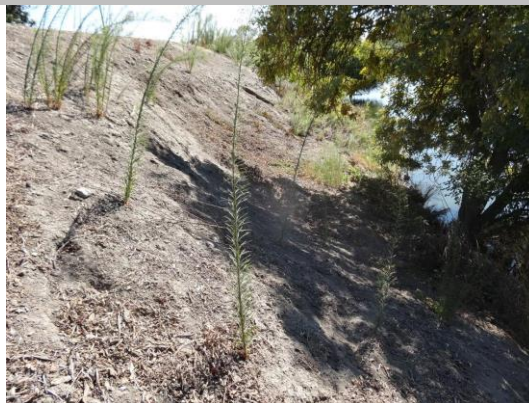
Photo 1 of 2 : SP_2017_RD2089_316_2_20170407_00002.jpg

LM Start	1.23	Rating **	M	Issue No.	2
LM End	1.24	Issue Type +	Ma	Location *	WS
Category	Supplemental			GPS Latitude/Longitude	
				Start	End
Item	DWR Erosion Survey			37.805580 °	37.805580 °
				-121.403010 °	-121.403010 °
DWR ID	DWR_RD2089_01_s_2017_2				
Comment Code					
Inspector Comment					
09/16/2016: The river was not navigable near the site due to the dense water grass, so the site was visited by land survey. No significant change observed.					
06/25/2015: No significant change observed.					
07/02/2014: No significant change observed.					
08/13/2013: The erosion is around a tree at the levee toe. Dense vegetation is visible. [2016 Site ID:RD2089U01RM29.04]

View of the erosion from levee slope.

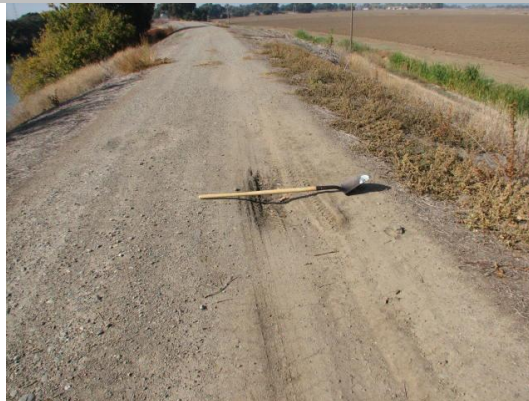
Photo 1 of 1 : SP_2017_RD2089_316_44_20170407_00025.jpg

LM Start	1.23	Rating **	M	Issue No.	44
LM End	1.23	Issue Type +	Ma	Location *	LS
Category	Earthen Levee			GPS Latitude/Longitude	
				Start	End
Item	Crown Surface / Depressions / Rutting			37.805801 °	37.805801 °
				-121.402913 °	-121.402913 °
DWR ID	DWR_RD2089_01_s_2012_44				
Comment Code					
C3 : Add appropriate gravel or road base. Grade and compact.					
Inspector Comment					
11/10/2011 Depression in roadway needs to be filled.

11/10/2011 Roadway depression.

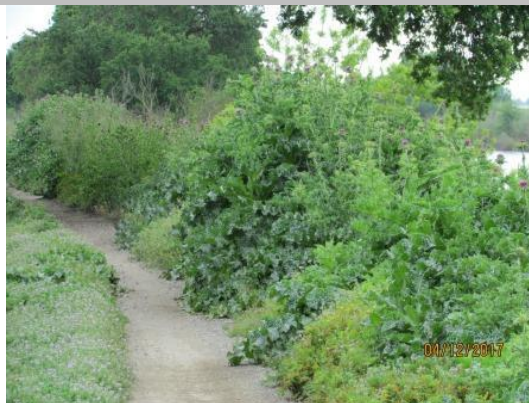
Photo 1 of 1 : SP_2017_RD2089_316_31_20170417_00049.jpg

LM Start	1.39	Rating **	U	Issue No.	31
LM End	1.50	Issue Type +	Ma	Location *	WS
Category	Earthen Levee			GPS Latitude/Longitude	
				Start	End
Item	Vegetation			37.806264 °	37.806602 °
				-121.405740 °	-121.407781 °
DWR ID	DWR_RD2089_01_s_2017_31				
Comment Code					
V2 : Remove the wild growth other than native grasses from the levee slopes.					
Inspector Comment					
Remove thistle from the levee slope.

View of the tall vegetation on the levee slope.

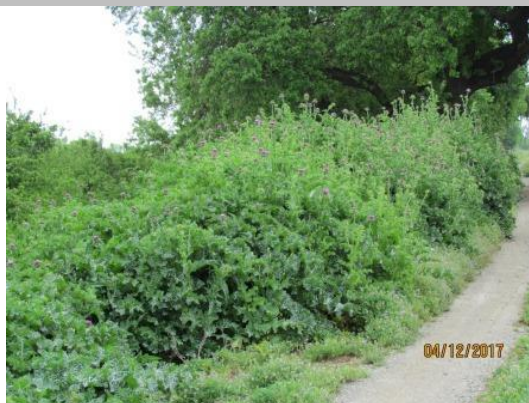
Photo 1 of 1 : SP_2017_RD2089_316_18_20170417_00050.jpg

LM Start	1.39	Rating **	U	Issue No.	18
LM End	1.50	Issue Type +	Ma	Location *	LS
Category	Earthen Levee			GPS Latitude/Longitude	
				Start	End
Item	Vegetation			37.806264 °	37.806604 °
				-121.405742 °	-121.407780 °
DWR ID	DWR_RD2089_01_s_2017_18				
Comment Code					
V2 : Remove the wild growth other than native grasses from the levee slopes.					
Inspector Comment					
Remove thistle from the levee slope.

View of the tall vegetation on the levee slope.

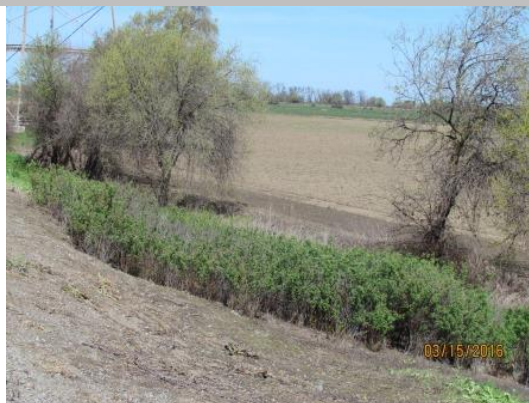
Photo 1 of 1 : SP_2017_RD2089_317_20_20170407_00020.jpg

LM Start	0.06	Rating **	U	Issue No.	20
LM End	0.06	Issue Type +	Ma	Location *	LS
Category	Earthen Levee			GPS Latitude/Longitude	
				Start	End
Item	Vegetation			37.807341 °	37.807341 °
				-121.408686 °	-121.408686 °
DWR ID	DWR_RD2089_02_s_2016_20				
Comment Code					
V2 : Remove the wild growth other than native grasses from the levee slopes.					
Inspector Comment

View of the vegetation on the landside levee slope.

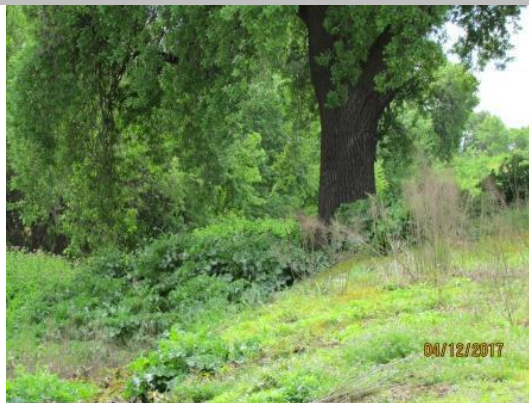
Photo 1 of 1 : SP_2017_RD2089_317_56_20170417_00061.jpg

LM Start	0.07	Rating **	U	Issue No.	56
LM End	0.12	Issue Type +	Ma	Location *	LS
Category	Earthen Levee			GPS Latitude/Longitude	
				Start	End
Item	Vegetation			37.807428 °	37.808070 °
				-121.408749 °	-121.409156 °
DWR ID	DWR_RD2089_02_s_2017_56				
Comment Code					
V1 : Control annual grass and weeds on the levee slopes and easements.					
Inspector Comment					
Remove thistle from the levee slope.

View of the tall vegetation on the levee slope.

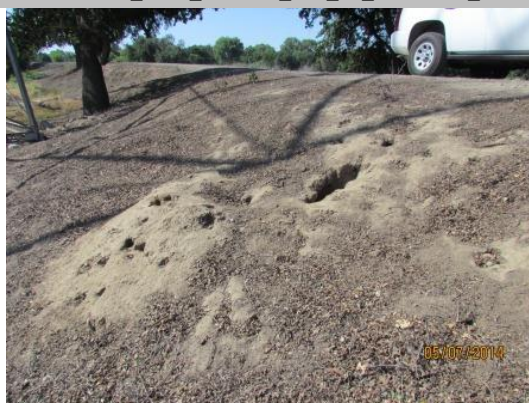
Photo 1 of 1 : SP_2017_RD2089_317_48_20170407_00042.jpg

LM Start	0.16	Rating **	U	Issue No.	48
LM End	0.16	Issue Type +	Ma	Location *	LS
Category	Earthen Levee			GPS Latitude/Longitude	
				Start	End
Item	Animal Control			37.808583 °	37.808583 °
				-121.409432 °	-121.409432 °
DWR ID	DWR_RD2089_02_f_2013_48				
Comment Code					
A3 : No rodents visible, but rodent burrows visible; need to backfill and compact or grout burrows.					
Inspector Comment

View of the rodent burrow on the landside levee slope.

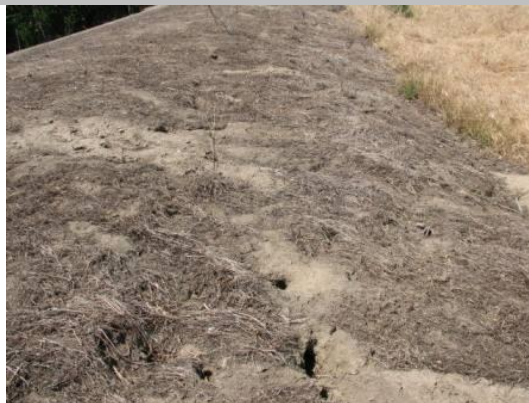
Photo 1 of 1 : SP_2017_RD2089_317_24_20170407_00022.jpg

LM Start	0.26	Rating **	M	Issue No.	24
LM End	0.26	Issue Type +	Ma	Location *	LS
Category	Earthen Levee			GPS Latitude/Longitude	
				Start	End
Item	Animal Control			37.809717 °	37.809717 °
				-121.410511 °	-121.410511 °
DWR ID	DWR_RD2089_02_s_2012_24				
Comment Code					
A1 : Exterminate rodents and backfill and compact or grout burrows.					
Inspector Comment					
Ground squirrel sighted and active burrowing in area.

05/24/2011 Active burrows, ground squirrel sighted in area.

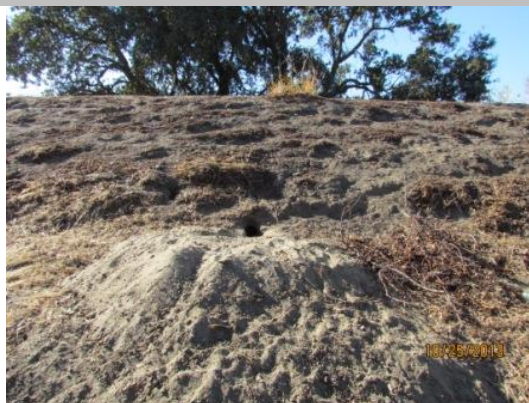
Photo 2 of 3 : SP_2017_RD2089_317_53_20170407_00047.jpg

View of the rodent burrow on the landside levee slope.

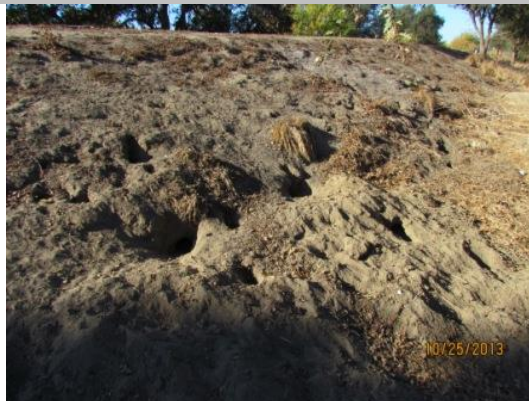
Photo 3 of 3 : SP_2017_RD2089_317_53_20170407_00048.jpg

Another view of the multiple rodent burrows on the landside levee slope.

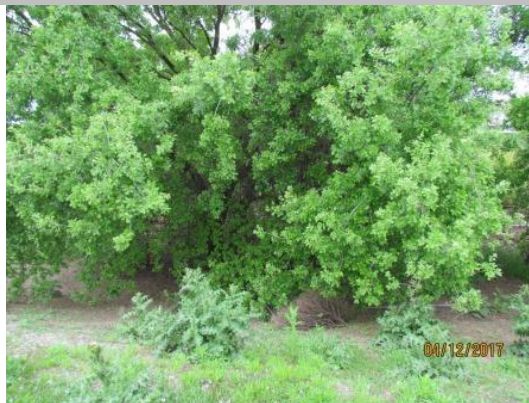
Photo 1 of 1 : SP_2017_RD2089_317_55_20170417_00060.jpg

LM Start	0.34	Rating **	M	Issue No.	55
LM End	0.34	Issue Type +	Ma	Location *	LS
Category	Earthen Levee			GPS Latitude/Longitude	
				Start	End
Item	Trim / Thin Trees			37.810052 °	37.810052 °
				-121.411966 °	-121.411966 °
DWR ID	DWR_RD2089_02_s_2017_55				
Comment Code					
T1 : Trim trees to at least five feet above ground level.					
Inspector Comment

View of the overgrown tree on the levee slope.

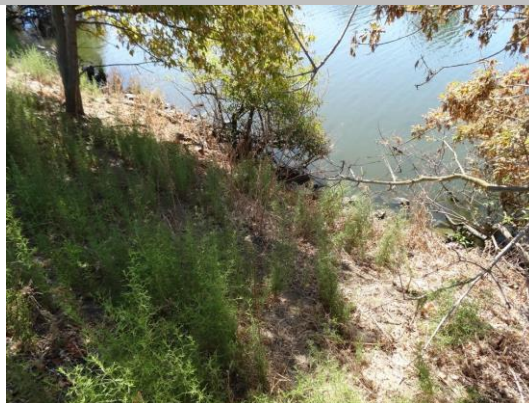
Photo 1 of 2 : SP_2017_RD2089_317_1_20170407_00001.jpg

View of the site from levee crest.

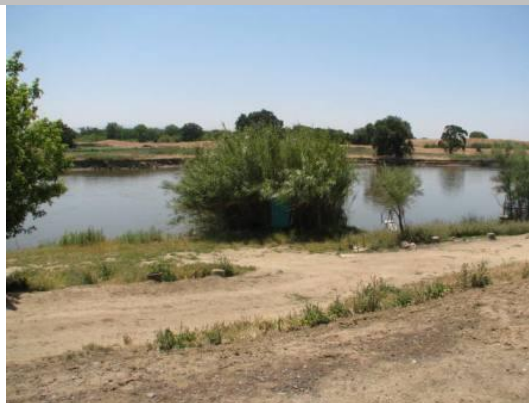
Photo 1 of 1 : SP_2017_RD2089_317_27_20170407_00024.jpg

LM Start	0.44	Rating **	M	Issue No.	27
LM End	0.44	Issue Type +	En	Location *	WS
Category	Earthen Levee			GPS Latitude/Longitude	
				Start	End
Item	Encroachments			37.810490 °	37.810490 °
				-121.413638 °	-121.413638 °
DWR ID	DWR_RD2089_02_s_2012_27				
Comment Code					
BU : Building					
Inspector Comment					
Portable toilet on bank, at water's edge.

05/24/2011 Portable toilet is in the shadows in the center of the photo at the water's edge.

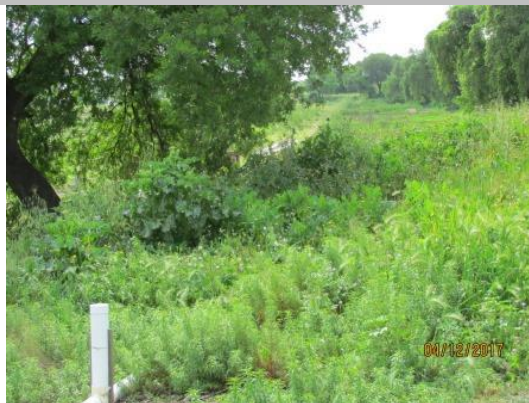
Photo 1 of 1 : SP_2017_RD2089_317_46_20170417_00058.jpg

LM Start	0.83	Rating **	U	Issue No.	46
LM End	1.23	Issue Type +	Ma	Location *	LS
Category	Earthen Levee			GPS Latitude/Longitude	
				Start	End
Item	Vegetation			37.814790 °	37.817976 °
				-121.414547 °	-121.419705 °
DWR ID	DWR_RD2089_02_s_2017_46				
Comment Code					
V1 : Control annual grass and weeds on the levee slopes and easements.					
Inspector Comment

View of the tall vegetation on the levee slope.

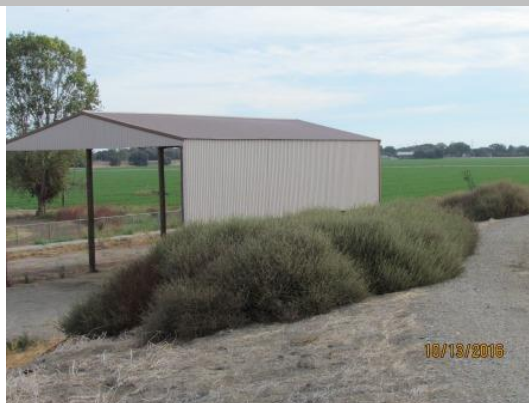
Photo 1 of 1 : SP_2017_RD2089_317_39_20170407_00034.jpg

LM Start	0.85	Rating **	U	Issue No.	39
LM End	0.88	Issue Type +	Ma	Location *	LS
Category	Earthen Levee			GPS Latitude/Longitude	
				Start	End
Item	Vegetation			37.814967 °	37.815017 °
				-121.414839 °	-121.415455 °
DWR ID	DWR_RD2089_02_f_2016_39				
Comment Code					
V2 : Remove the wild growth other than native grasses from the levee slopes.					
Inspector Comment					
Tumbleweeds on landside levee hinge and slope.

View of the vegetation on the landside levee slope.

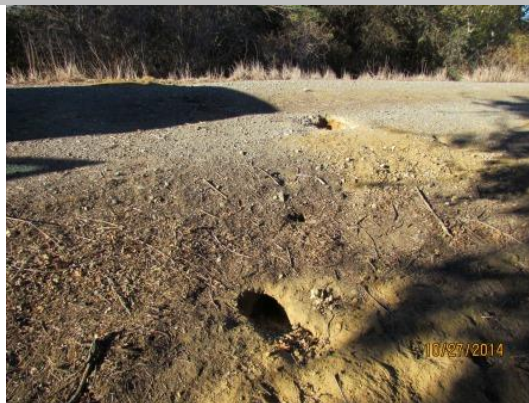
Photo 2 of 2 : SP_2017_RD2089_317_12_20170407_00012.jpg

LM Start	1.00	Rating **	U	Issue No.	12 (cont)	
LM End	1.00	Issue Type +	Ma	Location *	CR	
Category	Earthen Levee			GPS Latitude/Longitude		
				Start		End
Item	Animal Control			37.815182 °		37.815182 °
				-121.417439 °		-121.417439 °
DWR ID	DWR_RD2089_02_f_2014_12					
Comment Code						
A3 : No rodents visible, but rodent burrows visible; need to backfill and compact or grout burrows.						
Inspector Comment

View of several rodent burrows on landside levee hinge and crown.

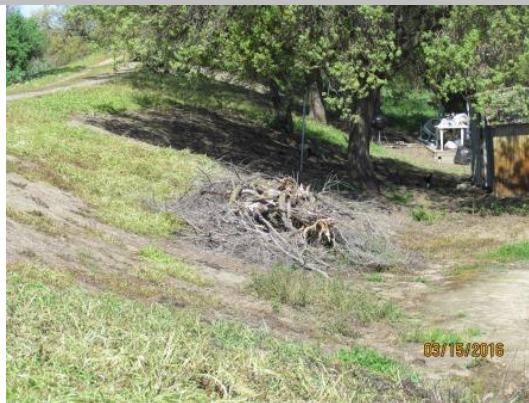
Photo 1 of 1 : SP_2017_RD2089_317_37_20170407_00033.jpg

LM Start	1.24	Rating **	U	Issue No.	37
LM End	1.24	Issue Type +	En	Location *	LS
Category	Earthen Levee			GPS Latitude/Longitude	
				Start	End
Item	Encroachments			37.818097 °	37.818097 °
				-121.419709 °	-121.419709 °
DWR ID	DWR_RD2089_02_s_2016_37				
Comment Code					
PR : Prunings					
Inspector Comment

View of the prunings on the landside levee slope.

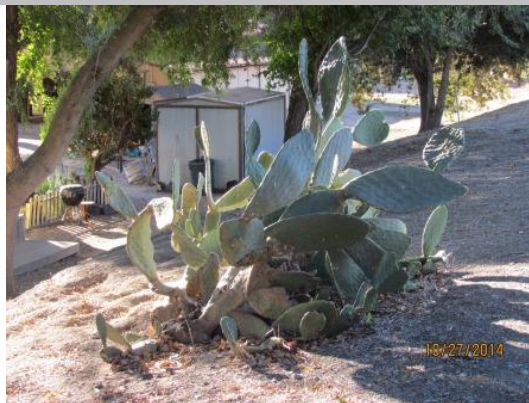
Photo 1 of 1 : SP_2017_RD2089_317_57_20170407_00050.jpg

LM Start	1.27	Rating **	M	Issue No.	57
LM End	1.27	Issue Type +	En	Location *	CR
Category	Earthen Levee			GPS Latitude/Longitude	
				Start	End
Item	Vegetation			37.818499 °	37.818499 °
				-121.419754 °	-121.419754 °
DWR ID	DWR_RD2089_02_f_2013_57				
Comment Code					
V6 : Landscaping					
Inspector Comment					
Remove cactus from levee crown.

View of the cactus on the landside levee shoulder.

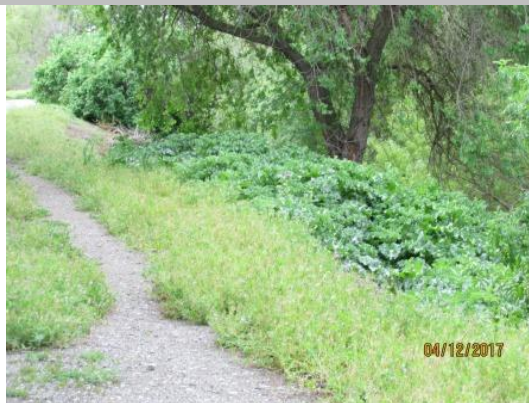
Photo 1 of 1 : SP_2017_RD2089_317_7_20170417_00054.jpg

LM Start	1.28	Rating **	U	Issue No.	7
LM End	1.28	Issue Type +	Ma	Location *	WS
Category	Earthen Levee			GPS Latitude/Longitude	
				Start	End
Item	Vegetation			37.818689 °	37.818689 °
				-121.419746 °	-121.419746 °
DWR ID	DWR_RD2089_02_s_2017_7				
Comment Code					
V2 : Remove the wild growth other than native grasses from the levee slopes.					
Inspector Comment					
Remove thistle from the levee slope.

View of the tall vegetation on the levee slope.

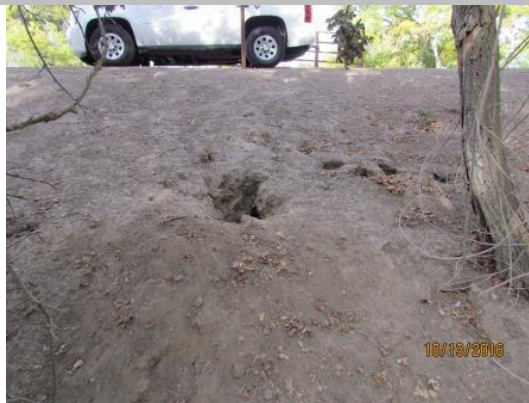
Photo 1 of 1 : SP_2017_RD2089_317_16_20170407_00016.jpg

LM Start	1.30	Rating **	U	Issue No.	16
LM End	1.30	Issue Type +	Ma	Location *	LS
Category	Earthen Levee			GPS Latitude/Longitude	
				Start	End
Item	Animal Control			37.818987 °	37.818987 °
				-121.419767 °	-121.419767 °
DWR ID	DWR_RD2089_02_s_2015_16				
Comment Code					
A1 : Exterminate rodents and backfill and compact or grout burrows.					
Inspector Comment

View of the rodent burrow in the landside levee slope.

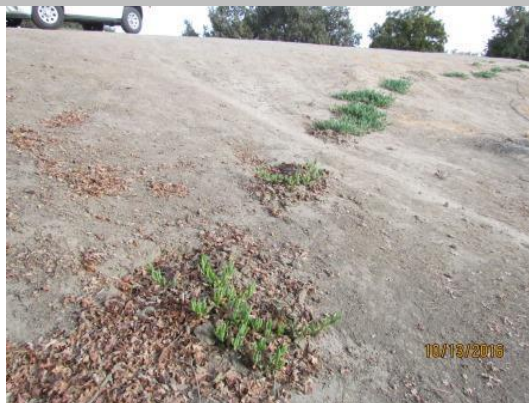
Photo 1 of 2 : SP_2017_RD2089_317_8_20170407_00006.jpg

LM Start	1.30	Rating **	M	Issue No.	8
LM End	1.34	Issue Type +	En	Location *	LS
Category	Earthen Levee			GPS Latitude/Longitude	
				Start	End
Item	Vegetation			37.818994 °	37.819556 °
				-121.419762 °	-121.419621 °
DWR ID	DWR_RD2089_02_f_2016_8				
Comment Code					
V6 : Landscaping					
Inspector Comment

View of the ice plant landscaping on the landside levee slope, looking downstream.
