**Flood Control Project Maintenance
Levee Inspections**
LMA District Cover Sheet
Spring 2018 Levee Inspection Results

Reclamation District No. 2089 Stark

Spring 2018 Levee Inspection Results

Waterway			Bank	Unit Miles
Unit No. 01 Old River			Right	1.51
	Spring (March - May)	Summer (June - August)	(September - November) Fall	Winter (December - February)
Unit Maintenance Rating (Fall Only)				
Date of Inspection	5/15/2018 - 5/15/2018			
DWR Inspector	Zach Jojola			
Accompanied By	Luz Dial DWR

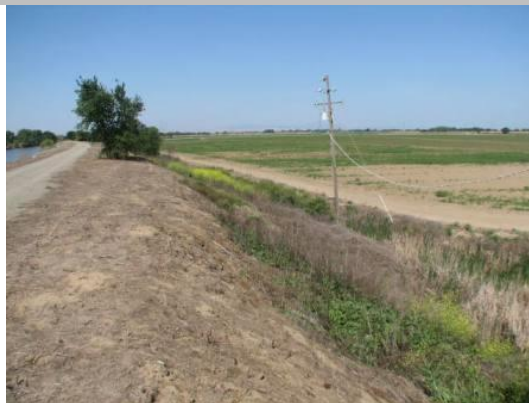
Photo 1 of 1 : SP_2018_RD2089_316_9_20180507_00009.jpg

LM Start	0.00	Rating **	M	Issue No.	9
LM End	0.38	Issue Type +	En	Location *	LS
Category	Earthen Levee			GPS Latitude/Longitude	
				Start	End
Item	Encroachments			37.811681 °	37.809755 °
				-121.384930 °	-121.391520 °
DWR ID	DWR_RD2089_01_s_2012_9				
Comment Code					
DT : Ditch					
Inspector Comment					
05/24/2011 Photo added of Ag ditch.

05/24/2011 Ditch flows parallel with the utility line shown in the photo.

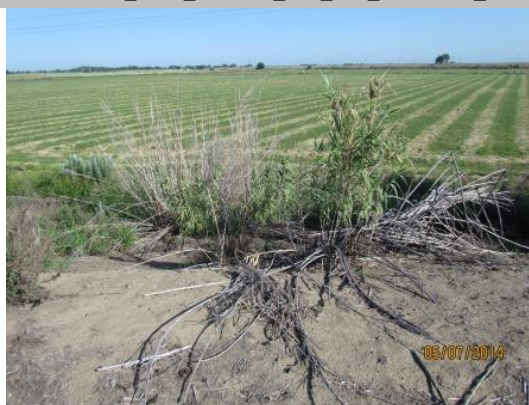
Photo 1 of 1 : SP_2018_RD2089_316_940_20180507_00042.jpg

LM Start	0.24	Rating **	M	Issue No.	940
LM End	0.24	Issue Type +	Ma	Location *	LS
Category	Earthen Levee			GPS Latitude/Longitude	
				Start	End
Item	Vegetation			37.810412 °	37.810412 °
				-121.389115 °	-121.389115 °
DWR ID	DWR_RD2089_01_s_2012_940				
Comment Code					
V2 : Remove the wild growth other than native grasses from the levee slopes.					
Inspector Comment					
Arundo has been trimmed back from the crown but still remains as an obstruction to the slope and obstructs visibility, needs to be removed.

The LMA is actively trying to remove the vegetation on the landside levee slope and toe.

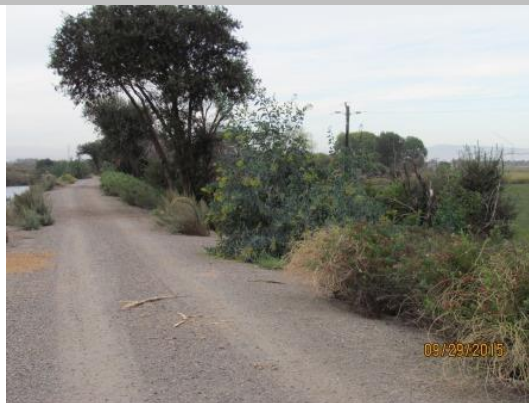
Photo 1 of 1 : SP_2018_RD2089_316_12_20180507_00010.jpg

LM Start	0.27	Rating **	U	Issue No.	12
LM End	0.39	Issue Type +	Ma	Location *	LS
Category	Earthen Levee			GPS Latitude/Longitude	
				Start	End
Item	Vegetation			37.810319 °	37.809740 °
				-121.389510 °	-121.391645 °
DWR ID	DWR_RD2089_01_s_2012_12				
Comment Code					
V2 : Remove the wild growth other than native grasses from the levee slopes.					
Inspector Comment					
Access and visibility completely blocked. 11/10/2011 issue has not changed.

Thick brush and wild rose completely block access and visibility of landside slope and toe.

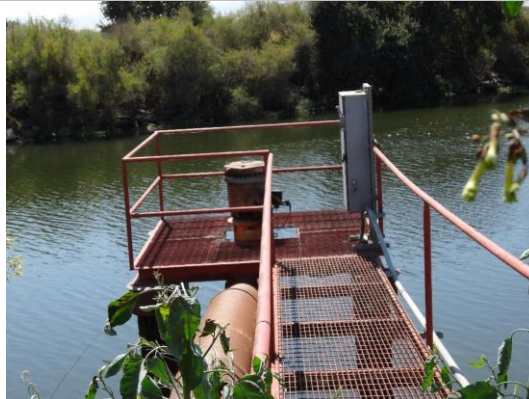
Photo 2 of 3 : UCIP_SP_2018_21635_36741.jpg

Comment Code						
Inspector Comment						
FS_ID:21635 DS_ID:23042 EP_NO: 5641 Repair Type: Non-Urgent Crossing Status: Found UCIP Comments: - damaged siphon breaker.- most of the pipe on landside exposed on levee slope. FIELD_STRUCT_DESC: 20-inch steel irrigation discharge pipe and electrical conduit through the levee, 5.8 feet below the crown. Pump on a pile structure in the stream. Siphon breaker on the landside (LS) slope. (Plans to replace a rusted out irrigation discharge pipe through the levee authorized under Permit No. 5641, 1967 - Theodore Stark). [Additional Reference(s): DWR Levee Log, 1991. USACE San Joaquin O&M Manual 8, 1968, (HLM 0.46), 21-inch pipe referenced]. FS Date: 9/12/2013

WS view: steel walkway, electric control box, and pump on steel piling structure in the channel.

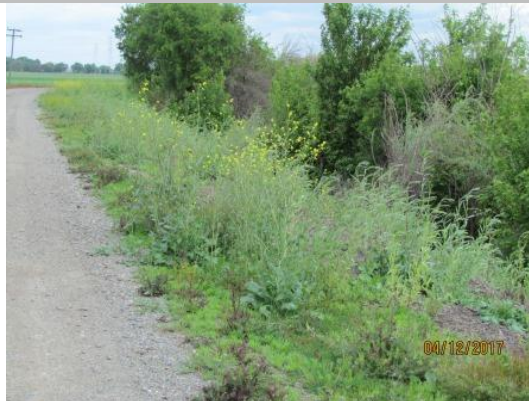
Photo 1 of 2 : SP_2018_RD2089_316_21_20180507_00022.jpg

LM Start	0.82	Rating **	M	Issue No.	21
LM End	0.94	Issue Type +	Ma	Location *	WS
Category	Earthen Levee			GPS Latitude/Longitude	
				Start	End
Item	Vegetation			37.808043 °	37.806442 °
				-121.397853 °	-121.397747 °
DWR ID	DWR_RD2089_01_f_2016_21				
Comment Code					
V2 : Remove the wild growth other than native grasses from the levee slopes.					
Inspector Comment					
Willows starting to encroach onto levee crown.

The willows are starting to creep up the levee slope.

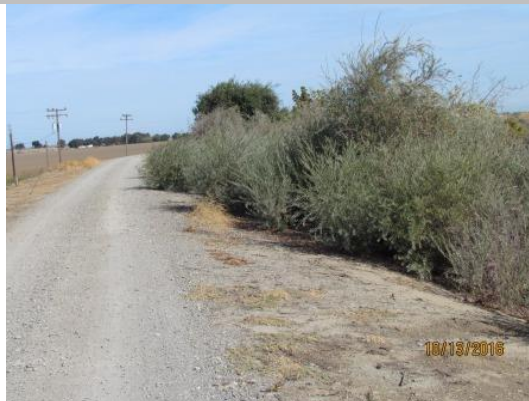
Photo 2 of 2 : SP_2018_RD2089_316_21_20180507_00023.jpg

View of the vegetation on the waterside levee slope. The willows were trimmed back.

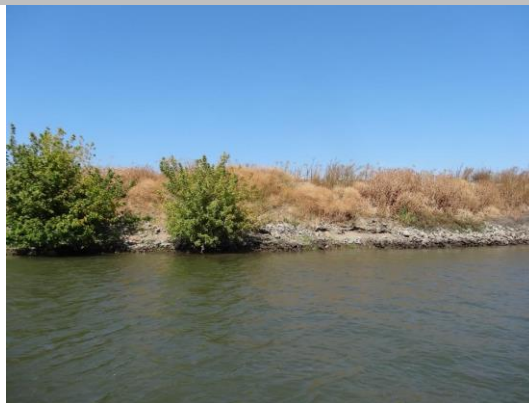
Photo 2 of 3 : SP_2018_RD2089_316_3_20180507_00005.jpg

LM Start	1.17	Rating **	A/W	Issue No.	3 (cont)	
LM End	1.17	Issue Type +	Ma	Location *	WS	
Category	Supplemental			GPS Latitude/Longitude		
				Start		End
Item	DWR Erosion Survey			37.805523 °	37.805523 °	
				-121.401718 °	-121.401718 °	
DWR ID	RD2089U01RM29.1					
Comment Code						
Inspector Comment						
09/13/2017: The erosion is at the upstream of a small tree, inside of a slight river bend. [2017 Site ID:RD2089U01RM29.1]

Front view of the erosion.

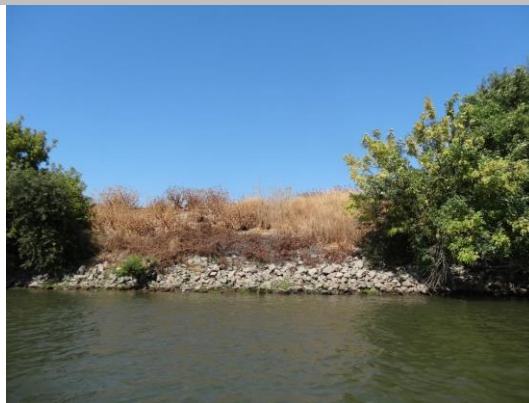
Photo 1 of 2 : SP_2018_RD2089_316_2_20180507_00002.jpg

Front view of the erosion.

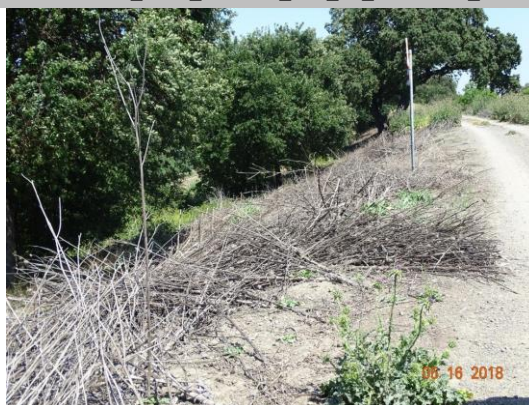
Photo 1 of 1 : SP_2018_RD2089_316_37_20180516_00058.jpg

LM Start	1.30	Rating **	M	Issue No.	37
LM End	1.51	Issue Type +	Ma	Location *	LS
Category	Earthen Levee			GPS Latitude/Longitude	
				Start	End
Item	Vegetation			37.806065 °	37.806666 °
				-121.404158 °	-121.407928 °
DWR ID	DWR_RD2089_01_s_2018_37				
Comment Code					
V2 : Remove the wild growth other than native grasses from the levee slopes.					
Inspector Comment

View of wild growth on the landside slope. Spring 2018.

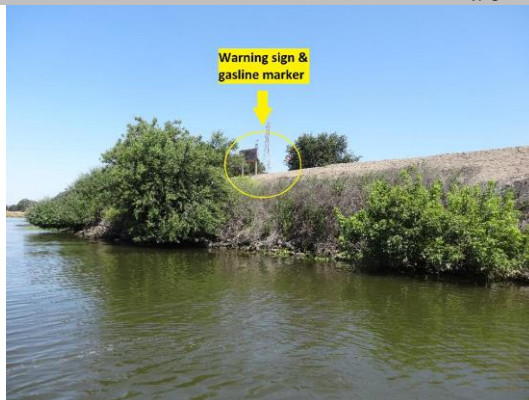
Photo 2 of 3 : UCIP_SP_2018_50736_74508.jpg

Gasline marker (for crossing with DS ID 25121) appr. 100 ft west of crossing.

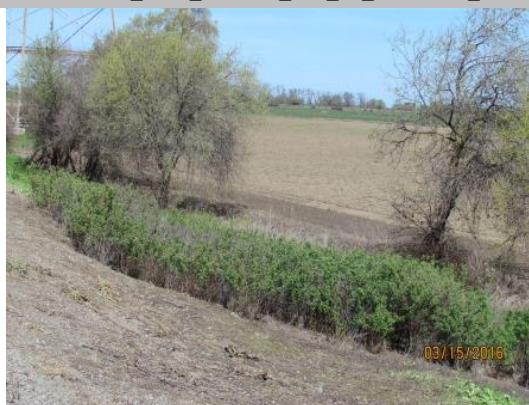
Photo 1 of 1 : SP_2018_RD2089_317_20_20180507_00022.jpg

LM Start	0.01	Rating **	U	Issue No.	20
LM End	0.11	Issue Type +	Ma	Location *	LS
Category	Earthen Levee			GPS Latitude/Longitude	
				Start	End
Item	Vegetation			37.806762 °	37.807958 °
				-121.408077 °	-121.409065 °
DWR ID	DWR_RD2089_02_s_2016_20				
Comment Code					
V2 : Remove the wild growth other than native grasses from the levee slopes.					
Inspector Comment

View of the vegetation on the landside levee slope.

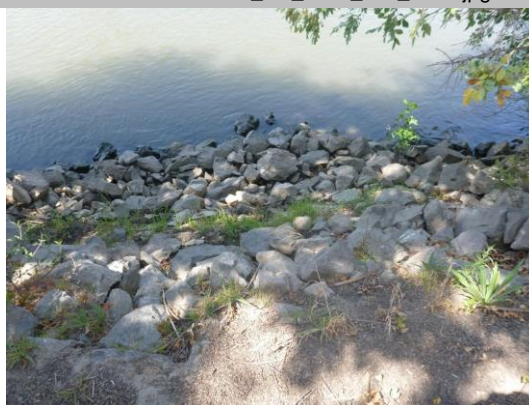
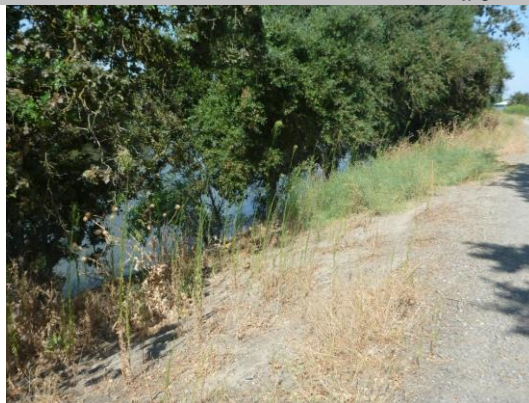
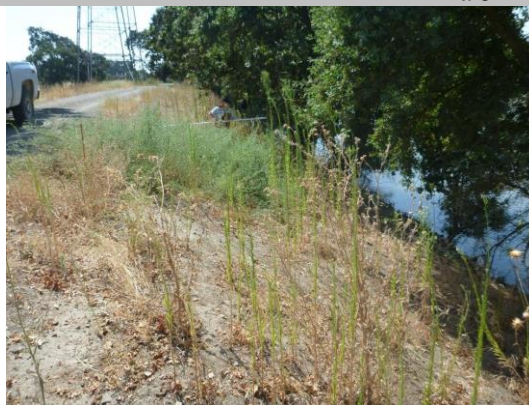
LM Start	0.20	Rating **	M	Issue No.	46
LM End	0.21	Issue Type +	Ma	Location *	
Category	Supplemental			GPS Latitude/Longitude	
				Start	End
Item	2017 Storm Damage			37.809100 °	37.809200 °
				-121.409800 °	-121.409900 °
DWR ID	DWR_RD2089_02_f _ 2017_46				
Comment Code					
Inspector Comment					
Levee Evaluation Comments					
Description:Slope protection repairs are needed along the waterside slope due to erosion and riprap displacement from high water. Based upon levee inspections, it was determined the waterside levee slope is eroding, deteriorating, and degrading. The eroded levee sections need to be restored back to design standards to prevent further deterioration and damage.					
Site ID No:509					
Site Designation:LMA-415					
Repair Type: Erosion					
Rating:Area of Concern					
Field Date:8/16/2017					
Notes: Displaced riprap at toe.

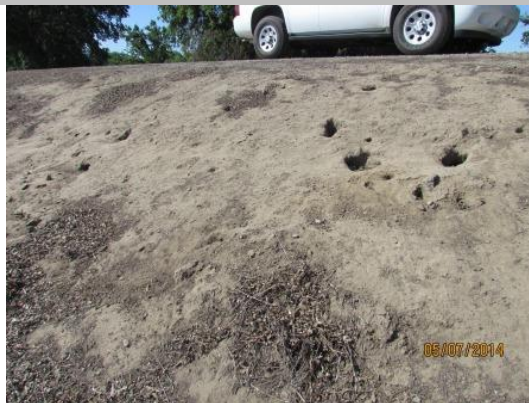
Photo 1 of 1 : SP_2018_RD2089_317_49_20180507_00054.jpg

LM Start	0.21	Rating **	M	Issue No.	49
LM End	0.21	Issue Type +	Ma	Location *	LS
Category	Earthen Levee			GPS Latitude/Longitude	
				Start	End
Item	Animal Control			37.809148 °	37.809148 °
				-121.409897 °	-121.409897 °
DWR ID	DWR_RD2089_02_s_2018_49				
Comment Code					
A3 : No rodents visible, but rodent burrows visible; need to backfill and compact or grout burrows.					
Inspector Comment

View of the multiple rodent burrows on the landside levee hinge and slope.

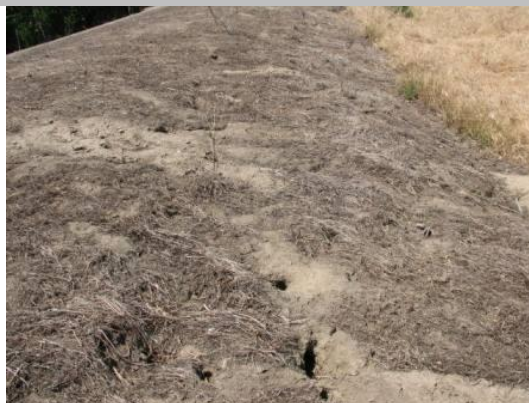
Photo 1 of 1 : SP_2018_RD2089_317_24_20180507_00024.jpg

LM Start	0.26	Rating **	M	Issue No.	24
LM End	0.26	Issue Type +	Ma	Location *	LS
Category	Earthen Levee			GPS Latitude/Longitude	
				Start	End
Item	Animal Control			37.809717 °	37.809717 °
				-121.410511 °	-121.410511 °
DWR ID	DWR_RD2089_02_s_2012_24				
Comment Code					
A1 : Exterminate rodents and backfill and compact or grout burrows.					
Inspector Comment					
Ground squirrel sighted and active burrowing in area.

05/24/2011 Active burrows, ground squirrel sighted in area.

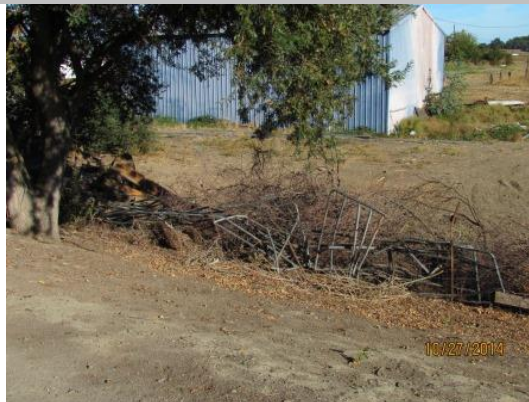
Photo 1 of 1 : SP_2018_RD2089_317_52_20180507_00059.jpg

LM Start	0.28	Rating **	U	Issue No.	52
LM End	0.30	Issue Type +	En	Location *	LS
Category	Earthen Levee			GPS Latitude/Longitude	
				Start	End
Item	Encroachments			37.809899 °	37.809997 °
				-121.410888 °	-121.411298 °
DWR ID	DWR_RD2089_02_f_2013_52				
Comment Code					
PR : Prunings					
Inspector Comment					
Remove prunings and other debris from the levee toe.

View of the tree branches on the landside levee toe obstructing access.

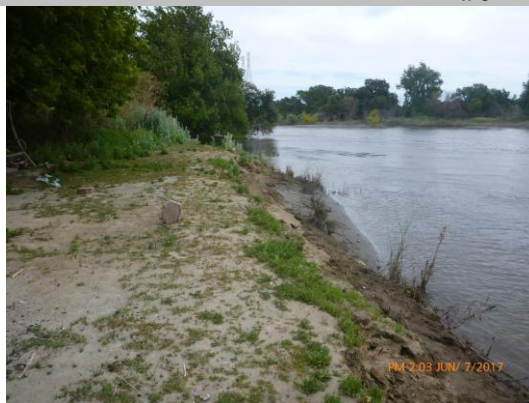
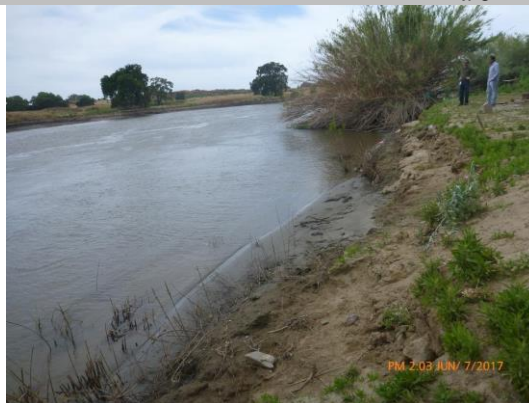
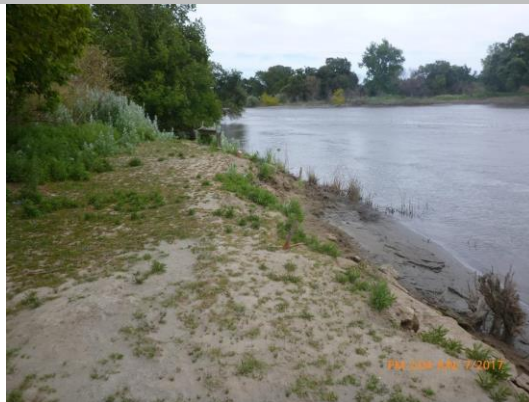
LM Start	0.32	Rating **	A/W	Issue No.	47
LM End	0.57	Issue Type +	Ma	Location *	
Category	Supplemental			GPS Latitude/Longitude	
				Start	End
Item	2017 Storm Damage			37.810020 °	37.811810 °
				-121.411550 °	-121.415390 °
DWR ID	DWR_RD2089_02_f_2017_47				
Comment Code					
Inspector Comment					
Levee Evaluation Comments					
Description:					
Site ID No:109					
Site Designation:335-103					
Repair Type: Erosion					
Rating:Area of Concern					
Field Date:6/7/2017					
Notes: vegetation too dense for evaluation

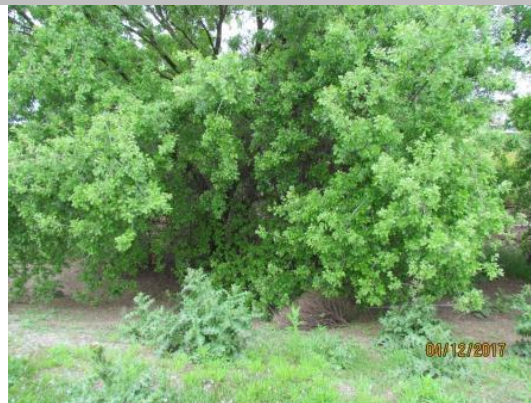
Photo 1 of 1 : SP_2018_RD2089_317_55_20180507_00064.jpg

LM Start	0.34	Rating **	M	Issue No.	55
LM End	0.34	Issue Type +	Ma	Location *	LS
Category	Earthen Levee			GPS Latitude/Longitude	
				Start	End
Item	Trim / Thin Trees			37.810052 °	37.810052 °
				-121.411966 °	-121.411966 °
DWR ID	DWR_RD2089_02_s_2017_55				
Comment Code					
T1 : Trim trees to at least five feet above ground level.					
Inspector Comment

View of the overgrown tree on the levee slope.

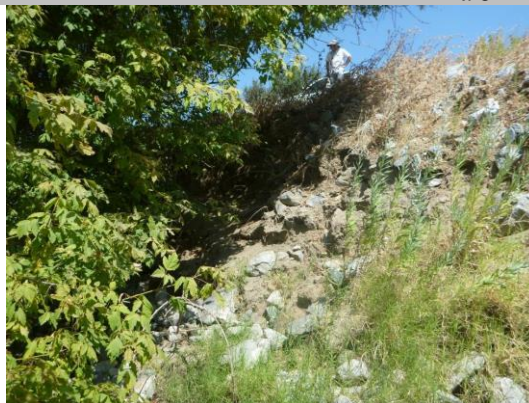
Photo 3 of 3 : LEVAL_SP_2018_508_4325.jpg

LM Start	0.39	Rating **	A/W	Issue No.	50 (cont)
LM End	0.41	Issue Type +	Ma	Location *	
Category	Supplemental			GPS Latitude/Longitude	
				Start	End
Item	2017 Storm Damage			37.810150 °	37.810270 °
				-121.412930 °	-121.413240 °
DWR ID	DWR_RD2089_02_f _ 2017_50				
Comment Code					
Inspector Comment					
Levee Evaluation Comments					
Description:Slope protection repairs are needed along the waterside slope due to erosion and riprap displacement from high water. Based upon levee inspections, it was determined the waterside levee slope is eroding, deteriorating, and degrading. The eroded levee sections need to be restored back to design standards to prevent further deterioration and damage.					
Site ID No:508					
Site Designation:LMA-414					
Repair Type: Erosion					
Rating:Serious					
Field Date:8/16/2017					
Notes: Large erosion around tree with a 12' vertical cut.

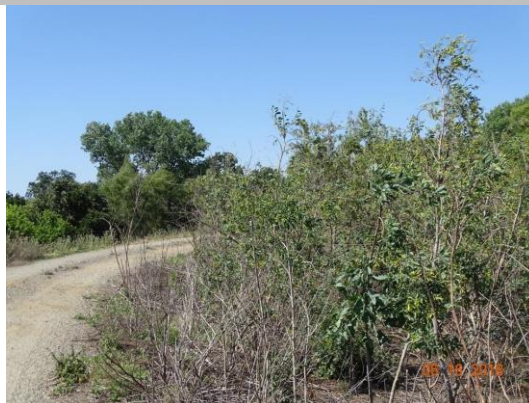
Photo 1 of 1 : SP_2018_RD2089_317_62_20180516_00072.jpg

LM Start	0.43	Rating **	M	Issue No.	62
LM End	0.93	Issue Type +	Ma	Location *	LS
Category	Earthen Levee			GPS Latitude/Longitude	
				Start	End
Item	Vegetation			37.810453 °	37.814923 °
				-121.413533 °	-121.416290 °
DWR ID	DWR_RD2089_02_s_2018_62				
Comment Code					
V2 : Remove the wild growth other than native grasses from the levee slopes.					
Inspector Comment

View of wild growth on the partially visible landside slope. Spring 2018.

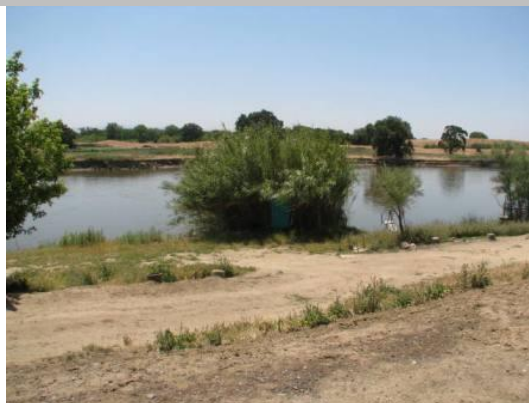
Photo 1 of 1 : SP_2018_RD2089_317_27_20180507_00026.jpg

LM Start	0.44	Rating **	M	Issue No.	27
LM End	0.44	Issue Type +	En	Location *	WS
Category	Earthen Levee			GPS Latitude/Longitude	
				Start	End
Item	Encroachments			37.810490 °	37.810490 °
				-121.413638 °	-121.413638 °
DWR ID	DWR_RD2089_02_s_2012_27				
Comment Code					
BU : Building					
Inspector Comment					
Portable toilet on bank, at water's edge.

05/24/2011 Portable toilet is in the shadows in the center of the photo at the water's edge.

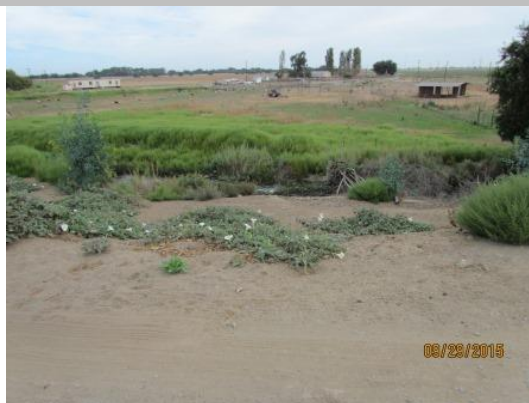
Photo 3 of 4 : SP_2018_RD2089_317_35_20180507_00033.jpg

LM Start	0.54	Rating **	M	Issue No.	35 (cont)
LM End	0.54	Issue Type +	Ma	Location *	CR

View of the levee crown depression looking to the landside.

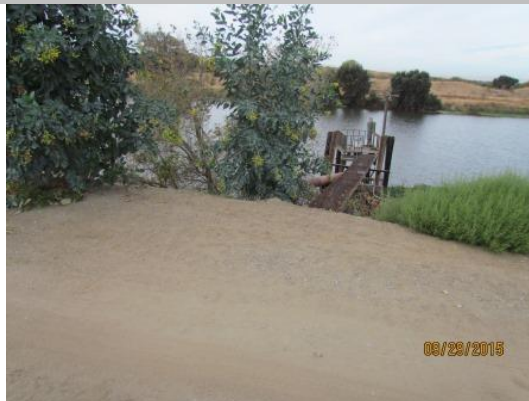
Photo 4 of 4 : SP_2018_RD2089_317_35_20180507_00034.jpg

LM Start	0.54	Rating **	M	Issue No.	35 (cont)
LM End	0.54	Issue Type +	Ma	Location *	CR

View of the levee crown depression looking to the waterside.

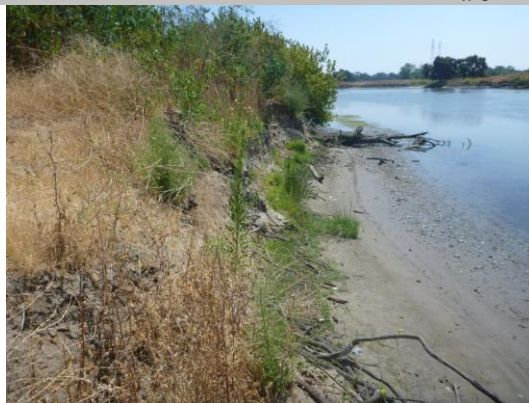
Photo 1 of 3 : LEVAL_SP_2018_507_4335.jpg

LM Start	0.60	Rating **	A/W	Issue No.	56
LM End	0.61	Issue Type +	Ma	Location *	
Category	Supplemental			GPS Latitude/Longitude	
				Start	End
Item	2017 Storm Damage			37.812000 °	37.812100 °
				-121.415700 °	-121.415900 °
DWR ID	DWR_RD2089_02_s_2018_56				
Comment Code					
Inspector Comment					
Levee Evaluation Comments					
Description:Slope protection repairs are needed along the waterside slope due to erosion and riprap displacement from high water. Based upon levee inspections, it was determined the waterside levee slope is eroding, deteriorating, and degrading. The eroded levee sections need to be restored back to design standards to prevent further deterioration and damage.					
Site ID No:507					
Site Designation:LMA-413					
Repair Type: Erosion					
Rating:Serious					
Field Date:8/16/2017					
Notes: Vertical cut on outside bend of river

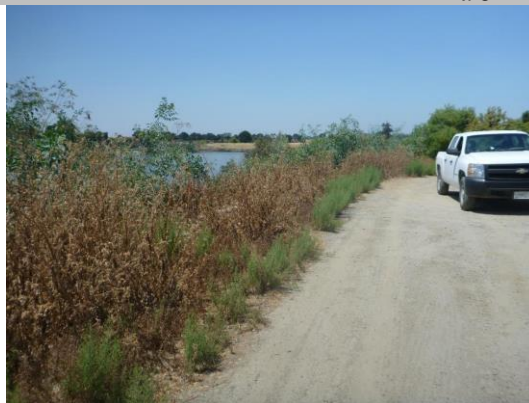
Photo 3 of 3 : LEVAL_SP_2018_507_4340.jpg

Item	2017 Storm Damage		37.812000 °	37.812100 °								
			-121.415700 °	-121.415900 °								
DWR ID	DWR_RD2089_02_s_2018_56											
Comment Code												
Inspector Comment												
<p>Levee Evaluation Comments</p> <p>Description: Slope protection repairs are needed along the waterside slope due to erosion and riprap displacement from high water. Based upon levee inspections, it was determined the waterside levee slope is eroding, deteriorating, and degrading. The eroded levee sections need to be restored back to design standards to prevent further deterioration and damage.</p> <p>Site ID No: 507</p> <p>Site Designation: LMA-413</p> <p>Repair Type: Erosion</p> <p>Rating: Serious</p> <p>Field Date: 8/16/2017</p> <p>Notes: Vertical cut on outside bend of river</p>

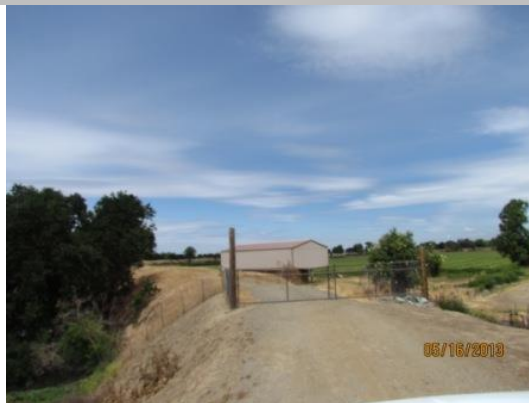
Photo 1 of 1 : SP_2018_RD2089_317_9_20180507_00010.jpg

LM Start	0.84	Rating **	M	Issue No.	9
LM End	0.84	Issue Type +	En	Location *	CR
Category	Earthen Levee			GPS Latitude/Longitude	
				Start	End
Item	Encroachments			37.814881 °	37.814881 °
				-121.414676 °	-121.414676 °
DWR ID	DWR_RD2089_02_s_2012_9				
Comment Code					
FE : Fence					
Inspector Comment					
Gate across levee crown.

View of the fence gate across levee crown.

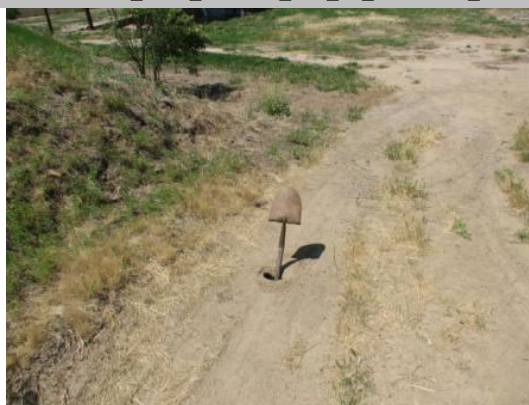
Photo 1 of 3 : SP_2018_RD2089_317_40_20180507_00039.jpg

LM Start	0.85	Rating **	U	Issue No.	40
LM End	0.90	Issue Type +	Ma	Location *	LS
Category	Earthen Levee			GPS Latitude/Longitude	
				Start	End
Item	Animal Control			37.814997 °	37.814970 °
				-121.414774 °	-121.415767 °
DWR ID	DWR_RD2089_02_s_2012_40				
Comment Code					
A1 : Exterminate rodents and backfill and compact or grout burrows.					
Inspector Comment					
Numerous burrows on landside slope adjacent to hay storage area. Deep burrows in crown and landside ramp.

05/24/2011 Deep vertical burrow in ramp on land side of levee.

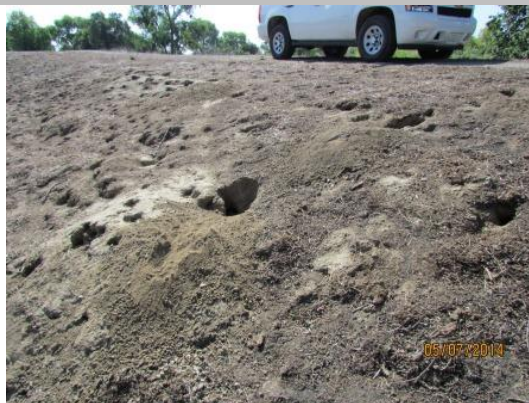
Photo 1 of 1 : SP_2018_RD2089_317_5_20180507_00005.jpg

LM Start	0.95	Rating **	U	Issue No.	5
LM End	0.95	Issue Type +	Ma	Location *	LS
Category	Earthen Levee			GPS Latitude/Longitude	
				Start	End
Item	Animal Control			37.814915 °	37.814915 °
				-121.416606 °	-121.416606 °
DWR ID	DWR_RD2089_02_s _ 2014_5				
Comment Code					
A1 : Exterminate rodents and backfill and compact or grout burrows.					
Inspector Comment

View of the rodent holes on the landside levee slope.

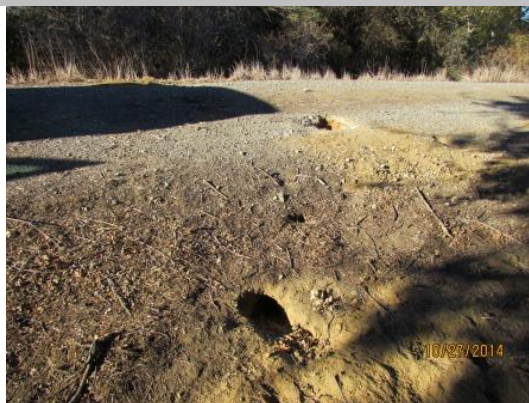
Photo 2 of 2 : SP_2018_RD2089_317_12_20180507_00014.jpg

LM Start	1.00	Rating **	U	Issue No.	12 (cont)
LM End	1.00	Issue Type +	Ma	Location *	CR

View of several rodent burrows on landside levee hinge and crown.

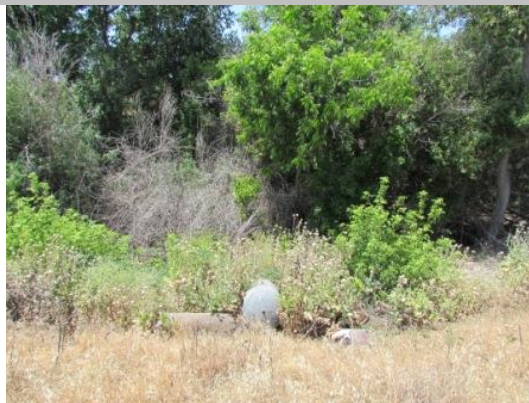
Photo 1 of 1 : SP_2018_RD2089_317_17_20180507_00019.jpg

LM Start	1.08	Rating **	M	Issue No.	17
LM End	1.08	Issue Type +	Ma	Location *	WS
Category	Earthen Levee			GPS Latitude/Longitude	
				Start	End
Item	Encroachments			37.816025 °	37.816025 °
				-121.418544 °	-121.418544 °
DWR ID	DWR_RD2089_02_s_2012_17				
Comment Code					
DE : Debris					
Inspector Comment					
Water tanks disposed of on levee are obstructive.

View of water tanks disposed on waterside slope.

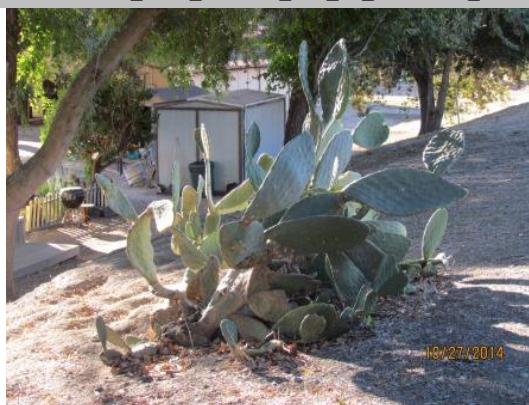
Photo 1 of 1 : SP_2018_RD2089_317_57_20180507_00068.jpg

LM Start	1.27	Rating **	M	Issue No.	57
LM End	1.27	Issue Type +	En	Location *	CR
Category	Earthen Levee			GPS Latitude/Longitude	
				Start	End
Item	Vegetation			37.818499 °	37.818499 °
				-121.419754 °	-121.419754 °
DWR ID	DWR_RD2089_02_f_2013_57				
Comment Code					
V6 : Landscaping					
Inspector Comment					
Remove cactus from levee crown.

View of the cactus on the landside levee shoulder.

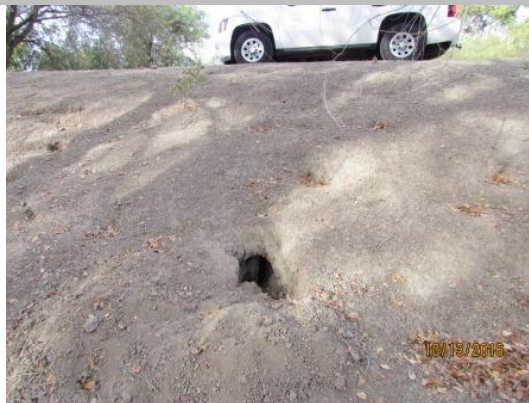
Photo 1 of 1 : SP_2018_RD2089_317_19_20180507_00021.jpg

LM Start	1.29	Rating **	U	Issue No.	19
LM End	1.29	Issue Type +	Ma	Location *	LS
Category	Earthen Levee			GPS Latitude/Longitude	
				Start	End
Item	Animal Control			37.818740 °	37.818740 °
				-121.419759 °	-121.419759 °
DWR ID	DWR_RD2089_02_f_2016_19				
Comment Code					
A3 : No rodents visible, but rodent burrows visible; need to backfill and compact or grout burrows.					
Inspector Comment

View of the rodent burrow in the landside levee slope.

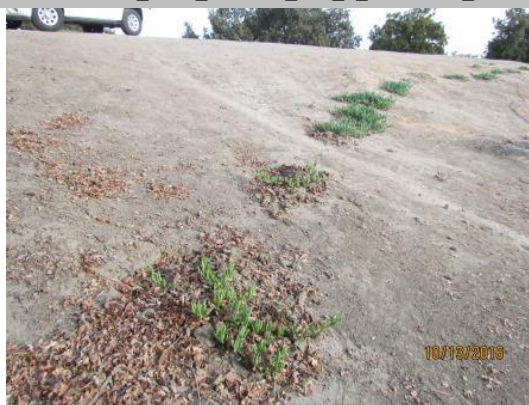
Photo 1 of 2 : SP_2018_RD2089_317_8_20180507_00008.jpg

LM Start	1.30	Rating **	M	Issue No.	8
LM End	1.34	Issue Type +	En	Location *	LS
Category	Earthen Levee			GPS Latitude/Longitude	
				Start	End
Item	Vegetation			37.818994 °	37.819556 °
				-121.419762 °	-121.419621 °
DWR ID	DWR_RD2089_02_f_2016_8				
Comment Code					
V6 : Landscaping					
Inspector Comment

View of the ice plant landscaping on the landside levee slope, looking downstream.
