**Flood Control Project Maintenance
Levee Inspections**
LMA District Cover Sheet
Spring 2019 Levee Inspection Results

Reclamation District No. 2089 Stark

Spring 2019 Levee Inspection Results

Waterway			Bank	Unit Miles
Unit No. 01 Old River			Right	1.51
	Spring (March - May)	Summer (June - August)	(September - November) Fall	Winter (December - February)
Unit Maintenance Rating (Fall Only)				
Date of Inspection	4/4/2019 - 4/4/2019			
DWR Inspector	Alberto De Leon			
Accompanied By	Wade Wylie DWR

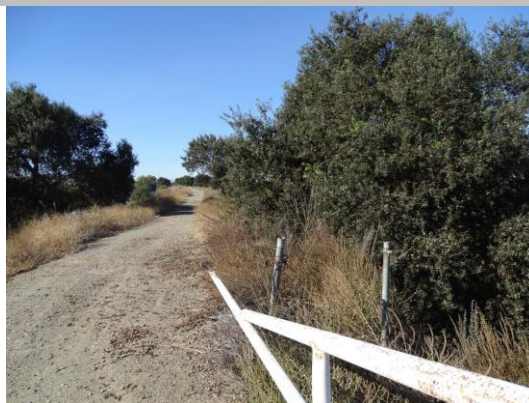
Photo 1 of 2 : SP_2019_RD2089_316_24_20190313_00025.jpg

LM Start	0.00	Rating **	U	Issue No.	24
LM End	0.77	Issue Type +	Ma	Location *	LS
Category	Earthen Levee			GPS Latitude/Longitude	
				Start	End
Item	Vegetation			37.811547 °	37.808843 °
				-121.385268 °	-121.397613 °
DWR ID	DWR_RD2089_01_f_2018_24				
Comment Code					
V1 : Control annual grass and weeds on the levee slopes and easements.					
Inspector Comment

Typical view of landward slope. (Fall 2018)

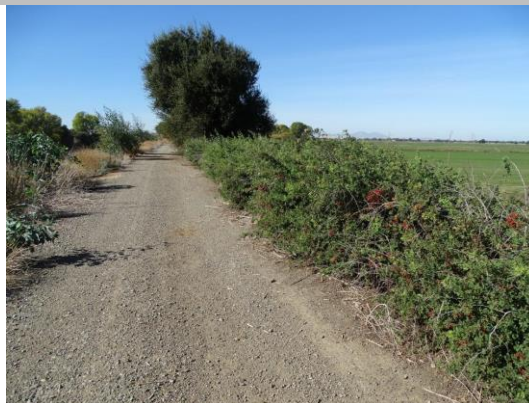
Photo 1 of 1 : SP_2019_RD2089_316_23_20190313_00024.jpg

LM Start	0.30	Rating **	U	Issue No.	23
LM End	0.32	Issue Type +	Ma	Location *	LS
Category	Earthen Levee			GPS Latitude/Longitude	
				Start	End
Item	Vegetation			37.810138 °	37.810043 °
				-121.390020 °	-121.390343 °
DWR ID	DWR_RD2089_01_f_2018_23				
Comment Code					
V2 : Remove the wild growth other than native grasses from the levee slopes.					
Inspector Comment					
Berryvines and wild roses on landward shoulder and slope blocking view.

Looking at dense berryvines and wild roses on landward shoulder and slope. (Fall 2018)

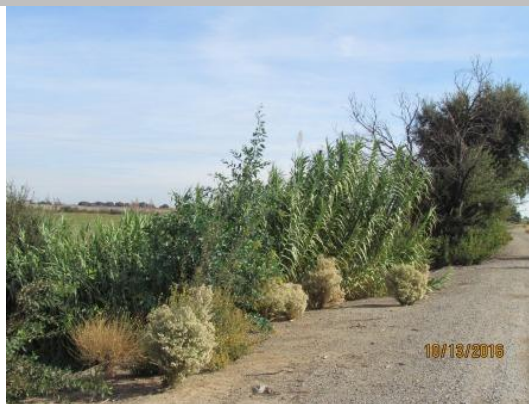
Photo 1 of 2 : SP_2019_RD2089_316_19_20190313_00018.jpg

LM Start	0.33	Rating **	U	Issue No.	19
LM End	0.33	Issue Type +	Ma	Location *	LS
Category	Earthen Levee			GPS Latitude/Longitude	
				Start	End
Item	Vegetation			37.810002 °	37.810002 °
				-121.390674 °	-121.390674 °
DWR ID	DWR_RD2089_01_s_2012_19				
Comment Code					
V2 : Remove the wild growth other than native grasses from the levee slopes.					
Inspector Comment					
Arundo needs to be maintained so that it does not obstruct visibility and access to the landside toe.

View of the arundo back on the landside levee slope. Fall 2016

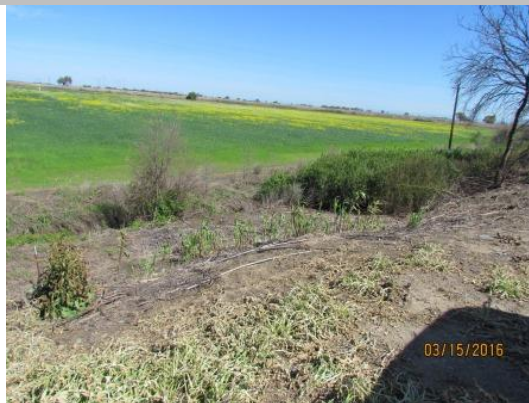
Photo 2 of 2 : SP_2019_RD2089_316_19_20190313_00019.jpg

LM Start	0.33	Rating **	U	Issue No.	19 (cont)	
LM End	0.33	Issue Type +	Ma	Location *	LS	
Category	Earthen Levee			GPS Latitude/Longitude		
				Start		End
Item	Vegetation			37.810002 °		37.810002 °
				-121.390674 °		-121.390674 °
DWR ID	DWR_RD2089_01_s_2012_19					
Comment Code						
V2 : Remove the wild growth other than native grasses from the levee slopes.						
Inspector Comment						
Arundo needs to be maintained so that it does not obstruct visibility and access to the landside toe.

View of trimmed arundo. Spring 2016

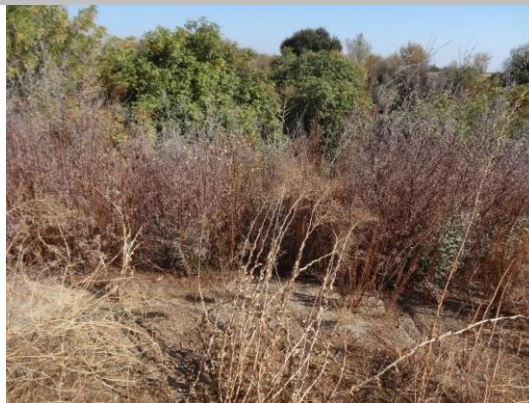
Photo 1 of 2 : SP_2019_RD2089_316_5_20190313_00008.jpg

Comment Code					
Inspector Comment					
09/13/2017: No significant change observed.					
07/25/2016: No significant change observed.					
06/25/2015: No significant change observed.					
07/02/2014: No significant change observed.					
08/13/2013: No significant change observed.					
08/07/2012: The site has been visited by boat survey. No significant change observed					
08/23/2011: The 5-foot vertical scarp shows no significant change from the last year inspection. No new erosion activities observed. Dense white willow trees on site.					
09/07/2010: It was difficult to view the erosion due to the thick Willow thickets and other vegetation at the water line. At the time of the inspection, there were no signs of repair on site. As noted during the last survey, there is a 5-foot vertical scarp along the lower slope that may be subjected to high flow velocities.					
08/05/2010: Recommended for repair, per CLRO; "Erosion of this site may be subjective to rapid rates of erosion."

09/28/2009: No major change observed; 5-foot vertical scarp is immediately downstream of where berm has tapered; site is recommended as local maintenance issue, per CLRO CES Evaluation 2008 Report; Site # is the same as RM29.6, LM0.60; previously rated "U".					
11/05/2008: No change observed; rodent holes on lower slope; wide levee crown. [2017 Site ID:RD2089U01RM29.61]

Front view of the site. The scarp erosion is at the levee slope but is not visible due to the dense vegetation at the site.

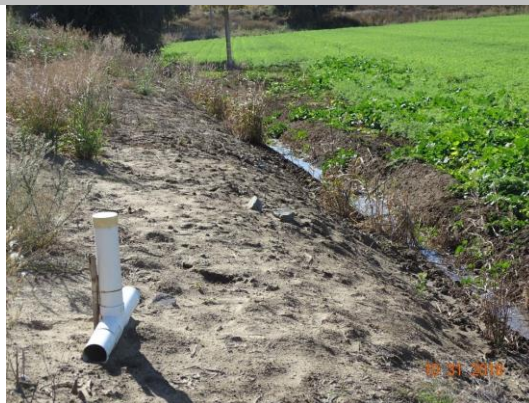
Photo 2 of 2 : SP_2019_RD2089_316_17_20190313_00016.jpg

LM Start	0.81	Rating **	U	Issue No.	17 (cont)	
LM End	0.94	Issue Type +	En	Location *	LS	
Category	Earthen Levee			GPS Latitude/Longitude		
				Start		End
Item	Encroachments			37.808319 °		37.806453 °
				-121.397881 °		-121.397755 °
DWR ID	DWR_RD2089_01_f_2014_17					
Comment Code						
AT : Agricultural tilling						
Inspector Comment						
The landside levee toe is cut due to farming.

View of vertical cut along the landward toe. (Fall 2018)

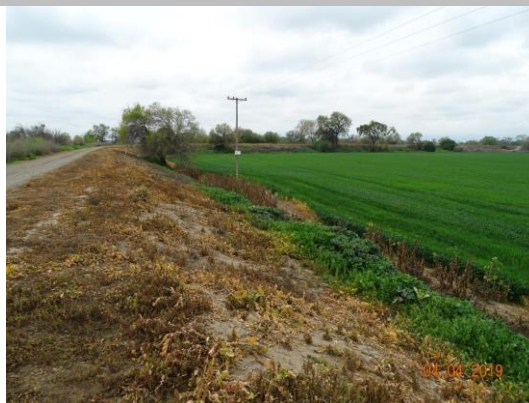
Photo 1 of 1 : SP_2019_RD2089_316_27_20190422_00057.jpg

LM Start	0.83	Rating **	U	Issue No.	27
LM End	1.51	Issue Type +	Ma	Location *	LS
Category	Earthen Levee			GPS Latitude/Longitude	
				Start	End
Item	Vegetation			37.807991 °	37.806638 °
				-121.397847 °	-121.407833 °
DWR ID	DWR_RD2089_01_s_2019_27				
Comment Code					
V2 : Remove the wild growth other than native grasses from the levee slopes.					
Inspector Comment					
Vegetation on landside toe needs to be maintained to allow access and visibility.

View of vegetation on landside slope. (spring 2019)

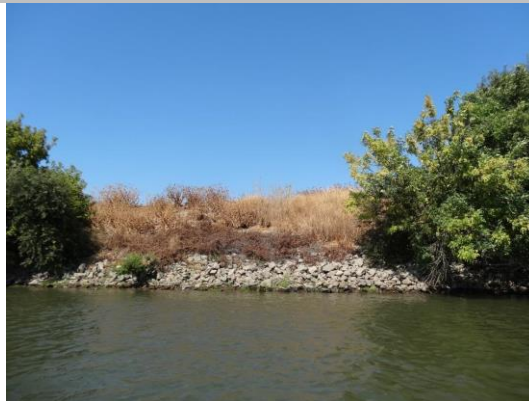
Photo 1 of 2 : SP_2019_RD2089_316_2_20190313_00003.jpg

Front view of the erosion.

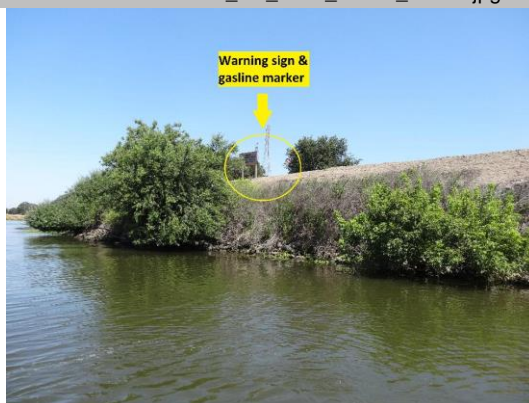
Photo 2 of 3 : UCIP_SP_2019_53182_74508.jpg

Gasline marker (for crossing with DS ID 25121) appr. 100 ft west of crossing.

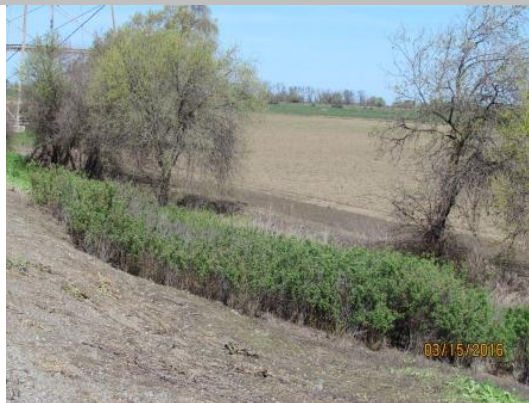
Photo 1 of 3 : SP_2019_RD2089_317_20_20190313_00022.jpg

LM Start	0.00	Rating **	U	Issue No.	20
LM End	0.11	Issue Type +	Ma	Location *	LS
Category	Earthen Levee			GPS Latitude/Longitude	
				Start	End
Item	Vegetation			37.806636 °	37.807958 °
				-121.407840 °	-121.409065 °
DWR ID	DWR_RD2089_02_s_2016_20				
Comment Code					
V2 : Remove the wild growth other than native grasses from the levee slopes.					
Inspector Comment

View of the vegetation on the landside levee slope.

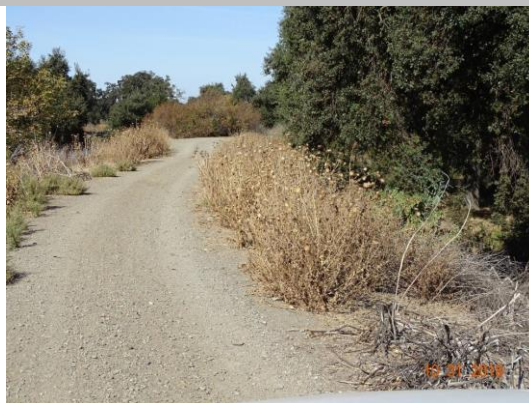
Photo 2 of 3 : SP_2019_RD2089_317_20_20190313_00023.jpg

View of dense veg on landward slope. (Fall 2018)

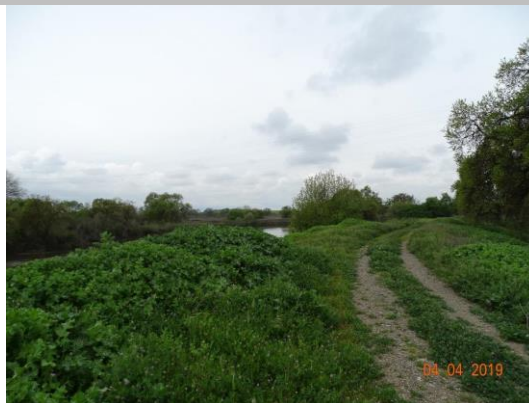
Photo 1 of 1 : SP_2019_RD2089_317_58_20190422_00070.jpg

LM Start	0.00	Rating **	U	Issue No.	58
LM End	1.34	Issue Type +	Ma	Location *	WS
Category	Earthen Levee			GPS Latitude/Longitude	
				Start	End
Item	Vegetation			37.806636 °	37.819608 °
				-121.407840 °	-121.419609 °
DWR ID	DWR_RD2089_02_s_2017_58				
Comment Code					
V2 : Remove the wild growth other than native grasses from the levee slopes.					
Inspector Comment					
Trim back the shrub to allow access and visibility.

Typical view of vegetation on waterside slope. (Spring 2019)

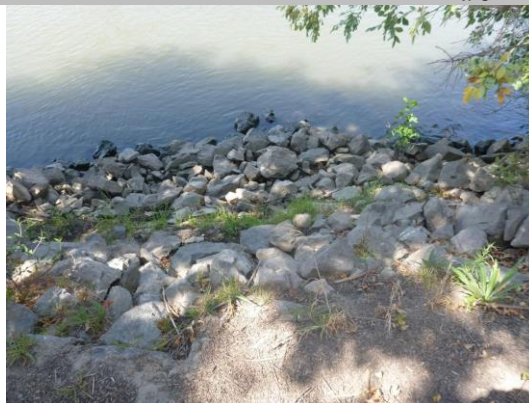
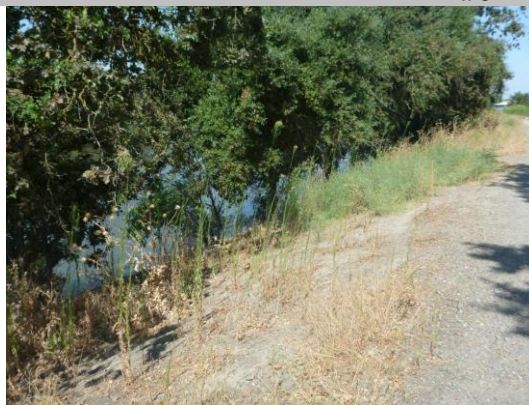
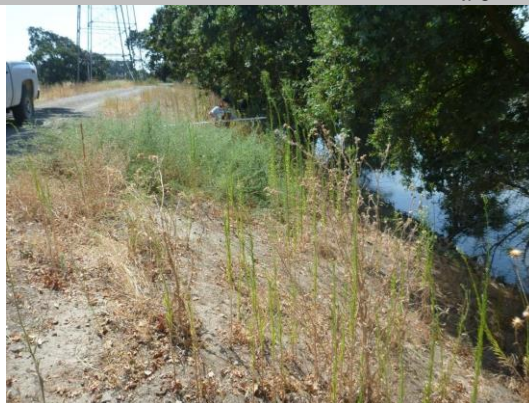
LM Start	0.20	Rating **	M	Issue No.	46
LM End	0.21	Issue Type +	Ma	Location *	
Category	Supplemental			GPS Latitude/Longitude	
				Start	End
Item	2017 Storm Damage			37.809100 °	37.809200 °
				-121.409800 °	-121.409900 °
DWR ID	DWR_RD2089_02_f_2017_46				
Comment Code					
Inspector Comment					
Levee Evaluation Comments					
Description:Slope protection repairs are needed along the waterside slope due to erosion and riprap displacement from high water. Based upon levee inspections, it was determined the waterside levee slope is eroding, deteriorating, and degrading. The eroded levee sections need to be restored back to design standards to prevent further deterioration and damage.					
Site ID No:509					
Site Designation:LMA-415					
Repair Type: Erosion					
Rating:Area of Concern					
Field Date:8/16/2017					
Notes: Displaced riprap at toe.

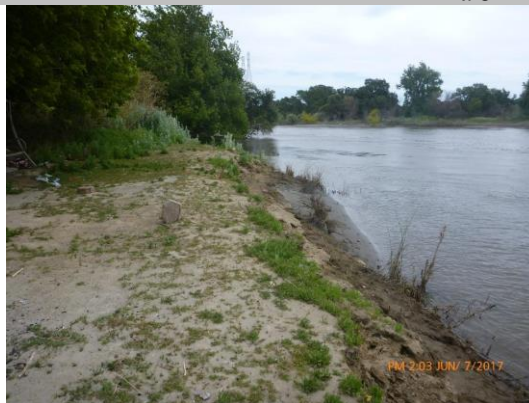
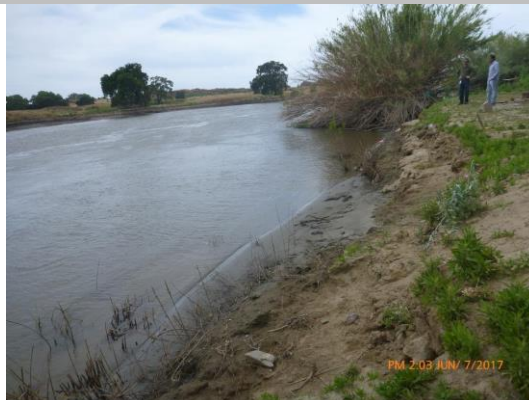
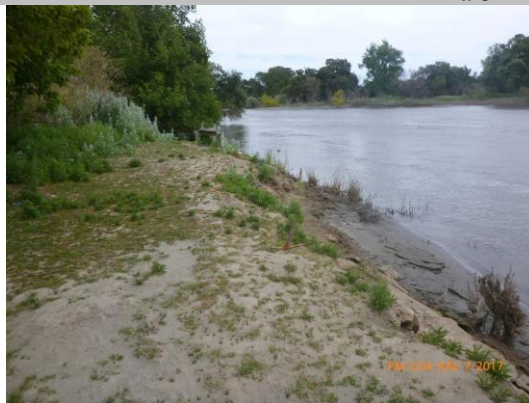
LM Start	0.32	Rating **	A/W	Issue No.	47 (cont)	
LM End	0.57	Issue Type +	Ma	Location *		
Category	Supplemental			GPS Latitude/Longitude		
				Start		End
Item	2017 Storm Damage			37.810020 °	37.811810 °	
				-121.411550 °	-121.415390 °	
DWR ID	DWR_RD2089_02_f_2017_47					
Comment Code						
Inspector Comment						
Levee Evaluation Comments						
Description:						
Site ID No:109						
Site Designation:335-103						
Repair Type: Erosion						
Rating:Area of Concern						
Field Date:6/7/2017						
Notes: vegetation too dense for evaluation

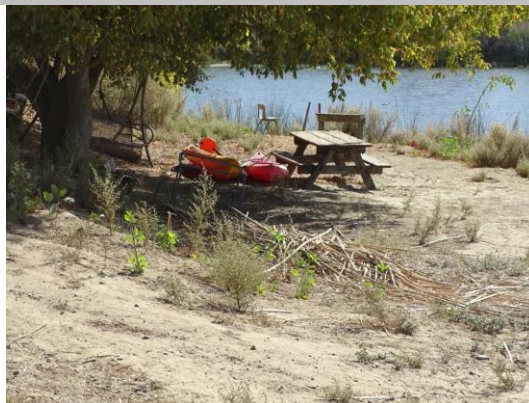
Photo 2 of 3 : SP_2019_RD2089_317_27_20190313_00028.jpg

LM Start	0.44	Rating **	M	Issue No.	27 (cont)	
LM End	0.44	Issue Type +	En	Location *	WS	
Category	Earthen Levee			GPS Latitude/Longitude		
				Start		End
Item	Encroachments			37.810490 °		37.810490 °
				-121.413638 °		-121.413638 °
DWR ID	DWR_RD2089_02_s_2012_27					
Comment Code						
BU : Building						
Inspector Comment						
There is a portable toilet on the bank at the water's edge as well as other items.

View of picnic table and other items on waterward berm. (Fall 2018)

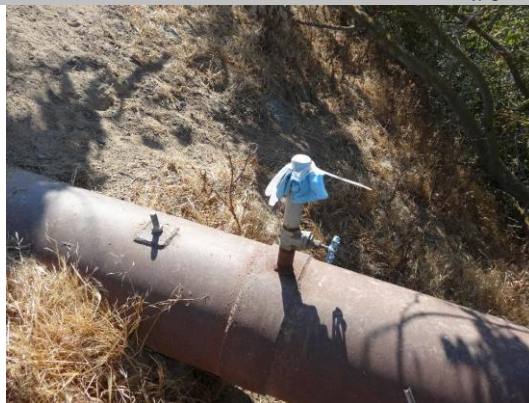
Photo 2 of 3 : UCIP_SP_2019_21676_36860.jpg

LM Start	0.54	Rating **	M	Issue No.	60 (cont)
LM End	0.54	Issue Type +	En	Location *

WS view: air relief valve on pipe. Pipe exposed in levee slope.

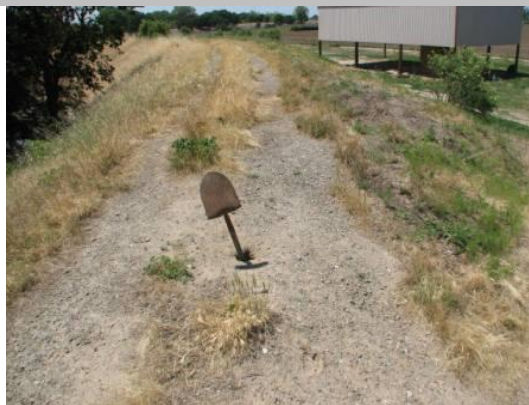
Photo 2 of 3 : SP_2019_RD2089_317_40_20190313_00039.jpg

View of deep vertical burrow in levee crown. 05/24/2011

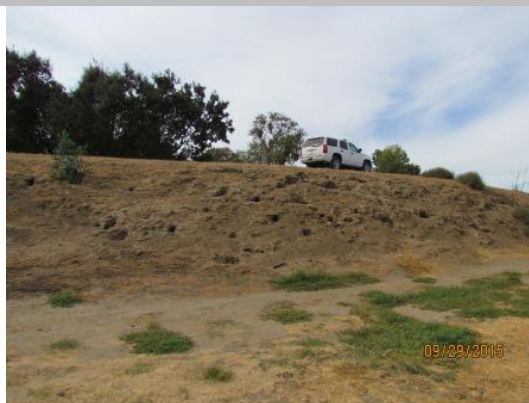
Photo 3 of 3 : SP_2019_RD2089_317_40_20190313_00040.jpg

LM Start	0.85	Rating **	U	Issue No.	40 (cont)
LM End	0.90	Issue Type +	Ma	Location *	LS

View of the multiple rodent holes on the landside levee slope.

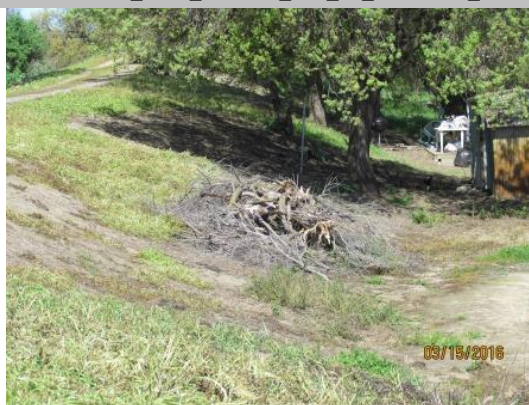
Photo 1 of 1 : SP_2019_RD2089_317_37_20190313_00037.jpg

LM Start	1.24	Rating **	M	Issue No.	37
LM End	1.24	Issue Type +	En	Location *	LS
Category	Earthen Levee			GPS Latitude/Longitude	
				Start	End
Item	Encroachments			37.818097 °	37.818097 °
				-121.419709 °	-121.419709 °
DWR ID	DWR_RD2089_02_s_2016_37				
Comment Code					
PR : Prunings					
Inspector Comment

View of the prunings on the landside levee slope.

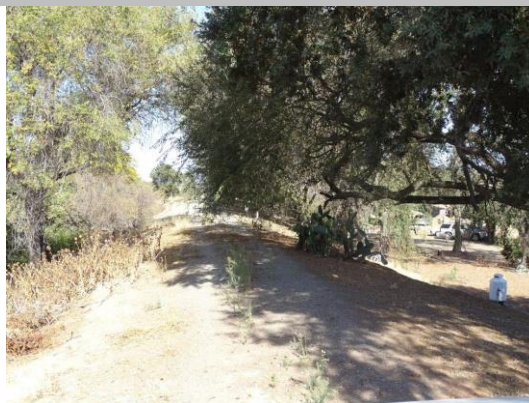
Photo 1 of 1 : SP_2019_RD2089_317_33_20190313_00032.jpg

LM Start	1.26	Rating **	U	Issue No.	33
LM End	1.26	Issue Type +	Ma	Location *	CR
Category	Earthen Levee			GPS Latitude/Longitude	
				Start	End
Item	Trim / Thin Trees			37.818408 °	37.818408 °
				-121.419738 °	-121.419738 °
DWR ID	DWR_RD2089_02_f_2018_33				
Comment Code					
T4 : Trim trees over roadway to at least 12 feet above ground level.					
Inspector Comment					
Tree on landward slope is overhanging crown of levee.

Looking west at trees overhanging crown of levee. (Fall 2018)

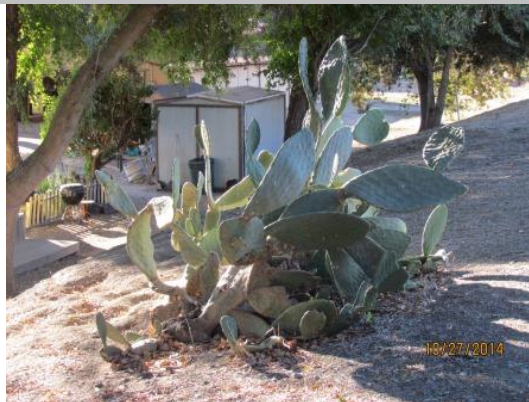
Photo 1 of 1 : SP_2019_RD2089_317_57_20190313_00064.jpg

LM Start	1.27	Rating **	M	Issue No.	57
LM End	1.27	Issue Type +	En	Location *	CR
Category	Earthen Levee			GPS Latitude/Longitude	
				Start	End
Item	Vegetation			37.818499 °	37.818499 °
				-121.419754 °	-121.419754 °
DWR ID	DWR_RD2089_02_f_2013_57				
Comment Code					
V6 : Landscaping					
Inspector Comment					
Remove cactus from levee crown.

View of the cactus on the crown at the landside levee shoulder.
