**Flood Control Project Maintenance
Levee Inspections**
LMA District Cover Sheet
Spring 2020 Levee Inspection Results

Reclamation District No. 2089 Stark

Spring 2020 Levee Inspection Results

| Waterway | | | Bank | Unit Miles |
|--|---|---|---|---|
| Unit No. 01 Old River | | | Right | 1.51 |

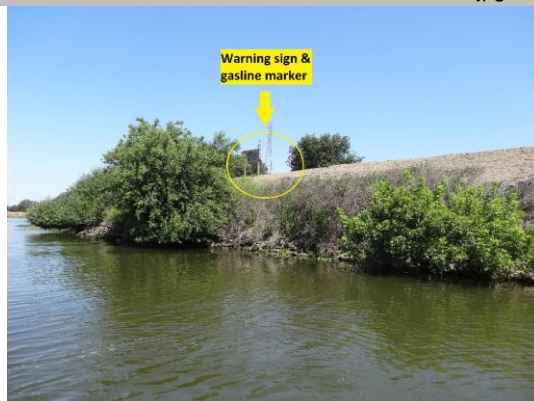
Photo 2 of 3 : UCIP_SP_2020_53182_74508.jpg

View up WS slope from water. Pipe does not cross channel.

Gasline marker (for crossing with DS ID 25121) appr. 100 ft west of crossing.

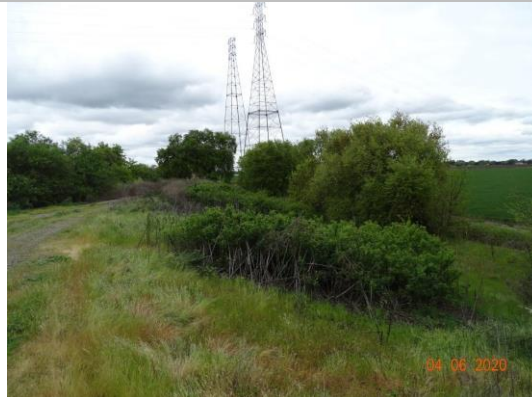
Photo 1 of 1 : SP_2020_RD2089_317_60_20200504_00068.jpg

View of overgrown vegetation on landside slope. Spring 2020

| LM Start | 0.00 | Rating ** | U | Issue No. | 58 |

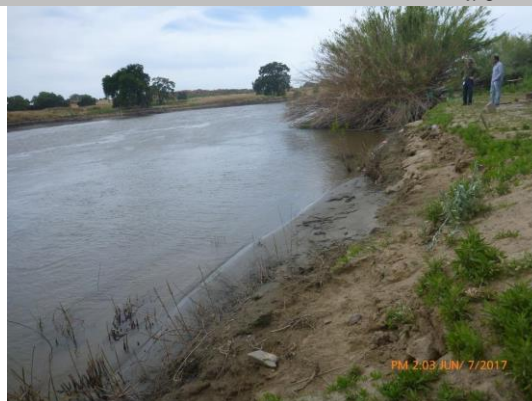
Photo 1 of 1 : LEVAL_SP_2020_109_1298.jpg

| 2017 Storm Damage Site, ID No: 109 | | | | | |

| LM Start | 0.34 | Rating ** | M | Issue No. | 55 |
| LM End | 0.34 | Issue Type + | Ma | Location * | LS |

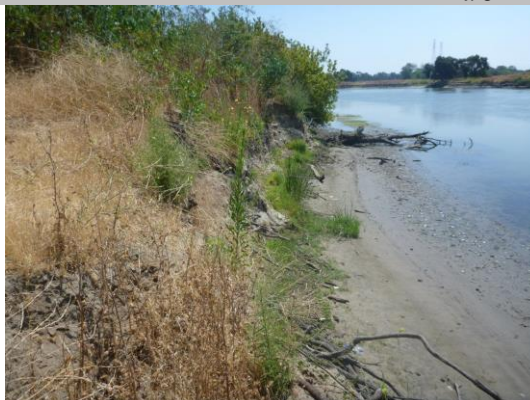
Photo 1 of 1 : LEVAL_SP_2020_507_4335.jpg

| 2017 Storm Damage Site, ID No:507, LMA-413. Vertical cut on outside bend of river | | | | | |

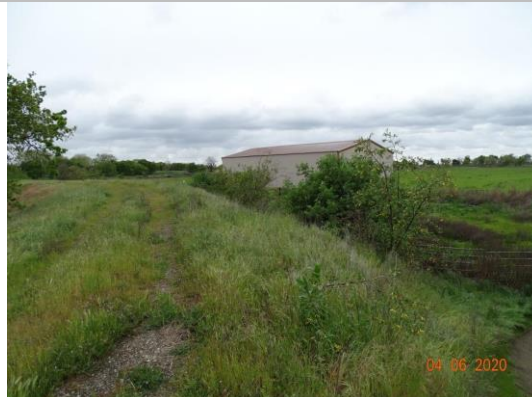
Photo 1 of 1 : SP_2020_RD2089_317_66_20200504_00080.jpg

View of overgrown vegetation on landside slope. Spring 2020

| LM Start | 0.84 | Rating ** | U | Issue No. | 67 |

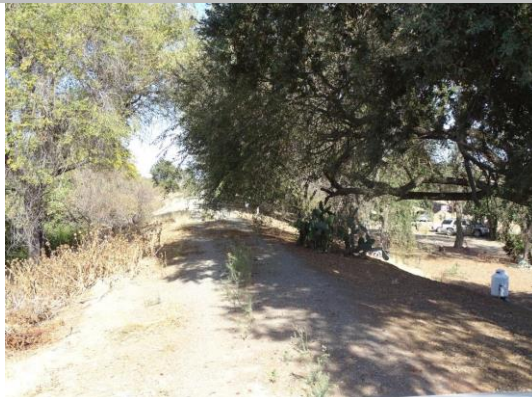
Photo 1 of 1 : SP_2020_RD2089_317_33_20200228_00028.jpg

Looking west at trees overhanging crown of levee. (Fall 2018)

| LM Start | 1.27 | Rating ** | M | Issue No. | 57 |
