Flood Control Project Maintenance Levee Inspections LMA District Cover Sheet

Reclamation District No. 2089 Stark

Levee Inspection Report By Mile - Spring 2021

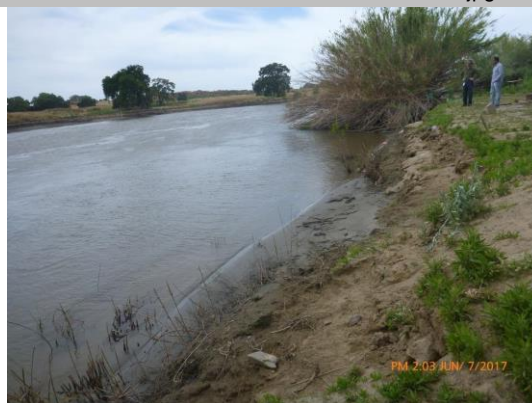
Photo 1 of 1 : LEVAL_SP_2021_109_1298.jpg

LM Start	0.32	Rating **	A/W	Issue No.	47
LM End	0.57	Issue Type +	Ma	Location *	WS
Category	Earthen Levee			GPS Latitude/Longitude	
				Start	End
Item	Erosion / Bank Caving			37.810020 °	37.811810 °
				-121.411550 °	-121.415390 °
DWR ID	335-103				
Comment Code					
E1 : Note and monitor erosion site.					
Inspector Comment					
2017 Storm Damage Site, ID No: 109
