**Flood Control Project Maintenance  
Levee Inspections  
LMA District Cover Sheet**

**Reclamation District No. 2089 Stark**

Waterway	Bank	Unit Miles
Unit No. 01 Old River	Right	1.51

**Levee Inspection Report By Mile - Spring 2022**

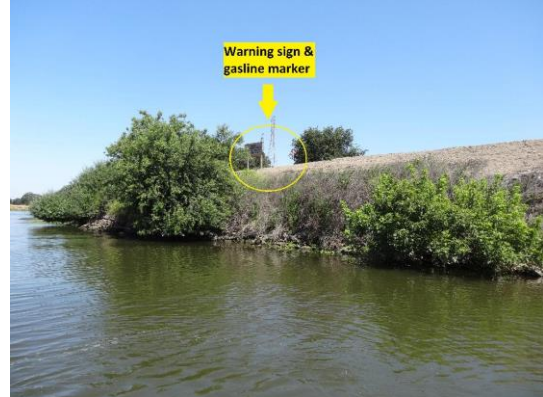
Photo 2 of 3 : UCIP\_SP\_2022\_53182\_74508.jpg

LM Start	1.48	Rating **	M	Issue No.	10 (cont)
LM End	1.48	Issue Type +	En	Location *	
Category	Supplemental			GPS Latitude/Longitude	
				Start	End
Item	DWR UCIP Field Study			37.806520 °	37.806520 °
				-121.407392 °	-121.407392 °
DWR ID	23046

Gasline marker (for crossing with DS ID 25121) appr. 100 ft west of crossing.

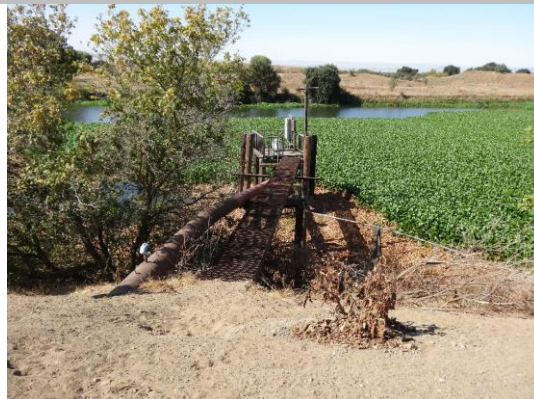
Photo 1 of 3 : UCIP\_SP\_2022\_21676\_36861.jpg

LM Start	0.54	Rating **	M	Issue No.	5	
LM End	0.54	Issue Type +	En	Location *		
Category	Supplemental			GPS Latitude/Longitude		
				Start		End
Item	DWR UCIP Field Study			37.811369 °		37.811369 °
				-121.415050 °		-121.415050 °
DWR ID	23047					
Comment Code						
Inspector Comment						
FS_ID:21676 DS_ID:23047 EP_NO: N/A Repair Type: Non-Urgent Crossing Status: Found UCIP Comments: - air relief valve on waterside. Needs repair.- concrete standpipe on landside. FIELD_STRUCT_DESC: 14-inch irrigation discharge pipe of an unknown material through the levee, 8 feet below the crown. Pump on a pile structure in the stream. Timber walkway to the pump. Air relief valve on the waterside (WS) slope. Concrete distribution standpipe on the landside (LS) toe. [Additional Reference(s): DWR Levee Log, 1991. USACE San Joaquin O&M Manual 8, 1968, (HLM 0.55)]. FS Date: 9/12/2013

WS view: pipe and pump on piling structure in water channel.
