**Flood Control Project Maintenance
Levee Inspections**

Fall 2017 Levee Maintenance Deficiency Summary Report

San Joaquin River Basin

Reclamation District No. 2091 Chase

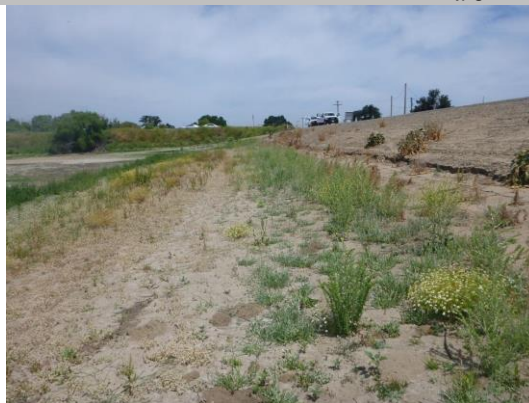
Photo 3 of 3 : LEVAL_FA_2017_117_855.jpg

LM Start	4.83	Rating **	A/W	Issue No.	41 (cont)	
LM End	4.83	Issue Type +	Ma	Location *		
Category	Supplemental			GPS Latitude/Longitude		
				Start	End	
Item	2017 Storm Damage			37.494300 °	37.494300 °	
				-121.078300 °	-121.078300 °	
DWR ID	DWR_RD2091_01_f_2017_41					
Comment Code						
Inspector Comment						
Levee Evaluation Comments						
Description:						
Site ID No:117						
Site Designation:LMA-37						
Repair Type: Erosion						
Rating:Area of Concern						
Field Date:6/7/2017						
Notes: Very minor erosion at toe of levee. Depth of erosion is 3" max.

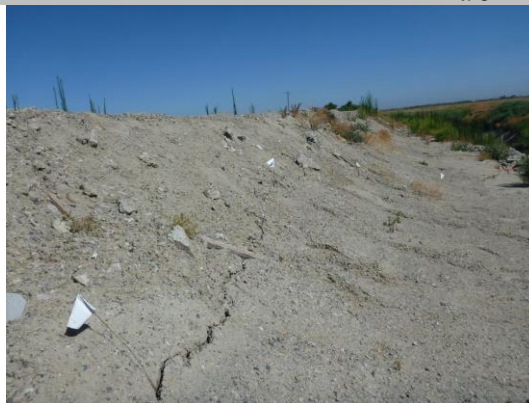
Photo 3 of 3 : LEVAL_FA_2017_473_2331.jpg

LM Start	7.45	Rating **	A/W	Issue No.	23 (cont)	
LM End	7.45	Issue Type +	Ma	Location *		
Category	Supplemental			GPS Latitude/Longitude		
				Start	End	
Item	2017 Storm Damage			37.479000 °	37.479000 °	
				-121.044000 °	-121.044000 °	
DWR ID	DWR_RD2091_01_f_2017_23					
Comment Code						
Inspector Comment						
Levee Evaluation Comments						
Description:Sloughing at Mile 7.59 of the San Joaquin River						
Site ID No:473						
Site Designation:LMA-300						
Repair Type: Erosion						
Rating:Area of Concern						
Field Date:7/20/2017						
Notes: Concrete rubble was installed here during the storms after noticing cracks and sloughing. It has rebar sticking out and needs to be replaced with clean rip rap. Responsibility is grey here because TID maintains channel and placed concrete during storm.
