**Flood Control Project Maintenance
Levee Inspections**

Fall 2018 Levee Maintenance Deficiency Summary Report

San Joaquin River Basin

Reclamation District No. 2091 Chase

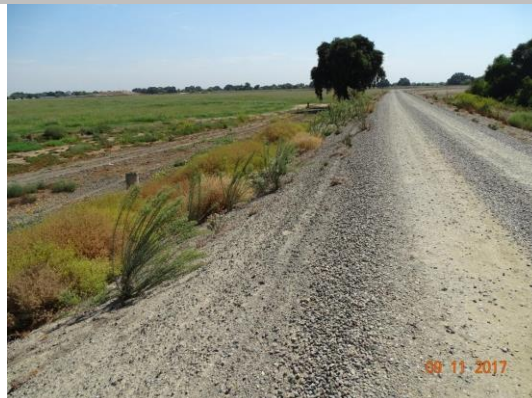
Photo 1 of 1 : FA_2018_RD2091_318_36_20180905_00029.jpg

LM Start	6.23	Rating **	M	Issue No.	36
LM End	6.27	Issue Type +	Ma	Location *	LS
Category	Earthen Levee			GPS Latitude/Longitude	
				Start	End
Item	Vegetation			37.485724 °	37.485234 °
				-121.058443 °	-121.058032 °
DWR ID	DWR_RD2091_01_f_2017_36				
Comment Code					
V2 : Remove the wild growth other than native grasses from the levee slopes.					
Inspector Comment

Looking southeast at landside slope.

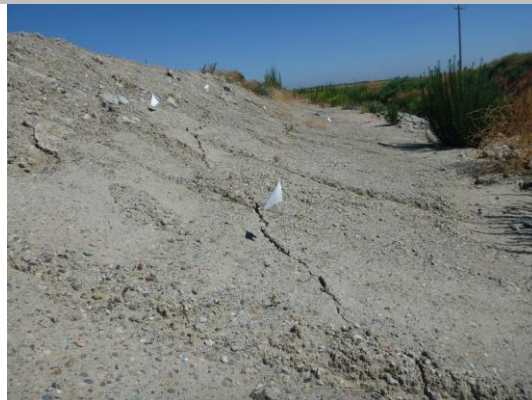
Photo 2 of 3 : LEVAL_FA_2018_473_2330.jpg

LM Start	7.45	Rating **	A/W	Issue No.	23 (cont)
LM End	7.45	Issue Type +	Ma	Location *	
Category	Supplemental			GPS Latitude/Longitude	
				Start	End
Item	2017 Storm Damage			37.479000°	37.479000°
				-121.044000°	-121.040000°
DWR ID	DWR_RD2091_01_f_2017_23				
Comment Code					
Inspector Comment					
Levee Evaluation Comments					
Description:Sloughing at Mile 7.59 of the San Joaquin River					
Site ID No:473					
Site Designation:LMA-300					
Repair Type: Erosion					
Rating:Area of Concern					
Field Date:7/20/2017					
Notes: Concrete rubble was installed here during the storms after noticing cracks and sloughing. It has rebar sticking out and needs to be replaced with clean rip rap. Responsibility is grey here because TID maintains channel and placed concrete during storm.

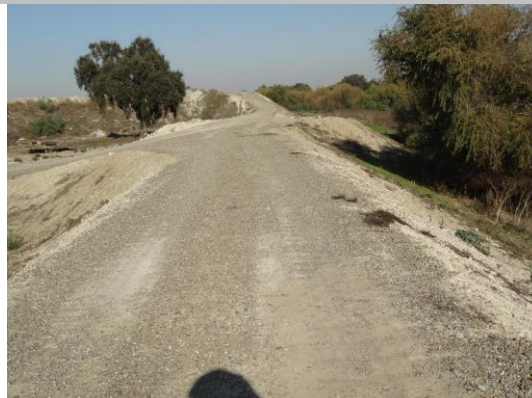
Photo 2 of 3 : UCIP_FA_2018_51390_76689.jpg

Comment Code						
Inspector Comment						
FS_ID:51390 DS_ID:23175 EP_NO: N/A Repair Type: Non-Urgent Crossing Status: Found UCIP Comments: 11/18/2016 Same as last inspection. This is a non-functional crossing with flap gate in the closed position. This crossing has been downgraded from Urgent to Non-Urgent -- no integrity issues were observed on the levee crown or slopes. According to Mike A. this crossing is abandoned and the City of Modesto is working with CVFPB to authorize proper abandonment/removal. The City is working at finding funds to pay for proper abandonment/removal of all the drainage structures through this levee. (O. Magana - DWR UCIP)10/15/2013 Flap gate rusted in-place and does not function. In closed position. (W. Wylie - DWR UCIP) FIELD_STRUCT_DESC: 24-inch corrugated metal drainage pipe through the levee, 16.4 feet below the crown. Flap gate on the waterside (WS) toe. [Additional Reference(s): DWR Levee Log, 1992]. FS Date: 11/18/2016

Overview photo of levee crown at crossing.

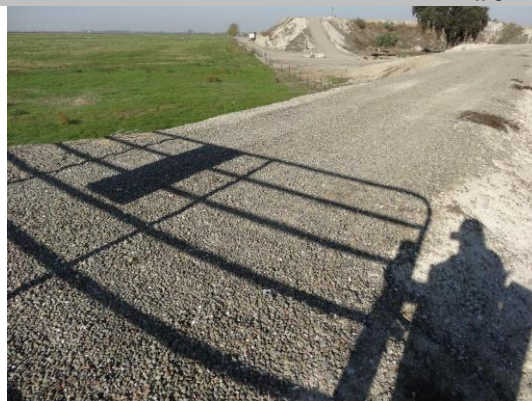
Photo 3 of 3 : UCIP_FA_2018_51390_76686.jpg

Overview of levee crown at crossing and at a distance there is a shooting range.
