**Flood Control Project Maintenance
Levee Inspections**

Fall 2017 Levee Maintenance Deficiency Summary Report

Reclamation District No. 2092 Dos Rios

Fall 2017 Levee Inspection Results

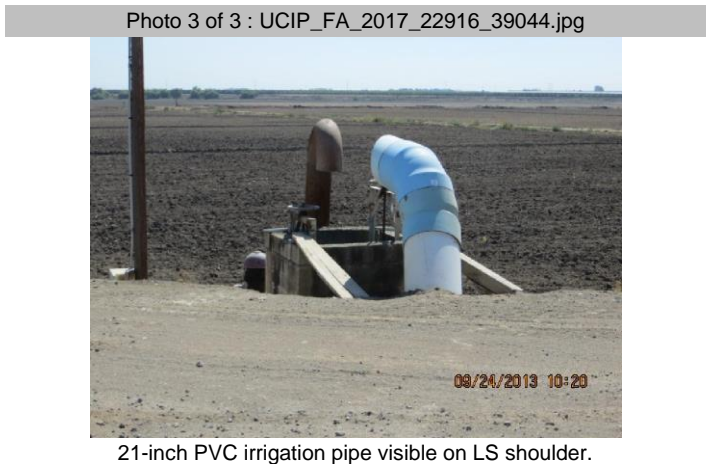
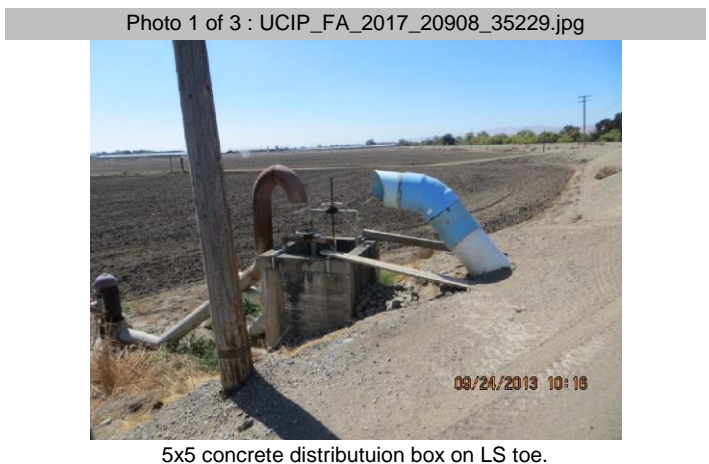
LM Start	2.34	Rating **	M	Issue No.	979	
LM End	2.34	Issue Type +	En	Location *		
Category	Supplemental			GPS Latitude/Longitude		
				Start	End	
Item	DWR UCIP Field Study			37.581226°	37.581226°	
				-121.156175°	-121.156175°	
DWR ID						
Comment Code						
Inspector Comment						
FS_ID:22916						
DS_ID:24680						
EP_NO: N/A						
Repair Type: Non-Urgent						
Crossing Status: Found						
UCIP Comments: No permit identified for this crossing.						
FIELD_STRUCT_DESC: 21-inch polyvinyl chloride (PVC) irrigation pipe						
through the levee, at an unknown depth. Pipe discharges into a						
concrete distribution box on the landside (LS) toe. Pump on pier off the						
waterside (WS) toe. [Additional Reference(s): DWR Levee Log, 2005].						
FS Date: 9/24/2013
