**Flood Control Project Maintenance
Levee Inspections**

Fall 2019 Levee Maintenance Deficiency Summary Report

San Joaquin River Basin

Reclamation District No. 2092 Dos Rios

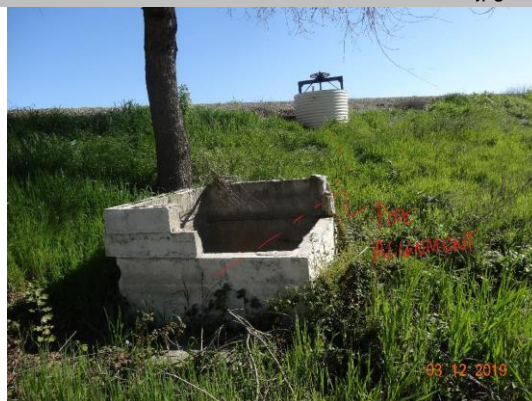
Photo 2 of 3 : UCIP_FA_2019_53820_79078.jpg

Comment Code						
Inspector Comment						
DS_ID:20562 FS_ID:53820 EP_NO: N/A Repair Type: Non-Urgent Crossing Status: Found UCIP Comments: 03/12/2019 During UCIP visual inspection, no pipe or levee integrity issues were observed. Distribution box located on the WS is falling apart (bricks missing). This crossing is an active crossing however, no permit has been found authorizing crossing. Need to determine who maintains and operates this crossing. (O. Magana - DWR UCIP) FIELD_STRUCT_DESC: 36-inch corrugated metal drainage pipe through the levee, 15 feet below the crown. Slide gate in a 48-inch corrugated metal pipe (CMP) riser on the waterside (WS) slope. 4-foot by 6-foot concrete distribution box on the landside (LS) toe. 5-foot by 5-foot concrete riser on the WS toe. [Additional Reference(s): DWR Levee Log, 2005. USACE San Joaquin O&M Manual 5, August 1961, (HLM 1.31)]. FS Date: 3/12/2019 12:06:00 PM

WS view: approximate alignment on WS.

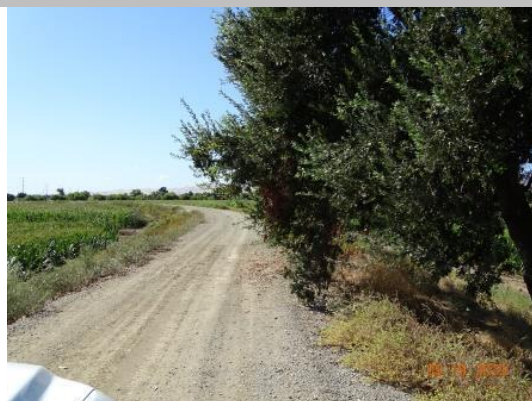
Photo 2 of 2 : FA_2019_RD2092_116_49_20190924_00075.jpg

LM Start	1.65	Rating **	M	Issue No.	49 (cont)	
LM End	1.65	Issue Type +	Ma	Location *	WS	
Category	Earthen Levee			GPS Latitude/Longitude		
				Start		End
Item	Trim / Thin Trees			37.586430 °	37.586430 °	
				-121.163108 °	-121.163108 °	
DWR ID	DWR_RD2092_01_f_2019_49					
Comment Code						
T4 : Trim trees over roadway to at least 12 feet above ground level.						
Inspector Comment

Looking upstream along the levee crown. (Fall 2019)

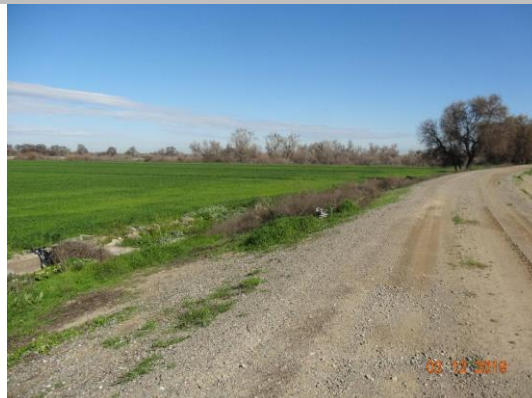
Photo 2 of 3 : UCIP_FA_2019_53817_79087.jpg

Comment Code						
Inspector Comment						
DS_ID:20563 FS_ID:53817 EP_NO: N/A Repair Type: Urgent Crossing Status: Found UCIP Comments: 03/12/2019 A thorough internal evaluation of this crossing is required, pipe shows evidence of pipe integrity (LS) issues (pipe wall sections missing on WS outlet). Internal inspection is recommended for this crossing to determine the extent of pipe damage through the levee. Maintenance issues identified at this crossing include: flap gate missing on WS, debris found inside concrete distribution box, and missing cover on riser. No permit has been identified for this crossing. Need to determine who maintains crossing; crossing appears functional. (O. Magana - DWR UCIP) FIELD_STRUCT_DESC: 24-inch corrugated metal drainage pipe through the levee, 14 feet below the crown. Slide gate in a corrugated metal pipe (CMP) riser on the waterside (WS) slope. Concrete U-shaped headwall at the landside (LS) toe. [Additional Reference(s): DWR Levee Log, 2005. USACE San Joaquin O&M Manual 5, August 1961, (HLM 1.71)]. FS Date: 3/12/2019 12:07:00 PM

WS view: overview of WS.

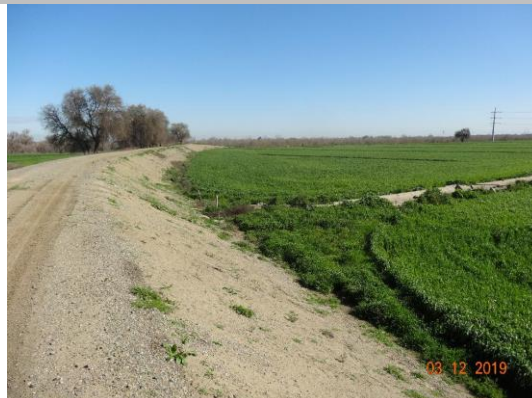
Photo 3 of 3 : UCIP_FA_2019_53817_79085.jpg

LS view: overview of LS.

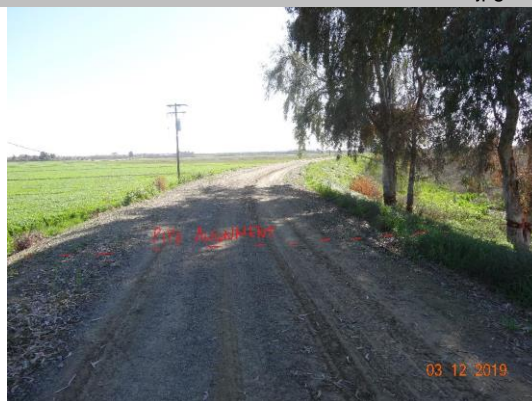
Photo 1 of 3 : UCIP_FA_2019_53814_79091.jpg

Comment Code						
Inspector Comment						
DS_ID:20564 FS_ID:53814 EP_NO: N/A Repair Type: Non-Urgent Crossing Status: Found UCIP Comments: 03/12/2019 Concrete headwall found on LS toe. Pipe appears to have been grouted through. No other appurtenances were found during inspection. WS outlet was not found. Need to coordinate with the CVFPB to determine if additional steps are needed to comply with Title 23. (O. Magana - DWR UCIP) FIELD_STRUCT_DESC: *ABANDONED* 30-inch corrugated metal drainage pipe through the levee, 15 feet below the crown. Flap gate on the waterside (WS) end. Concrete U-shaped headwalls on both ends. Filled with concrete on the landside (LS) toe. [Additional Reference(s): DWR Levee Log, 2005. USACE San Joaquin O&M Manual 5, August 1961, (HLM 2.10), 36-inch pipe listed]. FS Date: 3/12/2019 12:08:00 PM

Overview of levee crown, looking u/s from d/s, and approximate pipe alignment.

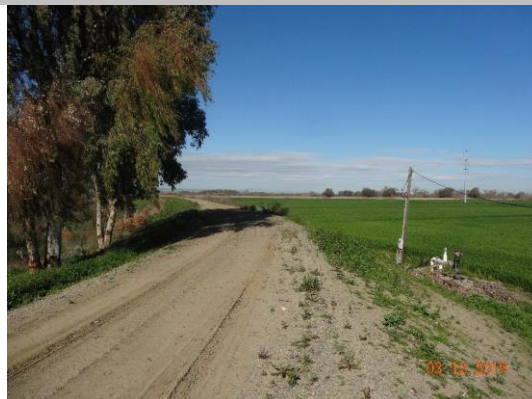
Photo 2 of 3 : UCIP_FA_2019_53814_79092.jpg

Overview of levee at crossing, photo taken u/s looking d/s towards pipe crossing.

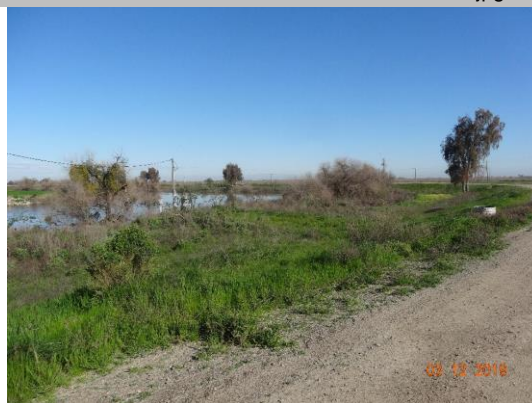
Photo 1 of 3 : UCIP_FA_2019_53805_79106.jpg

Comment Code					
Inspector Comment					
DS_ID:24680 FS_ID:53805 EP_NO: N/A Repair Type: Non-Urgent Crossing Status: Found UCIP Comments: 03/12/2019 No permit was found authorizing modifications to existing crossing. New crossing was added at this levee section using the old appurtenances associated with USACE O&M Legacy system Pipe (dsid 20566). The pipe associated with dsid 20566 has been grouted through (see dsid 20566 detail report). Irrigation pipe is functional and pipe is being maintained. Unable to confirm if riser located on WS is being used with this crossing. Need to coordinate with CVFPB to determine owner and if permit was issued for the modifications of this crossing. (O. Magana - DWR UCIP) 09/24/2013 No permit identified for this crossing. (W. Wylie - DWR UCIP) FIELD_STRUCT_DESC: 21-inch polyvinyl chloride (PVC) irrigation pipe through the levee, at an unknown depth. Pipe discharges into a concrete distribution box on the landside (LS) toe. Pump on pier off the waterside (WS) toe. [Additional Reference(s): DWR Levee Log, 2005]. FS Date: 3/12/2019 12:08:00 PM

WS view: overview of WS.

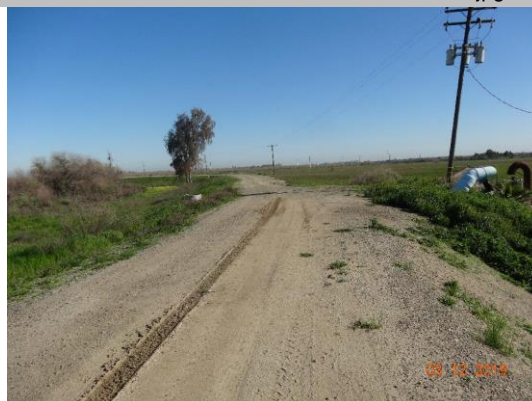
Photo 2 of 3 : UCIP_FA_2019_53805_79105.jpg

Comment Code						
Inspector Comment						
DS_ID:24680 FS_ID:53805 EP_NO: N/A Repair Type: Non-Urgent Crossing Status: Found UCIP Comments: 03/12/2019 No permit was found authorizing modifications to existing crossing. New crossing was added at this levee section using the old appurtenances associated with USACE O&M Legacy system Pipe (dsid 20566). The pipe associated with dsid 20566 has been grouted through (see dsid 20566 detail report). Irrigation pipe is functional and pipe is being maintained. Unable to confirm if riser located on WS is being used with this crossing. Need to coordinate with CVFPB to determine owner and if permit was issued for the modifications of this crossing. (O. Magana - DWR UCIP) 09/24/2013 No permit identified for this crossing. (W. Wylie - DWR UCIP) FIELD_STRUCT_DESC: 21-inch polyvinyl chloride (PVC) irrigation pipe through the levee, at an unknown depth. Pipe discharges into a concrete distribution box on the landside (LS) toe. Pump on pier off the waterside (WS) toe. [Additional Reference(s): DWR Levee Log, 2005]. FS Date: 3/12/2019 12:08:00 PM

Overview of levee crown looking d/s towards crossing.

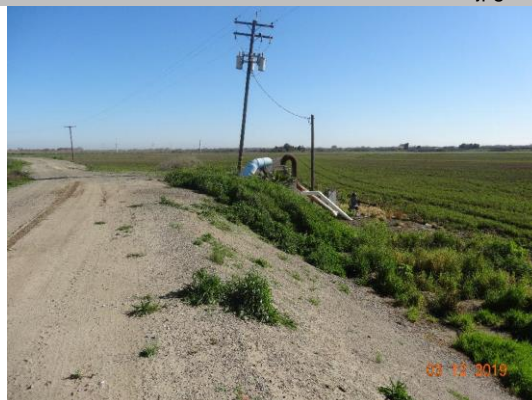
Photo 3 of 3 : UCIP_FA_2019_53805_79104.jpg

LS view: overview of LS.

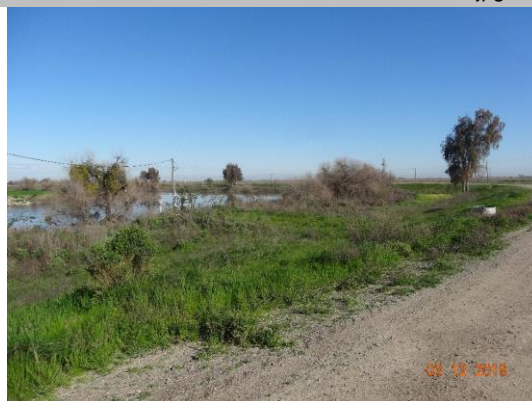
Photo 1 of 3 : UCIP_FA_2019_54051_79112.jpg

Comment Code						
Inspector Comment						
DS_ID:20566 FS_ID:54051 EP_NO: N/A Repair Type: Non-Urgent Crossing Status: Found UCIP Comments: 03/12/2019 Concrete distribution box found on LS with evidence that 24-inch pipe was going through levee. Pipe appears to have been grouted through. Riser is still present on WS however, unable to determine if pipe was grouted all the way through the levee section. Concrete distribution box is currently being used by an unauthorized pipe encroachment (see DSID 24680). Lid missing from CMP riser. Owner needs to add lid to riser to prevent entry in confined space. Need to coordinate with the CVFPB to determine how to address abandoned appurtenances and pipe abandonment. (O. Magana - DWR UCIP) 09/24/2013 Pipe appears abandoned and needs to be verified as having been done so properly. (W. Wylie - DWR UCIP) FIELD_STRUCT_DESC: *ABANDONED* 24-inch corrugated metal irrigation pipe through the levee, 11 feet below the crown. Slide gate in a 36-inch corrugated metal pipe (CMP) riser on the waterside (WS) slope. 5-foot by 5-foot concrete distribution box on the landside (LS). Pump on platform in the channel. Pipe filled with concrete on the LS toe. [Additional Reference(s): DWR Levee Log, 2005. USACE San Joaquin O&M Manual 5, August 1961, (HLM 2.38)]. FS Date: 3/12/2019 12:09:00 PM

WS view: overview of WS.

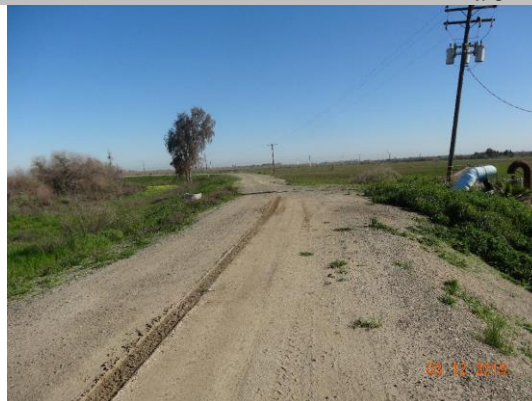
Photo 2 of 3 : UCIP_FA_2019_54051_79111.jpg

Overview of levee crown looking d/s looking towards crossing.

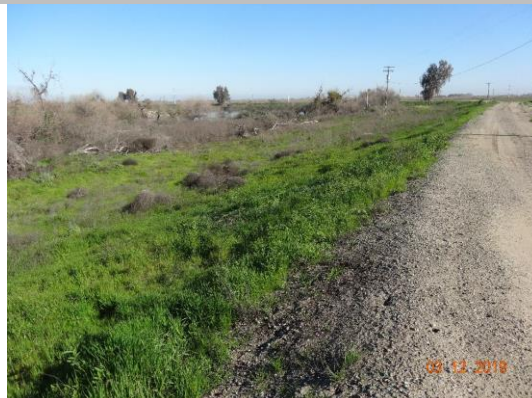
Photo 1 of 3 : UCIP_FA_2019_54052_79119.jpg

Comment Code						
Inspector Comment						
DS_ID:20567 FS_ID:54052 EP_NO: N/A Repair Type: Non-Urgent Crossing Status: Indicator Found UCIP Comments: 03/12/2019 Unable to locate concrete headwall on the WS due to high water. Unable to locate concrete headwall on LS due to dense vegetation. No permit was found authorizing crossing. If crossing is no longer in use recommend removing crossing and appurtenances from levee. Need to coordinate with CVFPB to determine pipe owner. (O. Magana - DWR UCIP) 09/24/2013 Appears abandoned and if so should be done so properly. (W. Wylie - DWR UCIP) FIELD_STRUCT_DESC: *ABANDONED* 24-inch corrugated metal drainage pipe through the levee, 15 feet below the crown. Flap gate on the waterside (WS) end. Concrete U-shaped headwall on the WS end. Concrete headwall on the landside (LS) toe next to pump. [Additional Reference(s): DWR Levee Log, 2005. USACE San Joaquin O&M Manual 5, August 1961, (HLM 2.44)]. FS Date: 3/12/2019 12:09:00 PM

WS view: overview of WS.

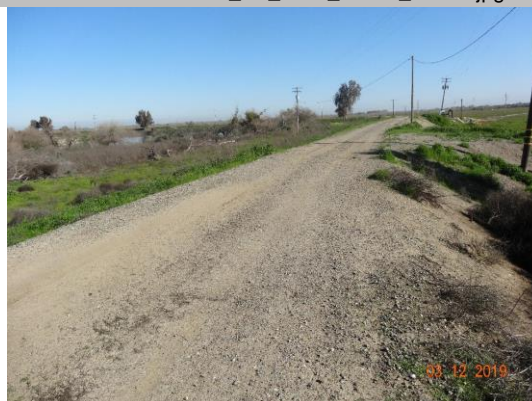
Photo 2 of 3 : UCIP_FA_2019_54052_79118.jpg

Overview of levee crown looking d/s towards crossing.

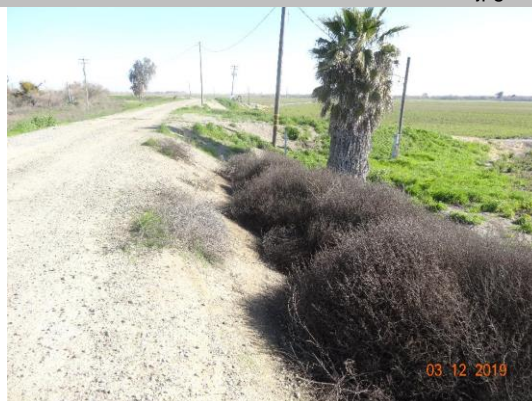
Photo 3 of 3 : UCIP_FA_2019_54052_79117.jpg

Comment Code						
Inspector Comment						
DS_ID:20567 FS_ID:54052 EP_NO: N/A Repair Type: Non-Urgent Crossing Status: Indicator Found UCIP Comments: 03/12/2019 Unable to locate concrete headwall on the WS due to high water. Unable to locate concrete headwall on LS due to dense vegetation. No permit was found authorizing crossing. If crossing is no longer in use recommend removing crossing and appurtenances from levee. Need to coordinate with CVFPB to determine pipe owner. (O. Magana - DWR UCIP) 09/24/2013 Appears abandoned and if so should be done so properly. (W. Wylie - DWR UCIP) FIELD_STRUCT_DESC: *ABANDONED* 24-inch corrugated metal drainage pipe through the levee, 15 feet below the crown. Flap gate on the waterside (WS) end. Concrete U-shaped headwall on the WS end. Concrete headwall on the landside (LS) toe next to pump. [Additional Reference(s): DWR Levee Log, 2005. USACE San Joaquin O&M Manual 5, August 1961, (HLM 2.44)]. FS Date: 3/12/2019 12:09:00 PM

LS view: overview of LS.

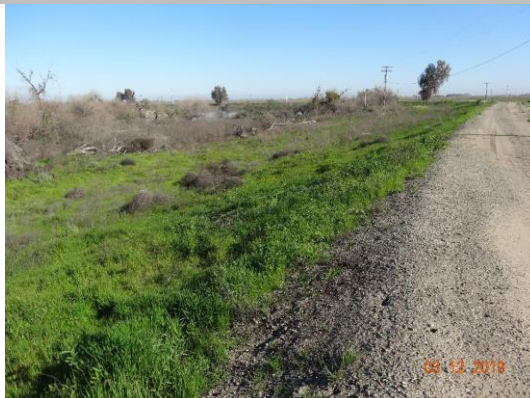
Photo 1 of 3 : UCIP_FA_2019_53808_79126.jpg

Comment Code						
Inspector Comment						
DS_ID:20568						
FS_ID:53808						
EP_NO: N/A						
Repair Type: Non-Urgent						
Crossing Status: Indicator Found						
UCIP Comments: 03/12/2019 No permit was found authorizing crossing. Crossing appears to be abandoned, if crossing is abandoned, owner will need to coordinate with CVFPB to comply with Title 23. (O. Magana - DWR UCIP)						
09/24/2013 Pipe abandoned and should be verified as having been removed from the levee. (W. Wylie - DWR UCIP)						
FIELD_STRUCT_DESC: *ABANDONED* 4-inch drainage pipe of an unknown material through the levee, 1 foot below the crown. Pump on sump at the landside (LS) toe. Roadway extending to the LS pump.						
[Additional Reference(s): DWR Levee Log, 2005].						
FS Date: 3/12/2019 12:10:00 PM

WS view: overview of WS.

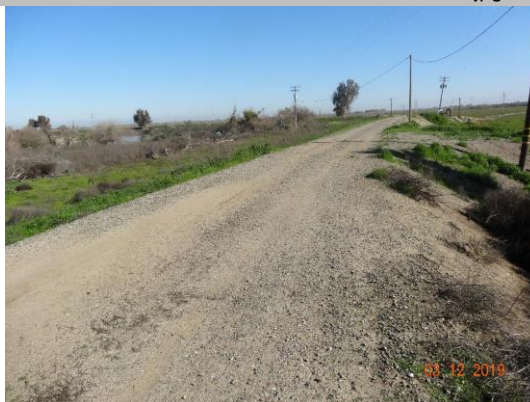
Photo 2 of 3 : UCIP_FA_2019_53808_79125.jpg

Overview of levee crown.

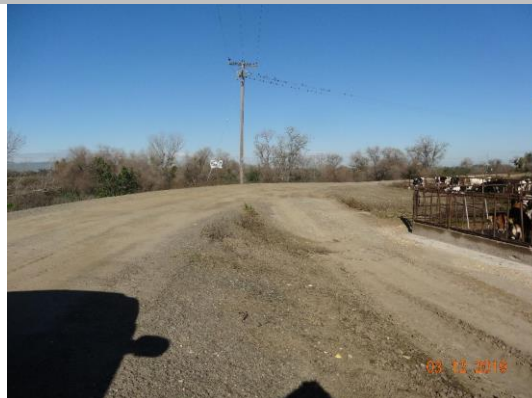
Photo 1 of 3 : UCIP_FA_2019_53813_79128.jpg

LM Start	2.79	Rating **	M	Issue No.	985
LM End	2.79	Issue Type +	En	Location *	
Category	Supplemental			GPS Latitude/Longitude	
				Start	End
Item	DRAFT DWR UCIP Field Study			37.575002 °	37.575002 °
				-121.156753 °	-121.156753 °
DWR ID	20569				
Comment Code					
Inspector Comment					
DS_ID:20569 FS_ID:53813 EP_NO: N/A Repair Type: Non-Urgent Crossing Status: Not Found UCIP Comments: 03/12/2019 Need to confirm status of crossing through levee section. (O. Magana - DWR UCIP) FIELD_STRUCT_DESC: 24-inch corrugated metal drainage pipe through the levee, 6 feet below the crown. Concrete U-shaped headwall and flap gate on the waterside (WS) end. [Additional Reference(s): DWR Levee Log, 2005. USACE San Joaquin O&M Manual 5, August 1961, (HLM 2.83)]. FS Date: 3/12/2019 12:10:00 PM

LS view: overview of LS.

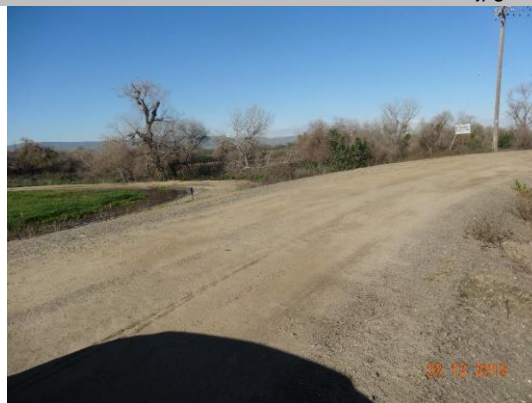
Photo 2 of 3 : UCIP_FA_2019_53813_79129.jpg

Overview of levee crown where crossing should be.

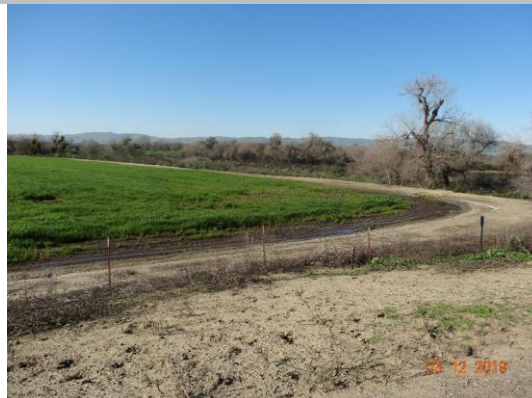
Photo 3 of 3 : UCIP_FA_2019_53813_79130.jpg

LM Start	2.79	Rating **	M	Issue No.	985 (cont)	
LM End	2.79	Issue Type +	En	Location *		
Category	Supplemental			GPS Latitude/Longitude		
				Start	End	
Item	DRAFT DWR UCIP Field Study			37.575002 °	37.575002 °	
				-121.156753 °	-121.156753 °	
DWR ID	20569					
Comment Code						
Inspector Comment						
DS_ID:20569 FS_ID:53813 EP_NO: N/A Repair Type: Non-Urgent Crossing Status: Not Found UCIP Comments: 03/12/2019 Need to confirm status of crossing through levee section. (O. Magana - DWR UCIP) FIELD_STRUCT_DESC: 24-inch corrugated metal drainage pipe through the levee, 6 feet below the crown. Concrete U-shaped headwall and flap gate on the waterside (WS) end. [Additional Reference(s): DWR Levee Log, 2005. USACE San Joaquin O&M Manual 5, August 1961, (HLM 2.83)]. FS Date: 3/12/2019 12:10:00 PM

WS view: overview of WS.

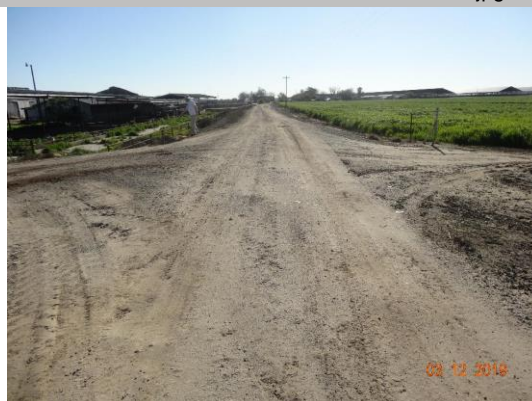
Photo 1 of 3 : UCIP_FA_2019_53810_79135.jpg

Comment Code						
Inspector Comment						
DS_ID:20570 FS_ID:53810 EP_NO: N/A Repair Type: Non-Urgent Crossing Status: Indicator Found UCIP Comments: 03/12/2019 Unable to locate concrete headwall on the WS. Concrete headwall is still visible on the LS however, this crossing appears to be abandoned. No permit was found authorizing crossing. If crossing is no longer in use recommend removing crossing and appurtenances from levee. (O. Magana - DWR UCIP) 09/24/2013 Appears abandoned and if so, should be done so properly. (W. Wylie - DWR UCIP) FIELD_STRUCT_DESC: *ABANDONED* 24-inch corrugated metal drainage pipe through the levee, 6.5 feet below the crown. Concrete U-shaped headwall and flap gate on the waterside (WS) end. Concrete headwall on the landside (LS) slope. [Additional Reference(s): DWR Levee Log, 2005. USACE San Joaquin O&M Manual 5, August 1961]. FS Date: 3/12/2019 12:11:00 PM

Overview of levee at crossing, photo taken d/s looking u/s towards crossing.

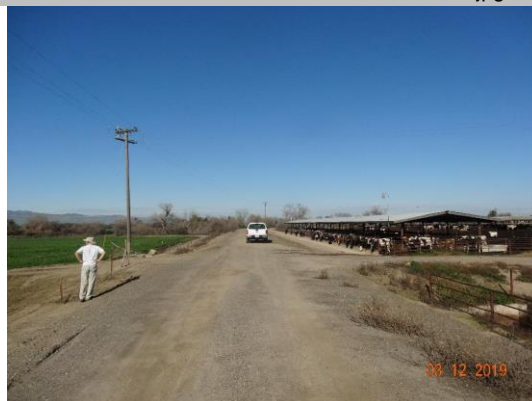
Photo 2 of 3 : UCIP_FA_2019_53810_79136.jpg

Overview of levee at crossing, photo taken u/s looking d/s towards crossing.

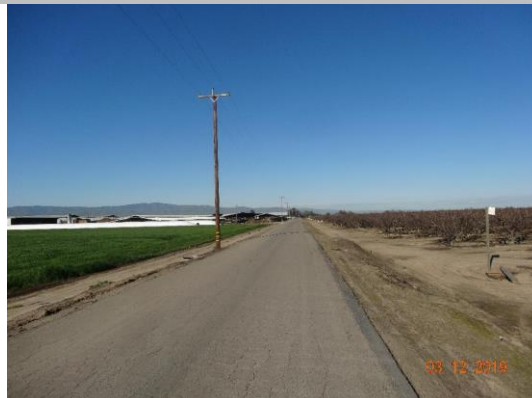
Photo 1 of 3 : UCIP_FA_2019_53786_79145.jpg

Overview of levee crown looking d/s towards crossing.

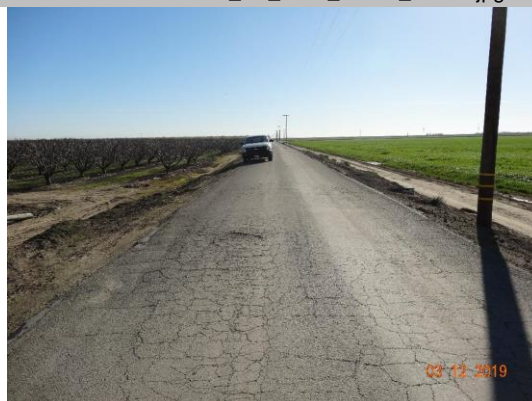
Photo 2 of 3 : UCIP_FA_2019_53786_79150.jpg

Overview of levee crown looking u/S towards crossing.

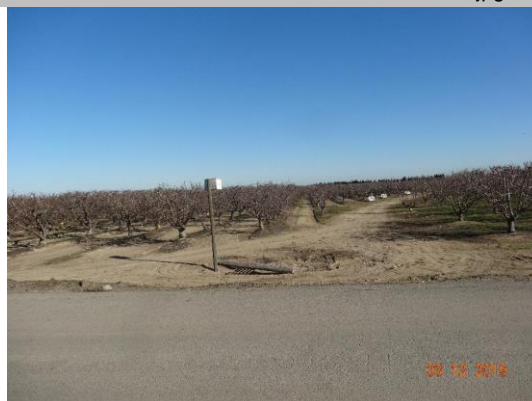
Photo 3 of 3 : UCIP_FA_2019_53786_79144.jpg

Comment Code						
Inspector Comment						
DS_ID:20572 FS_ID:53786 EP_NO: N/A Repair Type: Non-Urgent Crossing Status: Found UCIP Comments: 03/12/2019 No permit was found authorizing crossing. Unable to confirm if crossing is in use. Recommend adding cover to riser to address safety concern. No slide gate was found in CMP riser. If crossing is no longer in use, recommend proper abandonment or removal from levee. Owner will need to coordinate with CVFPB to be compliant with Title 23. (O. Magana - DWR UCIP) 09/24/2013 This pipe appears abandoned and if so, should be done so properly. (W. Wylie - DWR UCIP) FIELD_STRUCT_DESC: *ABANDONED* 36-inch corrugated metal drainage pipe through the levee, 11 feet below the crown. Slide gate in a corrugated metal pipe (CMP) riser on the waterside (WS) slope. Concrete headwalls on both ends. [Additional Reference(s): DWR Levee Log, 2005. USACE San Joaquin O&M Manual 5, August 1961, (HLM 3.52)]. FS Date: 3/12/2019 12:11:53 PM

LS view: overview of land use on LS.
