Flood Control Project Maintenance Levee Inspections

Fall 2020 Levee Maintenance Deficiency Summary Report

San Joaquin River Basin

Reclamation District No. 2092 Dos Rios

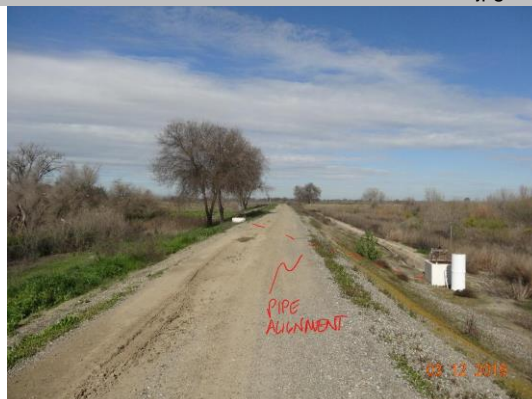
Photo 1 of 3 : UCIP_FA_2020_53820_79073.jpg

UCIP Comments: 03/12/2019 During UCIP visual inspection, no pipe or levee integrity issues were observed. Distribution box located on the WS is falling apart (bricks missing). This crossing is an active crossing however, no permit has been found authorizing crossing. Need to determine who maintains and operates this crossing. (O. Magana - DWR UCIP)

Overview of pipe alignment through levee, photo taking looking d/s toward crossing.

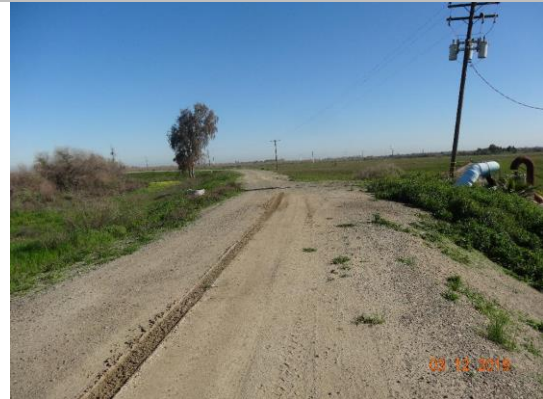
Photo 2 of 3 : UCIP_FA_2020_53805_79105.jpg

LM Start	2.34	Rating **	M	Issue No.	981 (cont)
LM End	2.34	Issue Type +	En	Location *	
Category	Supplemental		GPS Latitude/Longitude		
			Start	End	
Item	DWR UCIP Field Study		37.581226 °	37.581226 °	
			-121.156175 °	-121.156175 °	
DWR ID	24680

Overview of levee crown looking d/s towards crossing.

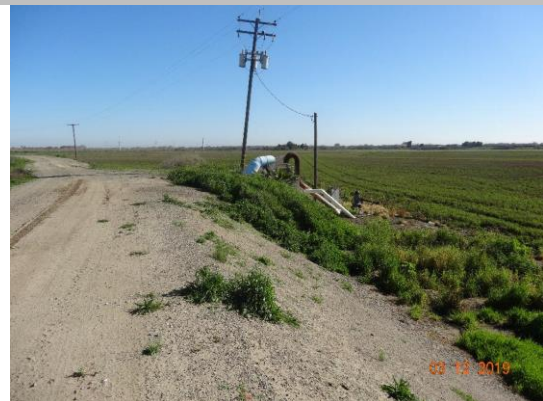
Photo 3 of 3 : UCIP_FA_2020_53805_79104.jpg

LS view: overview of LS.

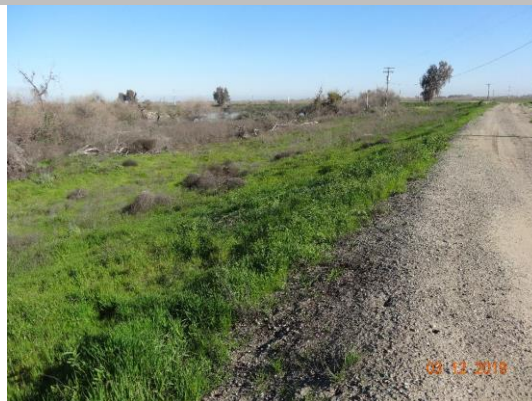
Photo 1 of 3 : UCIP_FA_2020_54052_79119.jpg

Comment Code						
Inspector Comment						
DS_ID:20567 FS_ID:54052 EP_NO: N/A Repair Type: Non-Urgent EVAL Issue: Limited Inspection/No UCIP Evaluation Crossing Status: Indicator Found UCIP Comments: 03/12/2019 Unable to locate concrete headwall on the WS due to high water. Unable to locate concrete headwall on LS due to dense vegetation. No permit was found authorizing crossing. If crossing is no longer in use recommend removing crossing and appurtenances from levee. Need to coordinate with CVFPB to determine pipe owner. (O. Magana - DWR UCIP) 09/24/2013 Appears abandoned and if so should be done so properly. (W. Wylie - DWR UCIP) FIELD_STRUCT_DESC: *ABANDONED* 24-inch corrugated metal drainage pipe through the levee, 15 feet below the crown. Flap gate on the waterside (WS) end. Concrete U-shaped headwall on the WS end. Concrete headwall on the landside (LS) toe next to pump. [Additional Reference(s): DWR Levee Log, 2005. USACE San Joaquin O&M Manual 5, August 1961, (HLM 2.44)]. FS Date: 3/12/2019 12:09:00 PM

WS view: overview of WS.

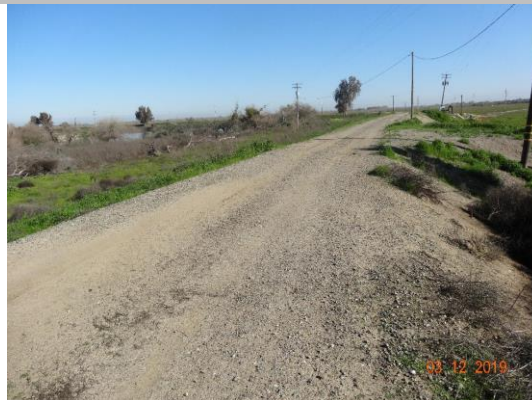
Photo 2 of 3 : UCIP_FA_2020_54052_79118.jpg

LM Start	2.40	Rating **	M	Issue No.	983 (cont)
LM End	2.40	Issue Type +	En	Location *

Overview of levee crown looking d/s towards crossing.

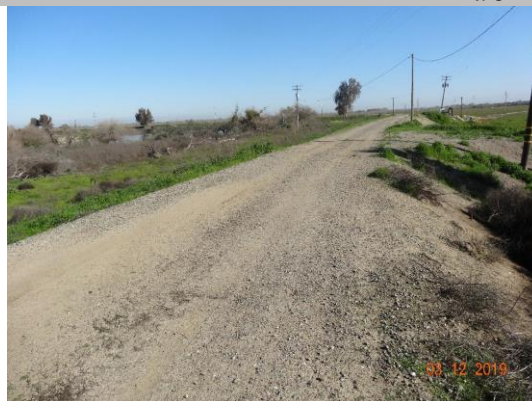
Photo 2 of 3 : UCIP_FA_2020_53808_79125.jpg

LM Start	2.41	Rating **	M	Issue No.	984 (cont)
LM End	2.41	Issue Type +	En	Location *	
Category	Supplemental		GPS Latitude/Longitude		
			Start	End	
Item	DWR UCIP Field Study		37.580405 °	37.580405 °	
			-121.156825 °	-121.156825 °	
DWR ID	20568

Overview of levee crown.

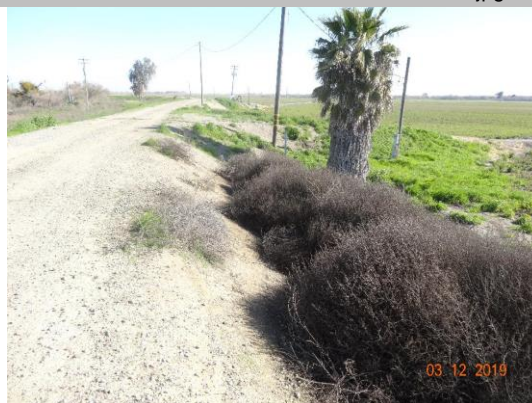
Photo 3 of 3 : UCIP_FA_2020_53808_79124.jpg

LS view: overview of LS.

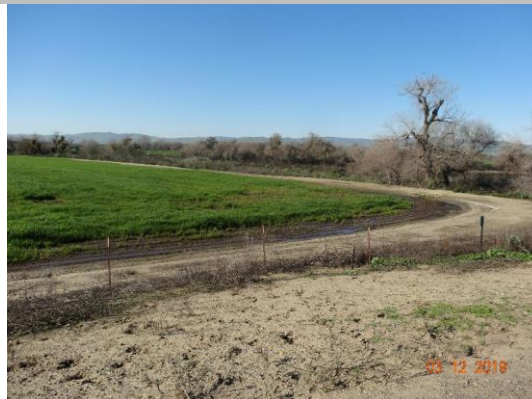
Photo 3 of 3 : UCIP_FA_2020_53813_79130.jpg

LM Start	2.79	Rating **	M	Issue No.	985 (cont)
LM End	2.79	Issue Type +	En	Location *	
Category	Supplemental		GPS Latitude/Longitude		
			Start	End	
Item	DWR UCIP Field Study		37.575002 °	37.575002 °	
			-121.156753 °	-121.156753 °	
DWR ID	20569

WS view: overview of WS.

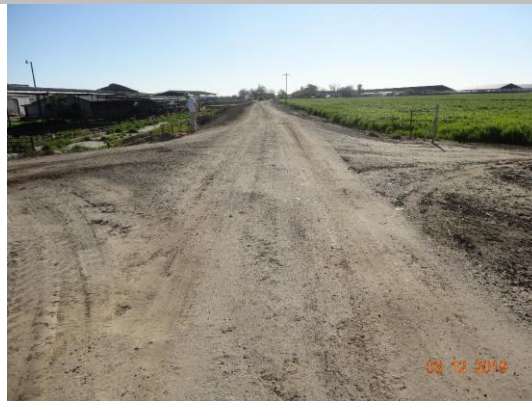
Photo 1 of 3 : UCIP_FA_2020_53810_79135.jpg

Comment Code						
Inspector Comment						
DS_ID:20570 FS_ID:53810 EP_NO: N/A Repair Type: Non-Urgent EVAL Issue: Unauthorized Encroachment, installed decades prior Crossing Status: Indicator Found UCIP Comments: 03/12/2019 Unable to locate concrete headwall on the WS. Concrete headwall is still visible on the LS however, this crossing appears to be abandoned. No permit was found authorizing crossing. If crossing is no longer in use recommend removing crossing and appurtenances from levee. (O. Magana - DWR UCIP) 09/24/2013 Appears abandoned and if so, should be done so properly. (W. Wylie - DWR UCIP) FIELD_STRUCT_DESC: *ABANDONED* 24-inch corrugated metal drainage pipe through the levee, 6.5 feet below the crown. Concrete U-shaped headwall and flap gate on the waterside (WS) end. Concrete headwall on the landside (LS) slope. [Additional Reference(s): DWR Levee Log, 2005. USACE San Joaquin O&M Manual 5, August 1961]. FS Date: 3/12/2019 12:11:00 PM

Overview of levee at crossing, photo taken d/s looking u/s towards crossing.

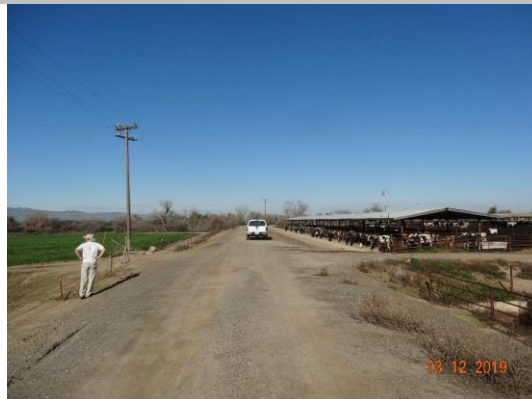
Photo 2 of 3 : UCIP_FA_2020_53810_79136.jpg

LM Start	2.86	Rating **	M	Issue No.	986 (cont)
LM End	2.86	Issue Type +	En	Location *	
Category	Supplemental		GPS Latitude/Longitude		
			Start	End	
Item	DWR UCIP Field Study		37.574741 °	37.574741 °	
			-121.155495 °	-121.155495 °	
DWR ID	20570

Overview of levee at crossing, photo taken u/s looking d/s towards crossing.

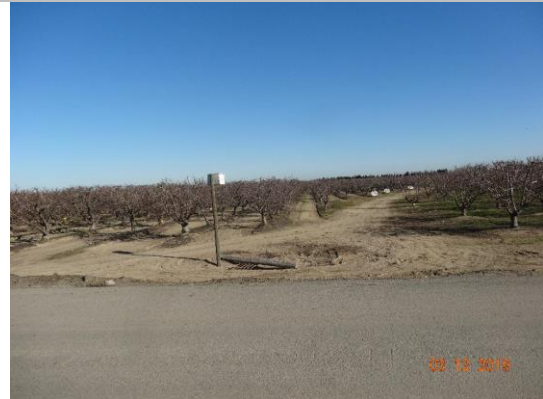
Photo 3 of 3 : UCIP_FA_2020_53786_79144.jpg

LM Start	3.47	Rating **	M	Issue No.	988 (cont)
LM End	3.47	Issue Type +	Ma	Location *	
Category	Supplemental			GPS Latitude/Longitude	
				Start	End
Item	DWR UCIP LMA Responsibility			37.573304 °	37.573304 °
				-121.144747 °	-121.144747 °
DWR ID	20572

LS view: overview of land use on LS.
