## Flood Control Project Maintenance Levee Inspections

### Fall 2021 Levee Maintenance Deficiency Summary Report

#### San Joaquin River Basin

**Reclamation District No. 2092 Dos Rios**

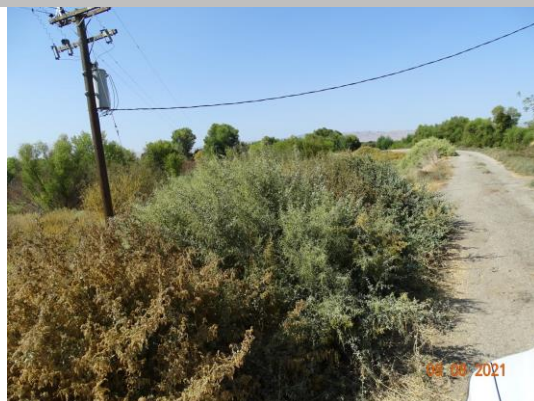
Photo 1 of 1 : FA\_2021\_RD2092\_116\_35\_20210909\_00064.jpg

LM Start	0.42	Rating **	U	Issue No.	35
LM End	0.85	Issue Type +	Ma	Location *	LS
Category	Earthen Levee			GPS Latitude/Longitude	
				Start	End
Item	Vegetation			37.601191 °	37.595959 °
				-121.165544 °	-121.168261 °
DWR ID	DWR_RD2092_01_f_2021_35				
Comment Code					
V1 : Control annual grass and weeds on the levee slopes and easements.					
Inspector Comment

Looking upstream along the landside slope. (Fall 2021)

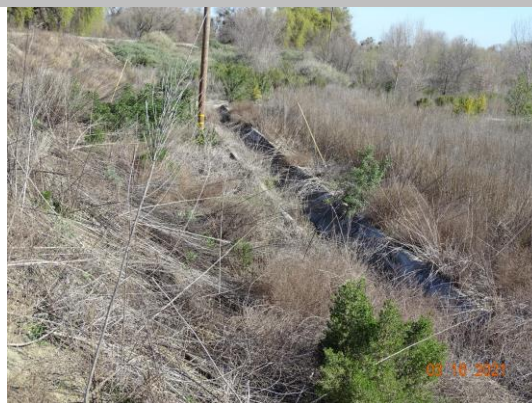
Photo 1 of 1 : FA\_2021\_RD2092\_116\_968\_20210830\_00021.jpg

LM Start	0.76	Rating **	M	Issue No.	968
LM End	1.31	Issue Type +	En	Location *	LS
Category	Earthen Levee			GPS Latitude/Longitude	
				Start	End
Item	Encroachments			37.597291 °	37.590568 °
				-121.168496 °	-121.164028 °
DWR ID	DWR_RD2092_01_s_2012_968				
Comment Code					
DT : Ditch					
Inspector Comment

View of concrete ditch running along the landside toe. (Spring 2021)

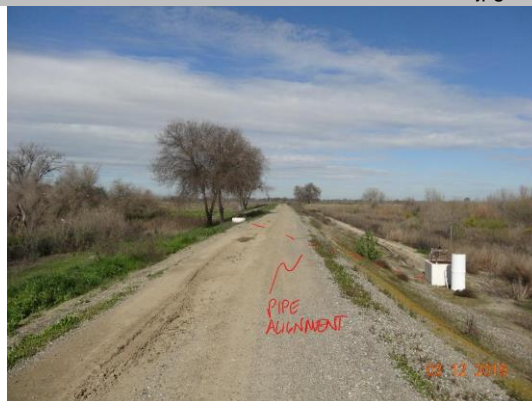
Photo 1 of 3 : UCIP\_FA\_2021\_53820\_79073.jpg

UCIP Comments: 03/12/2019 During UCIP visual inspection, no pipe or levee integrity issues were observed. Distribution box located on the WS is falling apart (bricks missing). This crossing is an active crossing however, no permit has been found authorizing crossing. Need to determine who maintains and operates this crossing. (O. Magana - DWR UCIP)

Overview of pipe alignment through levee, photo taking looking d/s toward crossing.

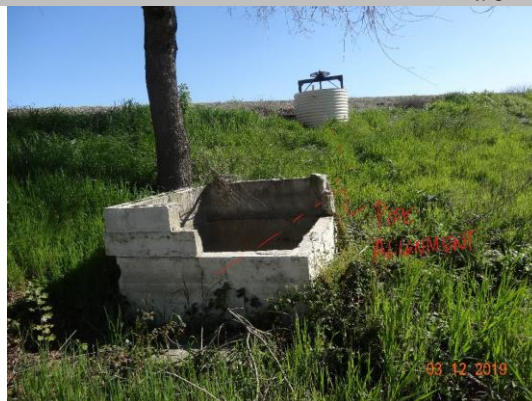
Photo 2 of 3 : UCIP\_FA\_2021\_53820\_79078.jpg

LM Start	<b>1.30</b>	Rating **	M	Issue No.	<b>977 (cont)</b>
LM End	<b>1.30</b>	Issue Type +	Ma	Location *	
Category	Supplemental		GPS Latitude/Longitude		
			Start	End	
Item	DWR UCIP LMA Responsibility		37.590603 °	37.590603 °	
			-121.164111 °	-121.164111 °	
DWR ID	20562

WS view: approximate alignment on WS.

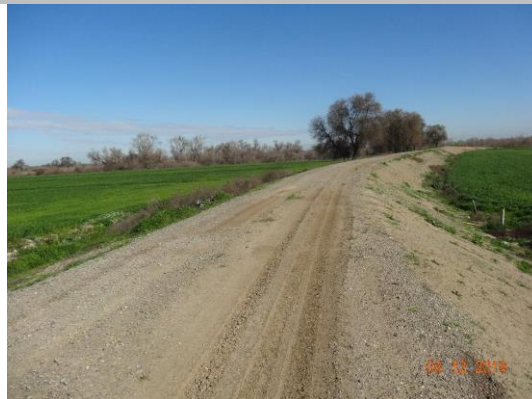
Photo 1 of 3 : UCIP\_FA\_2021\_53817\_79086.jpg

Comment Code					
Inspector Comment					
DS_ID:20563 FS_ID:53817 EP_NO: N/A Repair Type: Urgent EVAL Issue: Pipe Integrity Crossing Status: Found UCIP Comments: 03/12/2019 A thorough internal evaluation of this crossing is required, pipe shows evidence of pipe integrity (LS) issues (pipe wall sections missing on WS outlet). Internal inspection is recommended for this crossing to determine the extent of pipe damage through the levee. Maintenance issues identified at this crossing include: flap gate missing on WS, debris found inside concrete distribution box, and missing cover on riser. No permit has been identified for this crossing. Need to determine who maintains crossing; crossing appears functional. (O. Magana - DWR UCIP) FIELD_STRUCT_DESC: 24-inch corrugated metal drainage pipe through the levee, 14 feet below the crown. Slide gate in a corrugated metal pipe (CMP) riser on the waterside (WS) slope. Concrete U-shaped headwall at the landside (LS) toe. [Additional Reference(s): DWR Levee Log, 2005. USACE San Joaquin O&M Manual 5, August 1961, (HLM 1.71)]. FS Date: 3/12/2019 12:07:00 PM

Overview of levee crown looking d/s towards pipe crossing.

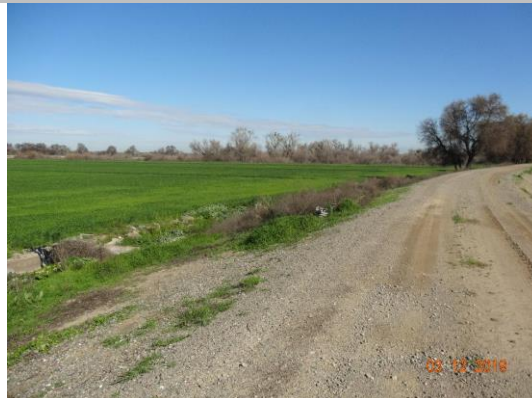
Photo 2 of 3 : UCIP\_FA\_2021\_53817\_79087.jpg

WS view: overview of WS.

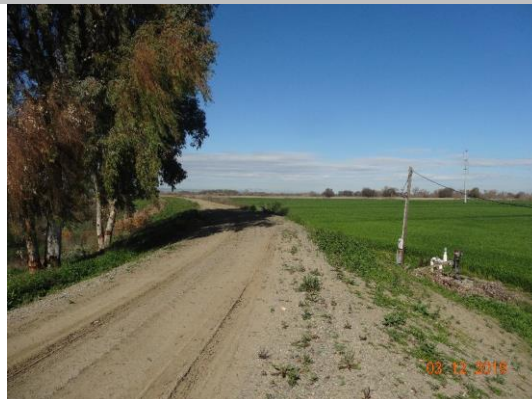
Photo 2 of 3 : UCIP\_FA\_2021\_53814\_79092.jpg

Comment Code						
Inspector Comment						
DS_ID:20564 FS_ID:53814 EP_NO: N/A Repair Type: Non-Urgent EVAL Issue: Unauthorized Encroachment, installed decades prior Crossing Status: Found UCIP Comments: 03/12/2019 Concrete headwall found on LS toe. Pipe appears to have been grouted through. No other appurtenances were found during inspection. WS outlet was not found. Need to coordinate with the CVFPB to determine if additional steps are needed to comply with Title 23. (O. Magana - DWR UCIP) FIELD_STRUCT_DESC: *ABANDONED* 30-inch corrugated metal drainage pipe through the levee, 15 feet below the crown. Flap gate on the waterside (WS) end. Concrete U-shaped headwalls on both ends. Filled with concrete on the landside (LS) toe. [Additional Reference(s): DWR Levee Log, 2005. USACE San Joaquin O&M Manual 5, August 1961, (HLM 2.10), 36-inch pipe listed]. FS Date: 3/12/2019 12:08:00 PM

Overview of levee at crossing, photo taken u/s looking d/s towards pipe crossing.

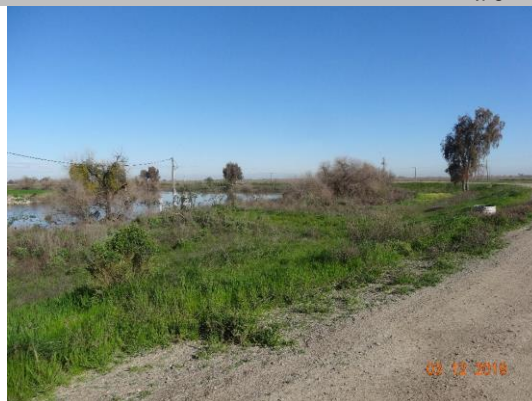
Photo 1 of 3 : UCIP\_FA\_2021\_53805\_79106.jpg

Comment Code						
Inspector Comment						
DS_ID:24680 FS_ID:53805 EP_NO: N/A Repair Type: Non-Urgent EVAL Issue: Unauthorized Modification or Non-Compliant Permit Crossing Status: Found UCIP Comments: 03/12/2019 No permit was found authorizing modifications to existing crossing. New crossing was added at this levee section using the old appurtenances associated with USACE O&M Legacy system Pipe (dsid 20566). The pipe associated with dsid 20566 has been grouted through (see dsid 20566 detail report). Irrigation pipe is functional and pipe is being maintained. Unable to confirm if riser located on WS is being used with this crossing. Need to coordinate with CVFPB to determine owner and if permit was issued for the modifications of this crossing. (O. Magana - DWR UCIP) 09/24/2013 No permit identified for this crossing. (W. Wylie - DWR UCIP) FIELD_STRUCT_DESC: 21-inch polyvinyl chloride (PVC) irrigation pipe through the levee, at an unknown depth. Pipe discharges into a concrete distribution box on the landside (LS) toe. Pump on pier off the waterside (WS) toe. [Additional Reference(s): DWR Levee Log, 2005]. FS Date: 3/12/2019 12:08:00 PM

WS view: overview of WS.

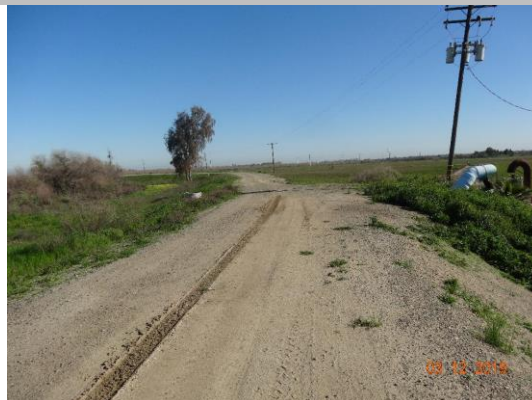
Photo 2 of 3 : UCIP\_FA\_2021\_53805\_79105.jpg

Overview of levee crown looking d/s towards crossing.

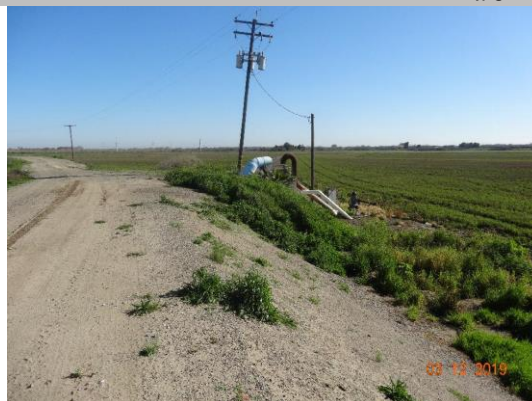
Photo 3 of 3 : UCIP\_FA\_2021\_53805\_79104.jpg

LM Start	<b>2.34</b>	Rating **	M	Issue No.	<b>981 (cont)</b>
LM End	<b>2.34</b>	Issue Type +	En	Location *	
Category	Supplemental		GPS Latitude/Longitude		
			Start	End	
Item	DWR UCIP Field Study		37.581226 °	37.581226 °	
			-121.156175 °	-121.156175 °	
DWR ID	24680

LS view: overview of LS.

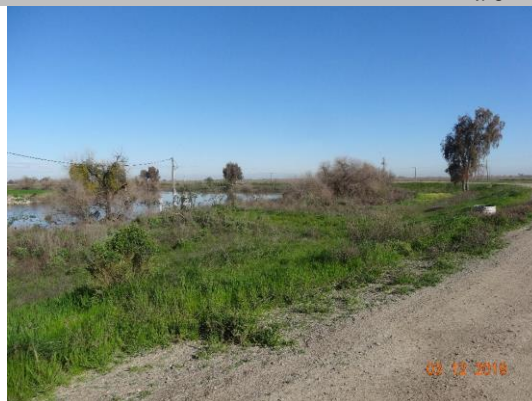
Photo 1 of 3 : UCIP\_FA\_2021\_54051\_79112.jpg

DS\_ID:20566  
FS\_ID:54051  
EP\_NO: N/A  
Repair Type: Non-Urgent  
EVAL Issue: Safety Issue  
Crossing Status: Found  
UCIP Comments: 03/12/2019 Concrete distribution box found on LS with evidence that 24-inch pipe was going through levee. Pipe appears to have been grouted through. Riser is still present on WS however, unable to determine if pipe was grouted all the way through the levee section. Concrete distribution box is currently being used by an unauthorized pipe encroachment (see DSID 24680). Lid missing from CMP riser. Owner needs to add lid to riser to prevent entry in confined space. Need to coordinate with the CVFPB to determine how to address abandoned appurtenances and pipe abandonment. (O. Magana - DWR UCIP)  
09/24/2013 Pipe appears abandoned and needs to be verified as having been done so properly. (W. Wylie - DWR UCIP)  
FIELD\_STRUCT\_DESC: \*ABANDONED\* 24-inch corrugated metal irrigation pipe through the levee, 11 feet below the crown. Slide gate in a 36-inch corrugated metal pipe (CMP) riser on the waterside (WS) slope. 5-foot by 5-foot concrete distribution box on the landside (LS). Pump on platform in the channel. Pipe filled with concrete on the LS toe. [Additional Reference(s): DWR Levee Log, 2005. USACE San Joaquin O&M Manual 5, August 1961, (HLM 2.38)].

WS view: overview of WS.

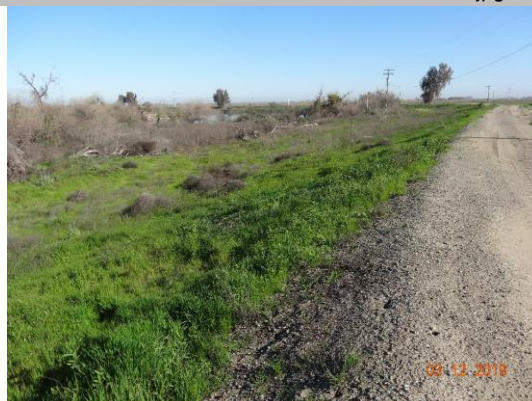
Photo 1 of 3 : UCIP\_FA\_2021\_54052\_79119.jpg

UCIP Comments: 03/12/2019 Unable to locate concrete headwall on the WS due to high water. Unable to locate concrete headwall on LS due to dense vegetation. No permit was found authorizing crossing. If crossing is no longer in use recommend removing crossing and appurtenances from levee. Need to coordinate with CVFPB to determine pipe owner. (O. Magana - DWR UCIP)

WS view: overview of WS.

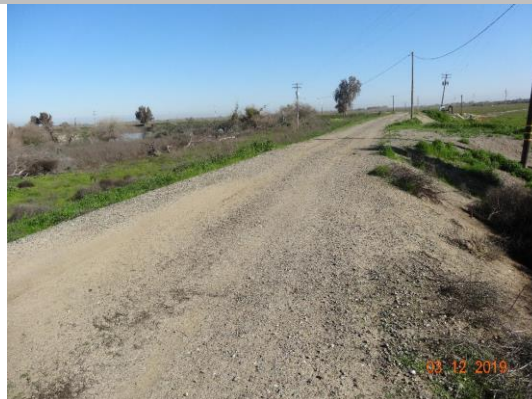
Photo 2 of 3 : UCIP\_FA\_2021\_54052\_79118.jpg

LM Start	<b>2.40</b>	Rating **	M	Issue No.	<b>983 (cont)</b>
LM End	<b>2.40</b>	Issue Type +	En	Location *	
Category	Supplemental		GPS Latitude/Longitude		
			Start	End	
Item	DWR UCIP Field Study		37.580426 °	37.580426 °	
			-121.156798 °	-121.156798 °	
DWR ID	20567

Overview of levee crown looking d/s towards crossing.

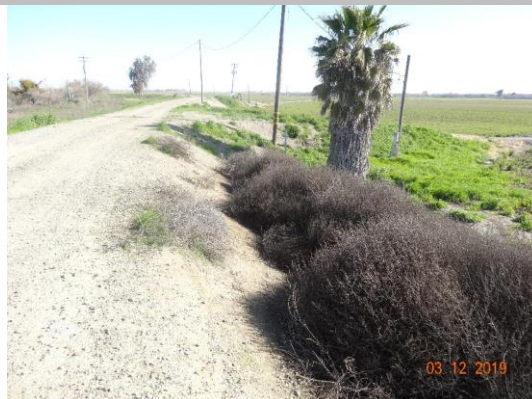
Photo 3 of 3 : UCIP\_FA\_2021\_54052\_79117.jpg

LM Start	<b>2.40</b>	Rating **	M	Issue No.	<b>983 (cont)</b>
LM End	<b>2.40</b>	Issue Type +	En	Location *

LS view: overview of LS.

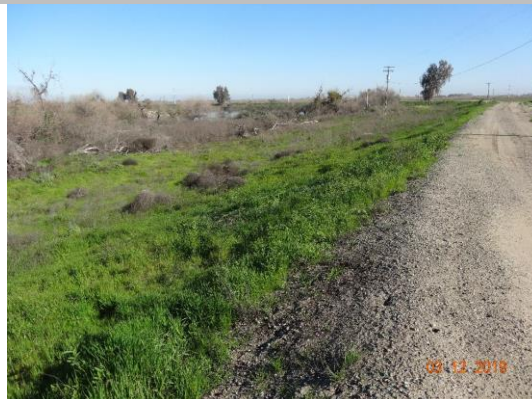
Photo 1 of 3 : UCIP\_FA\_2021\_53808\_79126.jpg

Comment Code						
Inspector Comment						
DS_ID:20568 FS_ID:53808 EP_NO: N/A Repair Type: Non-Urgent EVAL Issue: Unauthorized Encroachment, installed decades prior Crossing Status: Indicator Found UCIP Comments: 03/12/2019 No permit was found authorizing crossing. Crossing appears to be abandoned, if crossing is abandoned, owner will need to coordinate with CVFPB to comply with Title 23. (O. Magana - DWR UCIP) 09/24/2013 Pipe abandoned and should be verified as having been removed from the levee. (W. Wylie - DWR UCIP) FIELD_STRUCT_DESC: *ABANDONED* 4-inch drainage pipe of an unknown material through the levee, 1 foot below the crown. Pump on sump at the landside (LS) toe. Roadway extending to the LS pump. [Additional Reference(s): DWR Levee Log, 2005]. FS Date: 3/12/2019 12:10:00 PM

WS view: overview of WS.

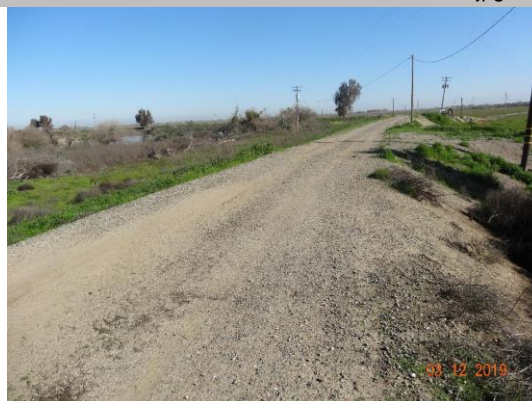
Photo 2 of 3 : UCIP\_FA\_2021\_53808\_79125.jpg

LM Start	<b>2.41</b>	Rating **	M	Issue No.	<b>984 (cont)</b>
LM End	<b>2.41</b>	Issue Type +	En	Location *

Overview of levee crown.

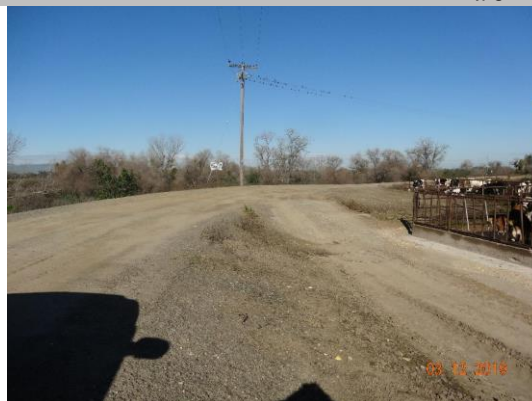
Photo 1 of 3 : UCIP\_FA\_2021\_53813\_79128.jpg

LM Start	<b>2.79</b>	Rating **	M	Issue No.	<b>985 (cont)</b>
LM End	<b>2.79</b>	Issue Type +	En	Location *

LS view: overview of LS.

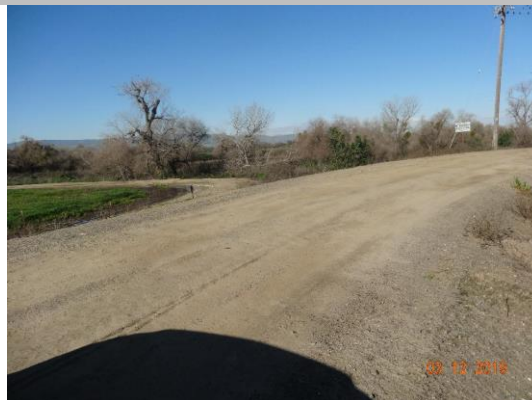
Photo 2 of 3 : UCIP\_FA\_2021\_53813\_79129.jpg

Overview of levee crown where crossing should be.

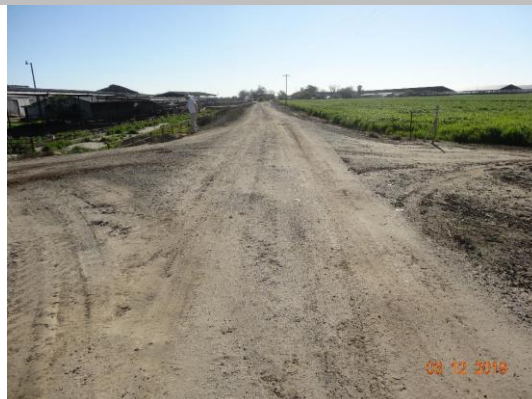
Photo 1 of 3 : UCIP\_FA\_2021\_53810\_79135.jpg

LM Start	<b>2.86</b>	Rating **	M	Issue No.	<b>986 (cont)</b>
LM End	<b>2.86</b>	Issue Type +	En	Location *

Overview of levee at crossing, photo taken d/s looking u/s towards crossing.

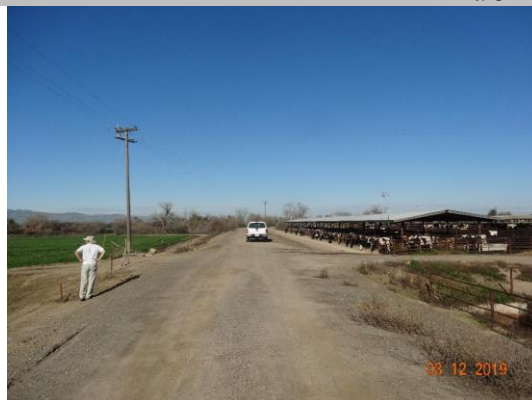
Photo 2 of 3 : UCIP\_FA\_2021\_53810\_79136.jpg

Overview of levee at crossing, photo taken u/s looking d/s towards crossing.

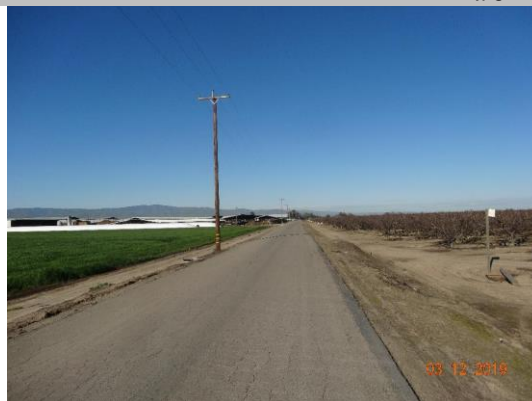
Photo 1 of 3 : UCIP\_FA\_2021\_53786\_79145.jpg

LM Start	<b>3.47</b>	Rating **	M	Issue No.	<b>988 (cont)</b>
LM End	<b>3.47</b>	Issue Type +	Ma	Location *

Overview of levee crown looking d/s towards crossing.

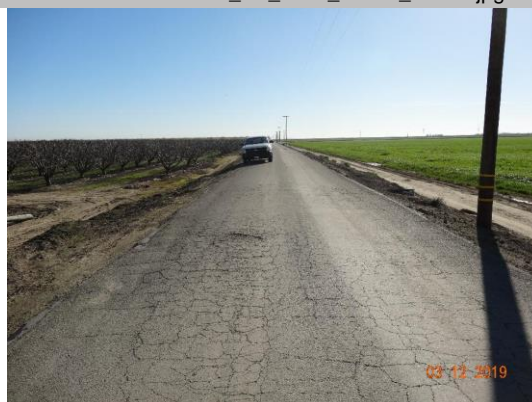
Photo 2 of 3 : UCIP\_FA\_2021\_53786\_79150.jpg

Overview of levee crown looking u/s towards crossing.

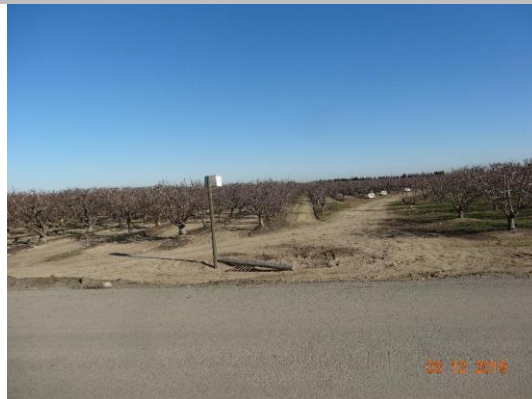
Photo 3 of 3 : UCIP\_FA\_2021\_53786\_79144.jpg

LM Start	3.47	Rating **	M	Issue No.	988 (cont)
LM End	3.47	Issue Type +	Ma	Location *	
Category	Supplemental			GPS Latitude/Longitude	
				Start	End
Item	DWR UCIP LMA Responsibility			37.573304 °	37.573304 °
				-121.144747 °	-121.144747 °
DWR ID	20572

LS view: overview of land use on LS.
