**Flood Control Project Maintenance
Levee Inspections
Fall 2022 Levee Maintenance Deficiency Summary Report**

San Joaquin River Basin

| RD2092 | Overall LMA Rating | Total LMA Miles | | | | | | |
|---|---|---|---|---|---|---|---|---|
| Reclamation District No. 2092 Dos Rios | U | 3.71 | | | | | | |

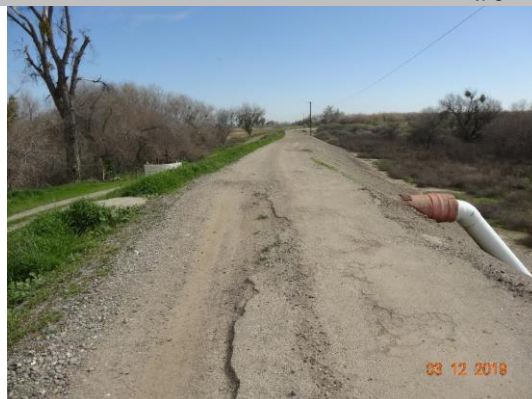
Photo 3 of 3 : UCIP_FA_2022_53815_79064.jpg

Overview of levee crown at pipe crossing, photo taking looking d/s.

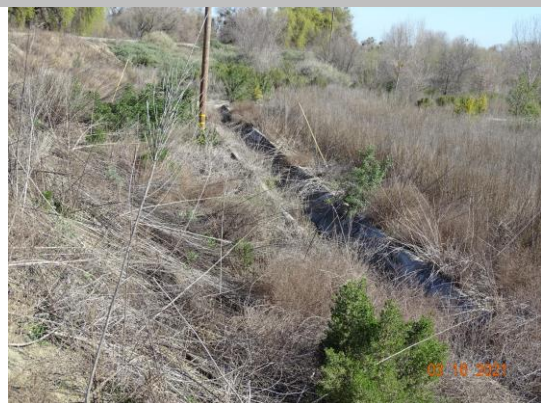
Photo 1 of 1 : FA_2022_RD2092_116_968_20220822_00029.jpg

View of concrete ditch running along the landside toe. (Spring 2021)

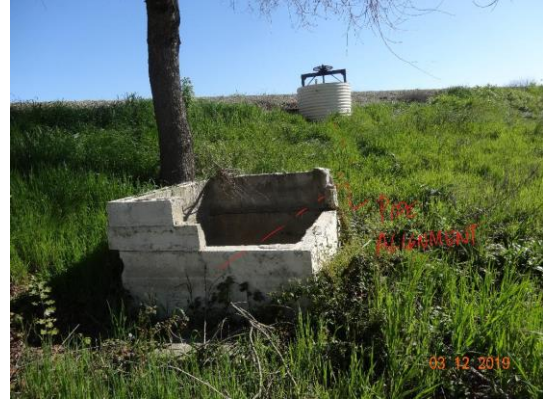
Photo 2 of 3 : UCIP_FA_2022_53820_79078.jpg

| DS_ID:20562 FS_ID:53820 EP_NO: N/A Repair Type: Non-Urgent EVAL Issue: 5, Pipe Damage Crossing Status: Found UCIP Comments: 03/12/2019 DMP internal video inspection has found pipe integrity issues. LOF of crossing is greater than or equal to 4.1 and less than 5. Crossing will be monitored until funding becomes available for rehabilitation. During UCIP visual inspection, no pipe or levee integrity issues were observed. Distribution box located on the WS is falling apart (bricks missing). This crossing is an active crossing however, no permit has been found authorizing crossing. Need to determine who maintains and operates this crossing. (O. Magana - DWR UCIP) FIELD_STRUCT_DESC: 36-inch corrugated metal drainage pipe through the levee, 15 feet below the crown. Slide gate in a 48-inch corrugated metal pipe (CMP) riser on the waterside (WS) slope. 4-foot by 6-foot concrete distribution box on the landside (LS) toe. 5-foot by 5-foot concrete riser on the WS toe. [Additional Reference(s): DWR Levee Log, 2005. USACE San Joaquin O&M Manual 5, August 1961, (HLM 1.31). USACE As-Built Drawing No. 07-04-1555, Sheet 19.3, upstream of STA 260+00, 15 November 1961]. FS Date: 3/12/2019 12:06:00 PM | | | | | |

WS view: approximate alignment on WS.

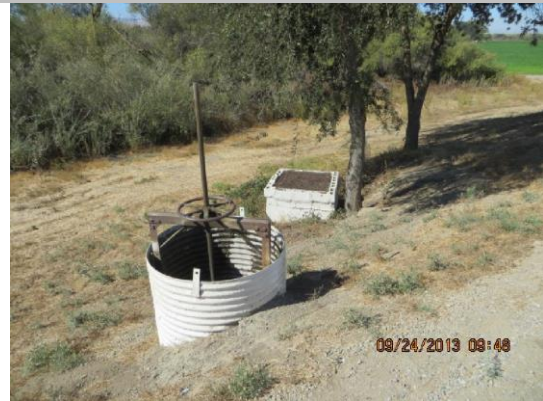
Photo 3 of 3 : UCIP_FA_2022_53820_35213.jpg

Slide gate in 48-inch CMP riser on WS slope.

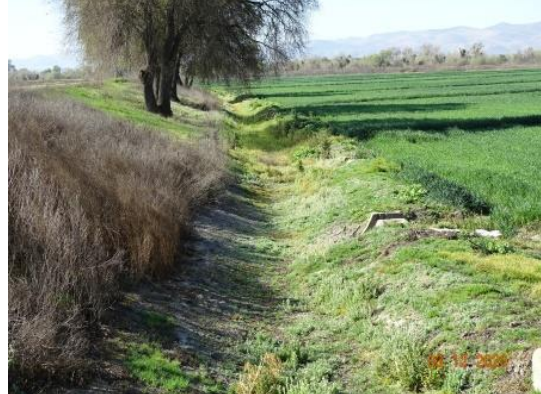
Photo 1 of 1 : FA_2022_RD2092_116_8_20220822_00001.jpg

View of unlined ditch along the waterside toe looking upstream. (Spring 2020)

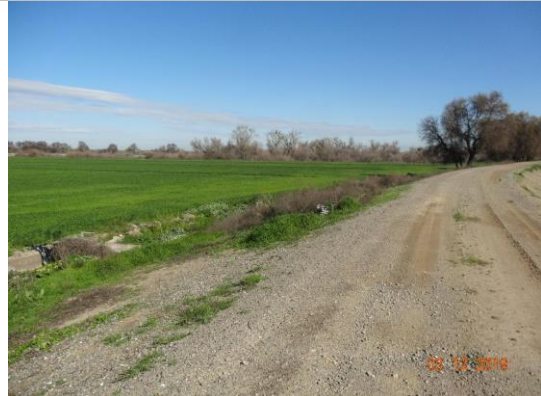
Photo 2 of 3 : UCIP_FA_2022_53817_79087.jpg

| DS_ID:20563 FS_ID:53817 EP_NO: N/A Repair Type: Urgent EVAL Issue: 1, Pipe Integrity Crossing Status: Found UCIP Comments: 03/12/2019 A thorough internal evaluation of this crossing is required, pipe shows evidence of pipe integrity (LS) issues (pipe wall sections missing on WS outlet). Internal inspection is recommended for this crossing to determine the extent of pipe damage through the levee. Maintenance issues identified at this crossing include: flap gate missing on WS, debris found inside concrete distribution box, and missing cover on riser. No permit has been identified for this crossing. Need to determine who maintains crossing; crossing appears functional. (O. Magana - DWR UCIP) FIELD_STRUCT_DESC: 24-inch corrugated metal drainage pipe through the levee, 14 feet below the crown. Slide gate in a corrugated metal pipe (CMP) riser on the waterside (WS) slope. Concrete U-shaped headwall at the landside (LS) toe. [Additional Reference(s): DWR Levee Log, 2005. USACE San Joaquin O&M Manual 5, August 1961, (HLM 1.71)]. FS Date: 3/12/2019 12:07:00 PM | | | | | |

WS view: overview of WS.

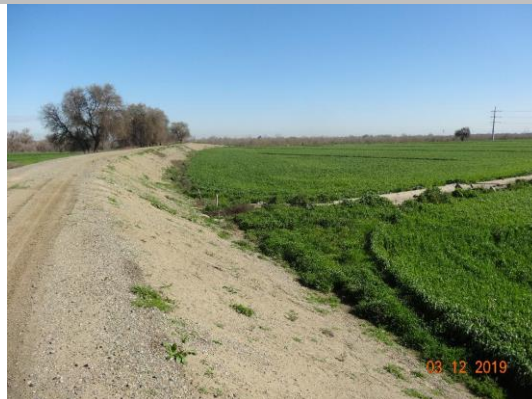
Photo 3 of 3 : UCIP_FA_2022_53817_79085.jpg

LS view: overview of LS.

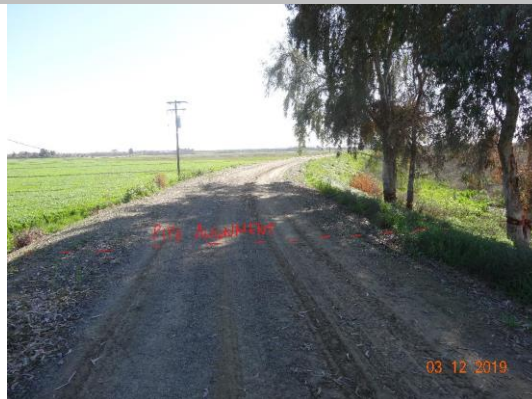
Photo 1 of 3 : UCIP_FA_2022_53814_79091.jpg

| DS_ID:20564 FS_ID:53814 EP_NO: N/A Repair Type: Non-Urgent EVAL Issue: Crossing Status: Found UCIP Comments: 03/12/2019 Concrete headwall found on LS toe. Pipe appears to have been grouted through. No other appurtenances were found during inspection. WS outlet was not found. Need to coordinate with the CVFPB to determine if additional steps are needed to comply with Title 23. (O. Magana - DWR UCIP) FIELD_STRUCT_DESC: *ABANDONED* 30-inch corrugated metal drainage pipe through the levee, 15 feet below the crown. Flap gate on the waterside (WS) end. Concrete U-shaped headwalls on both ends. Filled with concrete on the landside (LS) toe. [Additional Reference(s): DWR Levee Log, 2005. USACE San Joaquin O&M Manual 5, August 1961, (HLM 2.10), 36-inch pipe listed]. FS Date: 3/12/2019 12:08:00 PM | | | | | | |

Overview of levee crown, looking u/s from d/s, and approximate pipe alignment.

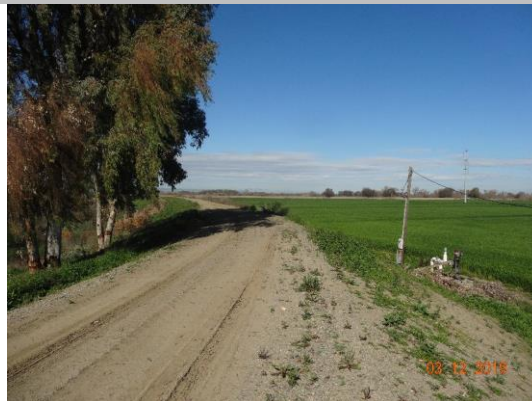
Photo 2 of 3 : UCIP_FA_2022_53814_79092.jpg

Overview of levee at crossing, photo taken u/s looking d/s towards pipe crossing.

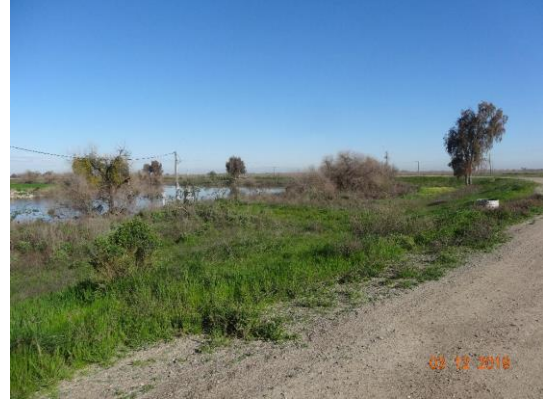
Photo 1 of 3 : UCIP_FA_2022_53805_79106.jpg

| DS_ID:24680 FS_ID:53805 EP_NO: N/A Repair Type: Non-Urgent EVAL Issue: 10, Unauthorized Modification or Non-Compliant Permit Crossing Status: Found UCIP Comments: 03/12/2019 No permit was found authorizing modifications to existing crossing. New crossing was added at this levee section using the old appurtenances associated with USACE O&M Legacy system Pipe (dsid 20566). The pipe associated with dsid 20566 has been grouted through (see dsid 20566 detail report). Irrigation pipe is functional and pipe is being maintained. Unable to confirm if riser located on WS is being used with this crossing. Need to coordinate with CVFPB to determine owner and if permit was issued for the modifications of this crossing. (O. Magana - DWR UCIP) 09/24/2013 No permit identified for this crossing. (W. Wylie - DWR UCIP) FIELD_STRUCT_DESC: 21-inch polyvinyl chloride (PVC) irrigation pipe through the levee, at an unknown depth. Pipe discharges into a concrete distribution box on the landside (LS) toe. Pump on pier off the waterside (WS) toe. [Additional Reference(s): DWR Levee Log, 2005]. FS Date: 3/12/2019 12:08:00 PM | | | | | |

WS view: overview of WS.

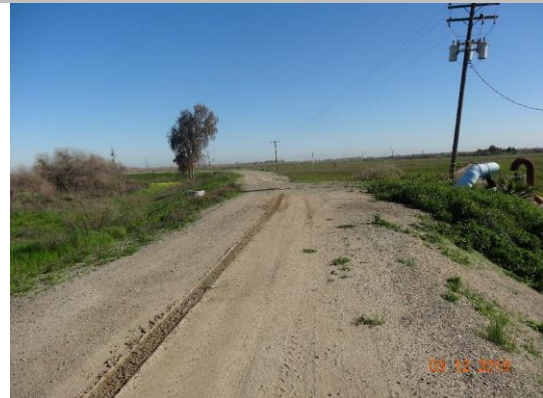
Photo 2 of 3 : UCIP_FA_2022_53805_79105.jpg

Overview of levee crown looking d/s towards crossing.

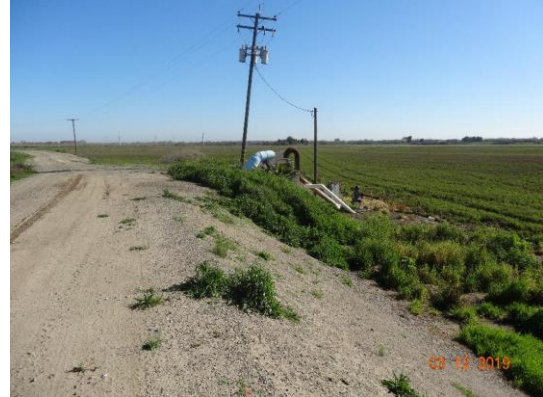
Photo 3 of 3 : UCIP_FA_2022_53805_79104.jpg

LS view: overview of LS.

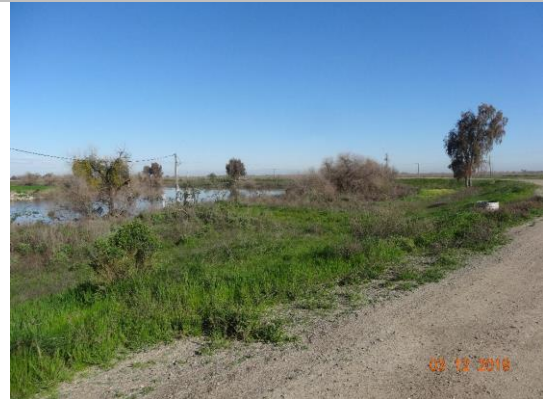
Photo 1 of 3 : UCIP_FA_2022_54051_79112.jpg

DS_ID:20566
 FS_ID:54051
 EP_NO: N/A
 Repair Type: Non-Urgent
 EVAL Issue: 4b, Safety Issue
 Crossing Status: Found
 UCIP Comments: 03/12/2019 Concrete distribution box found on LS with evidence that 24-inch pipe was going through levee. Pipe appears to have been grouted through. Riser is still present on WS however, unable to determine if pipe was grouted all the way through the levee section. Concrete distribution box is currently being used by an unauthorized pipe encroachment (see DSID 24680). Lid missing from CMP riser. Owner needs to add lid to riser to prevent entry in confined space. Need to coordinate with the CVFPB to determine how to address abandoned appurtenances and pipe abandonment. (O. Magana - DWR UCIP)
 09/24/2013 Pipe appears abandoned and needs to be verified as having been done so properly. (W. Wylie - DWR UCIP)
 FIELD_STRUCT_DESC: *ABANDONED* 24-inch corrugated metal irrigation pipe through the levee, 11 feet below the crown. Slide gate in a 36-inch corrugated metal pipe (CMP) riser on the waterside (WS) slope. 5-foot by 5-foot concrete distribution box on the landside (LS). Pump on platform in the channel. Pipe filled with concrete on the LS toe. [Additional Reference(s): DWR Levee Log, 2005. USACE San Joaquin O&M Manual 5, August 1961, (HLM 2.38)].

WS view: overview of WS.

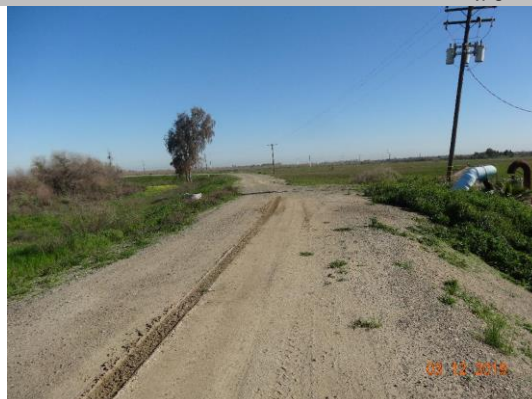
Photo 2 of 3 : UCIP_FA_2022_54051_79111.jpg

Overview of levee crown looking d/s looking towards crossing.

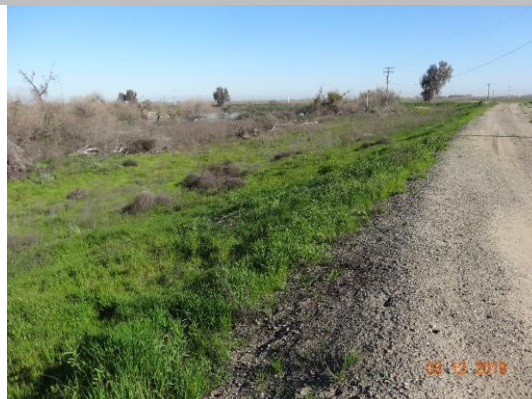
Photo 1 of 3 : UCIP_FA_2022_54052_79119.jpg

| DS_ID:20567 FS_ID:54052 EP_NO: N/A Repair Type: Non-Urgent EVAL Issue: Crossing Status: Indicator Found UCIP Comments: 03/12/2019 Unable to locate concrete headwall on the WS due to high water. Unable to locate concrete headwall on LS due to dense vegetation. No permit was found authorizing crossing. If crossing is no longer in use recommend removing crossing and appurtenances from levee. Need to coordinate with CVFPB to determine pipe owner. (O. Magana - DWR UCIP) 09/24/2013 Appears abandoned and if so should be done so properly. (W. Wylie - DWR UCIP) FIELD_STRUCT_DESC: *ABANDONED* 24-inch corrugated metal drainage pipe through the levee, 15 feet below the crown. Flap gate on the waterside (WS) end. Concrete U-shaped headwall on the WS end. Concrete headwall on the landside (LS) toe next to pump. [Additional Reference(s): DWR Levee Log, 2005. USACE San Joaquin O&M Manual 5, August 1961, (HLM 2.44)]. FS Date: 3/12/2019 12:09:00 PM | | | | | | |

WS view: overview of WS.

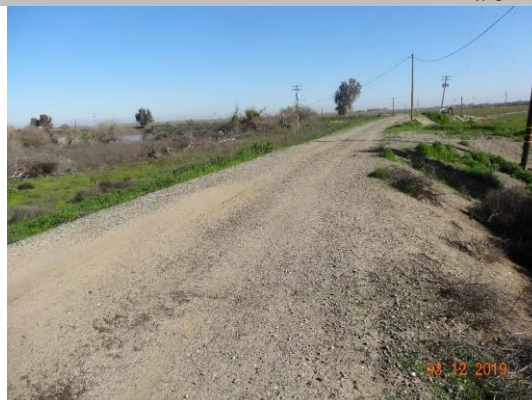
Photo 2 of 3 : UCIP_FA_2022_54052_79118.jpg

Overview of levee crown looking d/s towards crossing.

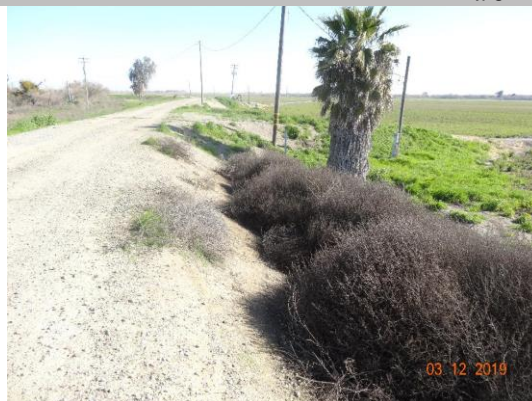
Photo 3 of 3 : UCIP_FA_2022_54052_79117.jpg

LS view: overview of LS.

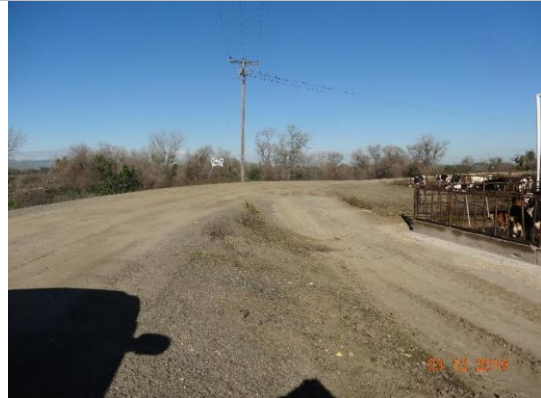
Photo 1 of 3 : UCIP_FA_2022_53813_79128.jpg

| DS_ID:20569 FS_ID:53813 EP_NO: N/A Repair Type: Non-Urgent EVAL Issue: Crossing Status: Not Found UCIP Comments: 03/12/2019 Need to confirm status of crossing through levee section. (O. Magana - DWR UCIP) FIELD_STRUCT_DESC: 24-inch corrugated metal drainage pipe through the levee, 6 feet below the crown. Concrete U-shaped headwall and flap gate on the waterside (WS) end. [Additional Reference(s): DWR Levee Log, 2005. USACE San Joaquin O&M Manual 5, August 1961, (HLM 2.83)]. FS Date: 3/12/2019 12:10:00 PM | | | | | |

LS view: overview of LS.

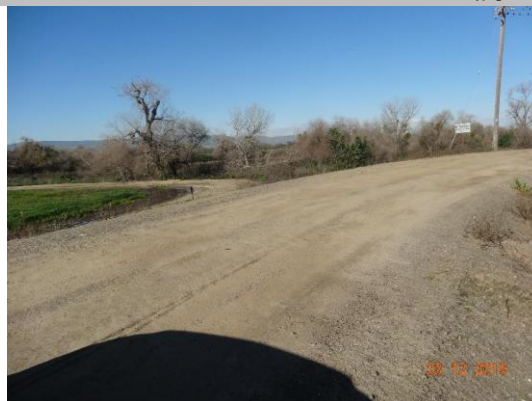
Photo 2 of 3 : UCIP_FA_2022_53813_79129.jpg

Overview of levee crown where crossing should be.

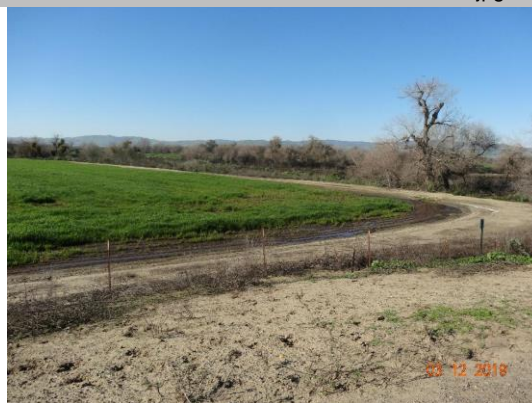
Photo 3 of 3 : UCIP_FA_2022_53813_79130.jpg

WS view: overview of WS.

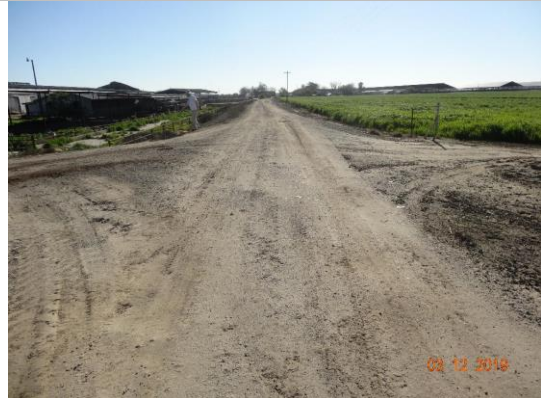
Photo 1 of 3 : UCIP_FA_2022_53810_79135.jpg

| DS_ID:20570 FS_ID:53810 EP_NO: N/A Repair Type: Non-Urgent EVAL Issue: Crossing Status: Indicator Found UCIP Comments: 03/12/2019 Unable to locate concrete headwall on the WS. Concrete headwall is still visible on the LS however, this crossing appears to be abandoned. No permit was found authorizing crossing. If crossing is no longer in use recommend removing crossing and appurtenances from levee. (O. Magana - DWR UCIP) 09/24/2013 Appears abandoned and if so, should be done so properly. (W. Wylie - DWR UCIP) FIELD_STRUCT_DESC: *ABANDONED* 24-inch corrugated metal drainage pipe through the levee, 6.5 feet below the crown. Concrete U-shaped headwall and flap gate on the waterside (WS) end. Concrete headwall on the landside (LS) slope. [Additional Reference(s): DWR Levee Log, 2005. USACE San Joaquin O&M Manual 5, August 1961]. FS Date: 3/12/2019 12:11:00 PM | | | | | | |

Overview of levee at crossing, photo taken d/s looking u/s towards crossing.

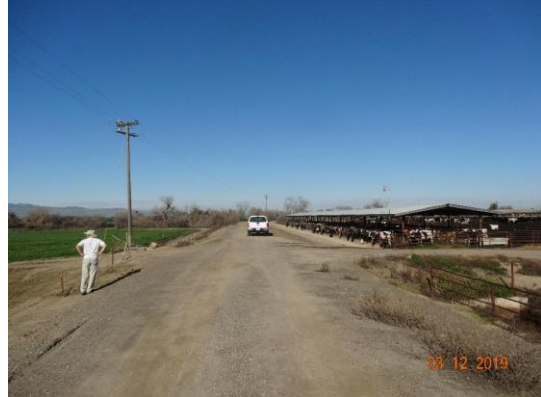
Photo 2 of 3 : UCIP_FA_2022_53810_79136.jpg

Overview of levee at crossing, photo taken u/s looking d/s towards crossing.

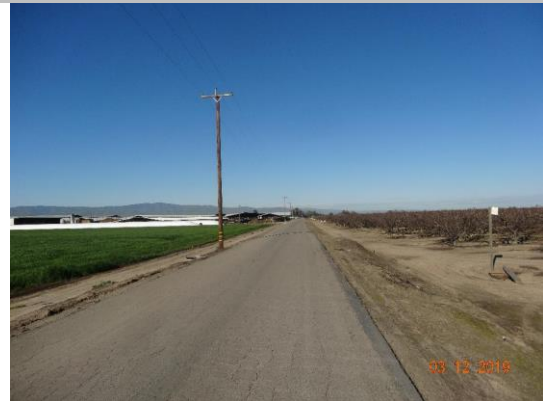
Photo 1 of 3 : UCIP_FA_2022_53786_79145.jpg

| DS_ID:20572 FS_ID:53786 EP_NO: N/A Repair Type: Non-Urgent EVAL Issue: 4b, Safety Issue Crossing Status: Found UCIP Comments: 03/12/2019 No permit was found authorizing crossing. Unable to confirm if crossing is in use. Recommend adding cover to riser to address safety concern. No slide gate was found in CMP riser. If crossing is no longer in use, recommend proper abandonment or removal from levee. Owner will need to coordinate with CVFPB to be compliant with Title 23. (O. Magana - DWR UCIP) 09/24/2013 This pipe appears abandoned and if so, should be done so properly. (W. Wylie - DWR UCIP) FIELD_STRUCT_DESC: *ABANDONED* 36-inch corrugated metal drainage pipe through the levee, 11 feet below the crown. Slide gate in a corrugated metal pipe (CMP) riser on the waterside (WS) slope. Concrete headwalls on both ends. [Additional Reference(s): DWR Levee Log, 2005. USACE San Joaquin O&M Manual 5, August 1961, (HLM 3.52)]. FS Date: 3/12/2019 12:11:53 PM | | | | | |

Overview of levee crown looking d/s towards crossing.

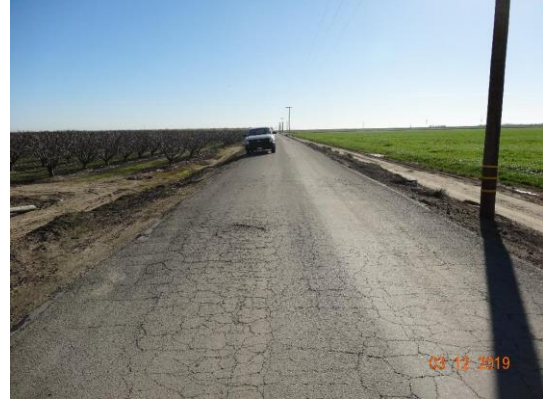
Photo 2 of 3 : UCIP_FA_2022_53786_79150.jpg

Overview of levee crown looking u/S towards crossing.

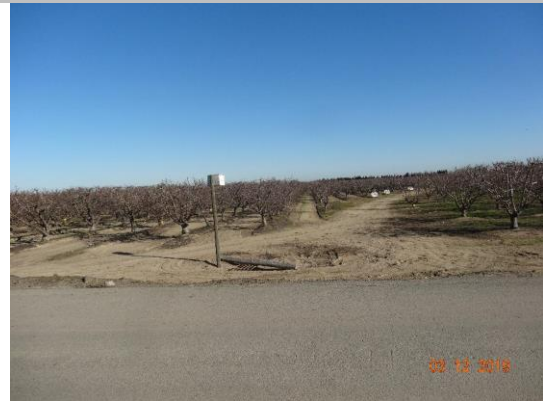
Photo 3 of 3 : UCIP_FA_2022_53786_79144.jpg

LS view: overview of land use on LS.
