**Flood Control Project Maintenance  
Levee Inspections  
Fall 2023 Levee Maintenance Deficiency Summary Report**

**San Joaquin River Basin**

**Reclamation District No. 2092 Dos Rios**

Waterway			Bank	Unit Miles
Unit No. 01 San Joaquin River			Right	3.71
	Spring (March - May)	Summer (June - August)	(September - November) Fall	Winter (December - February)
Unit Maintenance Rating (Fall Only)			<b>U</b>	
Date of Inspection	3/1/2023 - 3/1/2023		9/6/2023 - 9/6/2023	
DWR Inspector	Nate Hicks		Nate Hicks	
Accompanied By			Corey Fujitani DWR

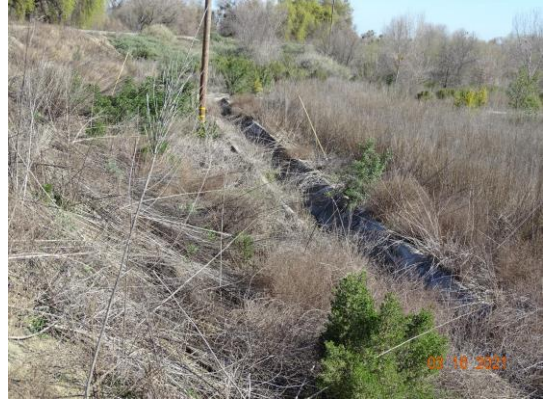
Photo 1 of 1 : FA\_2023\_RD2092\_116\_968\_20230905\_00034.jpg

LM Start	0.76	Rating **	M	Issue No.	968
LM End	1.31	Issue Type +	En	Location *	LS
Category	Earthen Levee			GPS Latitude/Longitude	
				Start	End
Item	Encroachments			37.597291°	37.590568°
				-121.168496°	-121.164028°
DWR ID	DWR_RD2092_01_s_2012_968				
Comment Code					
DT : Ditch					
Inspector Comment

View of concrete ditch running along the landside toe. (Spring 2021)

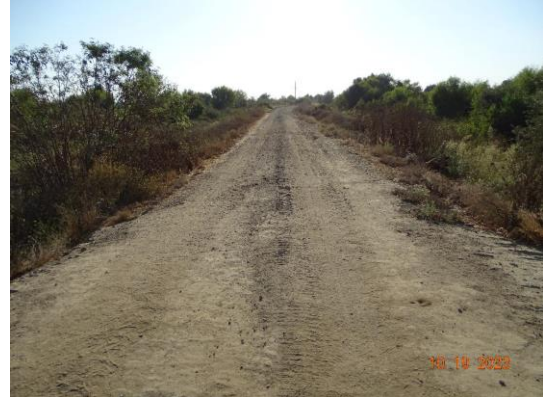
Photo 1 of 3 : UCIP\_FA\_2023\_81554\_117506.jpg

Comment Code					
Inspector Comment					
DS_ID:20562 FS_ID:81554 EP_NO: N/A Repair Type: Non-Urgent EVAL Issue: 5, Pipe Damage Crossing Status: Found UCIP Comments: 10/19/2023 Record remains Non-Urgent. DMP internal video inspection has found moderate pipe defects. Crossing will be monitored until funding becomes available for rehabilitation. Slide gate in a 48-inch CMP riser on WS slope not found. Distribution box on WS toe not found. Overgrown vegetation limits inspection of levee at this crossing on LS. (M. Thao - DWR UCIP) 03/12/2019 DMP internal video inspection has found pipe integrity issues. LOF of crossing is greater than or equal to 4.1 and less than 5. Crossing will be monitored until funding becomes available for rehabilitation. During UCIP visual inspection, no pipe or levee integrity issues were observed. Distribution box located on the WS is falling apart (bricks missing). This crossing is an active crossing however, no permit has been found authorizing crossing. Need to determine who maintains and operates this crossing. (O. Magana - DWR UCIP) FIELD_STRUCT_DESC: 36-inch corrugated metal drainage pipe through the levee, 15 feet below the crown. Slide gate in a 48-inch corrugated metal pipe (CMP) riser on the waterside (WS) slope. 4-foot by 6-foot concrete distribution box on the landside (LS) toe. 5-foot by 5-foot concrete riser on the WS toe. [Additional Reference(s): DWR Levee Log, 2005. USACE San Joaquin O&M Manual 5, August 1961, (HLM 1.31). USACE As-Built Drawing No. 07-04-1555, Sheet 19.3, upstream of STA 260+00, 15 November 1961]. FS Date: 10/19/2023 4:26:48 PM

Levee crown looking upstream.

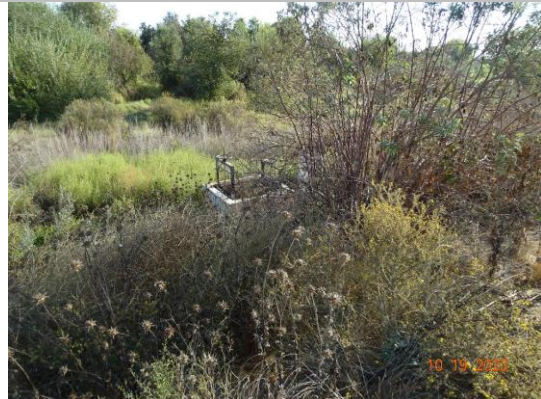
Photo 2 of 3 : UCIP\_FA\_2023\_81554\_117508.jpg

LS view: Concrete distribution box on toe; looking from crown.

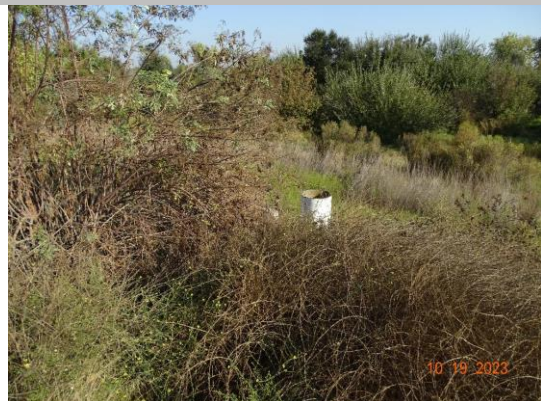
Photo 3 of 3 : UCIP\_FA\_2023\_81554\_117510.jpg

LS view: Concrete riser on toe; looking from crown.

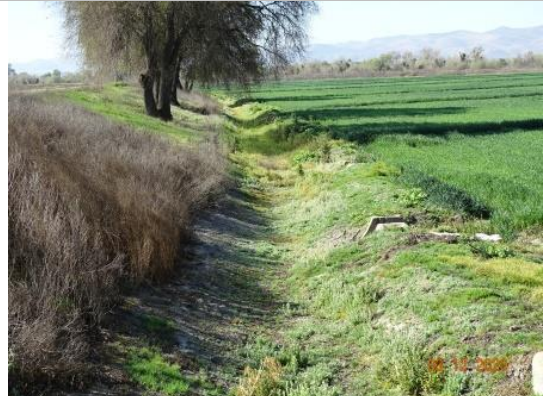
Photo 1 of 1 : FA\_2023\_RD2092\_116\_8\_20230905\_00001.jpg

LM Start	1.56	Rating **	M	Issue No.	8
LM End	1.84	Issue Type +	En	Location *	WS
Category	Earthen Levee			GPS Latitude/Longitude	
				Start	End
Item	Encroachments			37.587575°	37.584057°
				-121.162454°	-121.162387°
DWR ID	DWR_RD2092_01_s_2012_8				
Comment Code					
DT : Ditch					
Inspector Comment

View of unlined ditch along the waterside toe looking upstream. (Spring 2020)

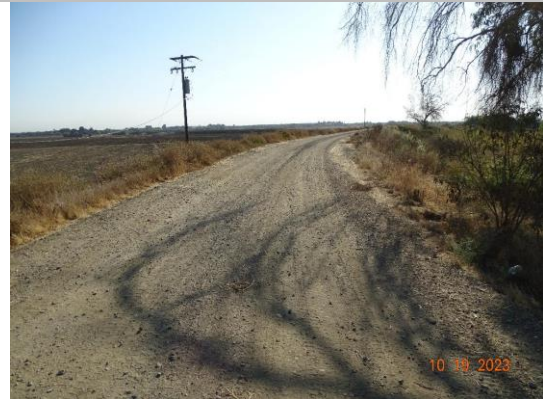
Photo 1 of 3 : UCIP\_FA\_2023\_81477\_117865.jpg

Comment Code					
Inspector Comment					
DS_ID:20564 FS_ID:81477 EP_NO: N/A Repair Type: Non-Urgent EVAL Issue: Crossing Status: Found UCIP Comments: 10/19/2023 Record remains Non-Urgent. Crossing appears abandoned; unable to locate a permit and confirm proper pipe abandonment. Overgrown vegetation limits inspection of levee on WS. (M. Thao - DWR UCIP) 03/12/2019 Concrete headwall found on LS toe. Pipe appears to have been grouted through. No other appurtenances were found during inspection. WS outlet was not found. Need to coordinate with the CVFPB to determine if additional steps are needed to comply with Title 23. (O. Magana - DWR UCIP) FIELD_STRUCT_DESC: *ABANDONED* 30-inch corrugated metal drainage pipe through the levee, 15 feet below the crown. Flap gate on the waterside (WS) end. Concrete U-shaped headwalls on both ends. Filled with concrete on the landside (LS) toe. [Additional Reference(s): DWR Levee Log, 2005. USACE San Joaquin O&M Manual 5, August 1961, (HLM 2.10), 36-inch pipe listed]. FS Date: 10/19/2023 2:50:09 PM

Levee crown looking upstream.

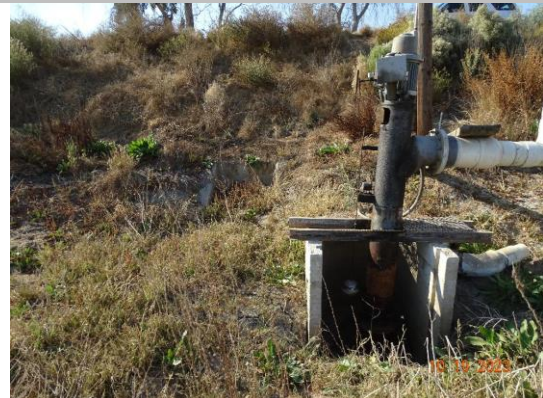
Photo 2 of 3 : UCIP\_FA\_2023\_81477\_117866.jpg

LS view: Concrete headwall and pipe inlet at toe (left); groundwater pump and concrete drop structure approximately 10 feet off toe (right).

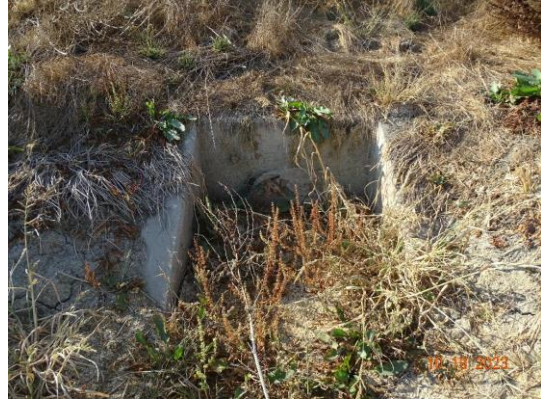
Photo 3 of 3 : UCIP\_FA\_2023\_81477\_117867.jpg

LS view: Close-up view of concrete headwall and pipe inlet on toe.

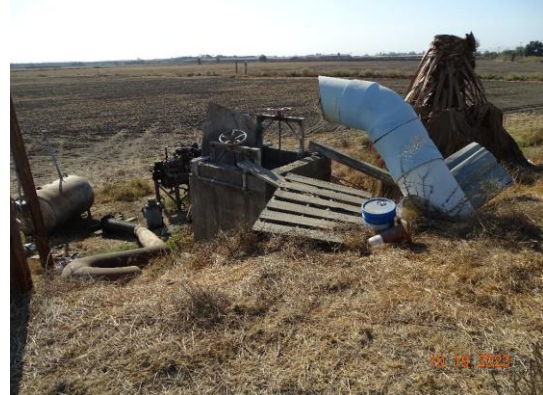
Photo 1 of 2 : UCIP\_FA\_2023\_81501\_117898.jpg

Comment Code					
Inspector Comment					
DS_ID:24680 FS_ID:81501 EP_NO: N/A Repair Type: Non-Urgent EVAL Issue: 4b, Safety Issue Crossing Status: Found UCIP Comments: 10/19/2023 Record remains Non-Urgent. Unable to find a permit for modification. New 21-inch PVC pipe seems to be added at this levee section using old appurtenances associated with DSID 20566. Debris present in CMP riser on WS and does not appear to be in use; recommend owner contact CVFPB to authorize modifications and abandon appurtenances no longer in use. No cover was present on concrete distribution box and CMP riser causing a safety hazard; recommend adding a cover to both. (M. Thao - DWR UCIP) 03/12/2019 No permit was found authorizing modifications to existing crossing. New crossing was added at this levee section using the old appurtenances associated with USACE O&M Legacy system Pipe (dsid 20566). The pipe associated with dsid 20566 has been grouted through (see dsid 20566 detail report). Irrigation pipe is functional and pipe is being maintained. Unable to confirm if riser located on WS is being used with this crossing. Need to coordinate with CVFPB to determine owner and if permit was issued for the modifications of this crossing. (O. Magana - DWR UCIP) 09/24/2013 No permit identified for this crossing. (W. Wylie - DWR UCIP) FIELD_STRUCT_DESC: 21-inch polyvinyl chloride (PVC) irrigation pipe through the levee, at an unknown depth. Pipe discharges into a concrete distribution box on the landside (LS) toe. Pump on pier off the waterside (WS) toe. [Additional Reference(s): DWR Levee Log, 2005]. FS Date: 10/19/2023 4:24:54 PM

LS view: General overview looking from crown; concrete distribution box and 21-inch PVC irrigation pipe on slope.

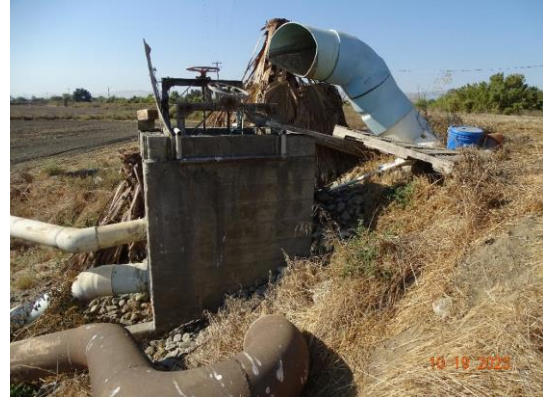
Photo 2 of 2 : UCIP\_FA\_2023\_81501\_117899.jpg

LS view: Different angle of concrete distribution box and 21-inch PVC irrigation pipe on slope; looking in upstream direction.

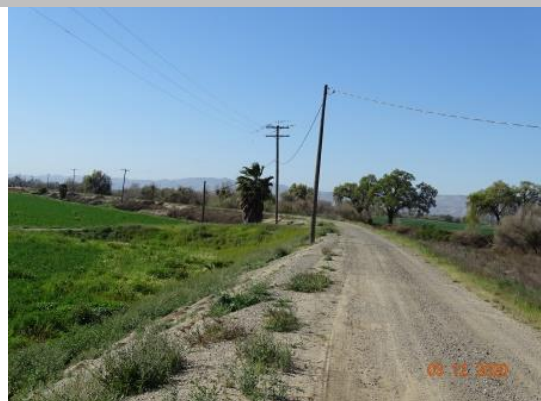
Photo 1 of 1 : FA\_2023\_RD2092\_116\_20\_20230905\_00004.jpg

LM Start	2.37	Rating **	M	Issue No.	20
LM End	2.37	Issue Type +	En	Location *	LS
Category	Earthen Levee			GPS Latitude/Longitude	
				Start	End
Item	Encroachments			37.580821°	37.580821°
				-121.156468°	-121.156468°
DWR ID	DWR_RD2092_01_f_2014_20				
Comment Code					
PO : Pole					
Inspector Comment

View of the pole on the landside slope of the levee looking upstream. (Spring 2020)

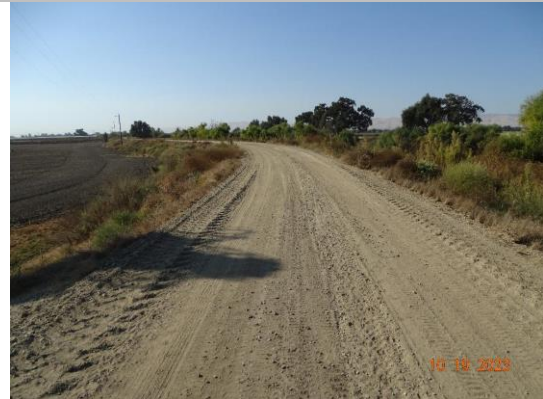
Photo 1 of 3 : UCIP\_FA\_2023\_81503\_117957.jpg

Comment Code						
Inspector Comment						
DS_ID:20567 FS_ID:81503 EP_NO: N/A Repair Type: Non-Urgent EVAL Issue: Crossing Status: Found UCIP Comments: 10/19/2023 Record remains Non-Urgent. Concrete head on LS may be buried; therefore, unable to locate concrete headwall. Concrete headwall on WS approximately 100 feet off toe was found; however, dense vegetation prevented inspection of the flap gate. Top of pipe leading to headwall is visible within the floodway. If crossing is no longer in use, recommend owner contact CVFPB to abandon pipe properly. (M. Thao - DWR UCIP) 03/12/2019 Unable to locate concrete headwall on the WS due to high water. Unable to locate concrete headwall on LS due to dense vegetation. No permit was found authorizing crossing. If crossing is no longer in use recommend removing crossing and appurtenances from levee. Need to coordinate with CVFPB to determine pipe owner. (O. Magana - DWR UCIP) 09/24/2013 Appears abandoned and if so should be done so properly. (W. Wylie - DWR UCIP) FIELD_STRUCT_DESC: *ABANDONED* 24-inch corrugated metal drainage pipe through the levee, 15 feet below the crown. Flap gate on the waterside (WS) end. Concrete U-shaped headwall on the WS end. Concrete headwall on the landside (LS) toe next to pump. [Additional Reference(s): DWR Levee Log, 2005. USACE San Joaquin O&M Manual 5, August 1961, (HLM 2.44)]. FS Date: 10/19/2023 8:57:18 AM

Levee crown looking upstream.

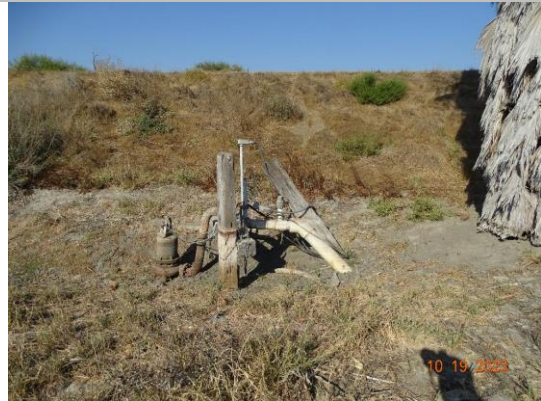
Photo 3 of 3 : UCIP\_FA\_2023\_81503\_117959.jpg

LS view: Looking toward levee; no concrete headwall found. Pipe appurtenances associated with a different record (DSID 20568).

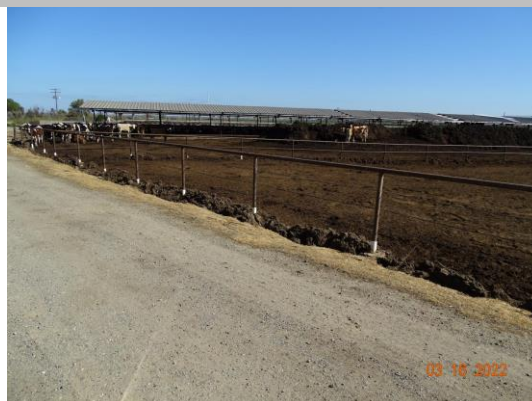
Photo 1 of 1 : FA\_2023\_RD2092\_116\_27\_20230905\_00006.jpg

LM Start	2.77	Rating **	M	Issue No.	27
LM End	2.77	Issue Type +	En	Location *	LS
Category	Earthen Levee			GPS Latitude/Longitude	
				Start	End
Item	Encroachments			37.575182°	37.575182°
				-121.157007°	-121.157007°
DWR ID	DWR_RD2092_01_f_2017_27				
Comment Code					
FE : Fence					
Inspector Comment

View of a fence on the landside toe of the levee looking downstream (Spring 2022).

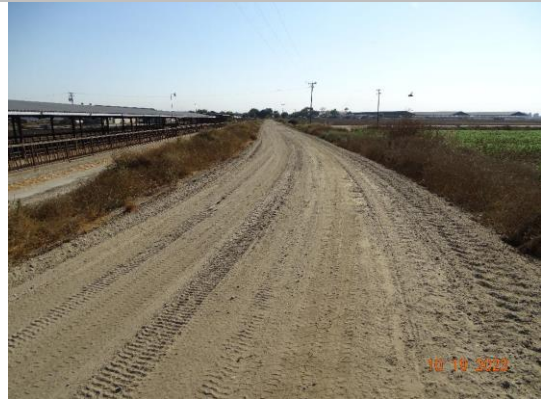
Photo 1 of 3 : UCIP\_FA\_2023\_81479\_117873.jpg

Levee crown looking upstream.

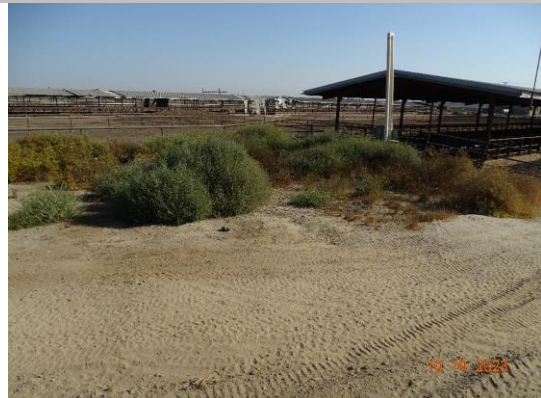
Photo 2 of 3 : UCIP\_FA\_2023\_81479\_117872.jpg

LS view: General overview looking from crown.

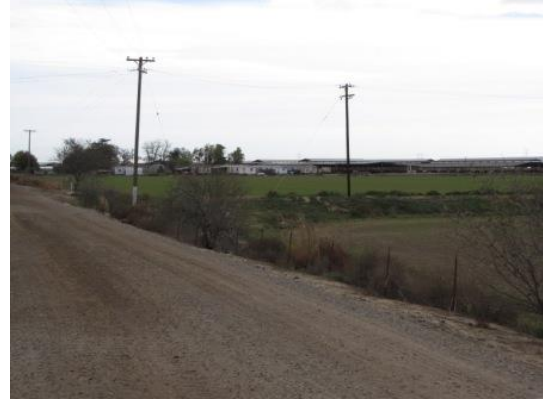
Photo 1 of 1 : FA\_2023\_RD2092\_116\_972\_20230905\_00035.jpg

LM Start	2.79	Rating **	M	Issue No.	972
LM End	3.05	Issue Type +	En	Location *	WS
Category	Earthen Levee			GPS Latitude/Longitude	
				Start	End
Item	Encroachments			37.574973°	37.574001°
				-121.156647°	-121.152183°
DWR ID	DWR_RD2092_01_f _ 2018_972				
Comment Code					
FE : Fence					
Inspector Comment					
Barbed wire fence on waterside toe of the levee.

View of barbed wire fence along the waterward slope looking upstream.

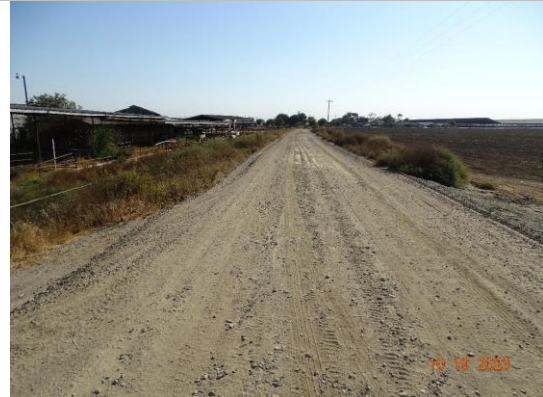
Photo 1 of 3 : UCIP\_FA\_2023\_81480\_117876.jpg

Levee crown looking upstream.

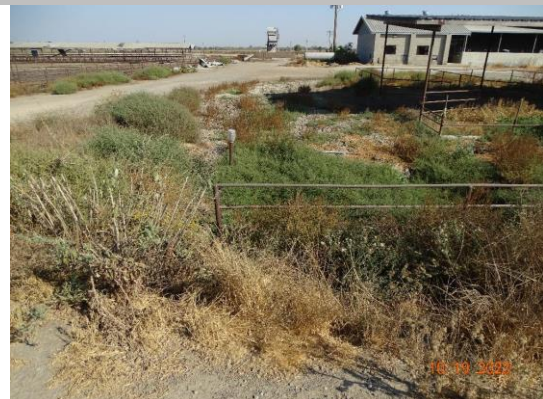
Photo 2 of 3 : UCIP\_FA\_2023\_81480\_117877.jpg

LS view: General overview looking from crown.

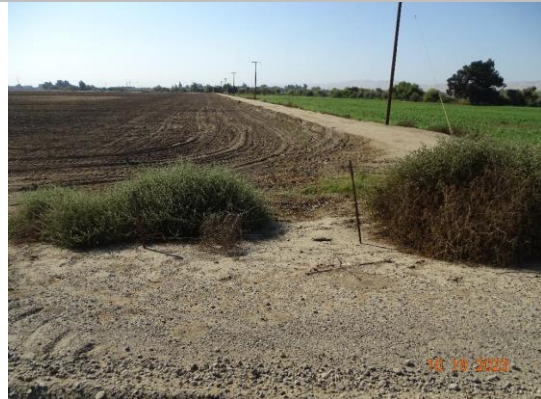
Photo 3 of 3 : UCIP\_FA\_2023\_81480\_117875.jpg

WS view: General overview looking from crown.
