**Flood Control Project Maintenance
Levee Inspections**

Fall 2016 Levee Maintenance Deficiency Summary Report

**Flood Control Project Maintenance
Levee Inspections**
LMA District Cover Sheet
Fall 2016 Levee Inspection Results

Reclamation District No. 2098 Cache and Haas Slough

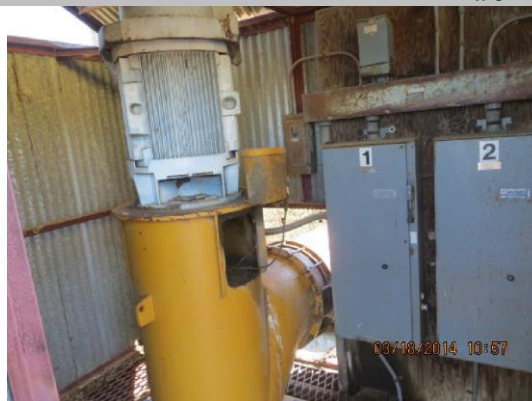
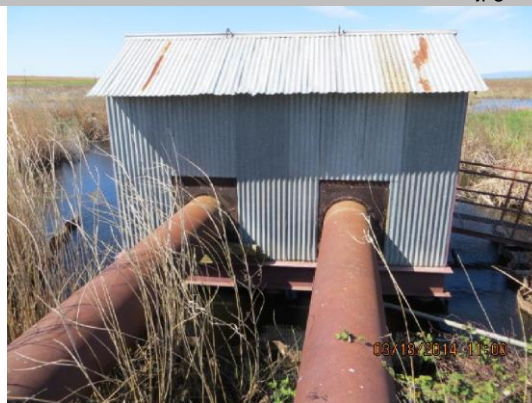
Photo 1 of 2 : UCIP_FA_2016_41717_58704.jpg

LM Start	3.50	Rating **	M	Issue No.	20 (cont)
LM End	3.50	Issue Type +	En	Location *	WS

Pump in pumphouse on LS toe.

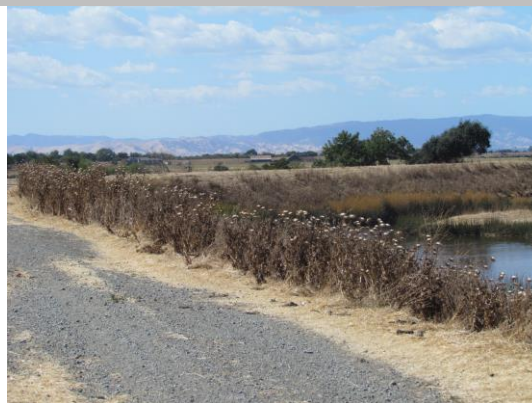
Photo 1 of 1 : FA_2016_RD2098_246_19_20161102_00023.jpg

LM Start	7.07	Rating **	U	Issue No.	19
LM End	7.17	Issue Type +	Ma	Location *	LS
Category	Earthen Levee			GPS Latitude/Longitude	
				Start	End
Item	Vegetation			38.292993 °	38.292992 °
				-121.722033 °	-121.723917 °
DWR ID	DWR_RD2098_02_f_2016_19				
Comment Code					
V2 : Remove the wild growth other than native grasses from the levee slopes.					
Inspector Comment					
Remove the tall milk weed from the landside slope and shoulder.

RD 2098 Unit 2 levee mile 7.07-7.17 landside shoulder and slope looking downstream.

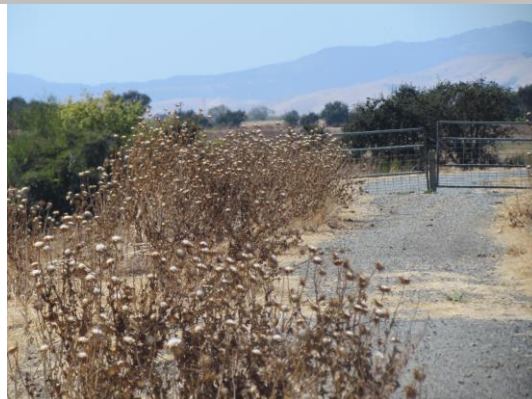
Photo 1 of 1 : FA_2016_RD2098_246_20_20161102_00024.jpg

LM Start	7.07	Rating **	U	Issue No.	20
LM End	7.17	Issue Type +	Ma	Location *	WS
Category	Earthen Levee			GPS Latitude/Longitude	
				Start	End
Item	Vegetation			38.292993 °	38.292990 °
				-121.722077 °	-121.723920 °
DWR ID	DWR_RD2098_02_f_2016_20				
Comment Code					
V2 : Remove the wild growth other than native grasses from the levee slopes.					
Inspector Comment					
Tall milk weed needs removing from waterside slope and shoulders.

RD 2098 Unit 2 looking downstream waterside shoulder and slope levee mile 7.07-7.17.

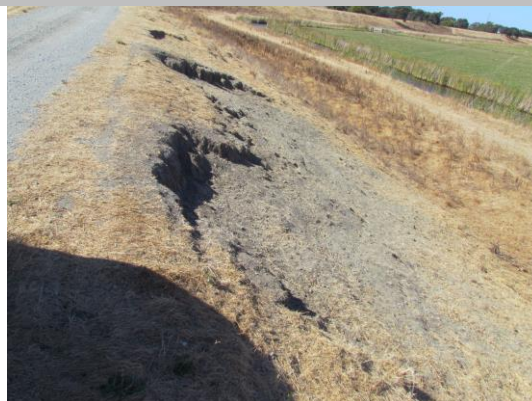
Photo 1 of 3 : FA_2016_RD2098_247_1_20161102_00008.jpg

LM Start	7.51	Rating **	U	Issue No.	1 (cont)
LM End	7.51	Issue Type +	Ma	Location *	LS

RD 2098 Unit 3 levee mile 7.51 landside slope.

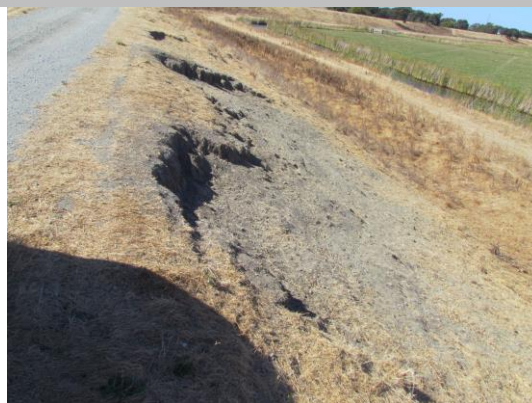
Photo 2 of 3 : FA_2016_RD2098_247_1_20161102_00009.jpg

Close up. Looking downstream.

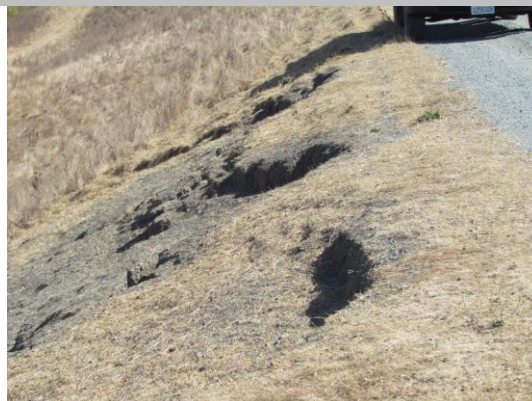
Photo 3 of 3 : FA_2016_RD2098_247_1_20161102_00010.jpg

Looking upstream.

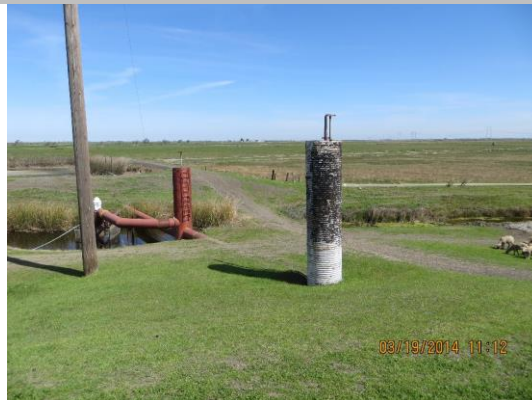
Photo 2 of 2 : UCIP_FA_2016_33785_61165.jpg

48-inch CMP riser with pump on metal pier visible at LS toe.

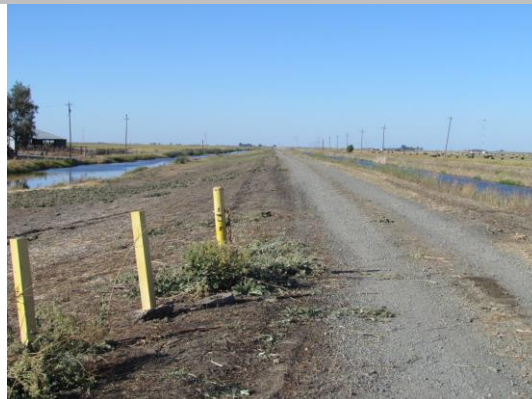
Photo 1 of 1 : FA_2016_RD2098_248_10_20161102_00018.jpg

LM Start	9.13	Rating **	A	Issue No.	10
LM End	12.05	Issue Type +	Ma	Location *	LS
Category	Earthen Levee			GPS Latitude/Longitude	
				Start	End
Item	Vegetation			38.315820 °	38.357841 °
				-121.739982 °	-121.740400 °
DWR ID	DWR_RD2098_04_f_2016_10				
Comment Code					
V1 : Control annual grass and weeds on the levee slopes and easements.					
Inspector Comment

RD 2098 Unit 4 levee mile 9.13 looking downstream.

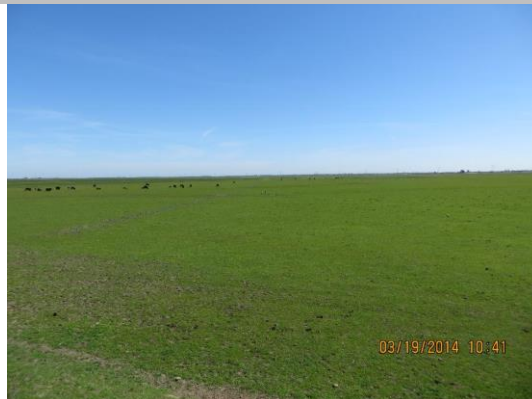
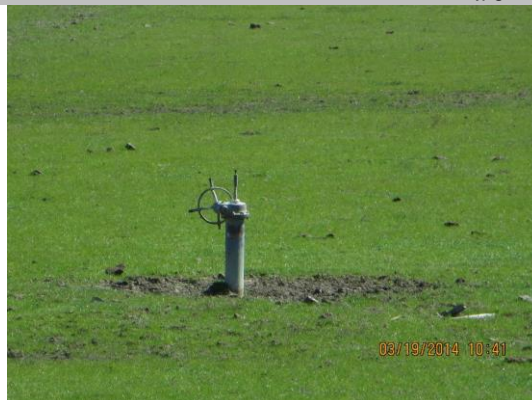
Photo 1 of 2 : UCIP_FA_2016_32383_58881.jpg

LM Start	9.49	Rating **	M	Issue No.	16 (cont)
LM End	9.49	Issue Type +	En	Location *	WS

Shutoff valve visible 370-feet off LS toe.

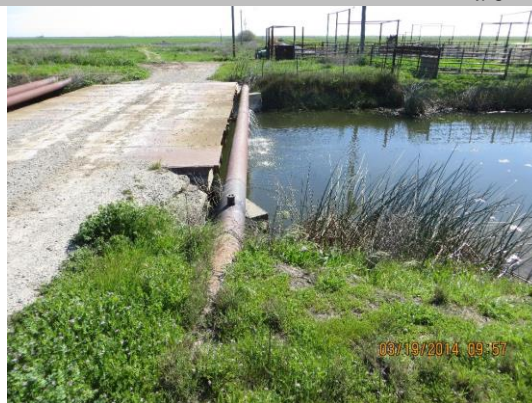
Photo 1 of 2 : UCIP_FA_2016_32403_58905.jpg

LM Start	11.07	Rating **	M	Issue No.	17
LM End	11.07	Issue Type +	En	Location *	WS
Category	Supplemental			GPS Latitude/Longitude	
				Start	End
Item	DWR UCIP Field Study			38.343608 °	38.343608 °
				-121.740836 °	-121.740836 °
DWR ID					
Comment Code					
Inspector Comment					
FS_ID:32403 DS_ID:20991 EP_NO: 12851 Repair Type: Non-Urgent Crossing Status: Found UCIP Comments: Holes in pipe next to rail car bridge may indicate further deterioration of pipe through levee. Good candidate for video inspection. FIELD_STRUCT_DESC: 12-inch steel irrigation pipe through the levee, 2-feet below the crown. Cutoff wall around pipe at center of levee. Siphon breaker on Landside toe at canal. 1-inch PVC electrical conduit at same location (Permit No. 12851-1980) FS Date: 3/19/2014

Pipe and siphon breaker visible on LS at canal crossing.

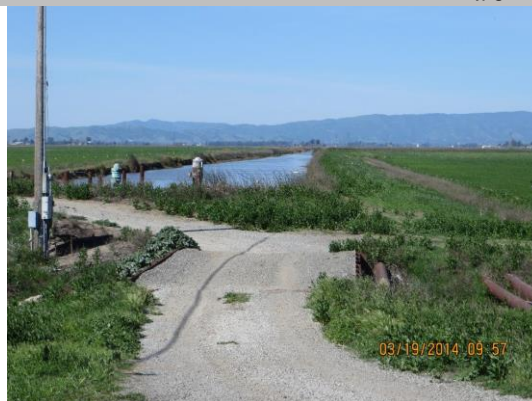
Photo 2 of 2 : UCIP_FA_2016_32403_58904.jpg

LM Start	11.07	Rating **	M	Issue No.	17 (cont)
LM End	11.07	Issue Type +	En	Location *	WS
Category	Supplemental			GPS Latitude/Longitude	
				Start	End
Item	DWR UCIP Field Study			38.343608 °	38.343608 °
				-121.740836 °	-121.740836 °
DWR ID					
Comment Code					
Inspector Comment					
FS_ID:32403 DS_ID:20991 EP_NO: 12851 Repair Type: Non-Urgent Crossing Status: Found UCIP Comments: Holes in pipe next to rail car bridge may indicate further deterioration of pipe through leve. Good candidate for video inspection. FIELD_STRUCT_DESC: 12-inch steel irrigation pipe through the levee, 2-feet below the crown. Cutoff wall around pipe at center of levee. Siphon breaker on Landside toe at canal. 1-inch PVC electrical conduit at same location (Permit No. 12851-1980) FS Date: 3/19/2014

Pump on pier in irrigation canal off WS toe.

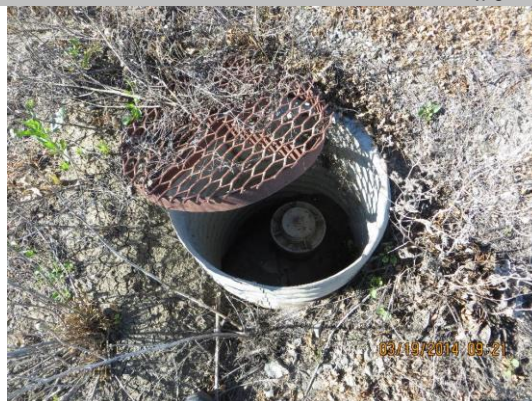
Photo 1 of 2 : UCIP_FA_2016_32327_58822.jpg

LM Start	12.05	Rating **	M	Issue No.	14 (cont)
LM End	12.05	Issue Type +	En	Location *	WS

Siphon breaker in CMP riser on LS shoulder.

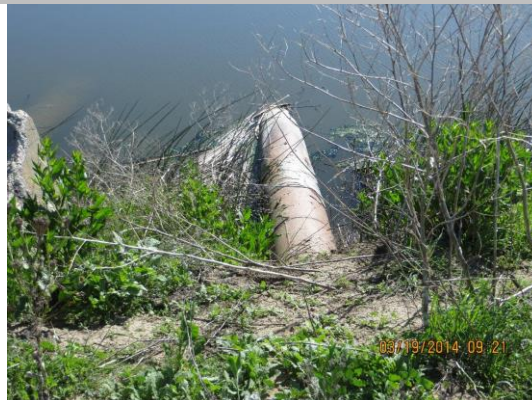
Photo 2 of 2 : UCIP_FA_2016_32327_58821.jpg

Pipe at canal on LS toe.

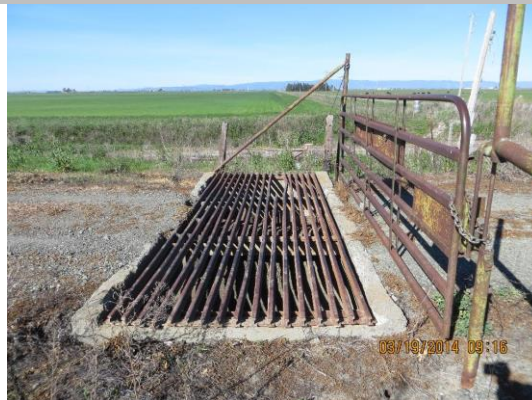
Photo 2 of 2 : UCIP_FA_2016_32326_58816.jpg

LM Start	12.05	Rating **	U	Issue No.	13 (cont)
LM End	12.05	Issue Type +	En	Location *	WS

Concrete cattle guard box over pipes at crown.

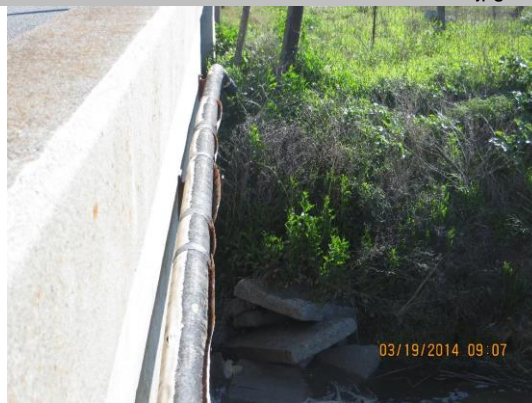
Photo 1 of 2 : UCIP_FA_2016_32566_59110.jpg

LM Start	12.07	Rating **	M	Issue No.	15
LM End	12.07	Issue Type +	En	Location *	WS
Category	Supplemental			GPS Latitude/Longitude	
				Start	End
Item	DWR UCIP Field Study			38.358110 °	38.358110 °
				-121.740381 °	-121.740381 °
DWR ID					
Comment Code					
Inspector Comment					
FS_ID:32566					
DS_ID:24845					
EP_NO: N/A					
Repair Type: Non-Urgent					
Crossing Status: Found					
UCIP Comments: Need to verify status with gas company and install signs. No permit identified for crossing, though it may be connected to a permitted line installed in RD 2068 under Permit No. 13490.					
FIELD_STRUCT_DESC: 6-inch steel gasoline through the levee 3-feet below the crown. Signs on East side of levee. Pipe visible on downstream side of roadway bridge.					
FS Date: 3/19/2014

Pipe visible on South side of Bridge at Swan Road.
