**Flood Control Project Maintenance
Levee Inspections**

Fall 2017 Levee Maintenance Deficiency Summary Report

Sacramento River Basin

RD2098	Overall LMA Rating	Total LMA Miles						
Reclamation District No. 2098 Cache and Haas Slough	U	10.91						
Rated Item	Maintenance Deficiency				Enforcement		Design & System Obsolescence	
	M Miles	U Miles	M + 4U Miles	Threshold %	M Miles	U Miles	M Miles	U Miles
<i>Earthen Levee</i>								
Vegetation	4.41		4.41	40.44%				
Trim / Thin Trees	0.01		0.01	0.09%				
Encroachments	0.02		0.02	0.18%	0.01			
Slope Stability	0.02		0.02	0.18%				
Erosion / Bank Caving	0.50		0.50	4.59%				
Cracking		0.01	0.04	0.37%				
Crown Surface / Depressions / Rutting	0.86		0.86	7.89%				
Repair Gates	0.02		0.02	0.18%				
<i>Supplemental</i>								
2015 USACE Erosion Survey, DRAFT	0.39		0.39	3.58%				
DWR UCIP Field Study					0.13	0.04		
DWR UCIP LMA Responsibility								
2017 Storm Damage	0.21		0.21	1.93%				
<i>LMA Totals:</i>	6.44	0.01	6.48	59.42%	0.14	0.04	0.00	0.00

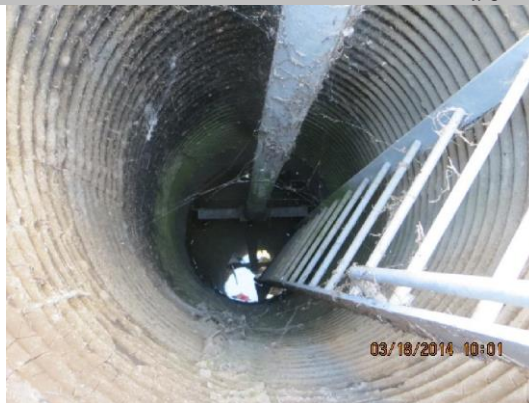
Photo 2 of 3 : UCIP_FA_2017_32207_58664.jpg

Comment Code						
Inspector Comment						
FS_ID:32207						
DS_ID:20966						
EP_NO: 10168						
Repair Type: Non-Urgent						
Crossing Status: Found						
UCIP Comments: Slide gate actuator bent but appears to be in closed position. No lid on standpipe. Appears abandoned and if so should be done so properly.						
FIELD_STRUCT_DESC: 24-inch irrigation pipe of an unknown material through the levee, 24.5 feet below the crown. Two corrugated metal cutoff walls around the pipe at the center of the levee. Slide gate in a 36-inch corrugated metal pipe (CMP) riser on the waterside (WS) slope. Concrete saddle and apron on the WS end. Flap gate and U-shaped headwall on the landside (LS) end. (This pipe was retained under Automatic Board Order (ABO) issued as Permit No. 10168, 1974 - Moresco Brothers). [Additional Reference(s): DWR Levee Log, 2003].						
FS Date: 3/18/2014

No lid on CMP riser that is 24-feet deep.

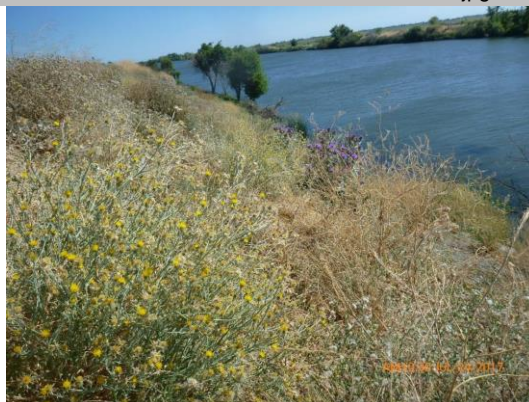
Photo 2 of 3 : LEVAL_FA_2017_417_2734.jpg

LM Start	2.22	Rating **	A/W	Issue No.	24 (cont)
LM End	2.23	Issue Type +	Ma	Location *	
Category	Supplemental			GPS Latitude/Longitude	
				Start	End
Item	2017 Storm Damage			38.296900 °	38.296800 °
				-121.693400 °	-121.693400 °
DWR ID	DWR_RD2098_01_f _ 2017_24				
Comment Code					
Inspector Comment					
Levee Evaluation Comments					
Description:The damage consists of scour and sloughing of the lower waterside levee slope.					
Site ID No:417					
Site Designation:LMA-244					
Repair Type: Erosion					
Rating:Area of Concern					
Field Date:7/24/2017					
Notes: Minor toe erosion around base of tree

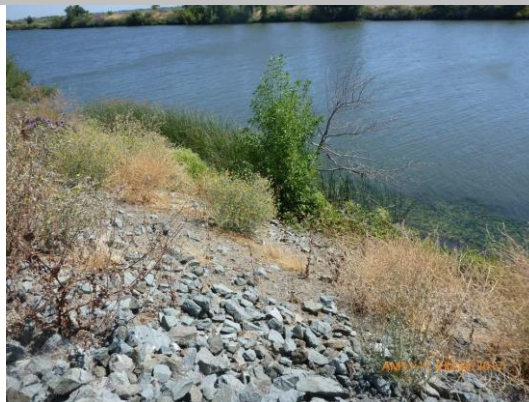
Photo 3 of 3 : LEVAL_FA_2017_418_3053.jpg

LM Start	2.25	Rating **	A/W	Issue No.	25 (cont)
LM End	2.25	Issue Type +	Ma	Location *	
Category	Supplemental			GPS Latitude/Longitude	
				Start	End
Item	2017 Storm Damage			38.296500 °	38.296500 °
				-121.693400 °	-121.693500 °
DWR ID	DWR_RD2098_01_f_2017_25				
Comment Code					
Inspector Comment					
Levee Evaluation Comments					
Description:The damage consists of scour and sloughing of the lower waterside levee slope.					
Site ID No:418					
Site Designation:LMA-245					
Repair Type: Erosion					
Rating:Critical					
Field Date:7/24/2017					
Notes: LMA 245 and LMA 246 have merged together. Erosion with sloughing on the upper slope. 10/26/17: Dutra repairs in progress.

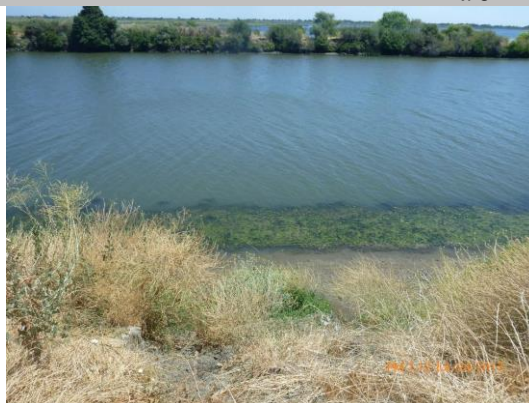
Photo 1 of 3 : LEVAL_FA_2017_423_3614.jpg

LM Start	2.35	Rating **	M	Issue No.	28
LM End	2.39	Issue Type +	Ma	Location *	
Category	Supplemental			GPS Latitude/Longitude	
				Start	End
Item	2017 Storm Damage			38.295100 °	38.294500 °
				-121.693400 °	-121.693400 °
DWR ID	DWR_RD2098_01_f _ 2017_28				
Comment Code					
Inspector Comment					
Levee Evaluation Comments					
Description:The damage consists of scour, sloughing, and cracking of the lower and mid waterside levee slope.					
Site ID No:423					
Site Designation:LMA-250					
Repair Type: Erosion					
Rating:Area of Concern					
Field Date:7/24/2017					
Notes: 2' of sloughing about half way up the slope.

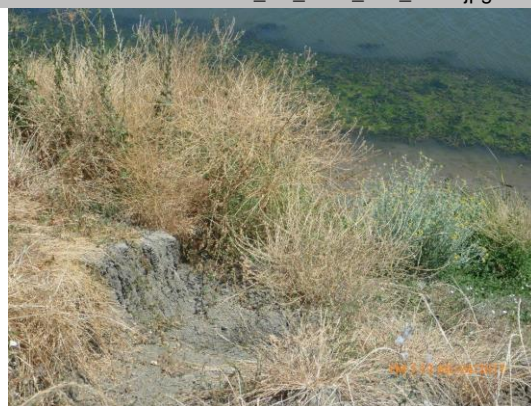
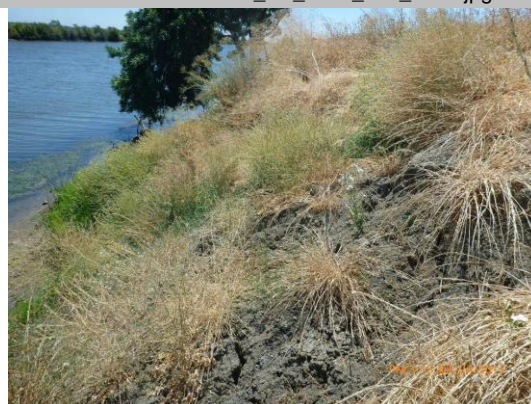
LM Start	2.35	Rating **	M	Issue No.	28 (cont)	
LM End	2.39	Issue Type +	Ma	Location *		
Category	Supplemental			GPS Latitude/Longitude		
				Start	End	
Item	2017 Storm Damage			38.295100 °	38.294500 °	
				-121.693400 °	-121.693400 °	
DWR ID	DWR_RD2098_01_f_2017_28					
Comment Code						
Inspector Comment						
Levee Evaluation Comments						
Description:The damage consists of scour, sloughing, and cracking of the lower and mid waterside levee slope.						
Site ID No:423						
Site Designation:LMA-250						
Repair Type: Erosion						
Rating:Area of Concern						
Field Date:7/24/2017						
Notes: 2' of sloughing about half way up the slope.

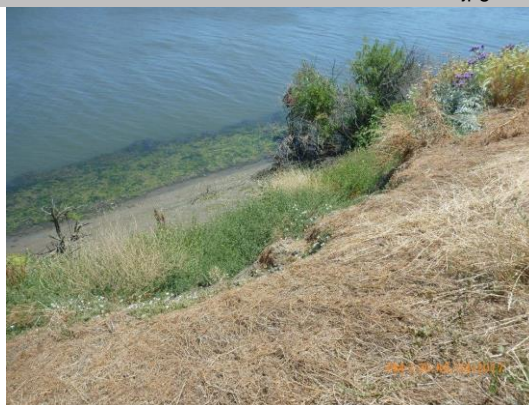
Photo 1 of 3 : LEVAL_FA_2017_425_3638.jpg

LM Start	2.50	Rating **	A/W	Issue No.	30
LM End	2.53	Issue Type +	Ma	Location *	
Category	Supplemental		GPS Latitude/Longitude		
			Start	End	
Item	2017 Storm Damage		38.292900 °	38.292500 °	
			-121.693500 °	-121.693500 °	
DWR ID	DWR_RD2098_01_f_2017_30				
Comment Code					
Inspector Comment					
Levee Evaluation Comments Description: The damage consists of scour and sloughing of the waterside levee slope. Site ID No: 425 Site Designation: LMA-252 Repair Type: Erosion Rating: Critical Field Date: 7/24/2017 Notes: Toe erosion has caused mid to upper slope sloughing. 10/26/17: Dutra repairs in progress.

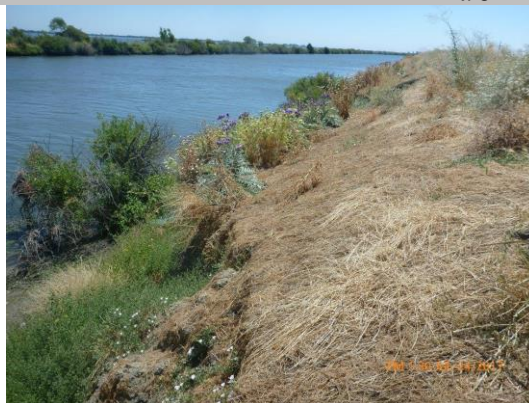
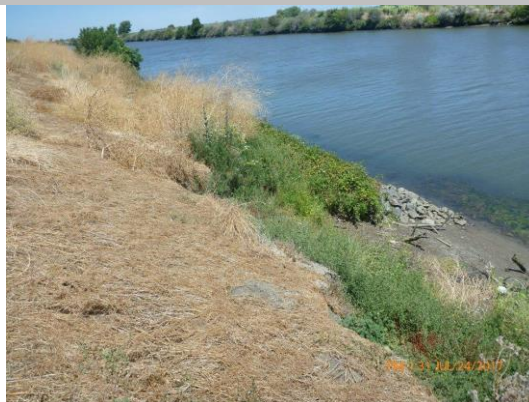
LM Start	2.50	Rating **	A/W	Issue No.	30 (cont)
LM End	2.53	Issue Type +	Ma	Location *	
Category	Supplemental			GPS Latitude/Longitude	
				Start	End
Item	2017 Storm Damage			38.292900 °	38.292500 °
				-121.693500 °	-121.693500 °
DWR ID	DWR_RD2098_01_f_2017_30				
Comment Code					
Inspector Comment					
Levee Evaluation Comments					
Description:The damage consists of scour and sloughing of the waterside levee slope.					
Site ID No:425					
Site Designation:LMA-252					
Repair Type: Erosion					
Rating:Critical					
Field Date:7/24/2017					
Notes: Toe erosion has caused mid to upper slope sloughing.					
10/26/17: Dutra repairs in progress.

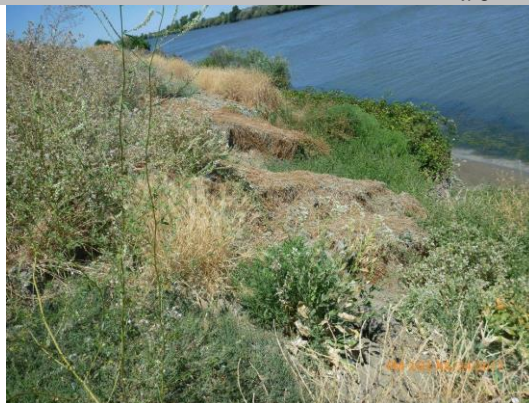
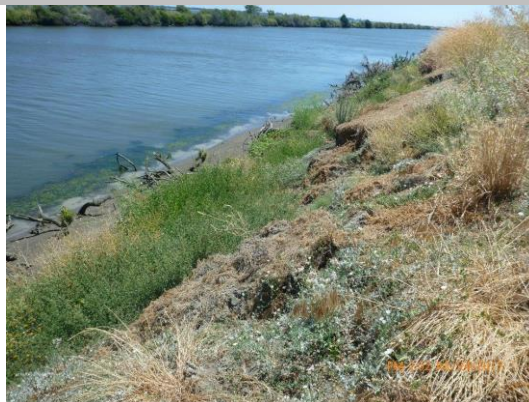
LM Start	2.54	Rating **	A/W	Issue No.	31
LM End	2.56	Issue Type +	Ma	Location *	
Category	Supplemental			GPS Latitude/Longitude	
				Start	End
Item	2017 Storm Damage			38.292300°	38.292000°
				-121.693400°	-121.693500°
DWR ID	DWR_RD2098_01_f_2017_31				
Comment Code					
Inspector Comment					
Levee Evaluation Comments					
Description:The damage consists of scour and sloughing of the waterside levee slope.					
Site ID No:426					
Site Designation:LMA-253					
Repair Type: Erosion					
Rating:Critical					
Field Date:7/24/2017					
Notes: Toe of slope has eroded away causing slumping of slope.					
10/26/17: Dutra repairs in progress.

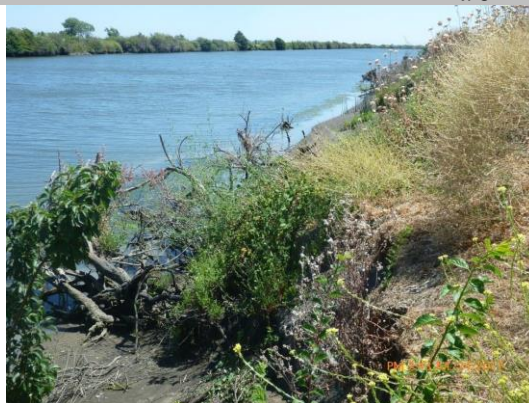
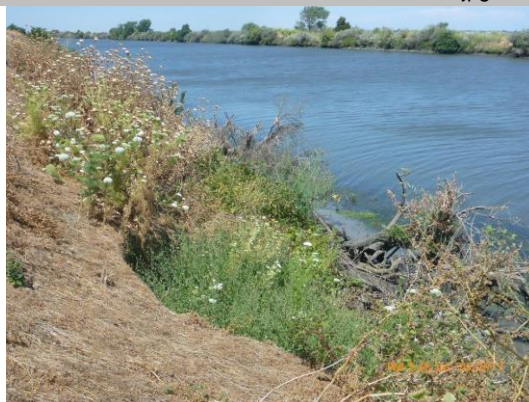
LM Start	2.57	Rating **	A/W	Issue No.	32 (cont)
LM End	2.59	Issue Type +	Ma	Location *	
Category	Supplemental			GPS Latitude/Longitude	
				Start	End
Item	2017 Storm Damage			38.291900 °	38.291600 °
				-121.693500 °	-121.693500 °
DWR ID	DWR_RD2098_01_f_2017_32				
Comment Code					
Inspector Comment					
Levee Evaluation Comments					
Description:The damage consists of scour and sloughing of the lower waterside levee slope.					
Site ID No:427					
Site Designation:LMA-254					
Repair Type: Erosion					
Rating:Critical					
Field Date:7/24/2017					
Notes: 8' vertical cut along 125'. 10/26/17: Dutra repairs in progress.

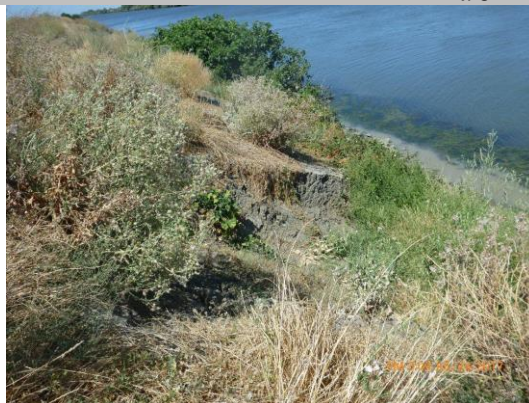
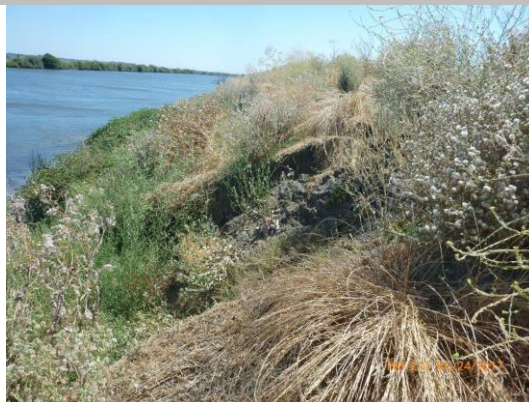
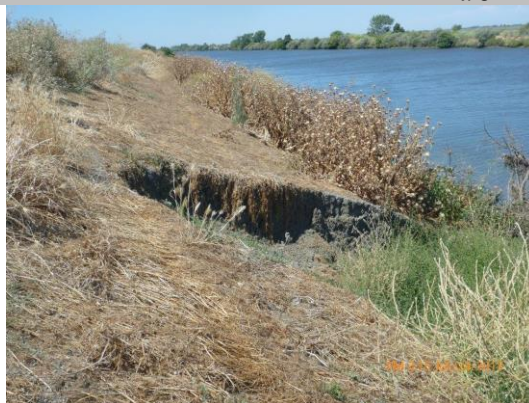
LM Start	2.59	Rating **	A/W	Issue No.	33
LM End	2.69	Issue Type +	Ma	Location *	
Category	Supplemental			GPS Latitude/Longitude	
				Start	End
Item	2017 Storm Damage			38.291600 °	38.290100 °
				-121.693500 °	-121.693500 °
DWR ID	DWR_RD2098_01_f_2017_33				
Comment Code					
Inspector Comment					
Levee Evaluation Comments					
Description:The damage consists of scour and sloughing of the waterside levee slope.					
Site ID No:428					
Site Designation:LMA-255					
Repair Type: Erosion					
Rating:Critical					
Field Date:7/24/2017					
Notes: Toe erosion along all 540' with 6-8 foot vertical cut. 7 sloughing locations within the site are critical. 10/26/17: Dutra repairs in progress.

LM Start	2.59	Rating **	A/W	Issue No.	33 (cont)
LM End	2.69	Issue Type +	Ma	Location *	
Category	Supplemental			GPS Latitude/Longitude	
				Start	End
Item	2017 Storm Damage			38.291600 °	38.290100 °
				-121.693500 °	-121.693500 °
DWR ID	DWR_RD2098_01_f_2017_33				
Comment Code					
Inspector Comment					
Levee Evaluation Comments					
Description:The damage consists of scour and sloughing of the waterside levee slope.					
Site ID No:428					
Site Designation:LMA-255					
Repair Type: Erosion					
Rating:Critical					
Field Date:7/24/2017					
Notes: Toe erosion along all 540' with 6-8 foot vertical cut. 7 sloughing locations within the site are critical. 10/26/17: Dutra repairs in progress.

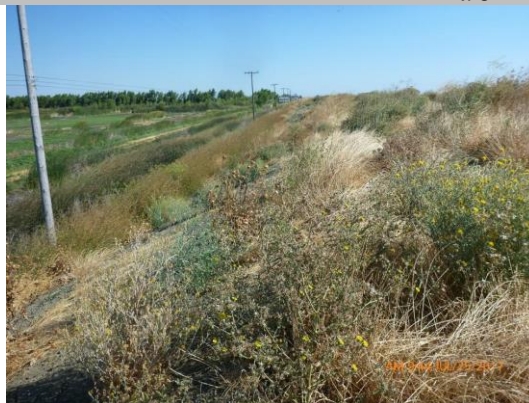
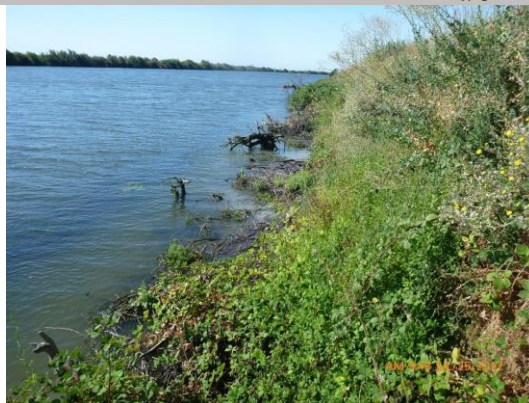
LM Start	2.78	Rating **	A/W	Issue No.	35
LM End	2.81	Issue Type +	Ma	Location *	
Category	Supplemental			GPS Latitude/Longitude	
				Start	End
Item	2017 Storm Damage			38.288800 °	38.288400 °
				-121.693500 °	-121.693500 °
DWR ID	DWR_RD2098_01_f_2017_35				
Comment Code					
Inspector Comment					
Levee Evaluation Comments					
Description:The damage consists of scour and sloughing of the waterside levee slope.					
Site ID No:430					
Site Designation:LMA-257					
Repair Type: Erosion					
Rating:Serious					
Field Date:7/25/2017					
Notes: Erosion at waterside toe, causing sloughing 2/3 down waterside slope.10/26/17: Dutra repairs in progress.

LM Start	2.78	Rating **	A/W	Issue No.	35 (cont)
LM End	2.81	Issue Type +	Ma	Location *	
Category	Supplemental			GPS Latitude/Longitude	
				Start	End
Item	2017 Storm Damage			38.288800 °	38.288400 °
				-121.693500 °	-121.693500 °
DWR ID	DWR_RD2098_01_f_2017_35				
Comment Code					
Inspector Comment					
Levee Evaluation Comments Description:The damage consists of scour and sloughing of the waterside levee slope. Site ID No:430 Site Designation:LMA-257 Repair Type: Erosion Rating:Serious Field Date:7/25/2017 Notes: Erosion at waterside toe, causing sloughing 2/3 down waterside slope.10/26/17: Dutra repairs in progress.

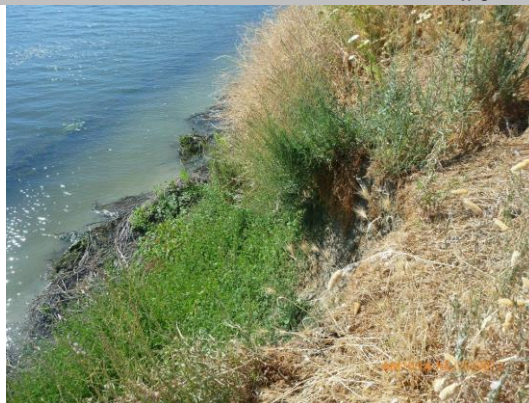
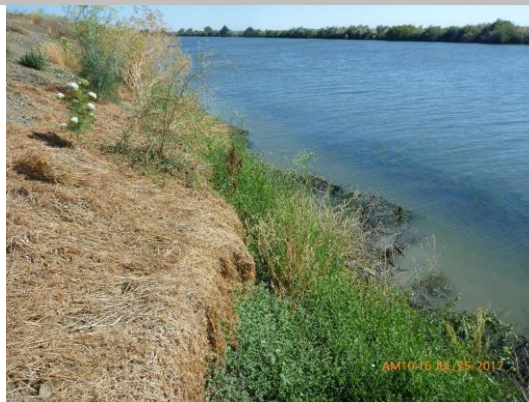
LM Start	2.99	Rating **	A/W	Issue No.	37
LM End	3.29	Issue Type +	Ma	Location *	
Category	Supplemental			GPS Latitude/Longitude	
				Start	End
Item	2017 Storm Damage			38.285700 °	38.281500 °
				-121.693500 °	-121.694300 °
DWR ID	DWR_RD2098_01_f_2017_37				
Comment Code					
Inspector Comment					
Levee Evaluation Comments					
Description:The damage consists of scour and sloughing of the waterside levee slope.					
Site ID No:432					
Site Designation:LMA-259					
Repair Type: Erosion					
Rating:Serious					
Field Date:7/25/2017					
Notes: Varying erosion and sloughing at WS toe. Revetment at end of levee section. 10/26/17: Dutra repairs in progress.

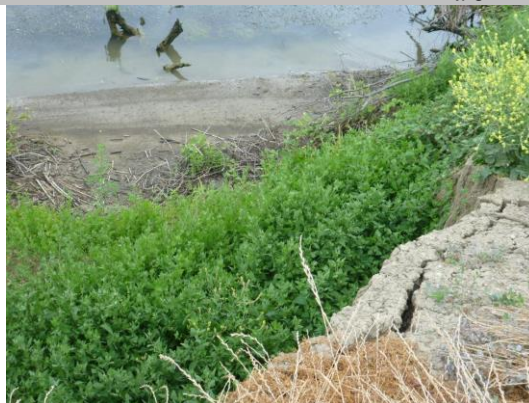
Photo 3 of 3 : LEVAL_FA_2017_115_619.jpg

LM Start	3.15	Rating **	M	Issue No.	38 (cont)	
LM End	3.15	Issue Type +	Ma	Location *		
Category	Supplemental			GPS Latitude/Longitude		
				Start		End
Item	2017 Storm Damage			38.283472 °		38.283472 °
				-121.693600 °		-121.693600 °
DWR ID	DWR_RD2098_01_f_2017_38					
Comment Code						
Inspector Comment						
Levee Evaluation Comments						
Description:						
Site ID No:115						
Site Designation:DWR_RD2098_01_s_2012_12						
Repair Type: Erosion						
Rating:Critical						
Field Date:6/9/2017						
Notes: noticable sloughing along Wsslope for entire levee reach						
10/26/17: Dutra has repaired erosion at 3.12-3.14.

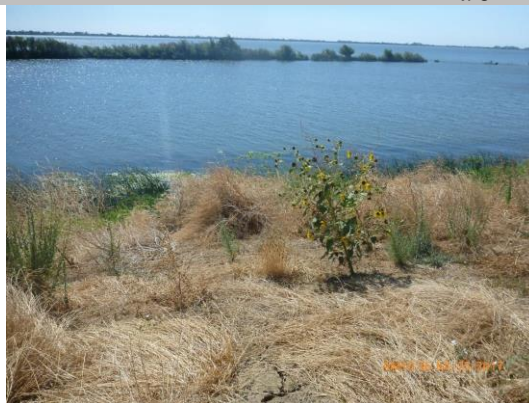
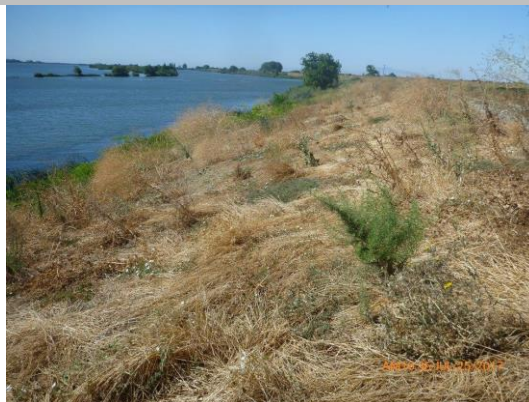
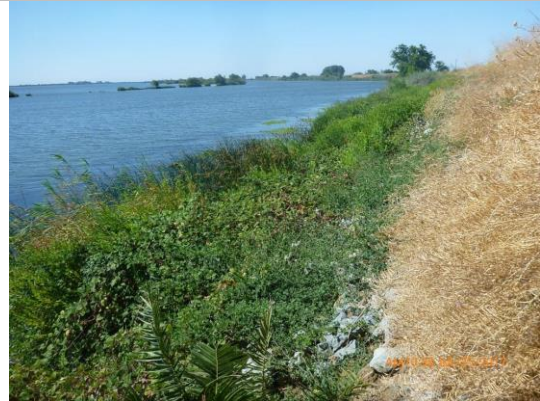
LM Start	3.31	Rating **	A/W	Issue No.	39
LM End	3.32	Issue Type +	Ma	Location *	
Category	Supplemental			GPS Latitude/Longitude	
				Start	End
Item	2017 Storm Damage			38.281200 °	38.281100 °
				-121.694500 °	-121.694600 °
DWR ID	DWR_RD2098_01_f_2017_39				
Comment Code					
Inspector Comment					
Levee Evaluation Comments					
Description:The damage consists of scour and sloughing of the lower waterside levee slope.					
Site ID No:433					
Site Designation:LMA-260					
Repair Type: Erosion					
Rating:Area of Concern					
Field Date:7/25/2017					
Notes: Two combined erosion sites (260 and 261) adjacent to each other at WS toe. Existing rip rap placed at area of concern.

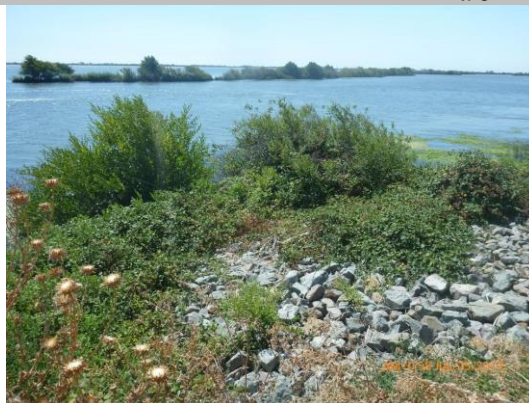
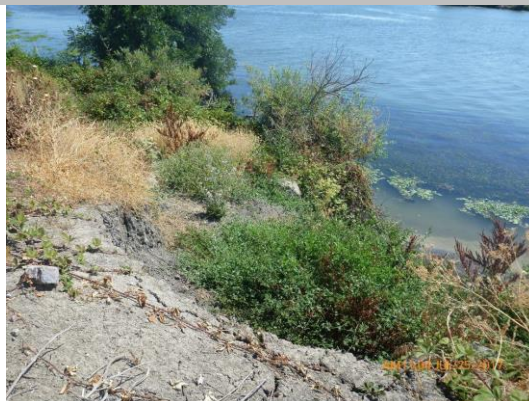
LM Start	3.50	Rating **	M	Issue No.	40 (cont)	
LM End	3.56	Issue Type +	Ma	Location *		
Category	Supplemental			GPS Latitude/Longitude		
				Start	End	
Item	2017 Storm Damage			38.278700 °	38.278000 °	
				-121.695900 °	-121.696100 °	
DWR ID	DWR_RD2098_01_f_2017_40					
Comment Code						
Inspector Comment						
Levee Evaluation Comments						
Description:The damage consists of scour and sloughing of the lower and mid waterside levee slope.						
Site ID No:435						
Site Designation:LMA-262						
Repair Type: Erosion						
Rating:Area of Concern						
Field Date:7/25/2017						
Notes: Two combined sloughing sites adjacent to each other on lower waterside slope. Existing rip rap on beginning 100' section of site 262. This site is combined with site 263.

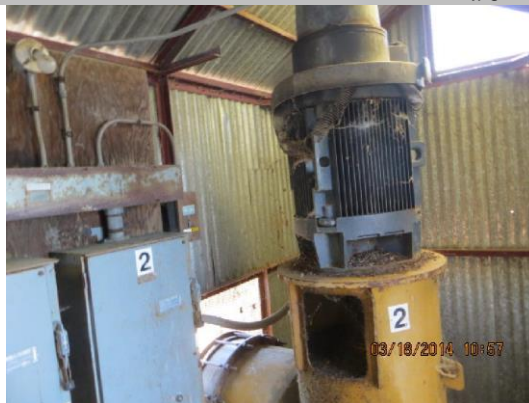
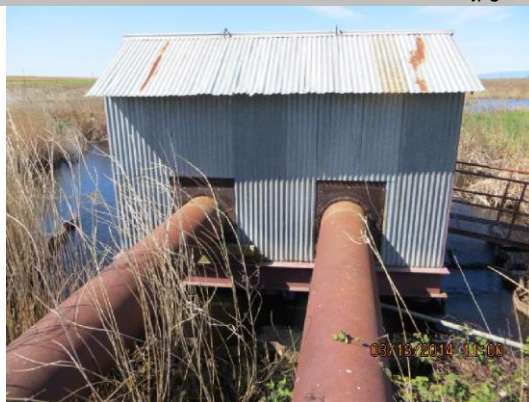
LM Start	3.50	Rating **	M	Issue No.	47
LM End	3.50	Issue Type +	En	Location *	
Category	Supplemental			GPS Latitude/Longitude	
				Start	End
Item	DWR UCIP Field Study			38.278759 °	38.278759 °
				-121.696059 °	-121.696059 °
DWR ID					
Comment Code					
Inspector Comment					
FS_ID:32245 DS_ID:20959 EP_NO: 15169 Repair Type: Non-Urgent Crossing Status: Found UCIP Comments: Soil and debris buildup in steel riser on WS shoulder may prevent proper function of siphon breaker. FIELD_STRUCT_DESC: 2 of 2: 24-inch coated steel irrigation pipe through the levee, 5.6 feet below the crown. Cutoff wall around the pipe at the center of the levee. Siphon breaker on the waterside (WS) shoulder. Flap gate on the WS end. Pump in pump house on piling structure on the landside (LS). (Permit No. 15169, 1989 - Maxim Development). [Additional Reference(s): DWR Levee Log, 2003]. FS Date: 3/18/2014

Pump in pumphouse on LS toe.

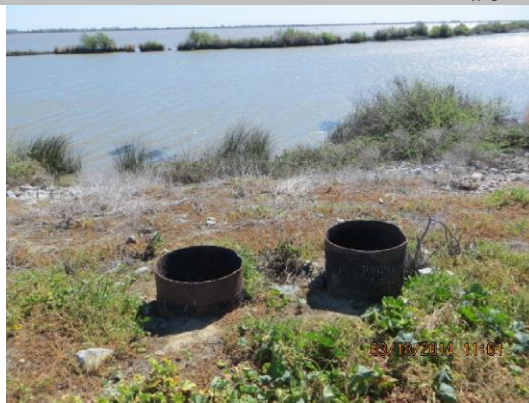
Comment Code						
Inspector Comment						
FS_ID:32245 DS_ID:20959 EP_NO: 15169 Repair Type: Non-Urgent Crossing Status: Found UCIP Comments: Soil and debris buildup in steel riser on WS shoulder may prevent proper function of siphon breaker. FIELD_STRUCT_DESC: 2 of 2: 24-inch coated steel irrigation pipe through the levee, 5.6 feet below the crown. Cutoff wall around the pipe at the center of the levee. Siphon breaker on the waterside (WS) shoulder. Flap gate on the WS end. Pump in pump house on piling structure on the landside (LS). (Permit No. 15169, 1989 - Maxim Development). [Additional Reference(s): DWR Levee Log, 2003]. FS Date: 3/18/2014

Siphon breaker in steel riser on WS shoulder.

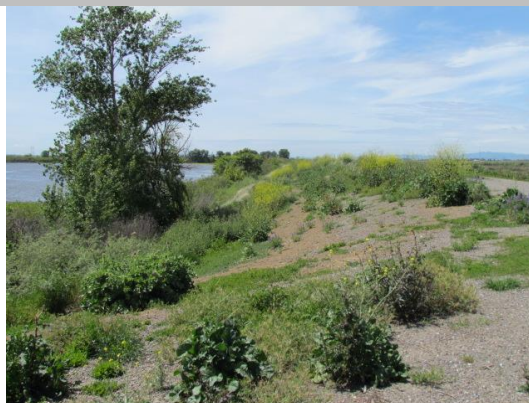
LM Start	0.00	Rating **	M	Issue No.	2
LM End	0.52	Issue Type +	Ma	Location *	WS
Category	Earthen Levee			GPS Latitude/Longitude	
				Start	End
Item	Vegetation			38.277382 °	38.275722 °
				-121.696270 °	-121.705675 °
DWR ID	DWR_RD2098_01A_s_2017_2				
Comment Code					
V2 : Remove the wild growth other than native grasses from the levee slopes.					
Inspector Comment					
Remove the wild grasses other than native from the levee section.

RD 2098 Unit 1A looking upstream from the waterside slope.

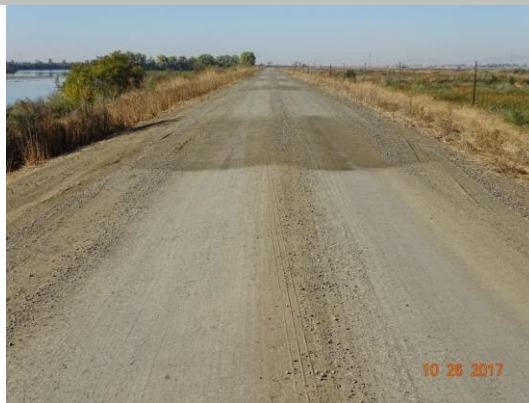
LM Start	0.45	Rating **	A/W	Issue No.	4
LM End	0.52	Issue Type +	Ma	Location *	CR
Category	Earthen Levee			GPS Latitude/Longitude	
				Start	End
Item	Crown Surface / Depressions / Rutting			38.275948 °	38.275722 °
				-121.704298 °	-121.705675 °
DWR ID	DWR_RD2098_01A_s_2017_4				
Comment Code					
C2 : Repair depressions or ruts in the crown or slope.					
Inspector Comment					
Dutra has graded road for erosion repair construction work.

Graded crown road.

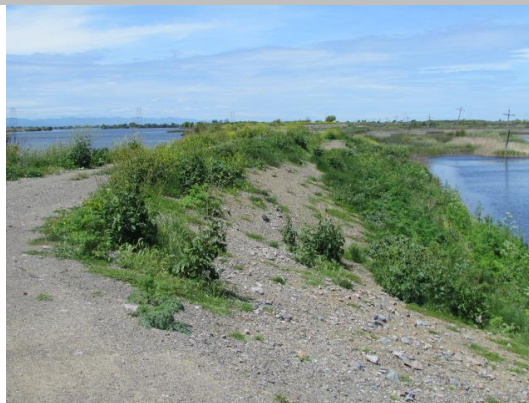
LM Start	5.30	Rating **	M	Issue No.	8
LM End	6.16	Issue Type +	Ma	Location *	LS
Category	Earthen Levee			GPS Latitude/Longitude	
				Start	End
Item	Vegetation			38.275757 °	38.284800 °
				-121.705818 °	-121.715200 °
DWR ID	DWR_RD2098_02_s_2017_8				
Comment Code					
V2 : Remove the wild growth other than native grasses from the levee slopes.					
Inspector Comment					
Remove the wild weed growth from the landside levee slope and berm.

RD 2098 Unit 2 Levee mile 5.30-7.14 wild growth on the landside slope.

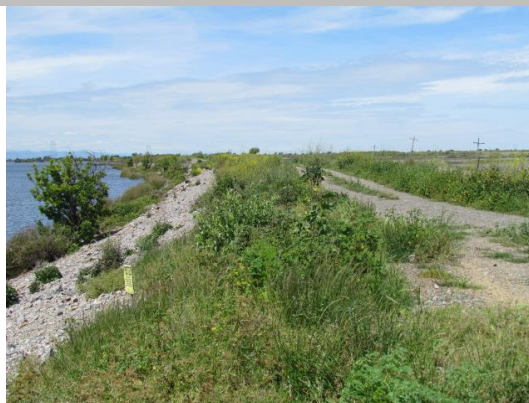
LM Start	5.30	Rating **	M	Issue No.	9
LM End	6.16	Issue Type +	Ma	Location *	WS
Category	Earthen Levee			GPS Latitude/Longitude	
				Start	End
Item	Vegetation			38.275757 °	38.284800 °
				-121.705818 °	-121.715200 °
DWR ID	DWR_RD2098_02_s_2017_9				
Comment Code					
V2 : Remove the wild growth other than native grasses from the levee slopes.					
Inspector Comment					
Remove the wild weed growth from the waterside levee slope.

RD 2098 Unit 2 levee mile 5.30- 7.14 waterside levee slope and shoulder.

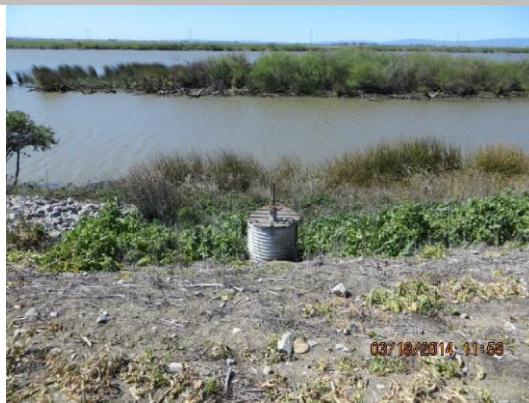
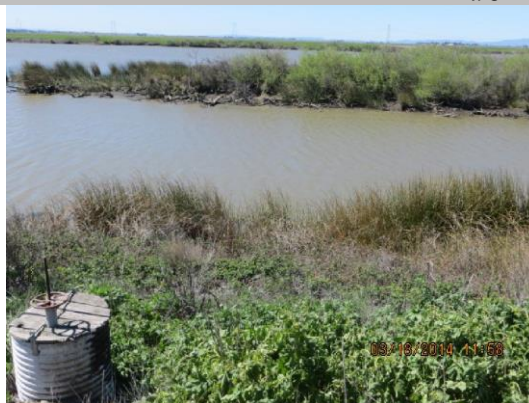
Slide gate in 36-inch standpipe on WS slope.

Comment Code						
Inspector Comment						
FS_ID:32287 DS_ID:20973 EP_NO: 10172 Repair Type: Non-Urgent Crossing Status: Found UCIP Comments: Pipe appears abandoned and if so should be done so properly. Slide gate appears to be open and should be closed for the season. FIELD_STRUCT_DESC: 24-inch corrugated metal irrigation pipe through the levee, 22.8 feet below the crown. Two cutoff walls around the pipe at the levee shoulders. Slide gate in 36-inch corrugated metal pipe (CMP) riser on the waterside (WS) slope. Flap gate and concrete U-shaped headwall on the landside (LS) end. (This pipe was retained under Automatic Board Order (ABO) issued as Permit No. 10172, 1974 - Moresco Brothers). [Additional Reference(s): DWR Levee Log, 2003]. FS Date: 3/18/2014

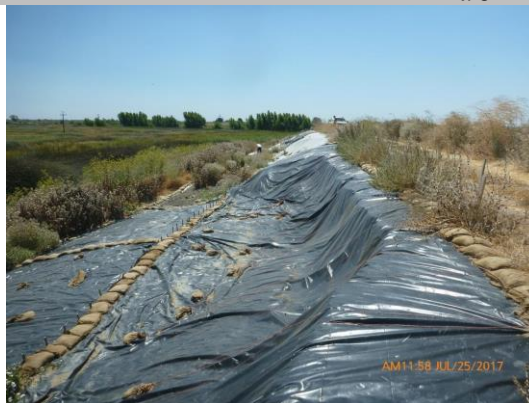
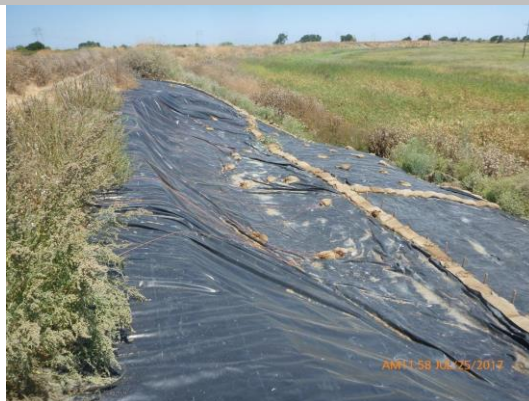
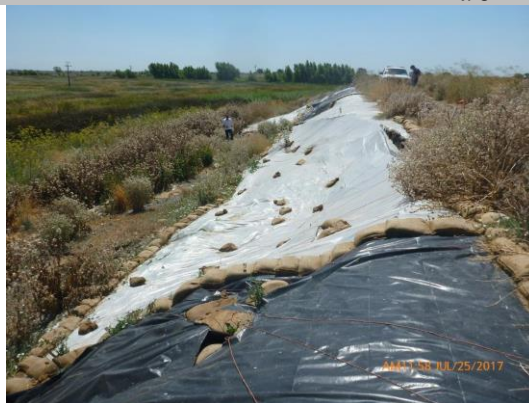
LM Start	6.34	Rating **	A/W	Issue No.	14
LM End	6.39	Issue Type +	Ma	Location *	
Category	Supplemental			GPS Latitude/Longitude	
				Start	End
Item	2017 Storm Damage			38.287200 °	38.287900 °
				-121.716000 °	-121.716500 °
DWR ID	DWR_RD2098_02_f_2017_14				
Comment Code					
Inspector Comment					
Levee Evaluation Comments					
Description:The damage consists of instability and cracking of the landside levee slope.					
Site ID No:439					
Site Designation:LMA-266					
Repair Type: Erosion					
Rating:Critical					
Field Date:7/25/2017					
Notes: Sloughing 2' from crown on landside slope to toe. RD has placed raincoat to prevent further damage. 10/26/17: Site is currently being repaired by Dutra.

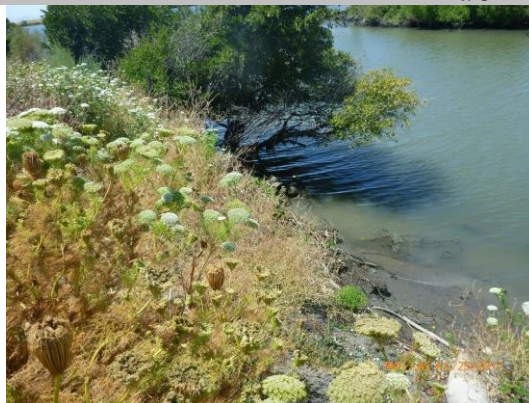
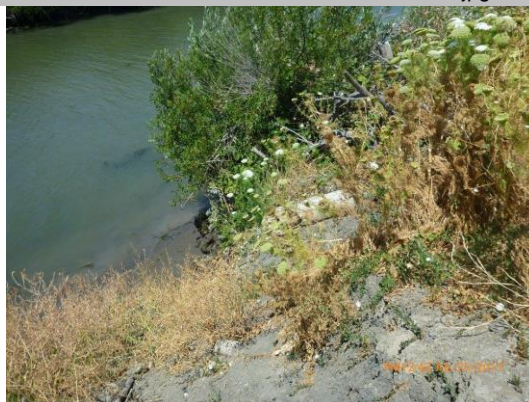
LM Start	6.46	Rating **	A/W	Issue No.	15 (cont)
LM End	6.46	Issue Type +	Ma	Location *	
Category	Supplemental			GPS Latitude/Longitude	
				Start	End
Item	2017 Storm Damage			38.288700 °	38.288800 °
				-121.717000 °	-121.717000 °
DWR ID	DWR_RD2098_02_f _ 2017_15				
Comment Code					
Inspector Comment					
Levee Evaluation Comments					
Description:The damage consists of scour of the lower and mid waterside levee slope.					
Site ID No:440					
Site Designation:LMA-267					
Repair Type: Erosion					
Rating:Area of Concern					
Field Date:7/25/2017					
Notes: Sloughing on waterside slope due to toe erosion.

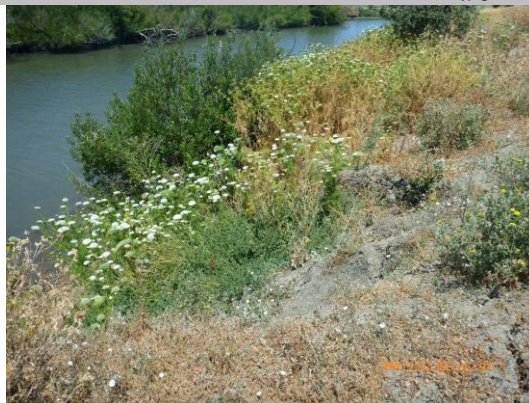
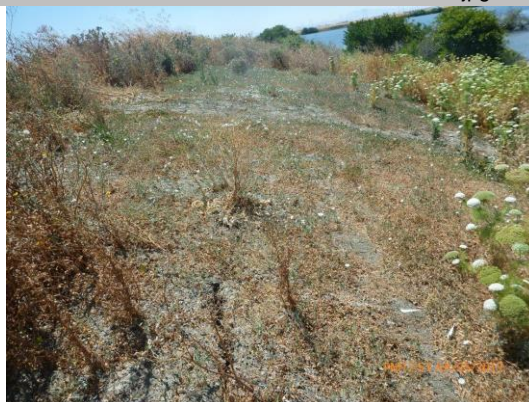
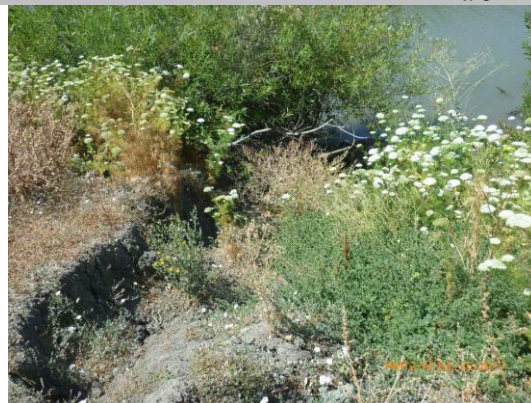
LM Start	6.47	Rating **	M	Issue No.	17
LM End	6.48	Issue Type +	Ma	Location *	
Category	Supplemental			GPS Latitude/Longitude	
				Start	End
Item	2017 Storm Damage			38.288900 °	38.289000 °
				-121.717000 °	-121.717000 °
DWR ID	DWR_RD2098_02_f_2017_17				
Comment Code					
Inspector Comment					
Levee Evaluation Comments					
Description:The damage consists of scour and sloughing of the lower and mid waterside levee slope.					
Site ID No:441					
Site Designation:LMA-268					
Repair Type: Erosion					
Rating:Area of Concern					
Field Date:7/25/2017					
Notes: Sloughing on waterside slope due to toe erosion.

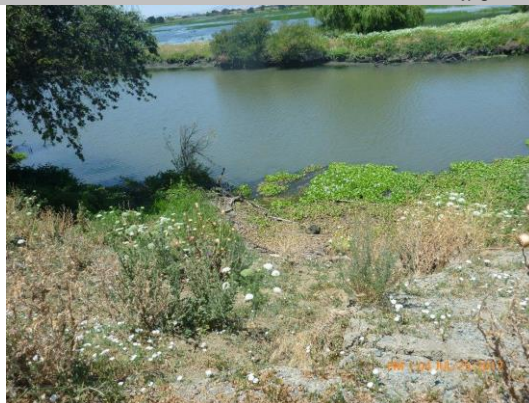
LM Start	6.64	Rating **	A/W	Issue No.	18
LM End	6.65	Issue Type +	Ma	Location *	
Category	Supplemental			GPS Latitude/Longitude	
				Start	End
Item	2017 Storm Damage			38.291300 °	38.291400 °
				-121.716100 °	-121.716000 °
DWR ID	DWR_RD2098_02_f_2017_18				
Comment Code					
Inspector Comment					
Levee Evaluation Comments					
Description:The damage consists of scour, cracking, instability, and sloughing of the waterside levee slope.					
Site ID No:442					
Site Designation:LMA-269					
Repair Type: Erosion					
Rating:Serious					
Field Date:7/25/2017					
Notes: Two sloughing sections along waterside slope due to toe erosion.					
LM Start	6.64	Rating **	A/W	Issue No.	18 (cont)
LM End	6.65	Issue Type +	Ma	Location *

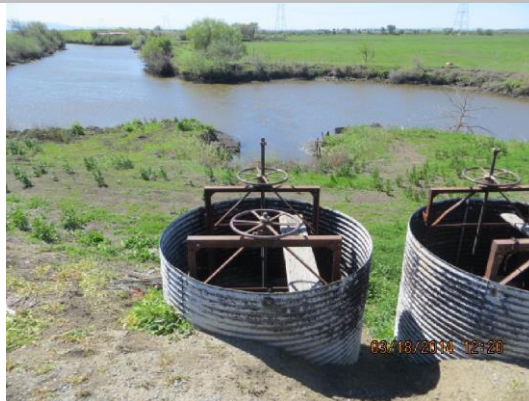
Photo 1 of 3 : UCIP_FA_2017_33784_61162.jpg

Comment Code					
Inspector Comment					
FS_ID:33784					
DS_ID:20976					
EP_NO: 10172					
Repair Type: Non-Urgent					
Crossing Status: Found					
UCIP Comments: Headwalls on WS toe failing at outlet. It is unclear if these were permanent installations or something that was installed as a temporary fix.					
FIELD_STRUCT_DESC: 1 of 2: 48-inch corrugated metal drainage pipe through the levee, 29 feet below the crown. Two slide gates in a 7-foot-diameter corrugated metal pipe (CMP) riser on the waterside (WS) slope. (two 48-inch [HLM 6.75] authorized under Automatic Board Order (ABO) issued as Permit No. 10172, 1974 - Moresco Brothers).					
[Additional Reference(s): DWR Levee Log, 2003. USACE Sacramento O&M Manual 109, April 1962, (HLM 6.75)].					
FS Date: 3/18/2014

Two slide gates in 7-foot diameter CMP riser on waterward slope.

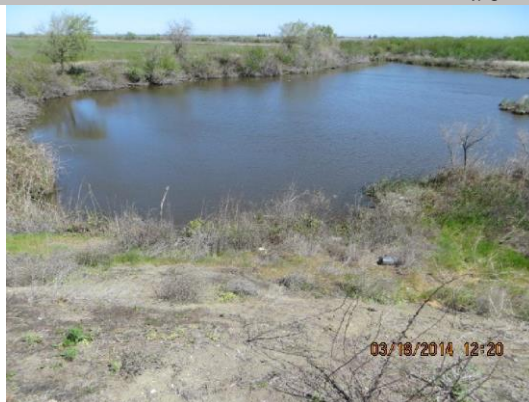
Photo 2 of 3 : UCIP_FA_2017_33784_61161.jpg

Inlet not visible on LS toe.

Comment Code						
Inspector Comment						
FS_ID:33784 DS_ID:20976 EP_NO: 10172 Repair Type: Non-Urgent Crossing Status: Found UCIP Comments: Headwalls on WS toe failing at outlet. It is unclear if these were permanent installations or something that was installed as a temporary fix. FIELD_STRUCT_DESC: 1 of 2: 48-inch corrugated metal drainage pipe through the levee, 29 feet below the crown. Two slide gates in a 7-foot-diameter corrugated metal pipe (CMP) riser on the waterside (WS) slope. (two 48-inch [HLM 6.75] authorized under Automatic Board Order (ABO) issued as Permit No. 10172, 1974 - Moresco Brothers). [Additional Reference(s): DWR Levee Log, 2003. USACE Sacramento O&M Manual 109, April 1962, (HLM 6.75)]. FS Date: 3/18/2014

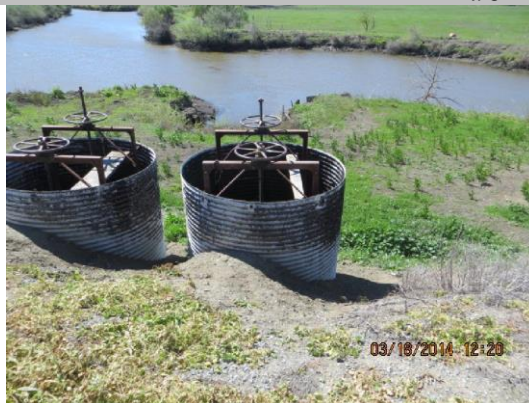
Photo 2 of 3 : UCIP_FA_2017_32285_58748.jpg

Comment Code						
Inspector Comment						
FS_ID:32285 DS_ID:20961 EP_NO: 10172 Repair Type: Non-Urgent Crossing Status: Found UCIP Comments: Headwalls at WS toe failing. It is uncertain if these retaining walls were a permanent fixture or a temporary fix that failed. FIELD_STRUCT_DESC: 2 of 2: 48-inch corrugated metal drainage pipe through the levee, 29 feet below the crown. Two slide gates in a 7-foot-diameter corrugated metal pipe (CMP) riser on the waterside (WS) slope. (two 48-inch pipes [HLM 6.75] authorized under Automatic Board Order (ABO) issued as Permit No. 10172, 1974 - Moresco Brothers). [Additional Reference(s): DWR Levee Log, 2003. USACE Sacramento O&M Manual 109, April 1962, (HLM 6.75)]. FS Date: 3/18/2014

7-foot diameter CMP riser with two slide gates inside.

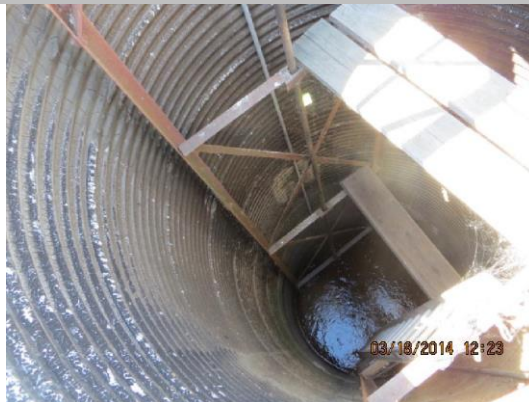
Photo 3 of 3 : UCIP_FA_2017_32285_58747.jpg

7-foot diameter CMP riser with two slide gates inside.

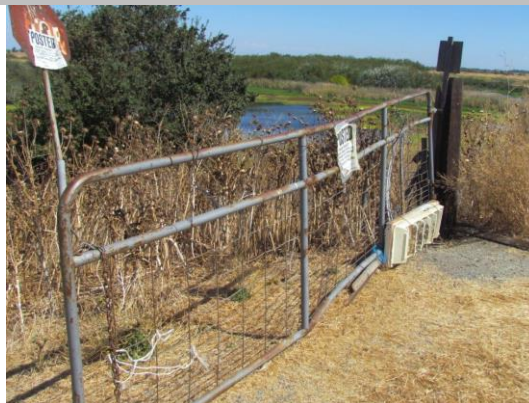
Photo 1 of 1 : FA_2017_RD2098_246_16_20171002_00006.jpg

LM Start	6.74	Rating **	M	Issue No.	16
LM End	6.74	Issue Type +	Ma	Location *	CR
Category	Earthen Levee			GPS Latitude/Longitude	
				Start	End
Item	Repair Gates			38.292467 °	38.292467 °
				-121.716138 °	-121.716138 °
DWR ID	DWR_RD2098_02_f_2016_16				
Comment Code					
Inspector Comment					
Repair this gate that has been damaged.

Levee mile 6.74 crown roadway gate crossing.

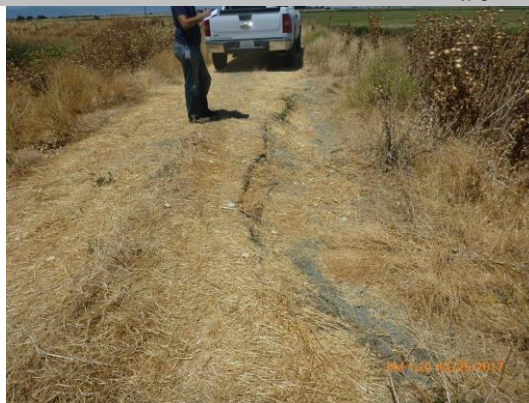
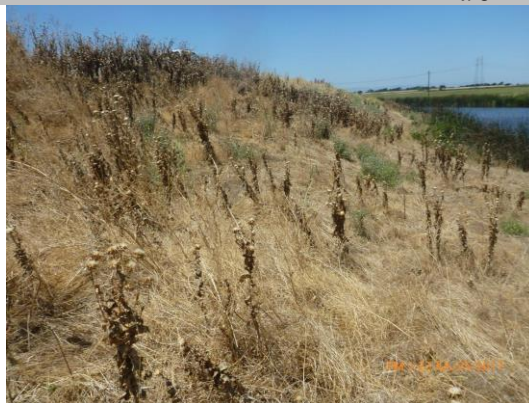
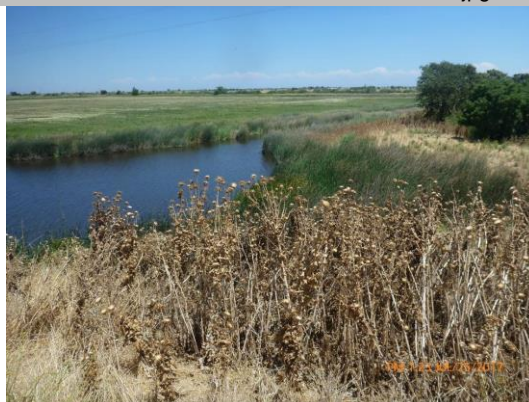
LM Start	6.74	Rating **	M	Issue No.	19
LM End	6.75	Issue Type +	Ma	Location *	
Category	Supplemental			GPS Latitude/Longitude	
				Start	End
Item	2017 Storm Damage			38.292500 °	38.292600 °
				-121.716100 °	-121.716200 °
DWR ID	DWR_RD2098_02_f_2017_19				
Comment Code					
Inspector Comment					
Levee Evaluation Comments					
Description:The damage consists of scour and sloughing of the waterside levee slope.					
Site ID No:443					
Site Designation:LMA-270					
Repair Type: Stability					
Rating:Area of Concern					
Field Date:7/25/2017					
Notes: Sloughing on crown into upper portion of landside levee slope.

LM Start	6.74	Rating **	M	Issue No.	19 (cont)
LM End	6.75	Issue Type +	Ma	Location *	
Category	Supplemental			GPS Latitude/Longitude	
				Start	End
Item	2017 Storm Damage			38.292500 °	38.292600 °
				-121.716100 °	-121.716200 °
DWR ID	DWR_RD2098_02_f_2017_19				
Comment Code					
Inspector Comment					
Levee Evaluation Comments					
Description:The damage consists of scour and sloughing of the					
waterside levee slope.					
Site ID No:443					
Site Designation:LMA-270					
Repair Type: Stability					
Rating:Area of Concern					
Field Date:7/25/2017					
Notes: Sloughing on crown into upper portion of landside levee slope.					
LM Start	6.74	Rating **	M	Issue No.	19 (cont)
LM End	6.75	Issue Type +	Ma	Location *

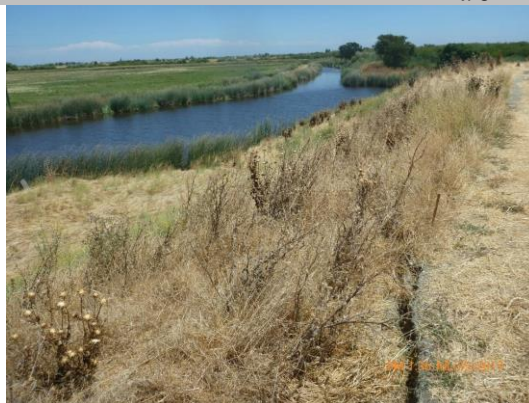
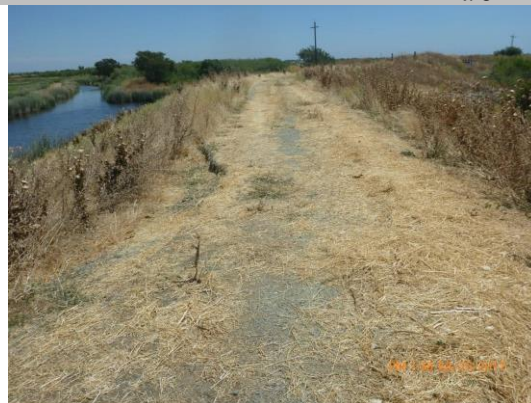
Description: The damage consists of cracking of the levee crest.

LM Start	6.77	Rating **	M	Issue No.	20 (cont)	
LM End	6.80	Issue Type +	Ma	Location *		
Category	Supplemental			GPS Latitude/Longitude		
				Start		End
Item	2017 Storm Damage			38.292900 °		38.293000 °
				-121.716600 °		-121.717000 °
DWR ID	DWR_RD2098_02_f_2017_20					
Comment Code						
Inspector Comment						
Levee Evaluation Comments						
Description:The damage consists of cracking of the levee crest.						
Site ID No:444						
Site Designation:LMA-271						
Repair Type: Erosion						
Rating:Area of Concern						
Field Date:7/25/2017						
Notes: Two combined sloughing locations (271 and 272) within levee crown into waterside and landside slopes. Sloughing on landside slope bulges into ditch at toe.

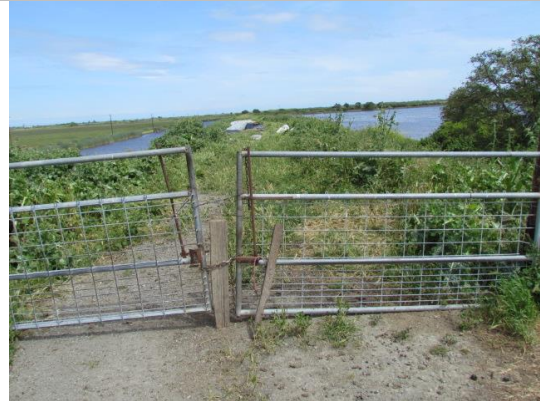
Photo 1 of 1 : FA_2017_RD2098_246_5_20171002_00001.jpg

LM Start	7.14	Rating **	M	Issue No.	5
LM End	7.14	Issue Type +	Ma	Location *	CR
Category	Earthen Levee			GPS Latitude/Longitude	
				Start	End
Item	Repair Gates			38.292962 °	38.292962 °
				-121.723312 °	-121.723312 °
DWR ID	DWR_RD2098_02_f_2013_5				
Comment Code					
Inspector Comment					
Gate damage, make repairs to this gate. This gate could cause injury to someone.

RD 2098 Levee mile 7.14.

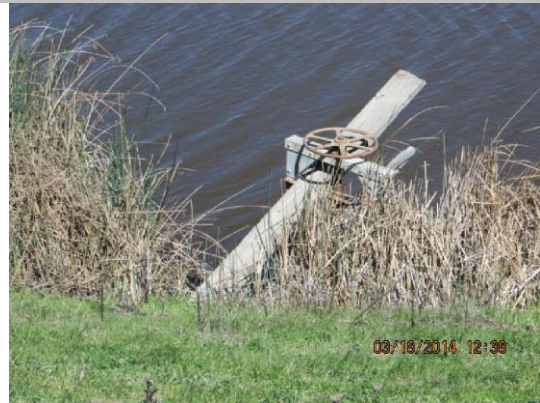
Photo 1 of 3 : UCIP_FA_2017_32290_58764.jpg

Comment Code						
Inspector Comment						
FS_ID:32290 DS_ID:20977 EP_NO: 10171 Repair Type: Non-Urgent Crossing Status: Found UCIP Comments: Pipe appears to be abandoned and if so it should be done so properly. Walkway to gate valve actuator on WS slope is in disrepair and does not appear to be safe for use. FIELD_STRUCT_DESC: 36-inch corrugated metal dual-purpose irrigation and drainage pipe through the levee, 23 feet below the crown. Walkway to slide gate on the waterside (WS) end. Slide gate at the landside (LS) toe. (This pipe was retained under Automatic Board Order (ABO) issued as Permit No. 10171, 1974 - Glenn A. Bowsbey). [Additional Reference(s): DWR Levee Log, 2003. USACE Sacramento O&M Manual 109, April 1962, (HLM 7.23)]. FS Date: 3/18/2014

Slide gate at LS toe.

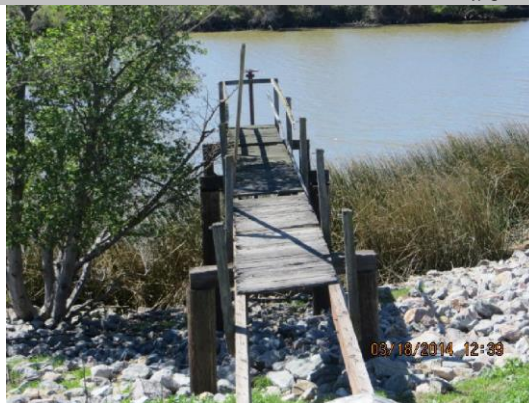
Photo 2 of 3 : UCIP_FA_2017_32290_58763.jpg

Comment Code						
Inspector Comment						
FS_ID:32290 DS_ID:20977 EP_NO: 10171 Repair Type: Non-Urgent Crossing Status: Found UCIP Comments: Pipe appears to be abandoned and if so it should be done so properly. Walkway to gate valve actuator on WS slope is in disrepair and does not appear to be safe for use. FIELD_STRUCT_DESC: 36-inch corrugated metal dual-purpose irrigation and drainage pipe through the levee, 23 feet below the crown. Walkway to slide gate on the waterside (WS) end. Slide gate at the landside (LS) toe. (This pipe was retained under Automatic Board Order (ABO) issued as Permit No. 10171, 1974 - Glenn A. Bowsbey). [Additional Reference(s): DWR Levee Log, 2003. USACE Sacramento O&M Manual 109, April 1962, (HLM 7.23)]. FS Date: 3/18/2014

Delapidated wooden pier on WS shoulder.

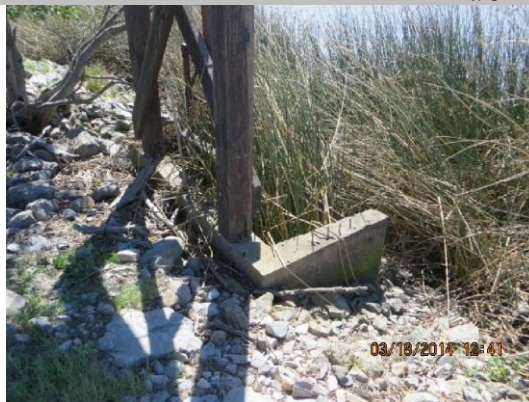
Photo 3 of 3 : UCIP_FA_2017_32290_58762.jpg

Concrete U-shaped headwall on WS toe.

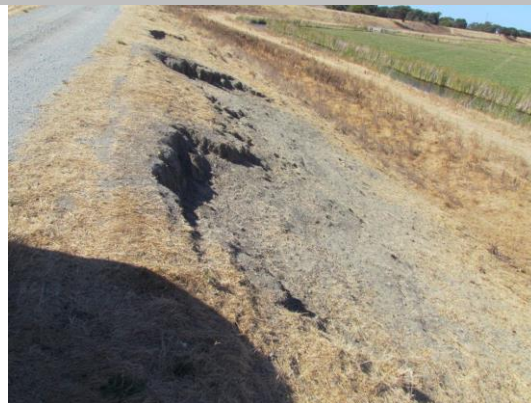
Photo 1 of 2 : FA_2017_RD2098_247_1_20171002_00001.jpg

LM Start	7.51	Rating **	M	Issue No.	1
LM End	7.51	Issue Type +	Ma	Location *	LS
Category	Earthen Levee			GPS Latitude/Longitude	
				Start	End
Item	Slope Stability			38.296846 °	38.296846 °
				-121.727546 °	-121.727546 °
DWR ID	DWR_RD2098_03_f_2016_1				
Comment Code					
S2 : Repair the levee slope damaged by foot traffic and prevent access where possible.					
Inspector Comment					
Make the repairs to the erosion site listed.

Close up. Looking downstream.

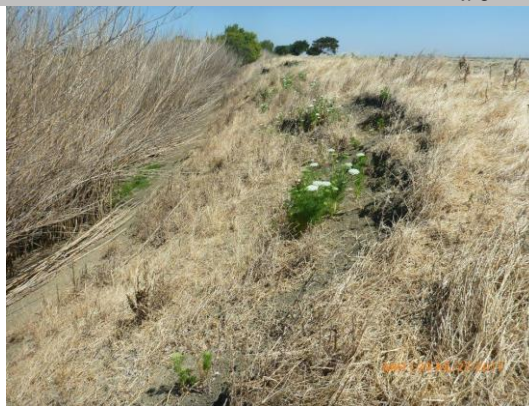
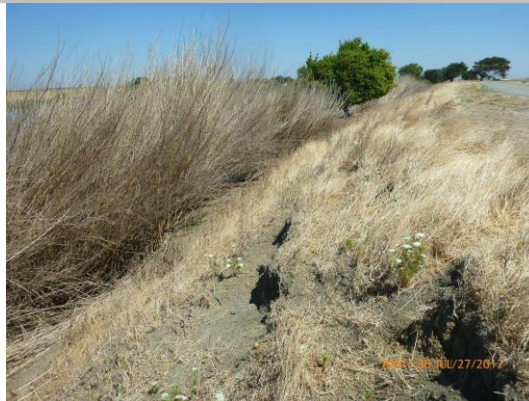
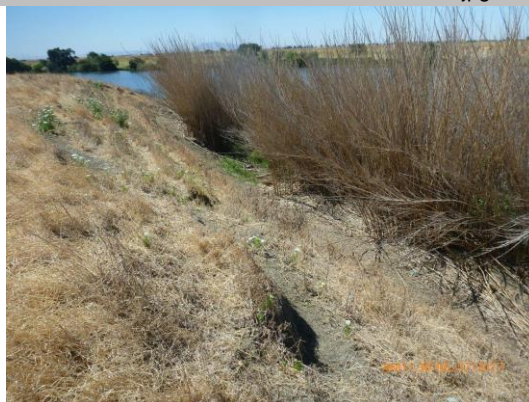
LM Start	7.61	Rating **	M	Issue No.	10
LM End	7.62	Issue Type +	Ma	Location *	
Category	Supplemental			GPS Latitude/Longitude	
				Start	End
Item	2017 Storm Damage			38.297900 °	38.298100 °
				-121.728900 °	-121.728900 °
DWR ID	DWR_RD2098_03_f_2017_10				
Comment Code					
Inspector Comment					
Levee Evaluation Comments					
Description:The damage consists of sloughing of the lower and mid waterside levee slope.					
Site ID No:449					
Site Designation:LMA-276					
Repair Type: Erosion					
Rating:Area of Concern					
Field Date:7/27/2017					
Notes: Sloughing on waterside slope due to erosion at waterside toe.

LM Start	7.61	Rating **	M	Issue No.	10 (cont)	
LM End	7.62	Issue Type +	Ma	Location *		
Category	Supplemental			GPS Latitude/Longitude		
				Start	End	
Item	2017 Storm Damage			38.297900 °	38.298100 °	
				-121.728900 °	-121.728900 °	
DWR ID	DWR_RD2098_03_f _ 2017_10					
Comment Code						
Inspector Comment						
Levee Evaluation Comments						
Description:The damage consists of sloughing of the lower and mid waterside levee slope.						
Site ID No:449						
Site Designation:LMA-276						
Repair Type: Erosion						
Rating:Area of Concern						
Field Date:7/27/2017						
Notes: Sloughing on waterside slope due to erosion at waterside toe.

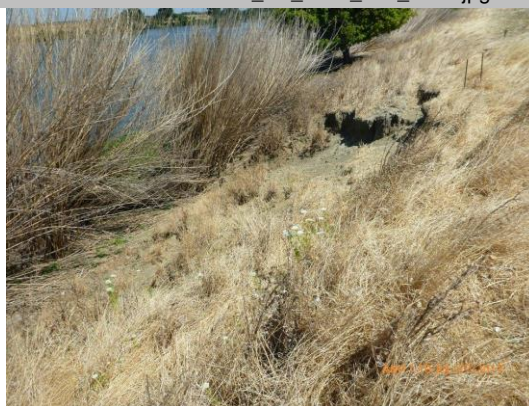
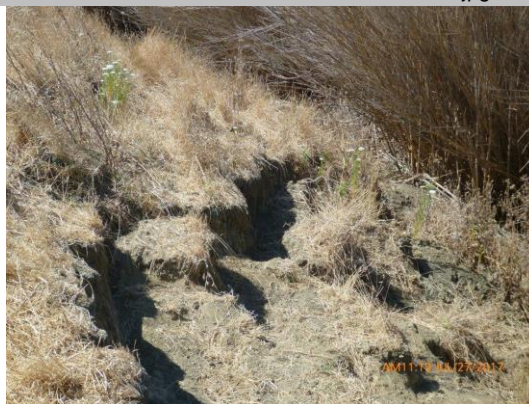
Description: The damage consists of scour and sloughing of the waterside levee slope.

LM Start	7.63	Rating **	M	Issue No.	13 (cont)
LM End	7.64	Issue Type +	Ma	Location *	
Category	Supplemental			GPS Latitude/Longitude	
				Start	End
Item	2017 Storm Damage			38.298300 °	38.298400 °
				-121.728800 °	-121.728800 °
DWR ID	DWR_RD2098_03_f _ 2017_13				
Comment Code					
Inspector Comment					
Levee Evaluation Comments					
Description:The damage consists of scour and sloughing of the waterside levee slope.					
Site ID No:450					
Site Designation:LMA-277					
Repair Type: Erosion					
Rating:Area of Concern					
Field Date:7/27/2017					
Notes: Sloughing on waterside due to waterside toe erosion.
