**Flood Control Project Maintenance
Levee Inspections**

Fall 2017 Levee Maintenance Deficiency Summary Report

Sacramento River Basin

RD2098	Overall LMA Rating	Total LMA Miles						
Reclamation District No. 2098 Cache and Haas Slough	U	10.91						
Rated Item	Maintenance Deficiency				Enforcement		Design & System Obsolescence	
	M Miles	U Miles	M + 4U Miles	Threshold %	M Miles	U Miles	M Miles	U Miles
<i>Earthen Levee</i>								
Vegetation	4.41		4.41	40.44%				
Trim / Thin Trees	0.01		0.01	0.09%				
Encroachments	0.02		0.02	0.18%	0.01			
Slope Stability	0.02		0.02	0.18%				
Erosion / Bank Caving	0.50		0.50	4.59%				
Cracking		0.01	0.04	0.37%				
Crown Surface / Depressions / Rutting	0.86		0.86	7.89%				
Repair Gates	0.02		0.02	0.18%				
<i>Supplemental</i>								
2015 USACE Erosion Survey, DRAFT	0.39		0.39	3.58%				
DWR UCIP Field Study					0.13	0.04		
DWR UCIP LMA Responsibility								
2017 Storm Damage	0.21		0.21	1.93%				
<i>LMA Totals:</i>	6.44	0.01	6.48	59.42%	0.14	0.04	0.00	0.00

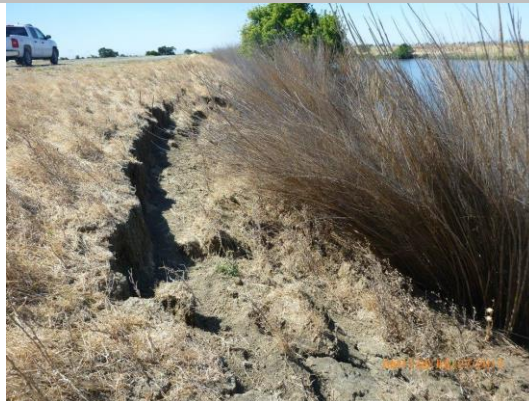
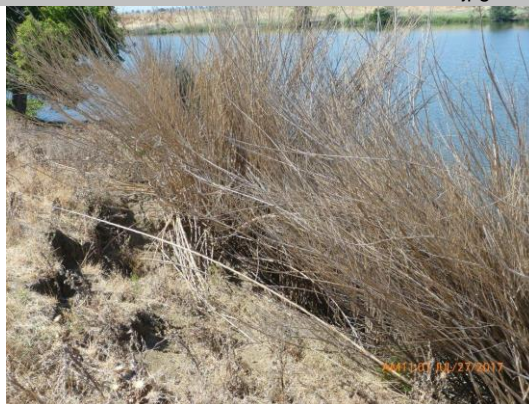
Levee Evaluation Comments
Description: The damage consists of scour and sloughing of the lower and mid waterside levee slope.
Site ID No: 451
Site Designation: LMA-278
Repair Type: Erosion
Rating: Area of Concern
Field Date: 7/27/2017
Notes: Sloughing on waterside slope due to waterside toe erosion.

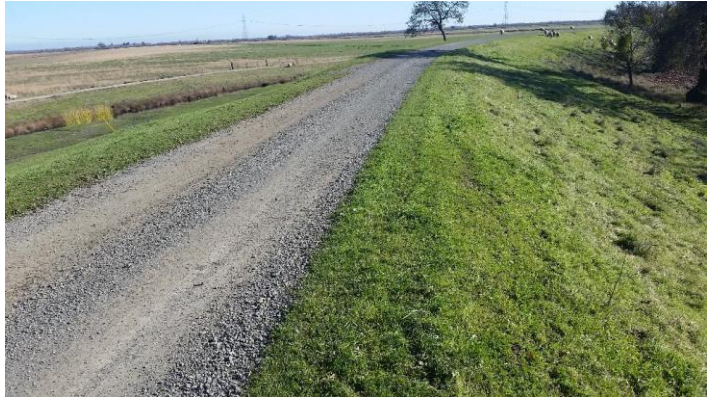
Photo 3 of 3 : UCIP_FA_2017_51453_76859.jpg

Comment Code						
Inspector Comment						
FS_ID:51453 DS_ID:20981 EP_NO: 10174 Repair Type: No Action Needed Crossing Status: Found UCIP Comments: 12/22/2016 Crossing has been downgraded from Urgent to No Action Needed walkways on both WS and LS have been rebuilt and the WS gate has been upgraded to stainless steel where previous corrodable material was present. (O. Magana - DWR UCIP)03/19/2014 Current walkway to slidegate on WS toe does not provide safe access to operate slidegate. (W. Wylie - DWR UCIP) FIELD_STRUCT_DESC: 36-inch steel dual-purpose irrigation and drainage pipe through the levee, 26 feet below the crown. Two corrugated metal cutoff walls around the pipe. Walkway to the slide gate on the waterside (WS) end. Combination slide and flap gate on the landside (LS) end. 48-inch corrugated metal pipe (CMP) riser and an adjoining pump on a metal pier at the LS toe. (36-inch pipe [HLM 8.20] authorized under Automatic Board Order (ABO) issued as Permit No. 10174, 1974 - Glen A. Bowsbey). [Additional Reference(s): DWR Levee Log, 2003. USACE Sacramento O&M Manual 109, April 1962, (HLM 8.20)]. FS Date: 12/22/2016

View of levee crown at pipe crossing.

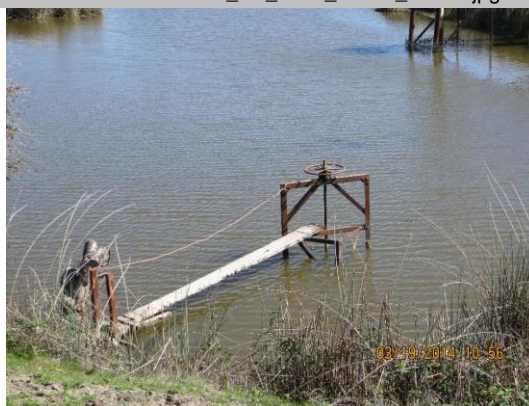
Photo 1 of 2 : UCIP_FA_2017_32384_58883.jpg

LM Start	8.35	Rating **	A/W	Issue No.	18
LM End	8.35	Issue Type +	Ma	Location *	
Category	Supplemental			GPS Latitude/Longitude	
				Start	End
Item	DWR UCIP LMA Responsibility			38.306916 °	38.306916 °
				-121.731984 °	-121.731984 °
DWR ID					
Comment Code					
Inspector Comment					
FS_ID:32384 DS_ID:20962 EP_NO: 10174 Repair Type: No Action Needed Crossing Status: Found UCIP Comments: FIELD_STRUCT_DESC: 60-inch corrugated metal drainage pipe through the levee, 25.5 feet below the crown. Walkway to the slide gates at both ends of the pipe. (Permit No. 1607, 1951 - R. F. Moore and Lorraine W. Zanetti. This pipe was retained under Automatic Board Order (ABO) issued as Permit No. 10174, 1974 - Glen A. Bowsbey). [Additional Reference(s): DWR Levee Log, 2003. USACE Sacramento O&M Manual 109, April 1962, (HLM 8.40)]. FS Date: 3/19/2014

Slide gate at LS toe.

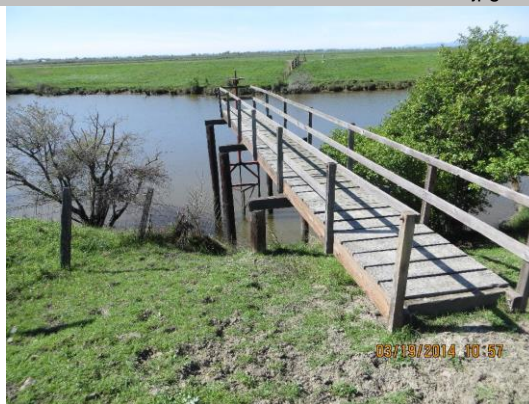
Photo 2 of 2 : UCIP_FA_2017_32384_58882.jpg

Walkway with slide gate on WS toe.

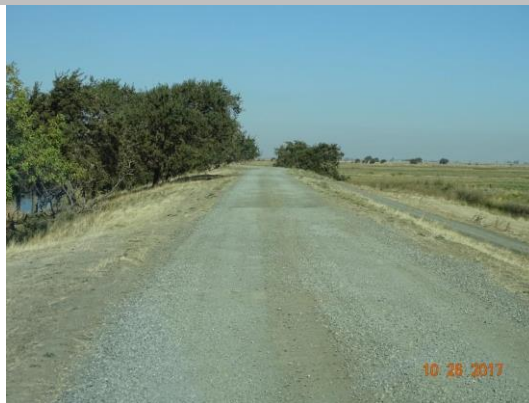
Photo 1 of 1 : FA_2017_RD2098_247_14_20171117_00025.jpg

LM Start	8.36	Rating **	A/W	Issue No.	14
LM End	9.11	Issue Type +	Ma	Location *	CR
Category	Earthen Levee			GPS Latitude/Longitude	
				Start	End
Item	Vegetation			38.306997 °	38.315668 °
				-121.732010 °	-121.739773 °
DWR ID	DWR_RD2098_03_s_2017_14				
Comment Code					
V9 : Keep the crown roadway free of vegetation.					
Inspector Comment

Crown vegetation is well managed.

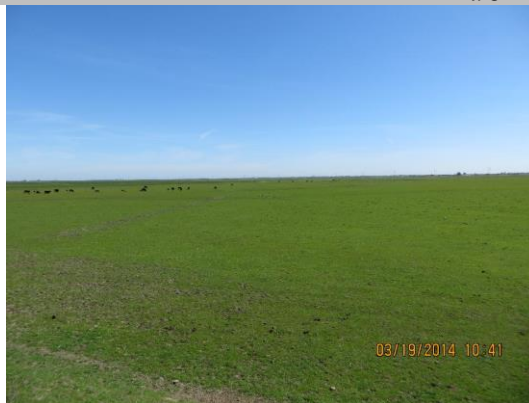
Photo 1 of 2 : UCIP_FA_2017_32383_58881.jpg

LM Start	9.49	Rating **	M	Issue No.	18
LM End	9.49	Issue Type +	En	Location *	
Category	Supplemental			GPS Latitude/Longitude	
				Start	End
Item	DWR UCIP Field Study			38.321032 °	38.321032 °
				-121.740154 °	-121.740154 °
DWR ID					
Comment Code					
Inspector Comment					
FS_ID:32383 DS_ID:20983 EP_NO: N/A Repair Type: Non-Urgent Crossing Status: Indicator Found UCIP Comments: need to verify status of gaslines in region with PG&E (888) 743-7431 Fax: Email: PipelineRequests@pge.com FIELD_STRUCT_DESC: 4-inch gas line of an unknown material through the levee, 2 feet below the crown. Shutoff valve located 370 feet east of the levee crown. [Additional Reference(s): DWR Levee Log, 2003]. FS Date: 3/19/2014

Shutoff valve visible 370-feet off LS toe.

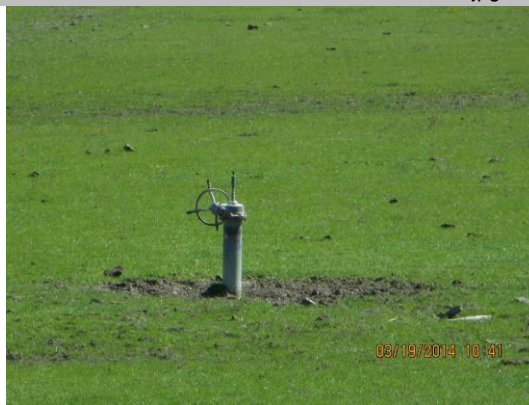
Photo 2 of 2 : UCIP_FA_2017_32383_58880.jpg

Shutoff valve visible 370-feet off LS toe.

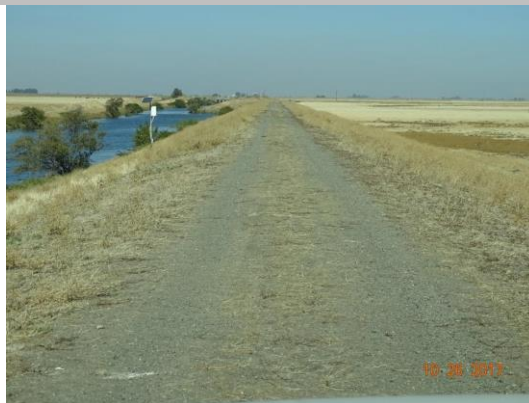
Photo 1 of 1 : FA_2017_RD2098_248_8_20171117_00020.jpg

LM Start	9.68	Rating **	M	Issue No.	8
LM End	9.73	Issue Type +	Ma	Location *	WS
Category	Earthen Levee			GPS Latitude/Longitude	
				Start	End
Item	Erosion / Bank Caving			38.323749 °	38.324467 °
				-121.740148 °	-121.740155 °
DWR ID	DWR_RD2098_04_s_2014_8				
Comment Code					
E1 : Note and monitor erosion site.					
Inspector Comment					
Several areas of scalloped erosion at waterside toe. Should be monitored and eventually repaired.

Several areas of scalloped erosion at waterside toe. Largest area is visible in distance in this photo.

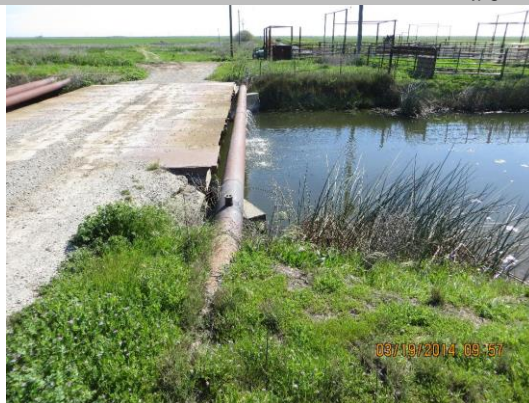
Photo 1 of 3 : UCIP_FA_2017_32403_58905.jpg

Comment Code						
Inspector Comment						
FS_ID:32403 DS_ID:20991 EP_NO: 12851 Repair Type: Non-Urgent Crossing Status: Found UCIP Comments: Holes in pipe next to rail car bridge may indicate further deterioration of pipe through levee. Good candidate for video inspection. FIELD_STRUCT_DESC: 12-inch steel irrigation pipe through the levee, 2 feet below the crown. Cutoff wall around the pipe at the center of the levee. Siphon breaker on the landside (LS) toe at the canal. 1-inch polyvinyl chloride (PVC) electrical conduit at the same location (Permit No. 12851, 1980 - Bunker Ranch). [Additional Reference(s): DWR Levee Log, 2003]. FS Date: 3/19/2014

Pipe and siphon breaker visible on LS at canal crossing.

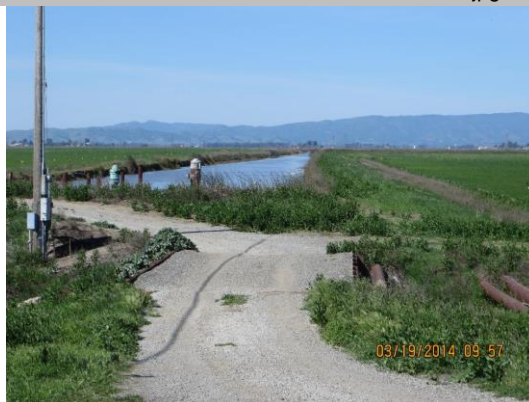
Photo 2 of 3 : UCIP_FA_2017_32403_58904.jpg

Pump on pier in irrigation canal off WS toe.

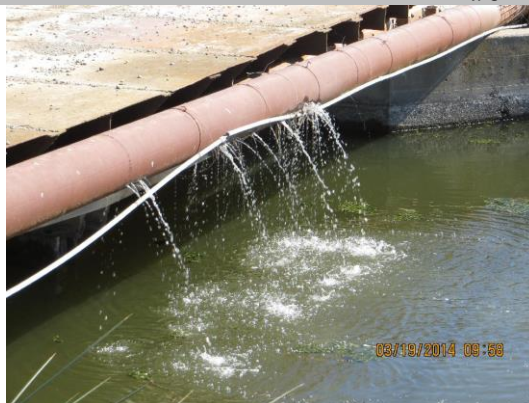
Photo 3 of 3 : UCIP_FA_2017_32403_58903.jpg

Comment Code						
Inspector Comment						
FS_ID:32403						
DS_ID:20991						
EP_NO: 12851						
Repair Type: Non-Urgent						
Crossing Status: Found						
UCIP Comments: Holes in pipe next to rail car bridge may indicate further deterioration of pipe through leve. Good candidate for video inspection.						
FIELD_STRUCT_DESC: 12-inch steel irrigation pipe through the levee, 2 feet below the crown. Cutoff wall around the pipe at the center of the levee. Siphon breaker on the landside (LS) toe at the canal. 1-inch polyvinyl chloride (PVC) electrical conduit at the same location (Permit No. 12851, 1980 - Bunker Ranch). [Additional Reference(s): DWR Levee Log, 2003].						
FS Date: 3/19/2014

Holes in pipe next to bridge. PVC electrical conduit shown.

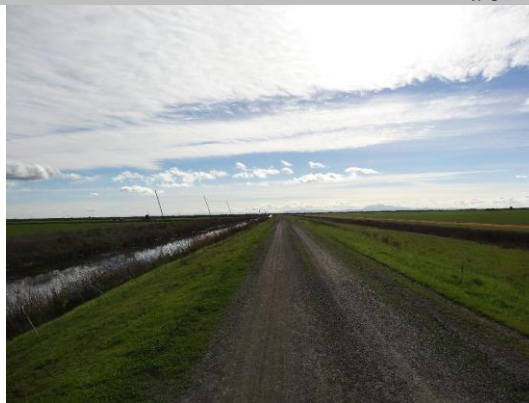
Photo 1 of 1 : UCIP_FA_2017_52555_76889.jpg

Comment Code						
Inspector Comment						
FS_ID:52555 DS_ID:20995 EP_NO: 17842 Repair Type: Urgent Crossing Status: Found UCIP Comments: 12/22/2016 same as previous inspection crossing remains Urgent due to unknown status of gas line--no markers present. According to LMA representative, RD 2068 issued a permit for a gas line however, the current status of this line is unknown. Permit issued by RD 2068 is 20040903. Need to contact owner to determine status of crossing. Markers will need to be installed per Title 23. (O. Magana - DWR UCIP)03/19/2014 No markers found. Need to contact owner to determine status and location. (W. Wylie - DWR UCIP) FIELD_STRUCT_DESC: 3-inch gas line of an unknown material bored under the levee and the channel, approximately 37 feet below the crown. (3-inch natural gas line authorized under Permit No. 17842, 2004 - Castle Minerals, Inc.). FS Date: 12/22/2016

View of levee crown and slopes through this section of the levee.

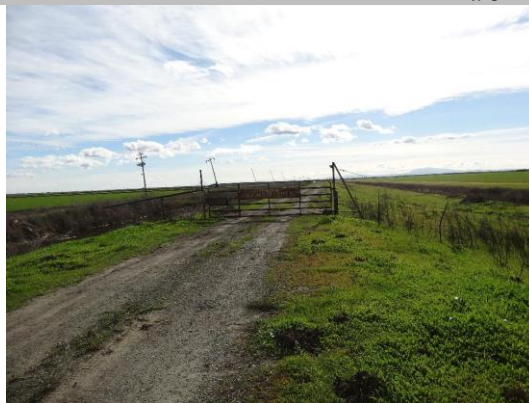
Photo 1 of 3 : UCIP_FA_2017_51454_76867.jpg

Comment Code					
Inspector Comment					
FS_ID:51454 DS_ID:20989 EP_NO: 11564 Repair Type: Urgent Crossing Status: Found UCIP Comments: 12/06/2016 Crossing has been upgraded from Non-Urgent to Urgent due to sections of the wall missing on the LS. Crossing is also opened on both WS and LS. According to Mr. Mike Hardesty, this crossing is not abandoned the crossing is out of service for now. Recommend internal intergrity inspection and coordinating with CVFPB to comply with Title 23. (O. Magana - DWR UCIP)03/19/2014 Pipe appears abandoned and if so should be done so properly. Pipe rusted through at outlet in canal. This may indicate further degradation of pipe within the levee. Good candidate for video inspection. (W. Wylie - DWR UCIP) FIELD_STRUCT_DESC: 18-inch steel drainage pipe through the levee, 2 feet below the crown. Steel cutoff wall around the pipe at the center of the levee. Siphon breaker on the apex of the pipe located on the landside (LS) shoulder. Pump missing from steel pump pad over a 4-foot by 4-foot concrete sump located on the waterside (WS) toe. (18-inch pipe authorized under Permit No. 11564, 1976 - Reclamation District No. 2068). [Additional Reference(s): DWR Levee Log, 2003]. FS Date: 12/6/2016

Overview of levee crown at multiple pipe crossings.

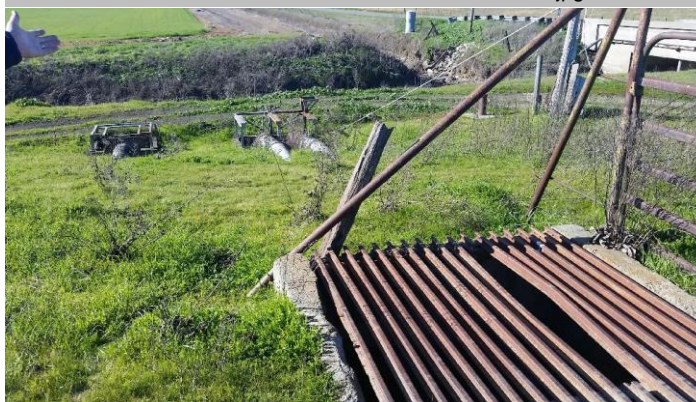
Photo 2 of 3 : UCIP_FA_2017_51454_76872.jpg

View of WS photo taken from levee crown.

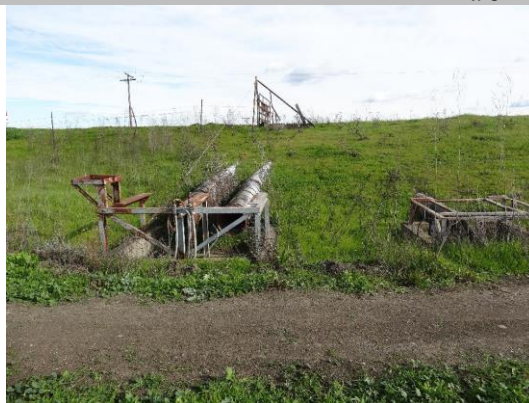
Photo 3 of 3 : UCIP_FA_2017_51454_76868.jpg

Comment Code						
Inspector Comment						
FS_ID:51454 DS_ID:20989 EP_NO: 11564 Repair Type: Urgent Crossing Status: Found UCIP Comments: 12/06/2016 Crossing has been upgraded from Non-Urgent to Urgent due to sections of the wall missing on the LS. Crossing is also opened on both WS and LS. According to Mr. Mike Hardesty, this crossing is not abandoned the crossing is out of service for now. Recommend internal integrity inspection and coordinating with CVFPB to comply with Title 23. (O. Magana - DWR UCIP)03/19/2014 Pipe appears abandoned and if so should be done so properly. Pipe rusted through at outlet in canal. This may indicate further degradation of pipe within the levee. Good candidate for video inspection. (W. Wylie - DWR UCIP) FIELD_STRUCT_DESC: 18-inch steel drainage pipe through the levee, 2 feet below the crown. Steel cutoff wall around the pipe at the center of the levee. Siphon breaker on the apex of the pipe located on the landside (LS) shoulder. Pump missing from steel pump pad over a 4-foot by 4-foot concrete sump located on the waterside (WS) toe. (18-inch pipe authorized under Permit No. 11564, 1976 - Reclamation District No. 2068). [Additional Reference(s): DWR Levee Log, 2003]. FS Date: 12/6/2016

View of WS--pipe crossing is located on the right.

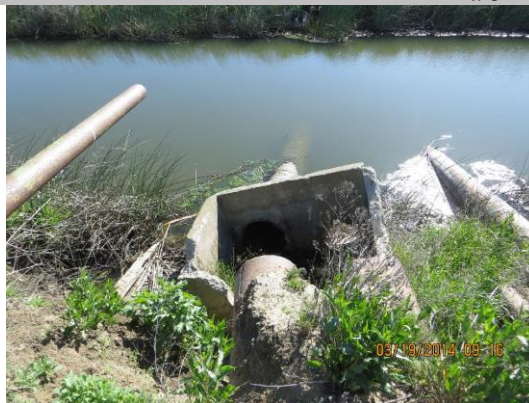
Photo 3 of 3 : UCIP_FA_2017_51455_58817.jpg

Comment Code						
Inspector Comment						
FS_ID:51455 DS_ID:20990 EP_NO: 5426-A Repair Type: Urgent Crossing Status: Found UCIP Comments: 12/06/2016 Crossing is opened on both WS and LS. Concrete box located on the LS has been removed. According to Mr. Mike Hardesty, this crossing is not abandoned the crossing is out of service for now. Recommend internal integrity inspection and coordinating with CVFPB to comply with Title 23. (O. Magana - DWR UCIP)03/19/2014 Pipe appears abandoned and if so should be done so properly. Foundation for concrete distribution box on LS toe at canal has failed. Box has fallen into canal and LS slope has erosion at same location. Pipe open on both ends. (W. Wylie - DWR UCIP) FIELD_STRUCT_DESC: 1 of 2: 18-inch coated steel drainage pipe through the levee, 3 feet below the crown. Vertical pump missing from steel platform over a 7-foot by 4-foot concrete box located on the waterside (WS) toe. Concrete cattle guard structure, 7 feet long, 15 feet wide, and 4 feet deep, located on the crown around the pipes. Discharge structure is located on the landside (LS) slope. (Permit No. 5426, 1966, and 5426-A, 1967 - Reclamation District No. 2068. Permit recordation indicates one 14-inch pipe and one 18-inch pipe to be installed). [Additional Reference(s): DWR Levee Log, 2003]. FS Date: 12/6/2016

Concrete distribution box on LS slope has slipped into canal.

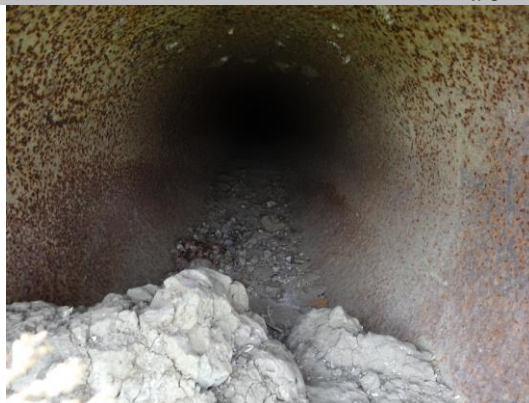
Photo 3 of 3 : UCIP_FA_2017_51456_76885.jpg

FS_ID:51456
DS_ID:21013
EP_NO: 5426-A
Repair Type: Urgent
Crossing Status: Found
UCIP Comments: 12/06/2016 Crossing is opened on both WS and LS. Concrete box located on the LS has been removed. According to Mr. Mike Hardesty, this crossing is not abandoned the crossing is out of service for now. Recommend internal integrity inspection and coordinating with CVFPB to comply with Title 23. (O. Magana - DWR UCIP)03/19/2014 Pipe appears abandoned and if so should be done so properly. Foundation for concrete distribution box on LS toe at canal has failed. Box has fallen into canal and LS slope has erosion at same location. Pipe open on both ends. (W. Wylie - DWR UCIP)
FIELD_STRUCT_DESC: 2 of 2: 18-inch coated steel drainage pipe through the levee, 3 feet below the crown. Vertical pumps missing from steel pad over a 7-foot by 4-foot concrete sump located on the waterside (WS) toe. Concrete cattle guard structure, 7 feet long, 15 feet wide, and 4 feet deep, located on the crown around the pipes. Discharge structure is located on the landside (LS) slope. (Permit No. 5426, 1966, and 5426-A, 1967 - Reclamation District No. 2068. Permit recordation indicates one 14-inch pipe and one 18-inch pipe to be installed). [Additional Reference(s): DWR Levee Log, 2003].

Inside view of pipe from LS.

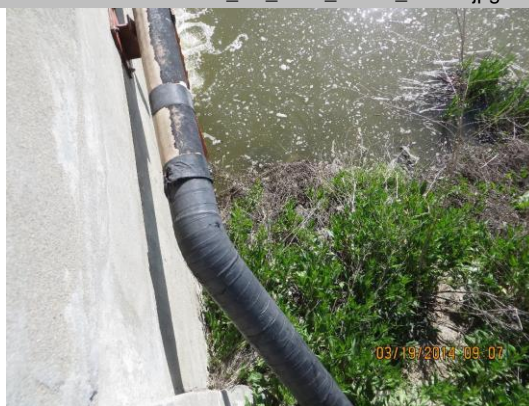
Photo 1 of 3 : UCIP_FA_2017_32566_59110.jpg

LM Start	12.07	Rating **	M	Issue No.	24	
LM End	12.07	Issue Type +	En	Location *		
Category	Supplemental			GPS Latitude/Longitude		
				Start	End	
Item	DWR UCIP Field Study			38.358110 °	38.358110 °	
				-121.740381 °	-121.740381 °	
DWR ID						
Comment Code						
Inspector Comment						
FS_ID:32566						
DS_ID:24845						
EP_NO: N/A						
Repair Type: Non-Urgent						
Crossing Status: Found						
UCIP Comments: Need to verify status with gas company and install signs. No permit identified for crossing, though it may be connected to a permitted line installed in RD 2068 under Permit No. 13490.						
FIELD_STRUCT_DESC: 6-inch coated steel gas line through the levee, 3 feet below the crown. Signs on the east side of the levee. Pipe visible on the downstream side of the roadway bridge.						
FS Date: 3/19/2014

Pipe visible on South side of Bridge at Swan Road.

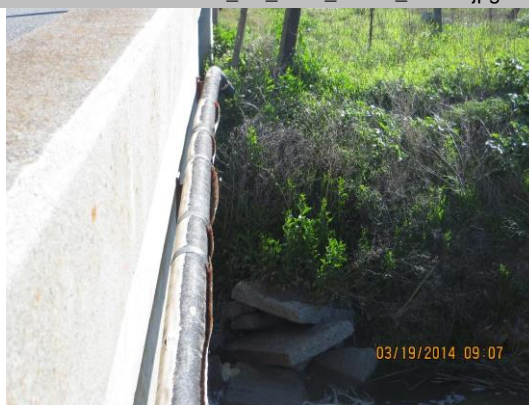
Photo 2 of 3 : UCIP_FA_2017_32566_59109.jpg

Pipe visible on South side of Bridge at Swan Road.

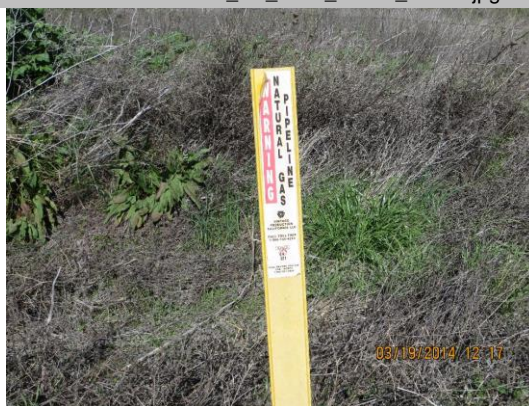
Photo 3 of 3 : UCIP_FA_2017_32566_59108.jpg

LM Start	12.07	Rating **	M	Issue No.	24 (cont)	
LM End	12.07	Issue Type +	En	Location *		
Category	Supplemental			GPS Latitude/Longitude		
				Start	End	
Item	DWR UCIP Field Study			38.358110 °	38.358110 °	
				-121.740381 °	-121.740381 °	
DWR ID						
Comment Code						
Inspector Comment						
FS_ID:32566						
DS_ID:24845						
EP_NO: N/A						
Repair Type: Non-Urgent						
Crossing Status: Found						
UCIP Comments: Need to verify status with gas company and install signs. No permit identified for crossing, though it may be connected to a permitted line installed in RD 2068 under Permit No. 13490.						
FIELD_STRUCT_DESC: 6-inch coated steel gas line through the levee, 3 feet below the crown. Signs on the east side of the levee. Pipe visible on the downstream side of the roadway bridge.						
FS Date: 3/19/2014

Sign off LS toe on East side of canal.
