**Flood Control Project Maintenance
Levee Inspections**

Fall 2018 Levee Maintenance Deficiency Summary Report

**Flood Control Project Maintenance
Levee Inspections****LMA District Cover Sheet****Fall 2018 Levee Inspection Results****Reclamation District No. 2098 Cache and Haas Slough**

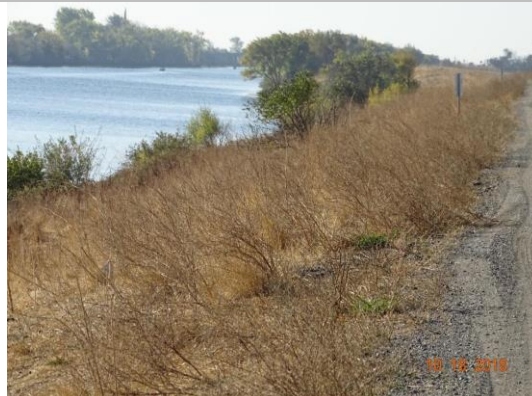
Photo 1 of 1 : FA_2018_RD2098_244_22_20181019_00060.jpg

LM Start	0.07	Rating **	M	Issue No.	22
LM End	0.67	Issue Type +	Ma	Location *	WS
Category	Earthen Levee			GPS Latitude/Longitude	
				Start	End
Item	Vegetation			38.328125 °	38.319367 °
				-121.694047 °	-121.694040 °
DWR ID	DWR_RD2098_01_f_2018_22				
Comment Code					
V1 : Control annual grass and weeds on the levee slopes and easements.					
Inspector Comment					
Manage vegetation on the water side slope.

View of vegetation on the water side slope. The vegetation is spread enough that can still see the levee but is thick enough that it should be removed (October 2018).

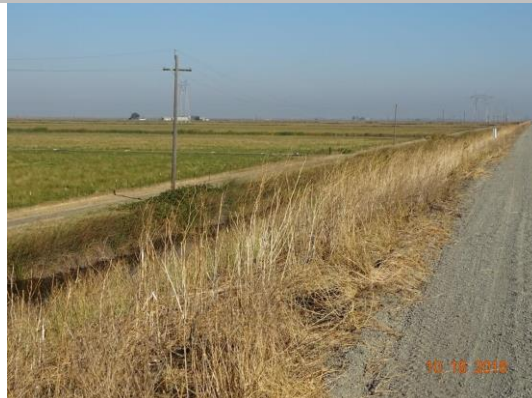
Photo 1 of 1 : FA_2018_RD2098_244_16_20181019_00061.jpg

LM Start	0.07	Rating **	M	Issue No.	16
LM End	1.01	Issue Type +	Ma	Location *	LS
Category	Earthen Levee			GPS Latitude/Longitude	
				Start	End
Item	Vegetation			38.328125 °	38.314483 °
				-121.694047 °	-121.694012 °
DWR ID	DWR_RD2098_01_f_2018_16				
Comment Code					
V1 : Control annual grass and weeds on the levee slopes and easements.					
Inspector Comment					
Remove vegetation on the land side slope.

View looking upstream at vegetation on the land side slope. Vegetation is spaced enough that still can partially see the levee slope but still should be removed (October 2018).

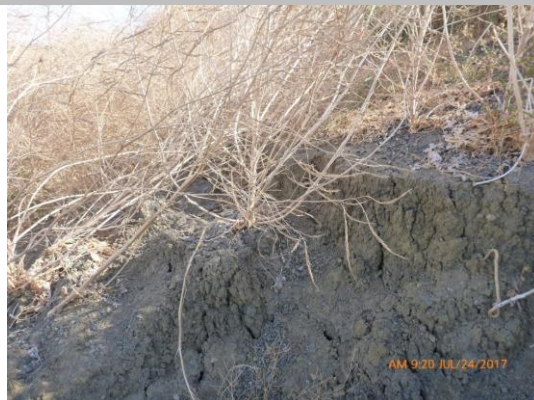
Photo 2 of 3 : LEVAL_FA_2018_414_3596.jpg

LM Start	0.96	Rating **	A/W	Issue No.	19
LM End	0.96	Issue Type +	Ma	Location *	
Category	Supplemental			GPS Latitude/Longitude	
				Start	End
Item	2017 Storm Damage			38.315200°	38.315100°
				-121.694100°	-121.694100°
DWR ID	DWR_RD2098_01_s_2018_19				
Comment Code					
Inspector Comment					
Levee Evaluation Comments					
Description:The damage consists of cracking and sloughing of the lower landside levee slope.					
Site ID No:414					
Site Designation:LMA-241					
Repair Type: Erosion					
Rating:Area of Concern					
Field Date:7/24/2017					
Notes: Landside sloughing about 2' deep and extends to toe ditch.

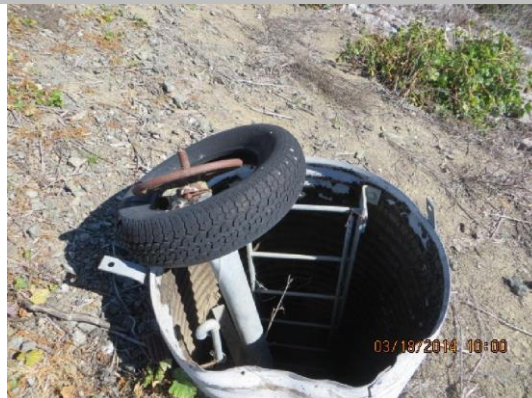
Photo 1 of 3 : UCIP_FA_2018_32207_58665.jpg

Comment Code						
Inspector Comment						
FS_ID:32207 DS_ID:20966 EP_NO: 10168 Repair Type: Non-Urgent Crossing Status: Found UCIP Comments: 12/22/2016 Met with Mike Hadesty, LMA Superintendent, and Brian Bush, LMA General Manager, to go over the list of pipes in RD2098. Per LMA records, this pipe is a drainage pipe. Need to coordinate with owner to obtain records to confirm line integrity. (O. Magana - DWR UCIP) 03/18/2014 Slide gate actuator bent but appears to be in closed position. No lid on standpipe. Appears abandoned and if so should be done so properly. (W. Wylie - DWR UCIP) FIELD_STRUCT_DESC: 24-inch drainage pipe of an unknown material through the levee, 24.5 feet below the crown. Two corrugated metal cutoff walls around the pipe at the center of the levee. Slide gate in a 36-inch corrugated metal pipe (CMP) riser on the waterside (WS) slope. Concrete saddle and apron on the WS end. Flap gate and U-shaped headwall on the landside (LS) end. (This pipe was retained under Automatic Board Order (ABO) issued as Permit No. 10168, 1974 - Moresco Brothers). [Additional Reference(s): DWR Levee Log, 2003]. FS Date: 3/18/2014

36-inch CMP riser with bent slide gate actuator on WS slope.

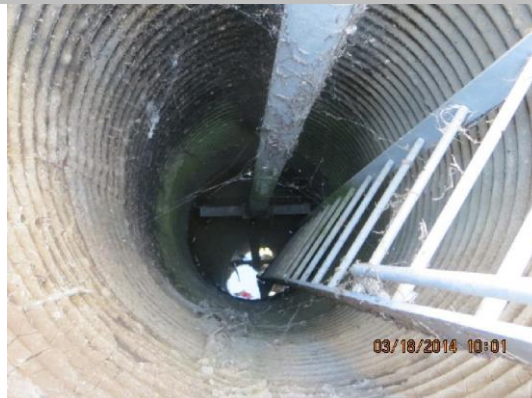
Photo 2 of 3 : UCIP_FA_2018_32207_58664.jpg

No lid on CMP riser that is 24-feet deep.

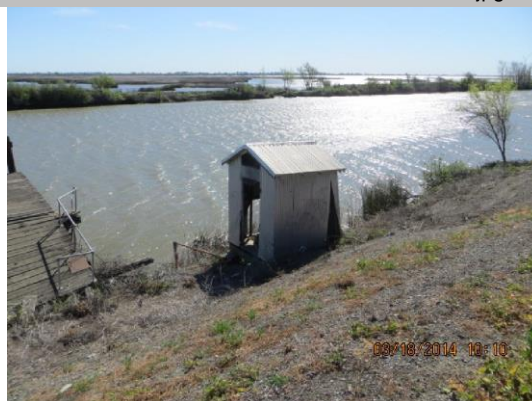
Photo 1 of 3 : UCIP_FA_2018_32225_58687.jpg

Comment Code					
Inspector Comment					
FS_ID:32225 DS_ID:20967 EP_NO: 10168 Repair Type: Non-Urgent Crossing Status: Found UCIP Comments: 12/22/2016 Met with Mike Hadesty, LMA Superintendent, and Brian Bush, LMA General Manager, to go over the list of pipes in RD2098. Per LMA, line has been abandoned. New property owner is Anderson. (O. Magana - DWR UCIP) 03/18/2014 Pipe appears abandoned and if so should be done so properly. Pipe open on WS at pumphouse as there is no connection to pump. (W. Wylie - DWR UCIP) FIELD_STRUCT_DESC: *ABANDONED* 2-inch galvanized iron irrigation pipe through the levee, 10 feet below the crown. Pump in pump house on the waterside (WS) slope next to fishing dock. Power pole and meter at the landside (LS) toe, next to hose bib. 1-inch steel electrical conduit at the same location. (This pipe was retained under Automatic Board Order (ABO) issued as Permit No. 10168, 1974 - Moresco Brothers). [Additional Reference(s): DWR Levee Log, 2003]. FS Date: 3/18/2014

Pumphouse next to fishing dock on WS slope.

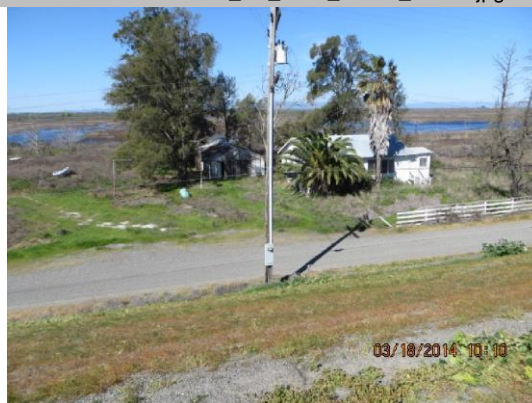
Photo 2 of 3 : UCIP_FA_2018_32225_58686.jpg

Power pole and meter next to spigot on LS toe.

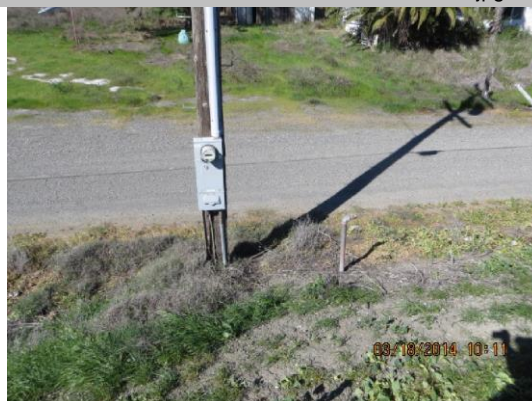
Photo 3 of 3 : UCIP_FA_2018_32225_58685.jpg

Comment Code						
Inspector Comment						
FS_ID:32225 DS_ID:20967 EP_NO: 10168 Repair Type: Non-Urgent Crossing Status: Found UCIP Comments: 12/22/2016 Met with Mike Hadesty, LMA Superintendent, and Brian Bush, LMA General Manager, to go over the list of pipes in RD2098. Per LMA, line has been abandoned. New property owner is Anderson. (O. Magana - DWR UCIP) 03/18/2014 Pipe appears abandoned and if so should be done so properly. Pipe open on WS at pumphouse as there is no connection to pump. (W. Wylie - DWR UCIP) FIELD_STRUCT_DESC: *ABANDONED* 2-inch galvanized iron irrigation pipe through the levee, 10 feet below the crown. Pump in pump house on the waterside (WS) slope next to fishing dock. Power pole and meter at the landside (LS) toe, next to hose bib. 1-inch steel electrical conduit at the same location. (This pipe was retained under Automatic Board Order (ABO) issued as Permit No. 10168, 1974 - Moresco Brothers). [Additional Reference(s): DWR Levee Log, 2003]. FS Date: 3/18/2014

Power pole and meter next to spigot on LS toe.

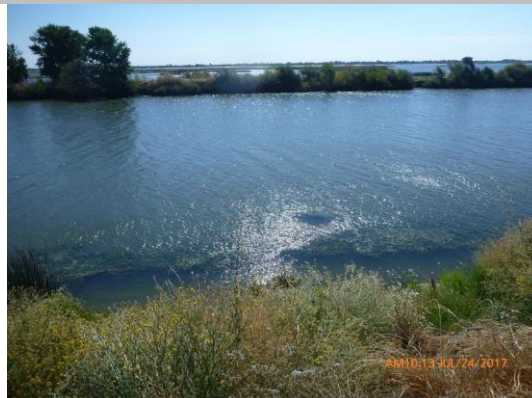
Photo 1 of 3 : LEVAL_FA_2018_416_2726.jpg

LM Start	2.21	Rating **	A/W	Issue No.	21
LM End	2.22	Issue Type +	Ma	Location *	
Category	Supplemental			GPS Latitude/Longitude	
				Start	End
Item	2017 Storm Damage			38.297100°	38.297000°
				-121.693300°	-121.693300°
DWR ID	DWR_RD2098_01_s_2018_21				
Comment Code					
Inspector Comment					
Levee Evaluation Comments					
Description:The damage consists of erosion, cracking, and sloughing of the waterside levee slope.					
Site ID No:416					
Site Designation:LMA-243					
Repair Type: Erosion					
Rating:Serious					
Field Date:7/24/2017					
Notes: Erosion with sloughing. About 2' vertical cut at top of erosion.

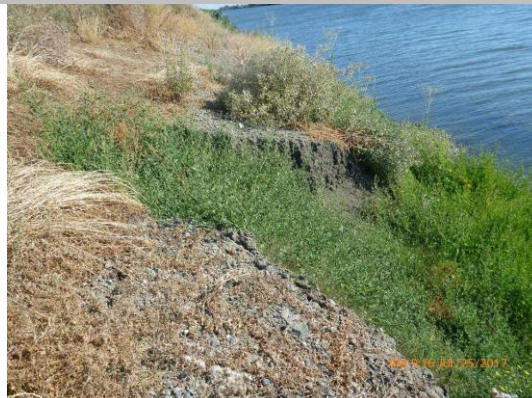
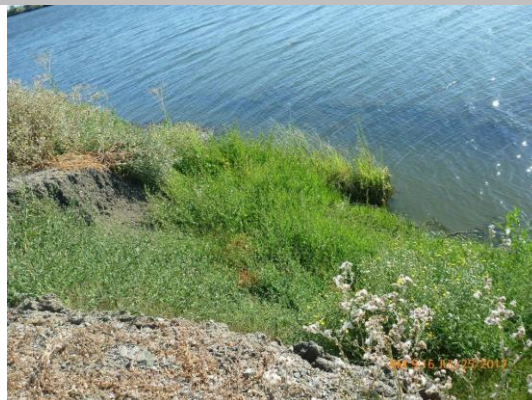
LM Start	2.75	Rating **	A/W	Issue No.	34
LM End	2.78	Issue Type +	Ma	Location *	
Category	Supplemental			GPS Latitude/Longitude	
				Start	End
Item	2017 Storm Damage			38.289200 °	38.288800 °
				-121.693500 °	-121.693500 °
DWR ID	DWR_RD2098_01_f_2017_34				
Comment Code					
Inspector Comment					
Levee Evaluation Comments					
Description:The damage consists of scour and sloughing of the waterside levee slope.					
Site ID No:429					
Site Designation:LMA-256					
Repair Type: Erosion					
Rating:Serious					
Field Date:7/25/2017					
Notes: Erosion at WS toe, causing sloughing half-way down WS slope.

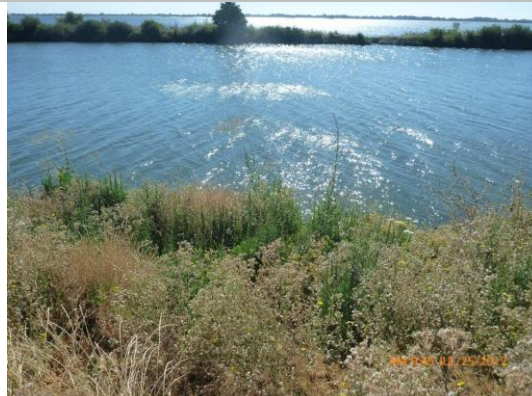
Photo 2 of 3 : FA_2018_RD2098_244_35_20180925_00022.jpg

LM Start	2.78	Rating **	A/W	Issue No.	35 (cont)
LM End	2.81	Issue Type +	Ma	Location *	
Category	Supplemental			GPS Latitude/Longitude	
				Start	End
Item	2017 Storm Damage			38.288800 °	38.288400 °
				-121.693500 °	-121.693500 °
DWR ID	DWR_RD2098_01_f_2017_35				
Comment Code					
Inspector Comment					
Levee Evaluation Comments					
Description:The damage consists of scour and sloughing of the waterside levee slope.					
Site ID No:430					
Site Designation:LMA-257					
Repair Type: Erosion					
Rating:Serious					
Field Date:7/25/2017					
Notes: Erosion at waterside toe, causing sloughing 2/3 down waterside slope.

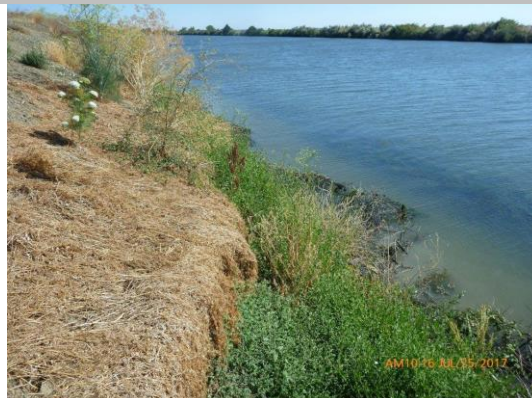
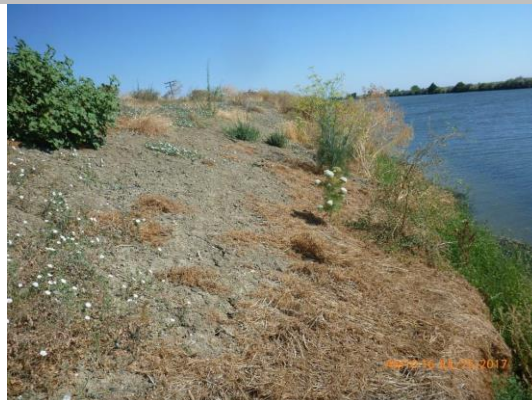
LM Start	2.99	Rating **	A/W	Issue No.	37 (cont)	
LM End	3.29	Issue Type +	Ma	Location *		
Category	Supplemental			GPS Latitude/Longitude		
				Start	End	
Item	2017 Storm Damage			38.285700 °	38.281500 °	
				-121.693500 °	-121.694300 °	
DWR ID	DWR_RD2098_01_f_2017_37					
Comment Code						
Inspector Comment						
Levee Evaluation Comments						
Description:The damage consists of scour and sloughing of the waterside levee slope.						
Site ID No:432						
Site Designation:LMA-259						
Repair Type: Erosion						
Rating:Serious						
Field Date:7/25/2017						
Notes: Varying erosion and sloughing at WS toe. Revetment at end of levee section.

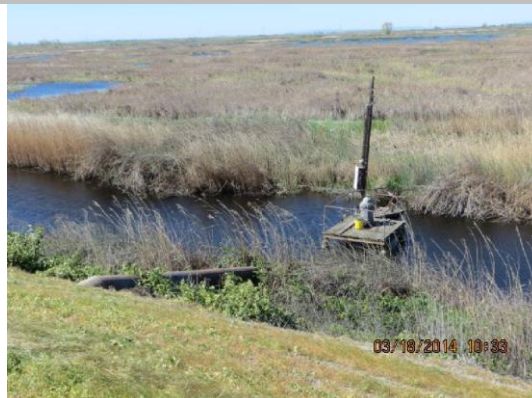
Photo 1 of 3 : UCIP_FA_2018_32227_58692.jpg

Pump on pile structure in drainage channel on LS toe.

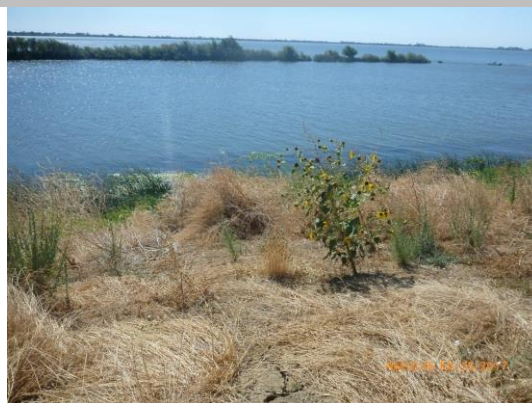
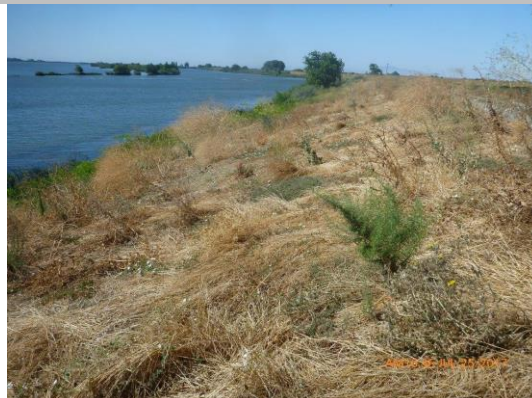
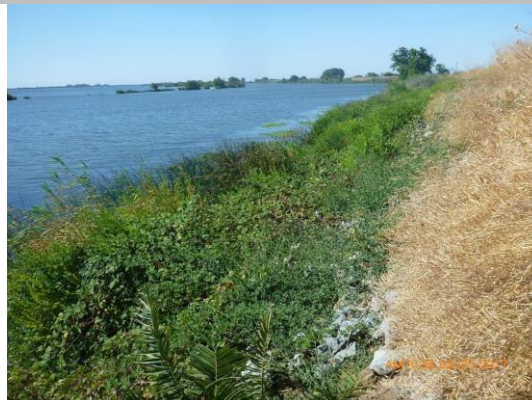
LM Start	3.31	Rating **	A/W	Issue No.	39
LM End	3.32	Issue Type +	Ma	Location *	
Category	Supplemental			GPS Latitude/Longitude	
				Start	End
Item	2017 Storm Damage			38.281200 °	38.281100 °
				-121.694500 °	-121.694600 °
DWR ID	DWR_RD2098_01_f_2017_39				
Comment Code					
Inspector Comment					
Levee Evaluation Comments					
Description:The damage consists of scour and sloughing of the lower waterside levee slope.					
Site ID No:433					
Site Designation:LMA-260					
Repair Type: Erosion					
Rating:Area of Concern					
Field Date:7/25/2017					
Notes: Two combined erosion sites (260 and 261) adjacent to each other at WS toe. Existing rip rap placed at area of concern.

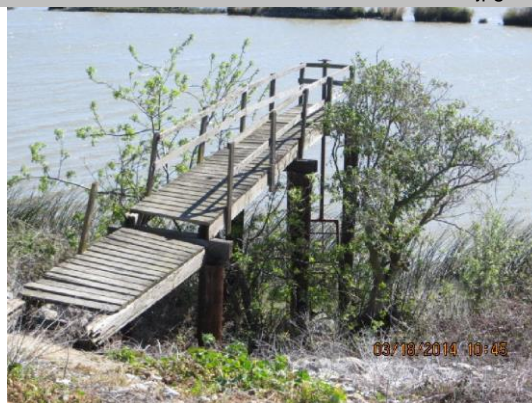
Photo 1 of 3 : UCIP_FA_2018_32243_58702.jpg

Comment Code					
Inspector Comment					
FS_ID:32243 DS_ID:20970 EP_NO: 10168 Repair Type: Non-Urgent Crossing Status: Found UCIP Comments: 03/18/2014 Walkway to slidegate on WS toe is in poor structural condition and may not be safe for accessing the slide gate actuator. Pipe appears abandoned and if so should be done so properly. Outlet on LS toe may be buried. (W. Wylie - DWR UCIP) FIELD_STRUCT_DESC: 24-inch steel irrigation pipe through the levee, 22.3 feet below the crown. Slide gate on the waterside (WS) end. Walkway from the WS shoulder to the slide gate control. Flap gate on the landside (LS) end. (This pipe was retained under Automatic Board Order (ABO) issued as Permit No. 10168, 1974 - Moresco Brothers). [Additional Reference(s): DWR Levee Log, 2003]. FS Date: 3/18/2014

Walkway to slide gate actuator on WS toe.

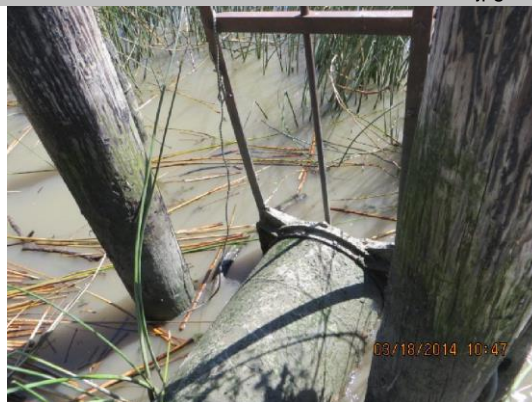
Photo 3 of 3 : UCIP_FA_2018_32243_58700.jpg

Slidegate on WS toe at pipe.

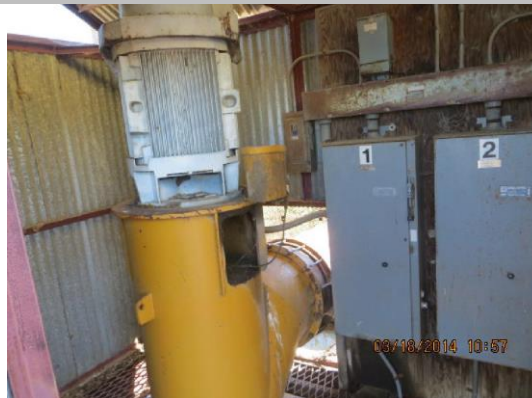
Photo 1 of 3 : UCIP_FA_2018_41717_58704.jpg

Pump in pumphouse on LS toe.

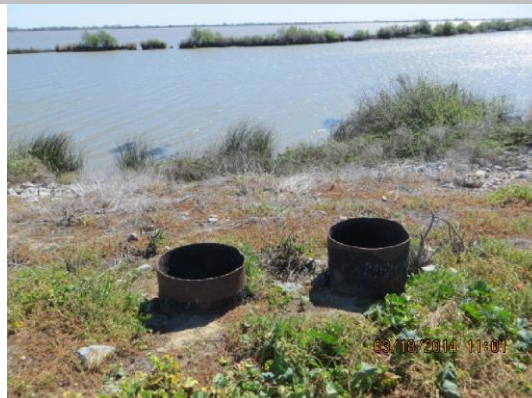
Photo 3 of 3 : UCIP_FA_2018_41717_58707.jpg

Comment Code						
Inspector Comment						
FS_ID:41717 DS_ID:20971 EP_NO: 15169 Repair Type: Non-Urgent Crossing Status: Found UCIP Comments: 12/22/2016 Met with Mike Hadesty, LMA Superintendent, and Brian Bush, LMA General Manager, to go over the list of pipes in RD2098. Per LMA, pipe is a drainage pipe. New property owner is John Anderson. (O. Magana - DWR UCIP) 03/18/2014 Debris and soil buildup in riser may prevent proper function of siphon breaker. (W. Wylie - DWR UCIP) FIELD_STRUCT_DESC: 1 of 2: 24-inch coated steel drainage pipe through the levee, 5.6 feet below the crown. Cutoff wall around the pipe at the center of the levee. Siphon breaker at the waterside (WS) shoulder. Flap gate on the WS end. Pump in pump house on piling structure on the landside (LS). (Permit No. 15169, 1989 - Maxim Development). [Additional Reference(s): DWR Levee Log, 2003]. FS Date: 3/18/2014

Siphon breaker in 24-inch steel riser on WS shoulder.

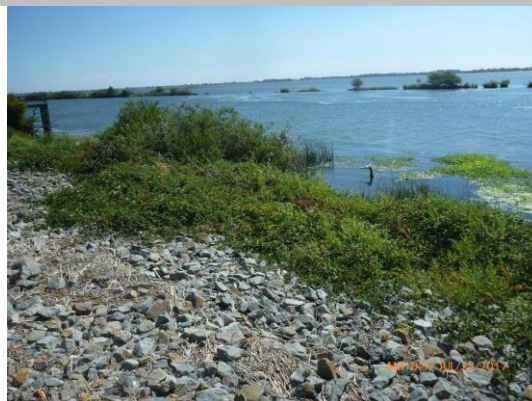
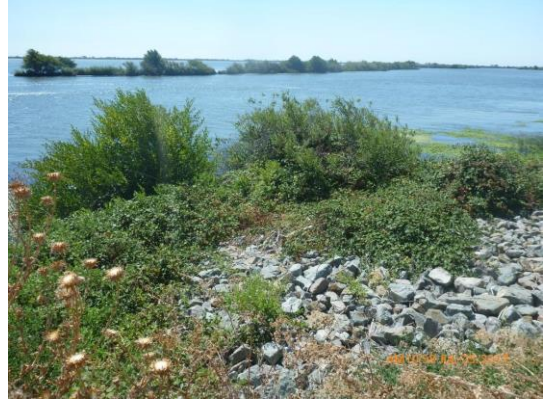
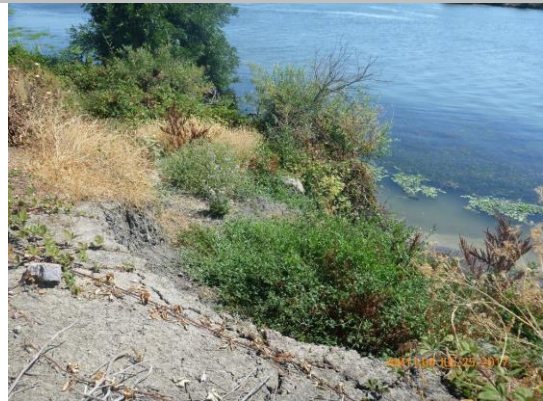
LM Start	3.50	Rating **	M	Issue No.	40
LM End	3.56	Issue Type +	Ma	Location *	
Category	Supplemental			GPS Latitude/Longitude	
				Start	End
Item	2017 Storm Damage			38.278700 °	38.278000 °
				-121.695900 °	-121.696100 °
DWR ID	DWR_RD2098_01_f_2017_40				
Comment Code					
Inspector Comment					
Levee Evaluation Comments					
Description:The damage consists of scour and sloughing of the lower and mid waterside levee slope.					
Site ID No:435					
Site Designation:LMA-262					
Repair Type: Erosion					
Rating:Area of Concern					
Field Date:7/25/2017					
Notes: Two combined sloughing sites adjacent to each other on lower waterside slope. Existing rip rap on beginning 100' section of site 262.					
This site is combined with site 263.

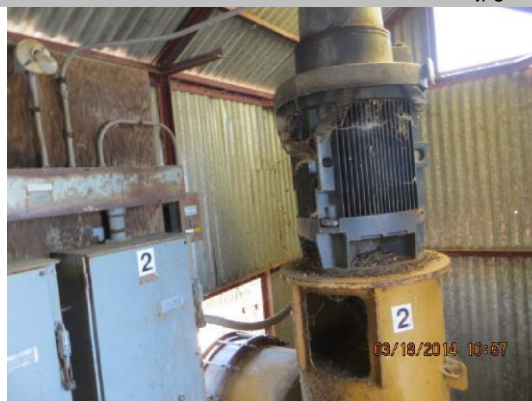
Photo 1 of 3 : UCIP_FA_2018_32245_58710.jpg

LM Start	3.50	Rating **	M	Issue No.	47 (cont)
LM End	3.50	Issue Type +	En	Location *

Pump in pumphouse on LS toe.

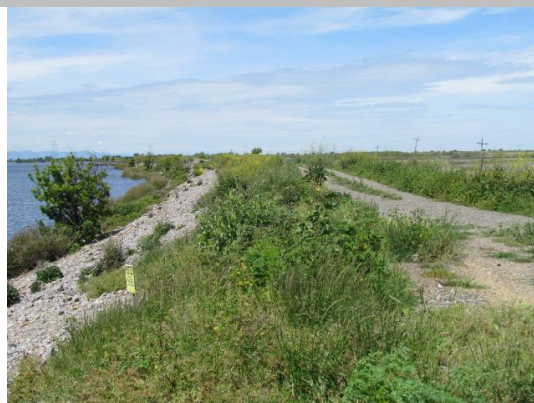
Photo 1 of 1 : FA_2018_RD2098_246_9_20180925_00002.jpg

LM Start	5.30	Rating **	M	Issue No.	9
LM End	5.56	Issue Type +	Ma	Location *	WS
Category	Earthen Levee			GPS Latitude/Longitude	
				Start	End
Item	Vegetation			38.275757 °	38.278863 °
				-121.705818 °	-121.708687 °
DWR ID	DWR_RD2098_02_s_2017_9				
Comment Code					
V2 : Remove the wild growth other than native grasses from the levee slopes.					
Inspector Comment					
Remove the wild weed growth from the waterside levee slope.

RD 2098 Unit 2 levee mile 5.30- 7.14 waterside levee slope and shoulder.

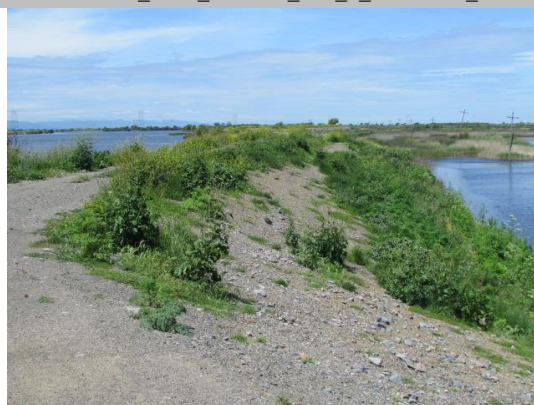
Photo 1 of 1 : FA_2018_RD2098_246_8_20180925_00001.jpg

LM Start	5.48	Rating **	M	Issue No.	8
LM End	5.61	Issue Type +	Ma	Location *	LS
Category	Earthen Levee			GPS Latitude/Longitude	
				Start	End
Item	Vegetation			38.277922 °	38.279443 °
				-121.707698 °	-121.709233 °
DWR ID	DWR_RD2098_02_s_2017_8				
Comment Code					
V2 : Remove the wild growth other than native grasses from the levee slopes.					
Inspector Comment					
Remove the wild weed growth from the landside levee slope and berm.

RD 2098 Unit 2 Levee mile 5.30-7.14 wild growth on the landside slope.

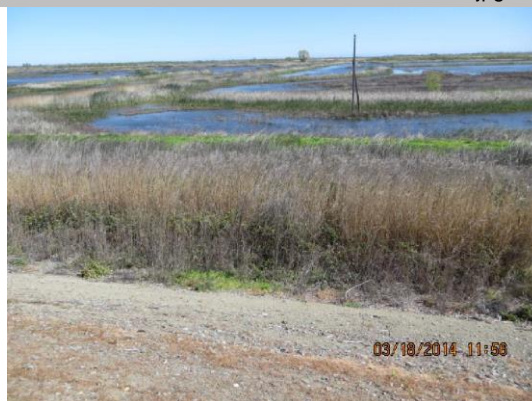
Photo 1 of 3 : UCIP_FA_2018_32287_58755.jpg

Comment Code					
Inspector Comment					
FS_ID:32287 DS_ID:20973 EP_NO: 10172 Repair Type: Non-Urgent Crossing Status: Found UCIP Comments: 12/22/2016 Met with Mike Hadesty, LMA Superintendent, and Brian Bush, LMA General Manager, to go over the list of pipes in RD2098. Per LMA, pipe is a drainage pipe. (O. Magana - DWR UCIP) 03/18/2014 Pipe appears abandoned and if so should be done so properly. Slide gate appears to be open and should be closed for the season. (W. Wylie - DWR UCIP) FIELD_STRUCT_DESC: 24-inch corrugated metal drainage pipe through the levee, 22.8 feet below the crown. Two cutoff walls around the pipe at the levee shoulders. Slide gate in 36-inch corrugated metal pipe (CMP) riser on the waterside (WS) slope. Flap gate and concrete U-shaped headwall on the landside (LS) end. (This pipe was retained under Automatic Board Order (ABO) issued as Permit No. 10172, 1974 - Moresco Brothers). [Additional Reference(s): DWR Levee Log, 2003]. FS Date: 3/18/2014

LS - no pipe visible.

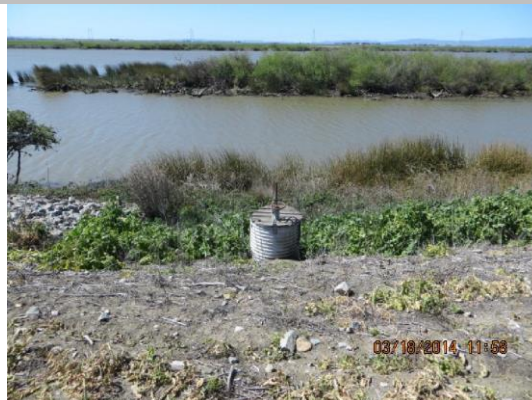
Photo 2 of 3 : UCIP_FA_2018_32287_58754.jpg

Slide gate in 36-inch standpipe on WS slope.

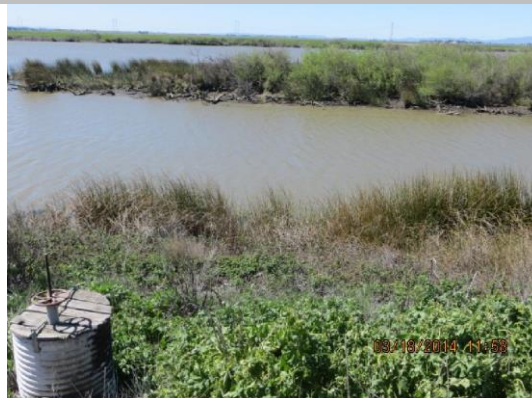
Photo 3 of 3 : UCIP_FA_2018_32287_58753.jpg

Comment Code						
Inspector Comment						
FS_ID:32287 DS_ID:20973 EP_NO: 10172 Repair Type: Non-Urgent Crossing Status: Found UCIP Comments: 12/22/2016 Met with Mike Hadesty, LMA Superintendent, and Brian Bush, LMA General Manager, to go over the list of pipes in RD2098. Per LMA, pipe is a drainage pipe. (O. Magana - DWR UCIP) 03/18/2014 Pipe appears abandoned and if so should be done so properly. Slide gate appears to be open and should be closed for the season. (W. Wylie - DWR UCIP) FIELD_STRUCT_DESC: 24-inch corrugated metal drainage pipe through the levee, 22.8 feet below the crown. Two cutoff walls around the pipe at the levee shoulders. Slide gate in 36-inch corrugated metal pipe (CMP) riser on the waterside (WS) slope. Flap gate and concrete U-shaped headwall on the landside (LS) end. (This pipe was retained under Automatic Board Order (ABO) issued as Permit No. 10172, 1974 - Moresco Brothers). [Additional Reference(s): DWR Levee Log, 2003]. FS Date: 3/18/2014

Slide gate in 36-inch standpipe on WS slope.

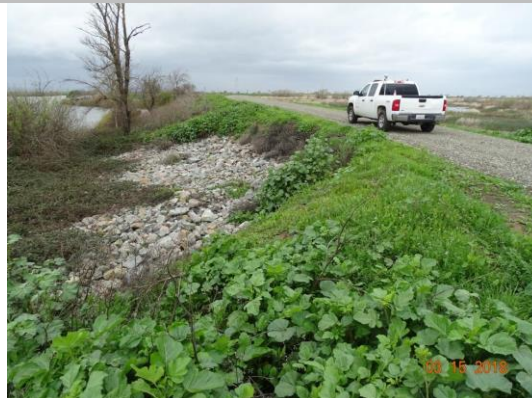
Photo 1 of 1 : FA_2018_RD2098_246_11_20180925_00004.jpg

LM Start	5.88	Rating **	M	Issue No.	11
LM End	5.88	Issue Type +	Ma	Location *	WS
Category	Earthen Levee			GPS Latitude/Longitude	
				Start	End
Item	Erosion / Bank Caving			38.282946 °	38.282946 °
				-121.710902 °	-121.710902 °
DWR ID	DWR_RD2098_02_s_2018_11				
Comment Code					
E2 : Schedule repair of erosion site prior to the next inspection.					
Inspector Comment					
This waterside slump site is not new, and is somewhat protected by riprap and thick brushy vegetation, but it has the potential to erode into crown during high water with a strong south wind. It currently has a two-foot vertical scarp at the levee shoulder. It should be repaired.

Repair slumping on waterside slope.

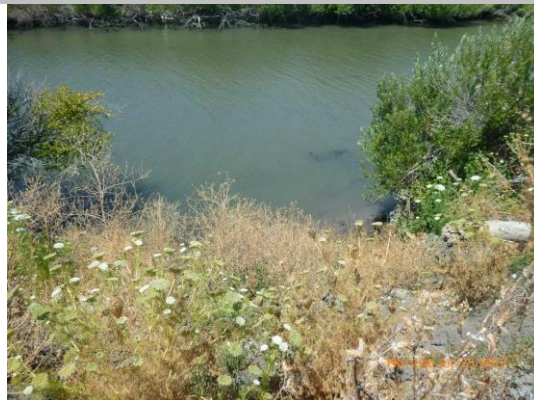
Photo 1 of 3 : FA_2018_RD2098_246_15_20180925_00005.jpg

LM Start	6.46	Rating **	A/W	Issue No.	15
LM End	6.46	Issue Type +	Ma	Location *	
Category	Supplemental			GPS Latitude/Longitude	
				Start	End
Item	2017 Storm Damage			38.288700 °	38.288800 °
				-121.717000 °	-121.717000 °
DWR ID	DWR_RD2098_02_f _ 2017_15				
Comment Code					
Inspector Comment					
Levee Evaluation Comments					
Description:The damage consists of scour of the lower and mid waterside levee slope.					
Site ID No:440					
Site Designation:LMA-267					
Repair Type: Erosion					
Rating:Area of Concern					
Field Date:7/25/2017					
Notes: Sloughing on waterside slope due to toe erosion.

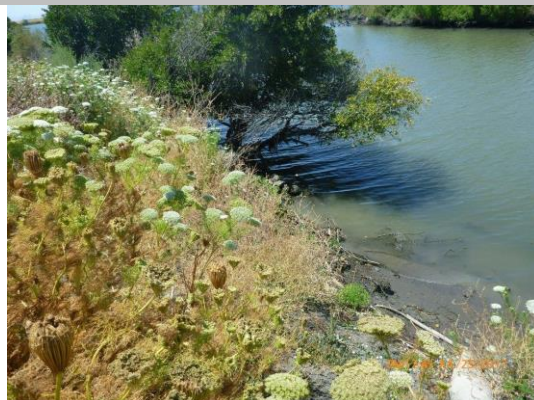
Photo 2 of 3 : FA_2018_RD2098_246_15_20180925_00006.jpg

LM Start	6.46	Rating **	A/W	Issue No.	15 (cont)
LM End	6.46	Issue Type +	Ma	Location *

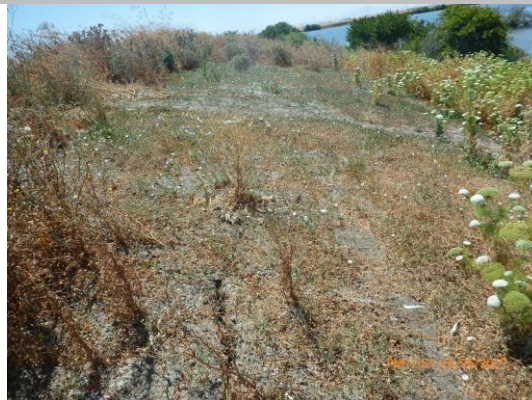
Photo 2 of 3 : FA_2018_RD2098_246_17_20180925_00009.jpg

LM Start	6.47	Rating **	A/W	Issue No.	17 (cont)
LM End	6.48	Issue Type +	Ma	Location *	
Category	Supplemental			GPS Latitude/Longitude	
				Start	End
Item	2017 Storm Damage			38.288900 °	38.289000 °
				-121.717000 °	-121.717000 °
DWR ID	DWR_RD2098_02_f _ 2017_17				
Comment Code					
Inspector Comment					
Levee Evaluation Comments					
Description:The damage consists of scour and sloughing of the lower and mid waterside levee slope.					
Site ID No:441					
Site Designation:LMA-268					
Repair Type: Erosion					
Rating:Area of Concern					
Field Date:7/25/2017					
Notes: Sloughing on waterside slope due to toe erosion.

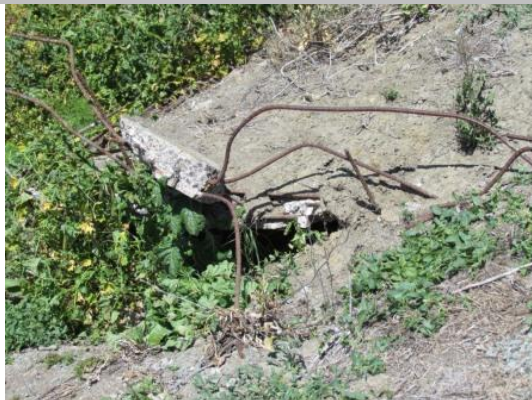
Photo 1 of 1 : FA_2018_RD2098_246_10_20180925_00003.jpg

LM Start	6.70	Rating **	M	Issue No.	10
LM End	6.70	Issue Type +	En	Location *	WS
Category	Earthen Levee			GPS Latitude/Longitude	
				Start	End
Item	Encroachments			38.292076 °	38.292076 °
				-121.715792 °	-121.715792 °
DWR ID	DWR_RD2098_02_s_2014_10				
Comment Code					
MA : Material					
Inspector Comment					
Large concrete slab partially buried on waterside slope should be removed.

There is some slope damage at this location under this concrete. No new photo; RD will send crew out to check area out.

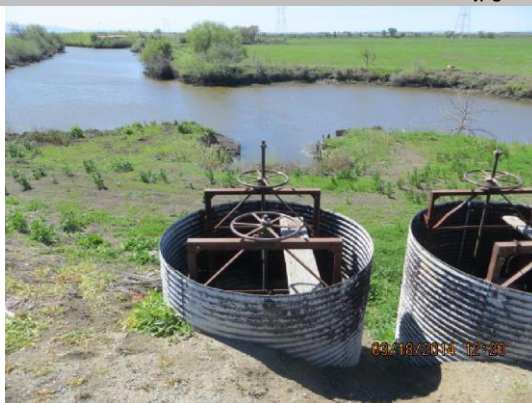
Photo 1 of 3 : UCIP_FA_2018_33784_61162.jpg

Comment Code						
Inspector Comment						
FS_ID:33784						
DS_ID:20976						
EP_NO: 10172						
Repair Type: Non-Urgent						
Crossing Status: Found						
UCIP Comments: 03/18/2014 Headwalls on WS toe failing at outlet. It is unclear if these were permanent installations or something that was installed as a temporary fix. (W. Wylie - DWR UCIP)						
FIELD_STRUCT_DESC: 1 of 2: 48-inch corrugated metal drainage pipe through the levee, 29 feet below the crown. Two slide gates in a 7-foot-diameter corrugated metal pipe (CMP) riser on the waterside (WS) slope. (two 48-inch [HLM 6.75] authorized under Automatic Board Order (ABO) issued as Permit No. 10172, 1974 - Moresco Brothers).						
[Additional Reference(s): DWR Levee Log, 2003. USACE Sacramento O&M Manual 109, April 1962, (HLM 6.75)].						
FS Date: 3/18/2014

Two slide gates in 7-foot diameter CMP riser on waterward slope.

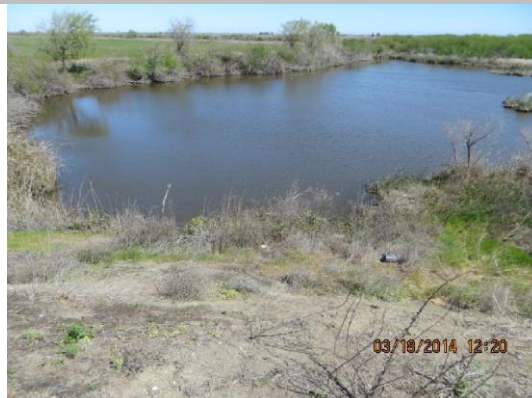
Photo 2 of 3 : UCIP_FA_2018_33784_61161.jpg

Comment Code						
Inspector Comment						
FS_ID:33784						
DS_ID:20976						
EP_NO: 10172						
Repair Type: Non-Urgent						
Crossing Status: Found						
UCIP Comments: 03/18/2014 Headwalls on WS toe failing at outlet. It is unclear if these were permanent installations or something that was installed as a temporary fix. (W. Wylie - DWR UCIP)						
FIELD_STRUCT_DESC: 1 of 2: 48-inch corrugated metal drainage pipe through the levee, 29 feet below the crown. Two slide gates in a 7-foot-diameter corrugated metal pipe (CMP) riser on the waterside (WS) slope. (two 48-inch [HLM 6.75] authorized under Automatic Board Order (ABO) issued as Permit No. 10172, 1974 - Moresco Brothers).						
[Additional Reference(s): DWR Levee Log, 2003. USACE Sacramento O&M Manual 109, April 1962, (HLM 6.75)].						
FS Date: 3/18/2014

Inlet not visible on LS toe.

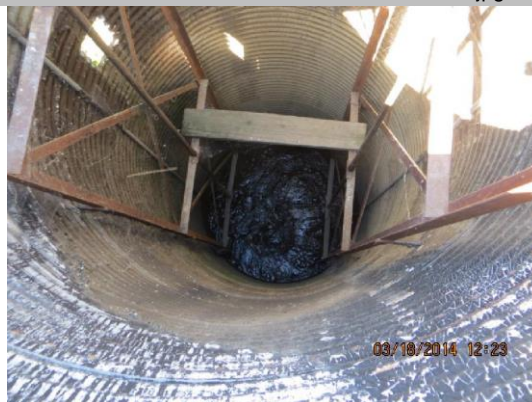
Photo 3 of 3 : UCIP_FA_2018_33784_61160.jpg

View inside CMP riser on WS shoulder.

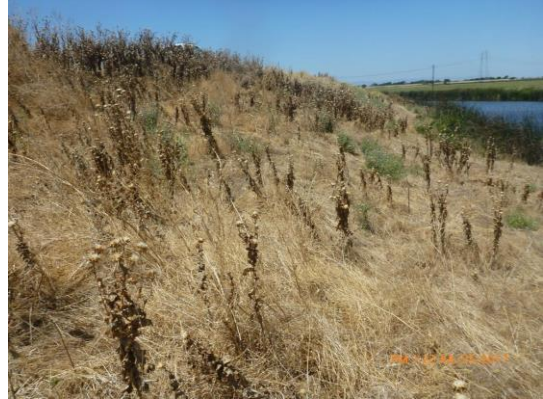
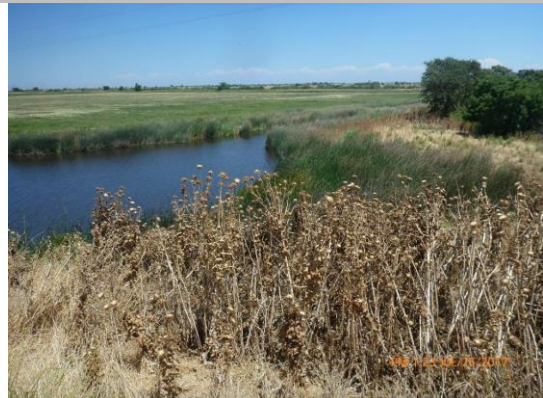
LM Start	6.74	Rating **	M	Issue No.	19
LM End	6.75	Issue Type +	Ma	Location *	LS
Category	Supplemental			GPS Latitude/Longitude	
				Start	End
Item	2017 Storm Damage			38.292500 °	38.292600 °
				-121.716100 °	-121.716200 °
DWR ID	DWR_RD2098_02_f_2017_19				
Comment Code					
Inspector Comment					
Levee Evaluation Comments					
Description:The damage consists of scour and sloughing of the					
landside levee slope.					
Site ID No:443					
Site Designation:LMA-270					
Repair Type: Stability					
Rating:Area of Concern					
Field Date:7/25/2017					
Notes: Sloughing on crown into upper portion of landside levee slope.

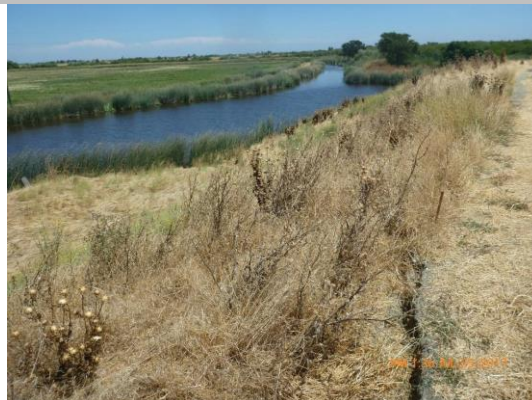
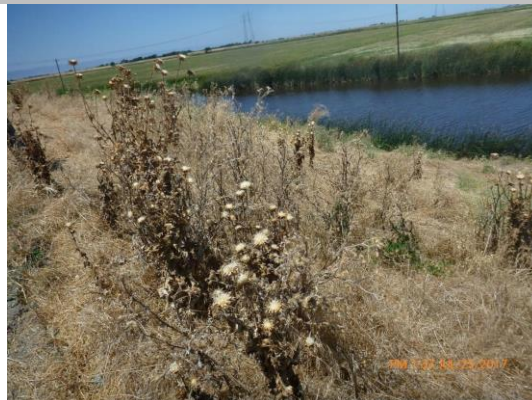
LM Start	6.77	Rating **	M	Issue No.	20
LM End	6.80	Issue Type +	Ma	Location *	LS
Category	Supplemental			GPS Latitude/Longitude	
				Start	End
Item	2017 Storm Damage			38.292900 °	38.293000 °
				-121.716600 °	-121.717000 °
DWR ID	DWR_RD2098_02_f_2017_20				
Comment Code					
Inspector Comment					
Levee Evaluation Comments					
Description:The damage consists of cracking of the levee crest.					
Site ID No:444					
Site Designation:LMA-271					
Repair Type: Erosion					
Rating:Area of Concern					
Field Date:7/25/2017					
Notes: Two combined sloughing locations (271 and 272) within levee crown into waterside and landside slopes. Sloughing on landside slope bulges into ditch at toe.

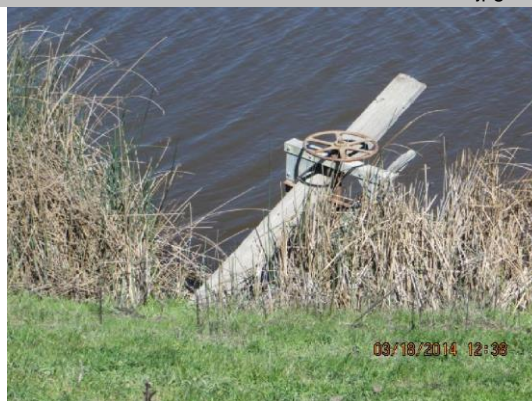
Photo 1 of 3 : UCIP_FA_2018_32290_58764.jpg

Comment Code					
Inspector Comment					
FS_ID:32290 DS_ID:20977 EP_NO: 10171 Repair Type: Non-Urgent Crossing Status: Found UCIP Comments: 12/22/2016 Met with Mike Hadesty, LMA Superintendent, and Brian Bush, LMA General Manager, to go over the list of pipes in RD2098. Per LMA, pipe is a drainage pipe.(O. Magana - DWR UCIP) 03/18/2014 Pipe appears to be abandoned and if so it should be done so properly. Walkway to gate valve actuator on WS slope is in disrepair and does not appear to be safe for use. (W. Wylie - DWR UCIP) FIELD_STRUCT_DESC: 36-inch corrugated metal drainage pipe through the levee, 23 feet below the crown. Walkway to slide gate on the waterside (WS) end. Slide gate at the landside (LS) toe. (This pipe was retained under Automatic Board Order (ABO) issued as Permit No. 10171, 1974 - Glenn A. Bowlsbey). [Additional Reference(s): DWR Levee Log, 2003. USACE Sacramento O&M Manual 109, April 1962, (HLM 7.23)]. FS Date: 3/18/2014

Slide gate at LS toe.

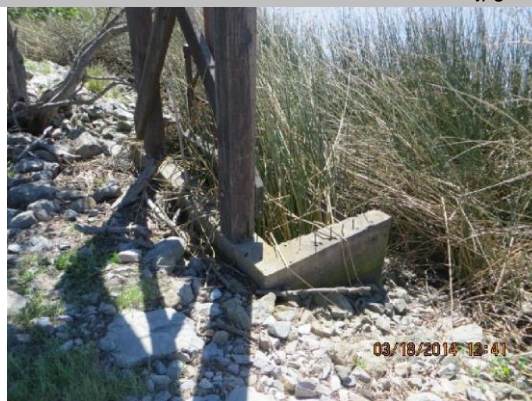
Photo 3 of 3 : UCIP_FA_2018_32290_58762.jpg

Comment Code						
Inspector Comment						
FS_ID:32290 DS_ID:20977 EP_NO: 10171 Repair Type: Non-Urgent Crossing Status: Found UCIP Comments: 12/22/2016 Met with Mike Hadesty, LMA Superintendent, and Brian Bush, LMA General Manager, to go over the list of pipes in RD2098. Per LMA, pipe is a drainage pipe.(O. Magana - DWR UCIP) 03/18/2014 Pipe appears to be abandoned and if so it should be done so properly. Walkway to gate valve actuator on WS slope is in disrepair and does not appear to be safe for use. (W. Wylie - DWR UCIP) FIELD_STRUCT_DESC: 36-inch corrugated metal drainage pipe through the levee, 23 feet below the crown. Walkway to slide gate on the waterside (WS) end. Slide gate at the landside (LS) toe. (This pipe was retained under Automatic Board Order (ABO) issued as Permit No. 10171, 1974 - Glenn A. Bowlsbey). [Additional Reference(s): DWR Levee Log, 2003. USACE Sacramento O&M Manual 109, April 1962, (HLM 7.23)]. FS Date: 3/18/2014

Concrete U-shaped headwall on WS toe.

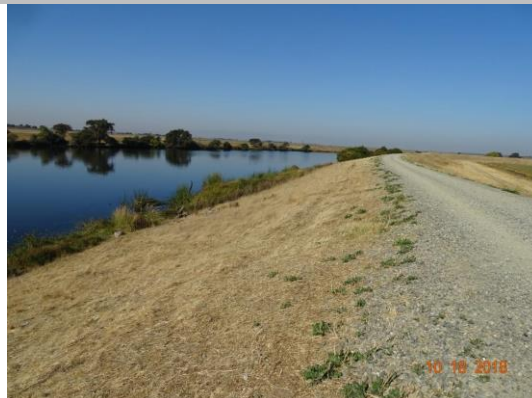
Photo 1 of 1 : FA_2018_RD2098_247_11_20181019_00022.jpg

LM Start	7.37	Rating **	A	Issue No.	11
LM End	8.22	Issue Type +	Ma	Location *	WS
Category	Earthen Levee			GPS Latitude/Longitude	
				Start	End
Item	Vegetation			38.295418 °	38.305932 °
				-121.725657 °	-121.730000 °
DWR ID	DWR_RD2098_03_f_2016_11				
Comment Code					
V2 : Remove the wild growth other than native grasses from the levee slopes.					
Inspector Comment					
Waterside vegetation is acceptable; continue to maintain.

View looking upstream of acceptable vegetation on the water side slope (October 2018).

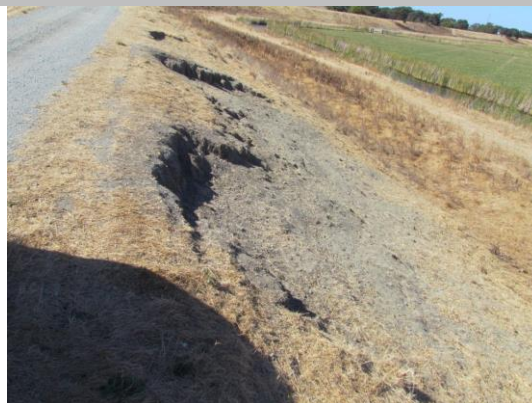
Photo 1 of 3 : FA_2018_RD2098_247_1_20180925_00001.jpg

LM Start	7.51	Rating **	M	Issue No.	1
LM End	7.51	Issue Type +	Ma	Location *	LS
Category	Earthen Levee			GPS Latitude/Longitude	
				Start	End
Item	Slope Stability			38.296846 °	38.296846 °
				-121.727546 °	-121.727546 °
DWR ID	DWR_RD2098_03_f_2016_1				
Comment Code					
S2 : Repair the levee slope damaged by foot traffic and prevent access where possible.					
Inspector Comment					
Make the repairs to the erosion site listed.

Close up. Looking upstream.

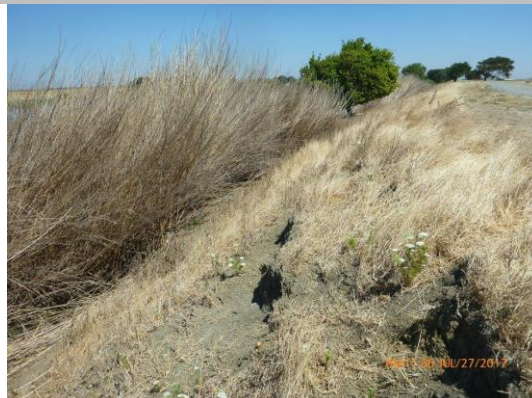
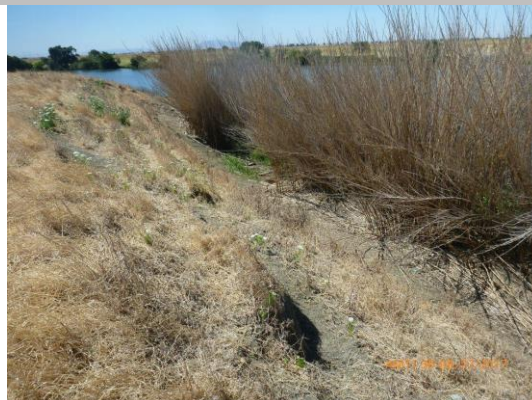
LM Start	7.61	Rating **	M	Issue No.	10 (cont)	
LM End	7.62	Issue Type +	Ma	Location *		
Category	Supplemental			GPS Latitude/Longitude		
				Start		End
Item	2017 Storm Damage			38.297900 °		38.298100 °
				-121.728900 °		-121.728900 °
DWR ID	DWR_RD2098_03_f _ 2017_10					
Comment Code						
Inspector Comment						
Levee Evaluation Comments						
Description:The damage consists of sloughing of the lower and mid waterside levee slope.						
Site ID No:449						
Site Designation:LMA-276						
Repair Type: Erosion						
Rating:Area of Concern						
Field Date:7/27/2017						
Notes: Sloughing on waterside slope due to erosion at waterside toe.

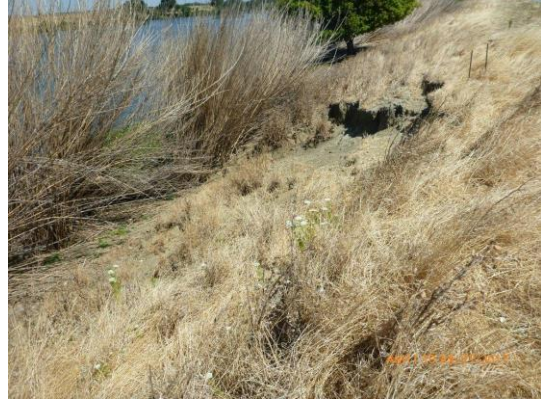
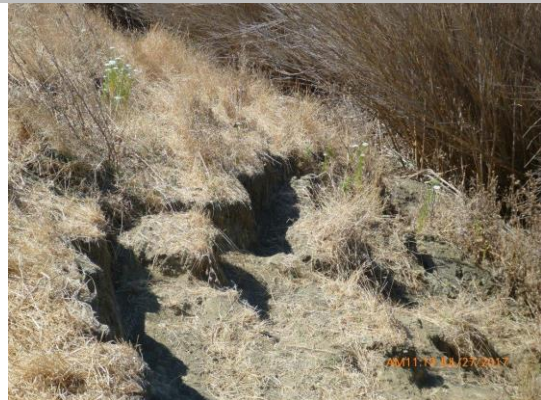
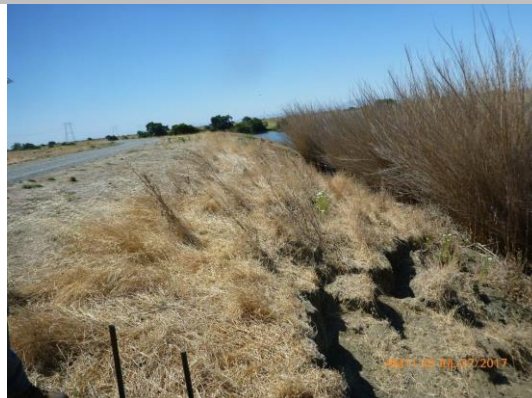
LM Start	7.63	Rating **	M	Issue No.	13
LM End	7.64	Issue Type +	Ma	Location *	
Category	Supplemental			GPS Latitude/Longitude	
				Start	End
Item	2017 Storm Damage			38.298300 °	38.298400 °
				-121.728800 °	-121.728800 °
DWR ID	DWR_RD2098_03_f_2017_13				
Comment Code					
Inspector Comment					
Levee Evaluation Comments					
Description:The damage consists of scour and sloughing of the waterside levee slope.					
Site ID No:450					
Site Designation:LMA-277					
Repair Type: Erosion					
Rating:Area of Concern					
Field Date:7/27/2017					
Notes: Sloughing on waterside due to waterside toe erosion.

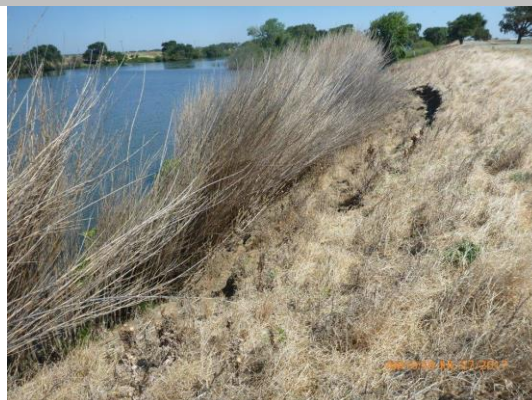
Photo 1 of 3 : FA_2018_RD2098_247_15_20180925_00014.jpg

LM Start	7.66	Rating **	M	Issue No.	15
LM End	7.68	Issue Type +	Ma	Location *	
Category	Supplemental			GPS Latitude/Longitude	
				Start	End
Item	2017 Storm Damage			38.298700 °	38.299000 °
				-121.728700 °	-121.728600 °
DWR ID	DWR_RD2098_03_f _ 2017_15				
Comment Code					
Inspector Comment					
Levee Evaluation Comments					
Description:The damage consists of scour and sloughing of the lower and mid waterside levee slope.					
Site ID No:451					
Site Designation:LMA-278					
Repair Type: Erosion					
Rating:Area of Concern					
Field Date:7/27/2017					
Notes: Sloughing on waterside slope due to watwrside toe erosion.

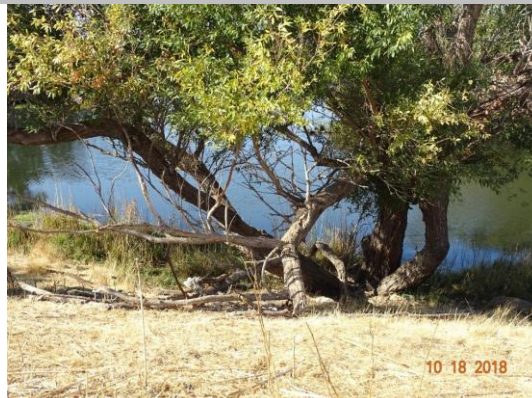
Photo 1 of 1 : FA_2018_RD2098_247_9_20181019_00023.jpg

LM Start	7.87	Rating **	M	Issue No.	9
LM End	7.87	Issue Type +	Ma	Location *	WS
Category	Earthen Levee			GPS Latitude/Longitude	
				Start	End
Item	Encroachments			38.301707°	38.301707°
				-121.728045°	-121.728045°
DWR ID	DWR_RD2098_03_s_2014_9				
Comment Code					
TR : Tree or limb					
Inspector Comment					
Remove the fallen tree limb from the water side slope.

View of fallen tree limb on the water side slope (October 2018).

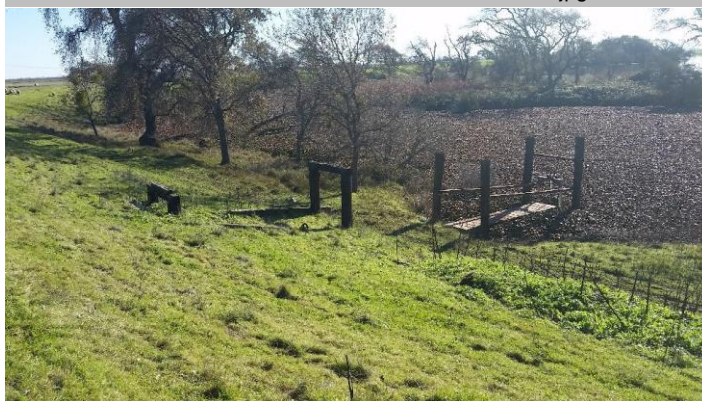
Photo 1 of 3 : UCIP_FA_2018_51453_76858.jpg

Comment Code						
Inspector Comment						
FS_ID:51453 DS_ID:20981 EP_NO: 10174 Repair Type: No Action Needed Crossing Status: Found UCIP Comments: 12/22/2016 Crossing has been downgraded from Urgent to No Action Needed walkways on both WS and LS have been rebuilt and the WS gate has been upgraded to stainless steel where previous corrodable material was present. (O. Magana - DWR UCIP)03/19/2014 Current walkway to slidegate on WS toe does not provide safe access to operate slidegate. (W. Wylie - DWR UCIP) FIELD_STRUCT_DESC: 36-inch steel dual-purpose irrigation and drainage pipe through the levee, 26 feet below the crown. Two corrugated metal cutoff walls around the pipe. Walkway to the slide gate on the waterside (WS) end. Combination slide and flap gate on the landside (LS) end. 48-inch corrugated metal pipe (CMP) riser and an adjoining pump on a metal pier at the LS toe. (36-inch pipe [HLM 8.20] authorized under Automatic Board Order (ABO) issued as Permit No. 10174, 1974 - Glen A. Bowsbey). [Additional Reference(s): DWR Levee Log, 2003. USACE Sacramento O&M Manual 109, April 1962, (HLM 8.20)]. FS Date: 12/22/2016

Walkway has been re-built, photo 1 of 2.

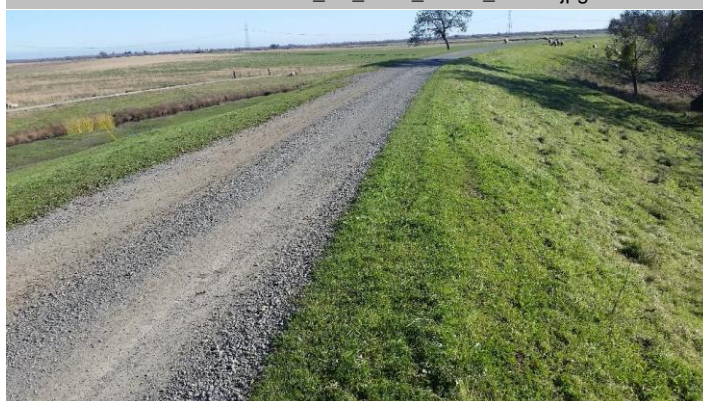
Photo 3 of 3 : UCIP_FA_2018_51453_76859.jpg

Comment Code						
Inspector Comment						
FS_ID:51453 DS_ID:20981 EP_NO: 10174 Repair Type: No Action Needed Crossing Status: Found UCIP Comments: 12/22/2016 Crossing has been downgraded from Urgent to No Action Needed walkways on both WS and LS have been rebuilt and the WS gate has been upgraded to stainless steel where previous corrodable material was present. (O. Magana - DWR UCIP)03/19/2014 Current walkway to slidegate on WS toe does not provide safe access to operate slidegate. (W. Wylie - DWR UCIP) FIELD_STRUCT_DESC: 36-inch steel dual-purpose irrigation and drainage pipe through the levee, 26 feet below the crown. Two corrugated metal cutoff walls around the pipe. Walkway to the slide gate on the waterside (WS) end. Combination slide and flap gate on the landside (LS) end. 48-inch corrugated metal pipe (CMP) riser and an adjoining pump on a metal pier at the LS toe. (36-inch pipe [HLM 8.20] authorized under Automatic Board Order (ABO) issued as Permit No. 10174, 1974 - Glen A. Bowsbey). [Additional Reference(s): DWR Levee Log, 2003. USACE Sacramento O&M Manual 109, April 1962, (HLM 8.20)]. FS Date: 12/22/2016

View of levee crown at pipe crossing.

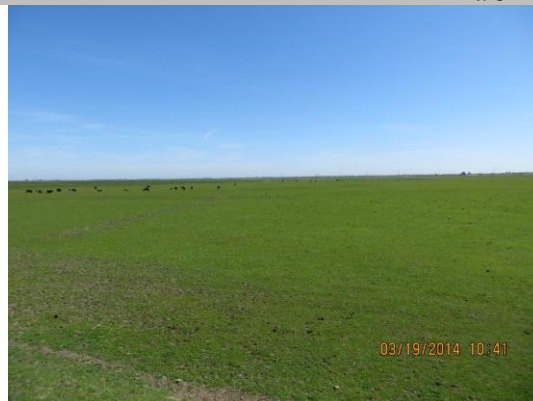
Photo 1 of 2 : UCIP_FA_2018_32383_58881.jpg

LM Start	9.49	Rating **	M	Issue No.	18	
LM End	9.49	Issue Type +	En	Location *		
Category	Supplemental			GPS Latitude/Longitude		
				Start	End	
Item	DWR UCIP Field Study			38.321032 °	38.321032 °	
				-121.740154 °	-121.740154 °	
DWR ID	20983					
Comment Code						
Inspector Comment						
FS_ID:32383 DS_ID:20983 EP_NO: N/A Repair Type: Non-Urgent Crossing Status: Indicator Found UCIP Comments: 03/19/2014 need to verify status of gaslines in region with PG&E (888) 743-7431 Email: PipelineRequests@pge.com. (W. Wylie - DWR UCIP) FIELD_STRUCT_DESC: 4-inch gas line of an unknown material through the levee, 2 feet below the crown. Shutoff valve located 370 feet east of the levee crown. [Additional Reference(s): DWR Levee Log, 2003]. FS Date: 3/19/2014

Shutoff valve visible 370-feet off LS toe.

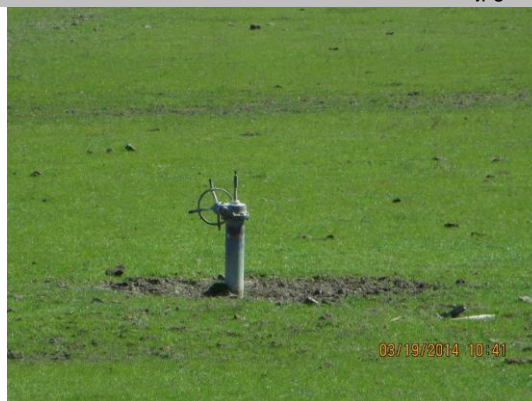
Photo 2 of 2 : UCIP_FA_2018_32383_58880.jpg

LM Start	9.49	Rating **	M	Issue No.	18 (cont)	
LM End	9.49	Issue Type +	En	Location *		
Category	Supplemental			GPS Latitude/Longitude		
				Start	End	
Item	DWR UCIP Field Study			38.321032 °	38.321032 °	
				-121.740154 °	-121.740154 °	
DWR ID	20983					
Comment Code						
Inspector Comment						
FS_ID:32383 DS_ID:20983 EP_NO: N/A Repair Type: Non-Urgent Crossing Status: Indicator Found UCIP Comments: 03/19/2014 need to verify status of gaslines in region with PG&E (888) 743-7431 Email: PipelineRequests@pge.com. (W. Wylie - DWR UCIP) FIELD_STRUCT_DESC: 4-inch gas line of an unknown material through the levee, 2 feet below the crown. Shutoff valve located 370 feet east of the levee crown. [Additional Reference(s): DWR Levee Log, 2003]. FS Date: 3/19/2014

Shutoff valve visible 370-feet off LS toe.

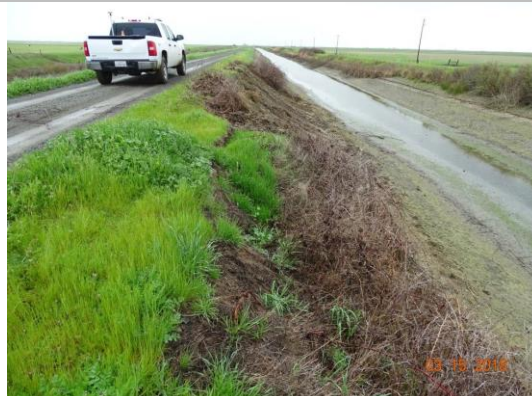
Photo 1 of 1 : FA_2018_RD2098_248_17_20180925_00002.jpg

LM Start	10.02	Rating **	A/W	Issue No.	17
LM End	10.02	Issue Type +	Ma	Location *	LS
Category	Earthen Levee			GPS Latitude/Longitude	
				Start	End
Item	Slope Stability			38.328368 °	38.328438 °
				-121.740617 °	-121.740612 °
DWR ID	DWR_RD2098_04_s_2017_17				
Comment Code					
S2 : Repair the levee slope damaged by foot traffic and prevent access where possible.					
Inspector Comment					
Sloughing landside slope has been temporarily repaired at this specific location, but this area shows cracks along shoulder and should continue to be monitored.

Slumping landside slope should be monitored and repaired as needed.

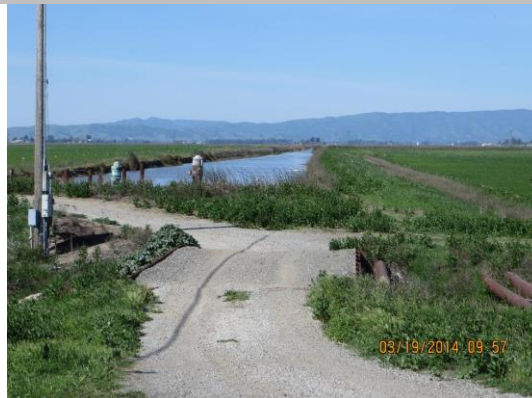
Photo 2 of 3 : UCIP_FA_2018_32403_58904.jpg

Comment Code						
Inspector Comment						
FS_ID:32403 DS_ID:20991 EP_NO: 12851 Repair Type: Non-Urgent Crossing Status: Found UCIP Comments: 12/22/2016 Met with Mike Hadesty, LMA Superintendent, and Brian Bush, LMA General Manager, to go over the list of pipes in RD2098. Per LMA, suspended pipe with leaks was repaired in the summer of 2016. (O. Magana - DWR UCIP) 03/19/2014 Holes in pipe next to rail car bridge may indicate further deterioration of pipe through levee. Good candidate for video inspection. (W. Wylie - DWR UCIP) FIELD_STRUCT_DESC: 12-inch steel irrigation pipe through the levee, 2 feet below the crown. Cutoff wall around the pipe at the center of the levee. Siphon breaker on the landside (LS) toe at the canal. 1-inch polyvinyl chloride (PVC) electrical conduit at the same location (Permit No. 12851, 1980 - Bunker Ranch). [Additional Reference(s): DWR Levee Log, 2003]. FS Date: 3/19/2014

Pump on pier in irrigation canal off WS toe.
